FORMATION TESTING REPORT RESULTS

Company CANDECCA RESOURCES Ltd Well No SEATON ROSS 4 I Test No 2

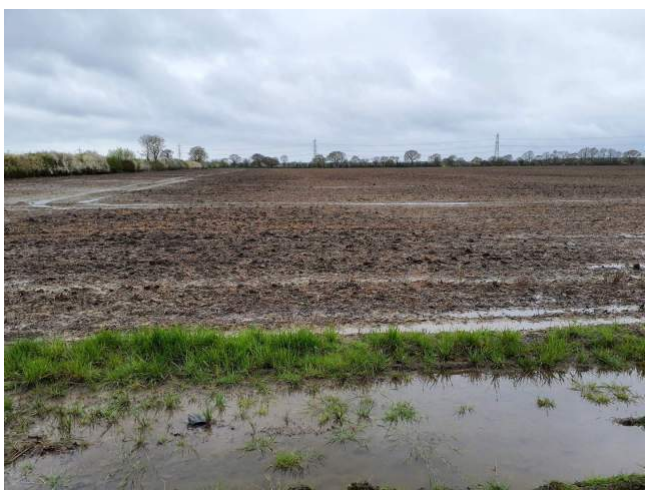
| 1a. Main land use(s) | 13zi | W | |

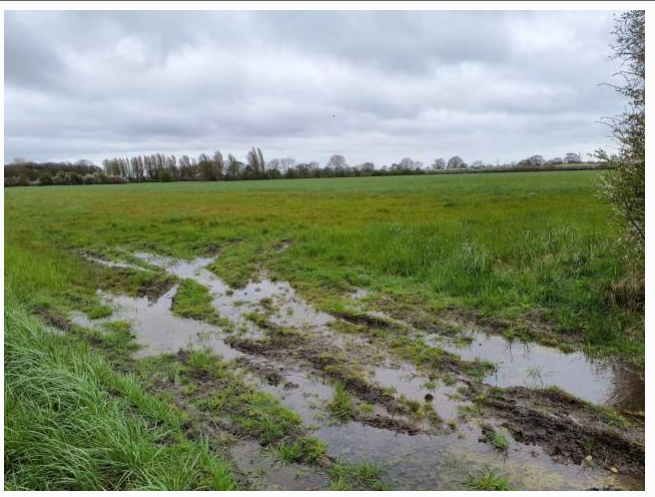
| 1a. Main land use(s) | 13zj from ne corner | SW | |

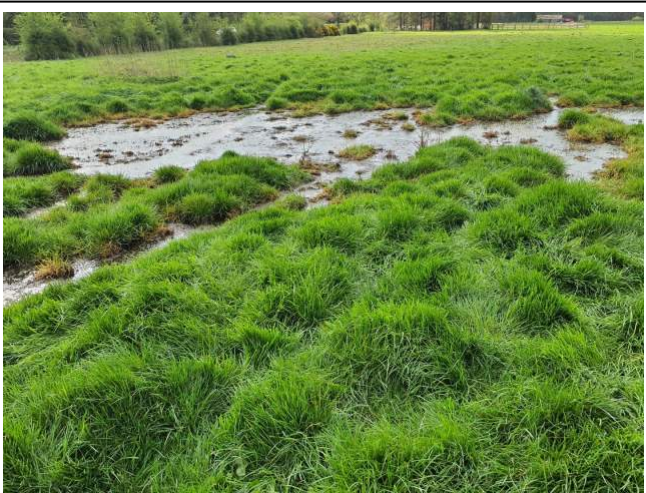
| OTHER | Typical conditions within 15b (any sheen is coincidental, no contamination observed) | S | |

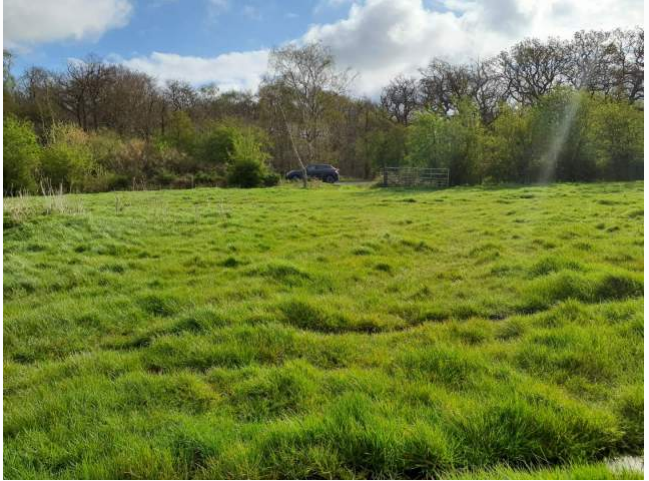
| <p>2a. Access constraints - general.</p> | <p>Access to 15b from General In</p> | <p>E</p> | |

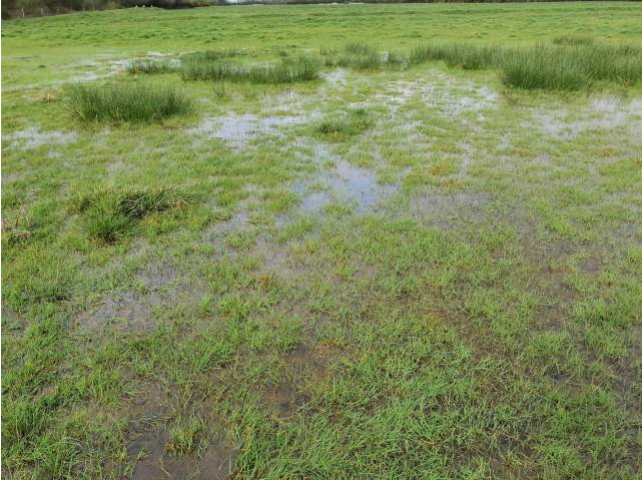
| <p>4d. Surface waters on site</p> | <p>Very wet conditions at 15a/b boundary</p> | <p>W</p> | |

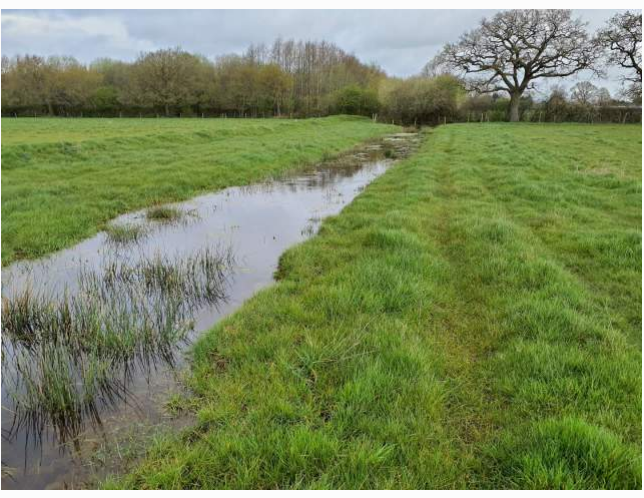
| <p>4d. Surface waters on site</p> | <p>Ditch marking 15a/b boundary</p> | <p>W</p> | |

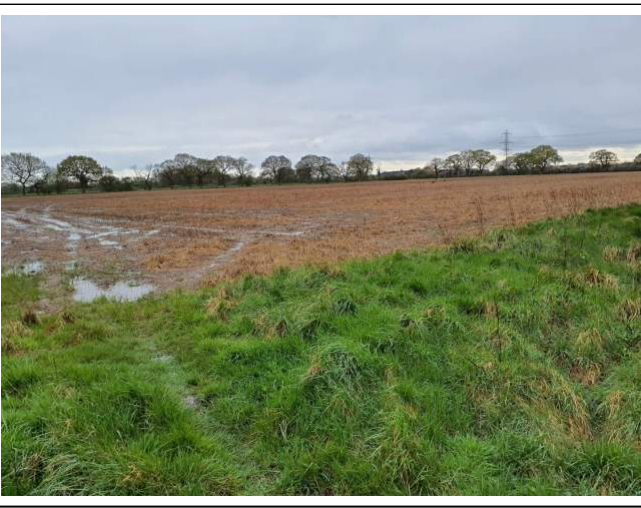
| <p>1a. Main land use(s)</p> | <p>3d from NW corner</p> | <p>SW</p> | |

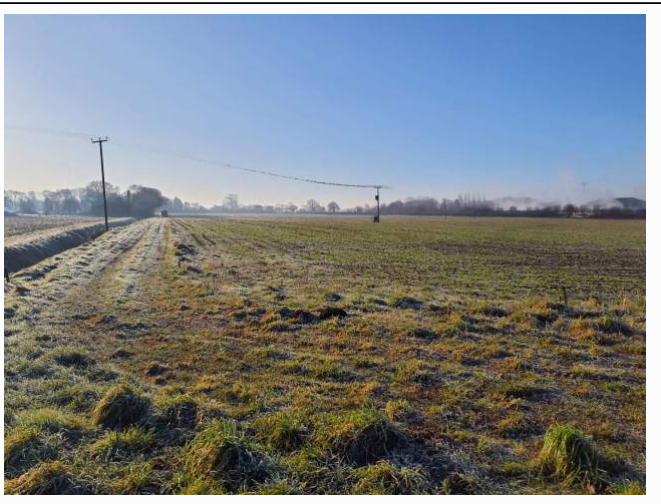
| <p>1a. Main land use(s)</p> | <p>23a. Solar panels in southwest corner. Telephone lines run from road to the east, running southwest.</p> | <p>S</p> | |

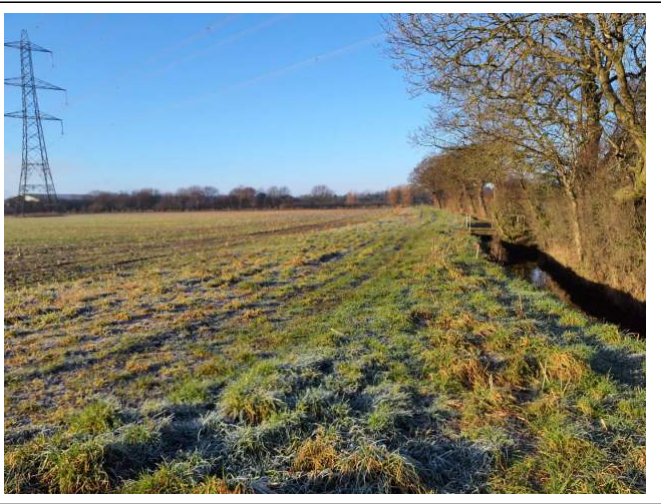
| <p>1a. Main land use(s)</p> | <p>23a. Pylon within the field on the western boundary.</p> | <p>W</p> | |

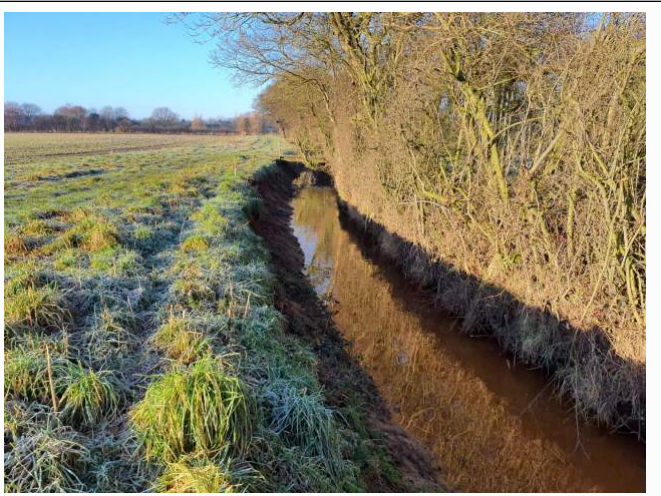
| <p>4d. Surface waters on site</p> | <p>Ditch between 23a and 23b, running east-west. Water was shallow and clear.</p> | <p>W</p> | |

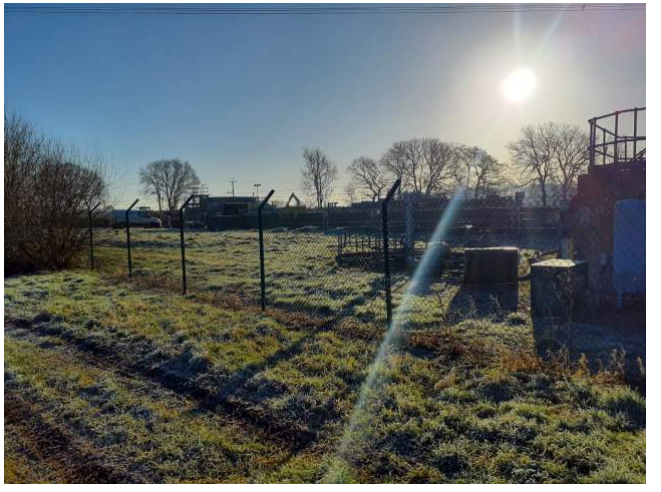
| <p>1c. Adjacent land use(s)</p> | <p>Morrisons Water services/Yorkshire water site adjacent to 23a-d.</p> | <p>SE</p> | |

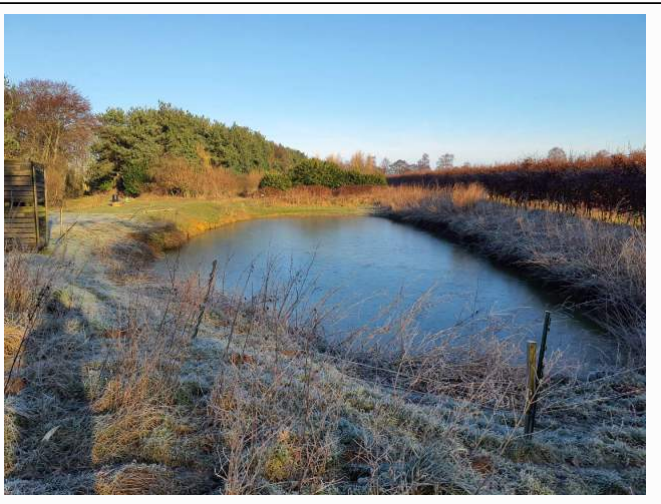
| <p>4d. Surface waters on site</p> | <p>Pond between 23b and 23c, part of the 23c footprint.</p> | <p>N</p> | |

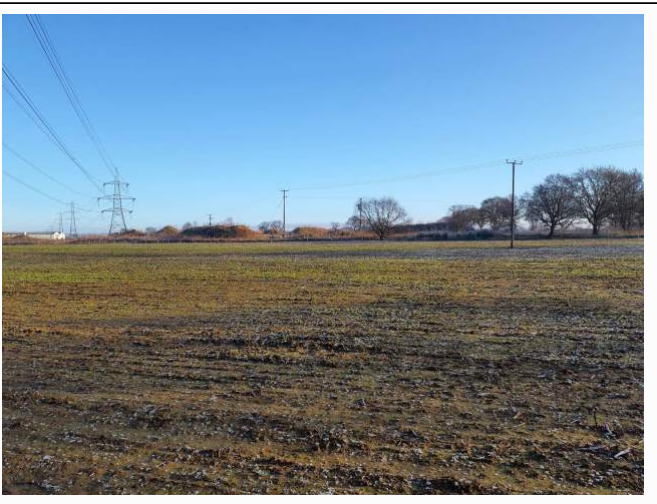
| <p>5c. Buried and overhead services</p> | <p>Telephone lines running across 23c North East from water works to road and beyond. Likely through 23d,f,g,h.</p> | <p>NE</p> | |

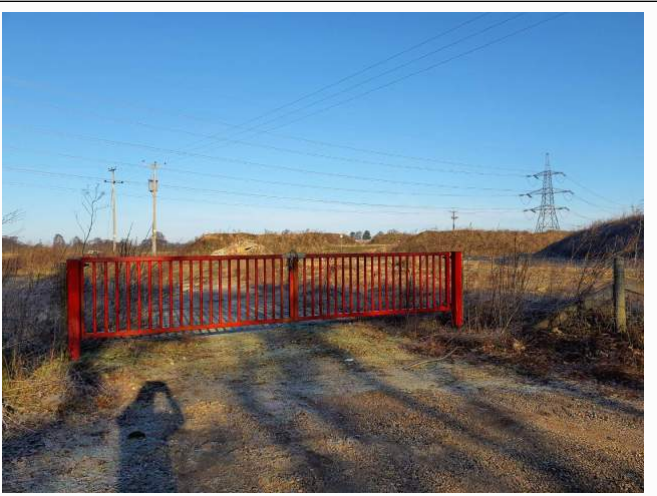
| <p>1a. Main land use(s)</p> | <p>Access to 23d. Telephone wires running across. On site dumping. Stockpiles of unknown material. View from SW corner looking NE.</p> | <p>NE</p> | |

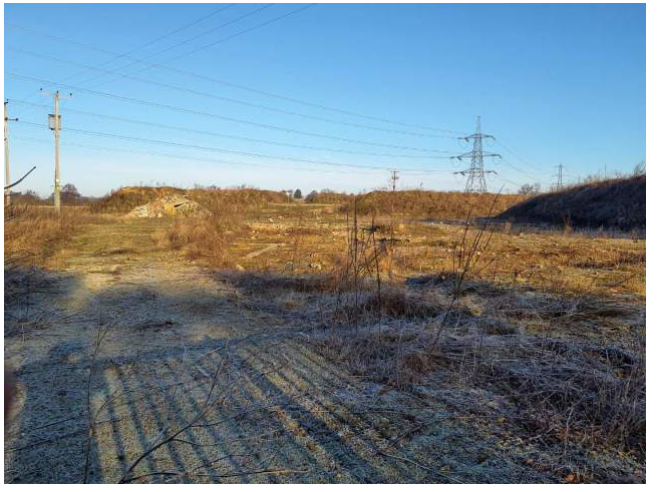
| Question | Combined Response |
|---|---|
| F3. Are there any remains of building structures present on or adjacent to site? | Yes : foundations observed in 23D between the stockpiles of rubble and soil. |

| <p>7b. Waste storage</p> | <p>Evidence of former buildings in 23d shown by foundations.</p> | <p>NE</p> | |

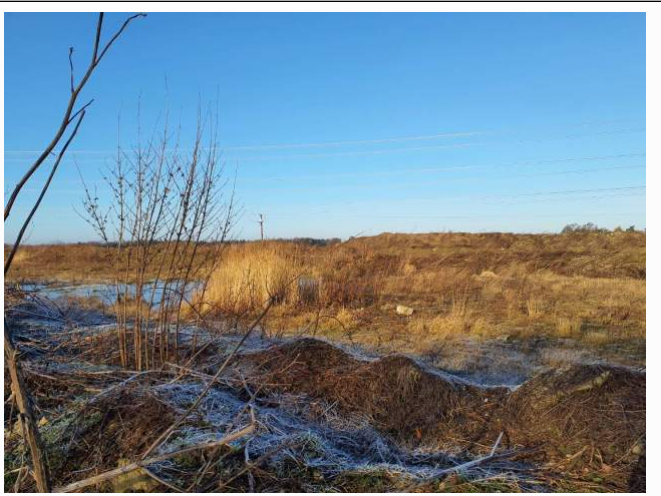
| Question | Combined Response |
|---|--|
| G2. Is there any waste storage on site? | Yes : Piles of pallets and waste grasses in area 24H-L. Large piles of rubble and waste noted in 23d. |

| <p>1a. Main land use(s)</p> | <p>23d. Further stockpiles within 23c.</p> | <p>N</p> | |

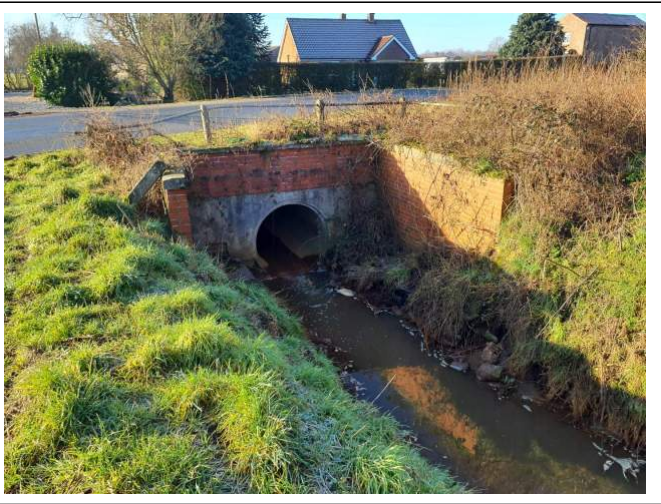
| <p>4e. Surface waters adjacent (within 250m)</p> | <p>Ditch at western boundary 23k-m, culverted under the road from farm to the south. Slight smell. Runs southwest-northeast between these fields.</p> | <p>SW</p> | |

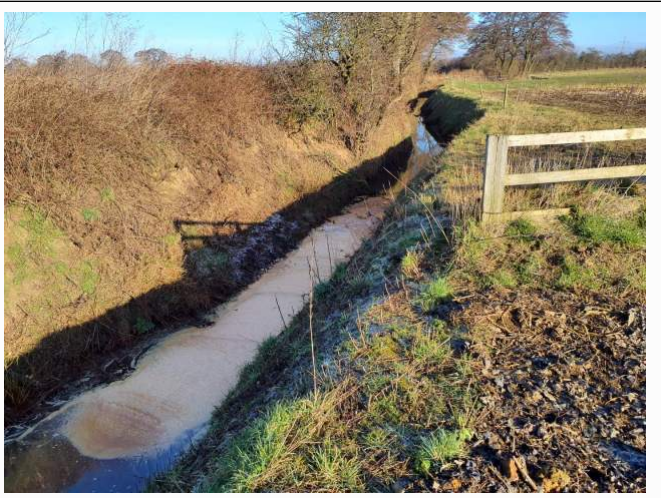
| <p>4e. Surface waters adjacent (within 250m)</p> | <p>Ditch at western boundary 23k-m, culverted under the road from farm to the south. Slight smell. Runs southwest-northeast between these fields. Foam present on surface of water.</p> | <p>NE</p> | |

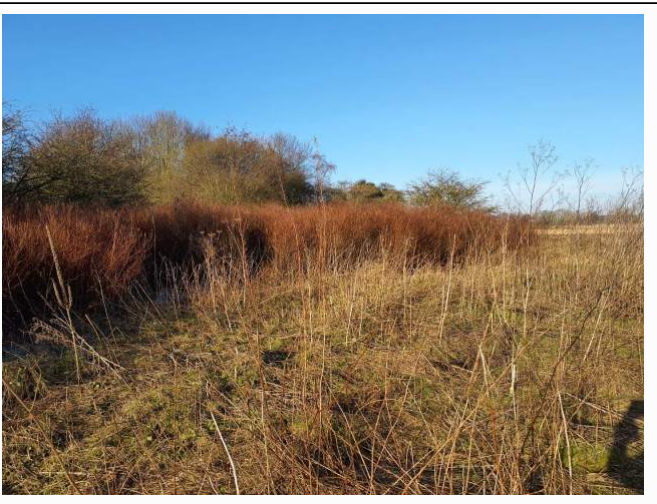
| <p>1a. Main land use(s)</p> | <p>23J. Former landfill now heavily vegetated.</p> | <p>W</p> | |

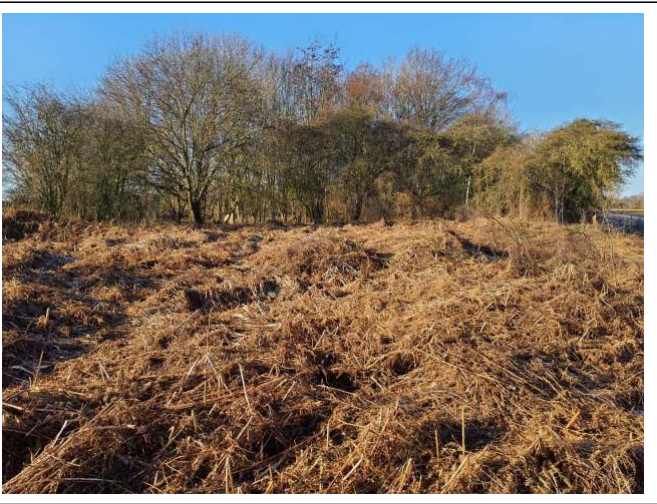
| <p>1a. Main land use(s)</p> | <p>23J. Former landfill now heavily vegetated. View from field 23i to the north.</p> | <p>SW</p> | |

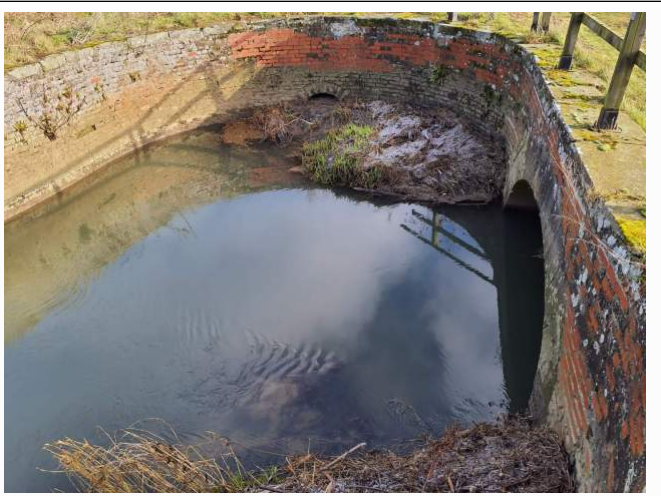
| <p>4d. Surface waters on site</p> | <p>Bridge between canal and beck (water runs to Thornton weir). Outfall from the east is silted up. Water generally clear.</p> | <p>S</p> | |

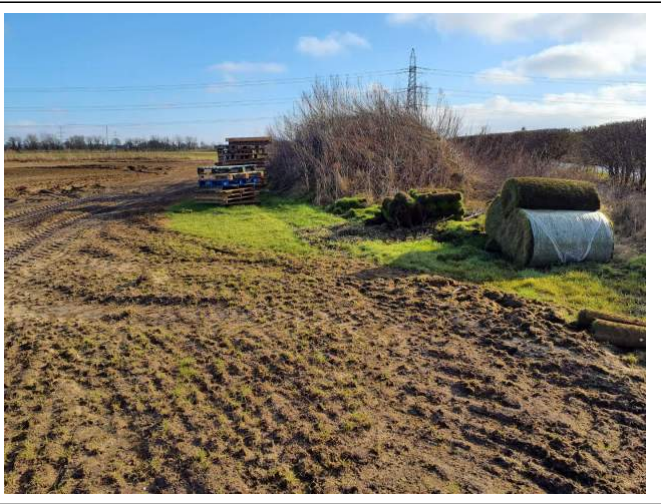
| <p>7d. Fly-tipping</p> | <p>Material storage by road edge in 24J.</p> | <p>E</p> | |

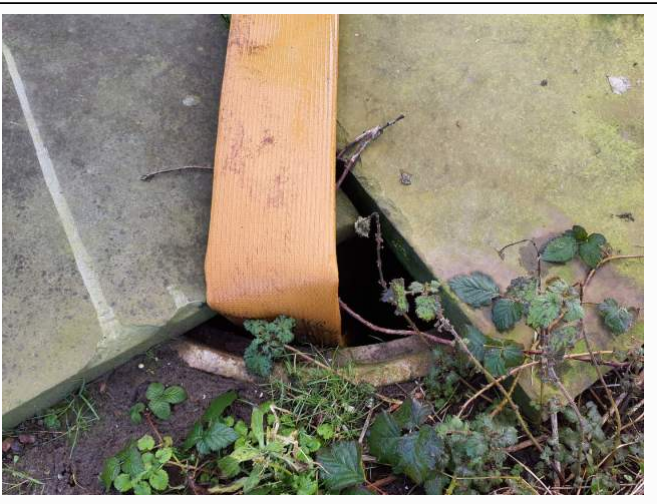
| Question | Combined Response |
|--|---|
| E5. Are there any underground structures present on or adjacent to site? | Yes : Field drains observed in some fields and larger manhole seen in 24K by the road entrance. Services along roads |

| <p>4g. Site drainage</p> | <p>Deep manhole with flowing water at 24k entry. Water hose had been cut and no water was coming from it.</p> | <p>E</p> | |

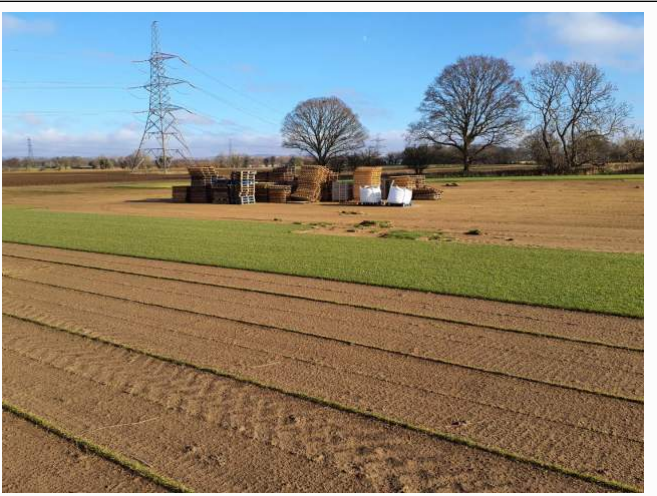
| <p>7b. Waste storage</p> | <p>Materials left at top of 24I. Pallets, turf rolls and large bags of unknown material.</p> | <p>E</p> | |
