SEI Appendix D: Additional Potential Restoration Areas

Table 1 – Summary of Additional Potential Restoration Areas

Table 2 – Additional Potential Restoration Areas

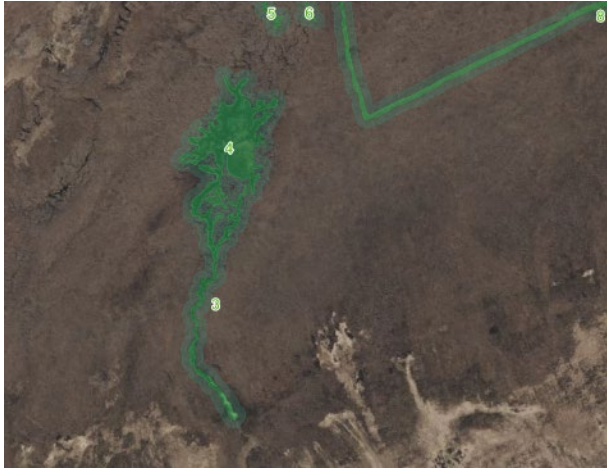
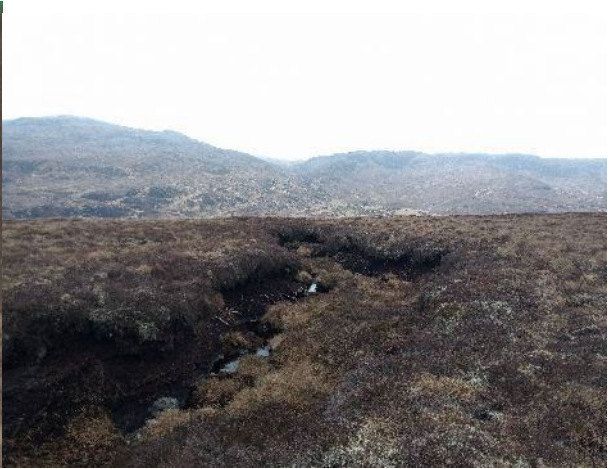
Area ID and Description	Recommended Restoration Techniques	Images	
<p>Area ID: 3 Location: NH 42634 25713 Description: Erosional features up to 2 m depth. Erosional gullies connected via underground peat pipes. Downgradient gullies open up into acid grassland. Area (m²): 1,632</p>	<p>Repair of eroded / bare areas using machine-based techniques Access via non wind farm tracks</p>

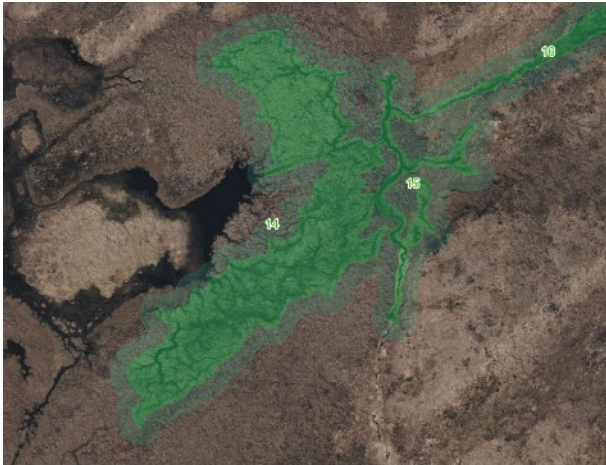
Area ID and Description	Recommended Restoration Techniques	Images	
<p>Area ID: 14</p> <p>Location: NH 43430 27600</p> <p>Description: Large network of dendritic erosional features with extensive bare peat and some surface water accumulation in basin of ridge adjacent to lochan. Drained via OS watercourse flowing south from Area 15 and by watercourse flowing south from lochan. Water table likely lowered by grazing and burning modifying influences on peatland.</p> <p>Area: 12,559 m²</p>	<p>Repair of eroded / bare areas using hand techniques and helicoptered materials</p> <p>Personnel access via argocat</p>

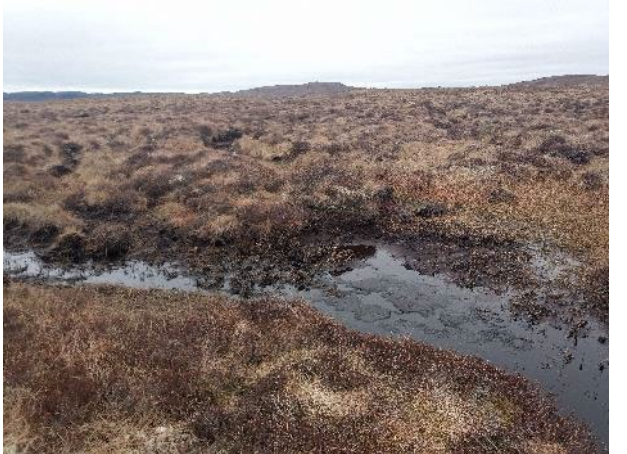
<p>Area ID: 15</p> <p>Location: NH 43517 27625</p> <p>Description: Surface water channel draining south with some bare peat exposed. Lowering of water table contributing to nearby peat erosion. Drained via OS watercourse flowing south from area.</p> <p>Area: 1,844 m²</p>	<p>Repair of eroded / bare areas using hand techniques and helicoptered materials</p> <p>Personnel access via argocat</p>

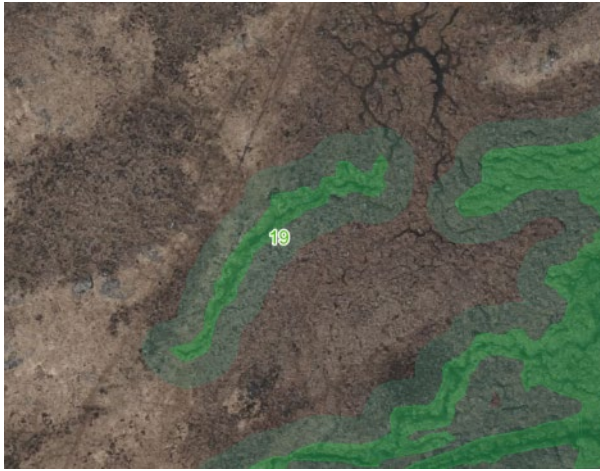
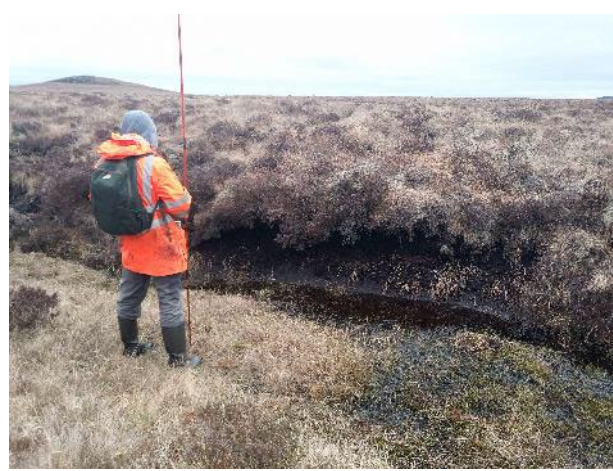
<p>Area ID: 19</p> <p>Location: NH 43649 27824</p> <p>Description: Erosional gullies draining to south with bare peat exposure up to 1.2 m deep. Lowering of water table is threatening bog pool area to north.</p> <p>Area: 812 m²</p>	<p>Repair of eroded / bare areas using hand techniques and helicoptered materials</p> <p>Personnel access via argocat</p>

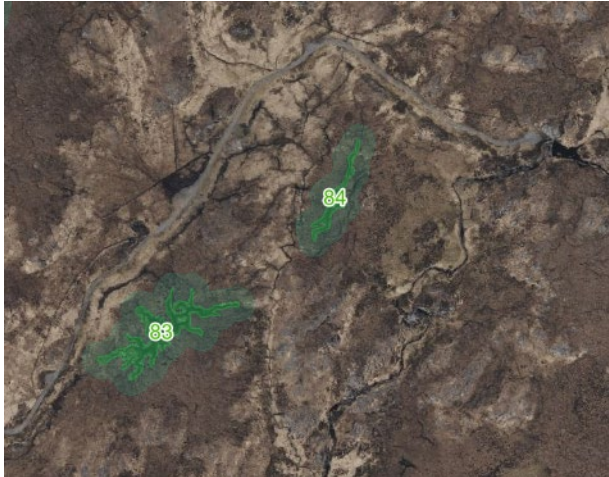
Area ID and Description	Recommended Restoration Techniques	Images	
<p>Area ID: 84</p> <p>Location: NH 43742 21587</p> <p>Description: Bog pools and some near natural features within modified bog habitat are threatened by peat erosional gully, pictured.</p> <p>Area: 333 m²</p>	<p>Repair of eroded / bare areas using hand techniques</p> <p>Personnel and materials access via argocat</p>

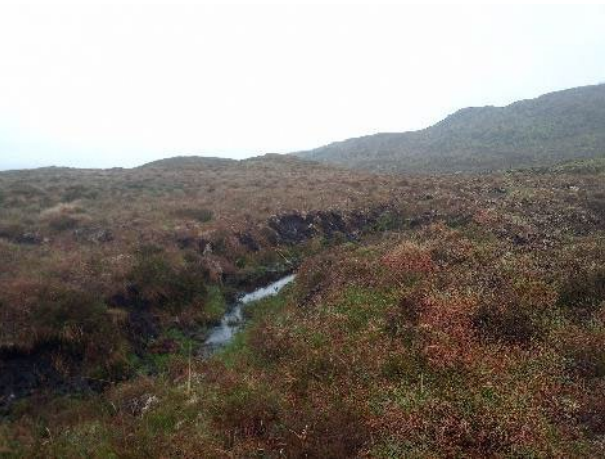
<p>Area ID: 85</p> <p>Location: NH 42081 20887</p> <p>Description: Erosional gully retaining some surface water and bog vegetation but actively eroding with some bare peat exposure.</p> <p>Area: 1,337 m²</p>	<p>Repair of eroded / bare areas using hand techniques and helicoptered materials</p> <p>Personnel access via argocat</p>

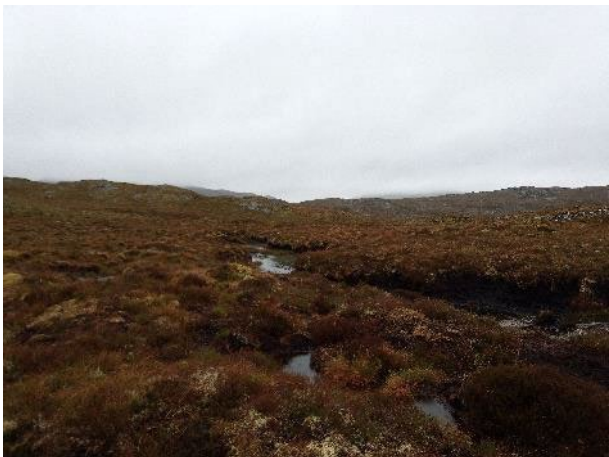
<p>Area ID: 87</p> <p>Location: NH 41346 21592</p> <p>Description: Extensive bare peat area draining via dendritic erosional gullies, with bare peat exposures up to 2 m deep.</p> <p>Area: 6,833 m²</p>	<p>Repair of eroded / bare areas using hand techniques and helicoptered materials</p> <p>Personnel access via argocat</p>

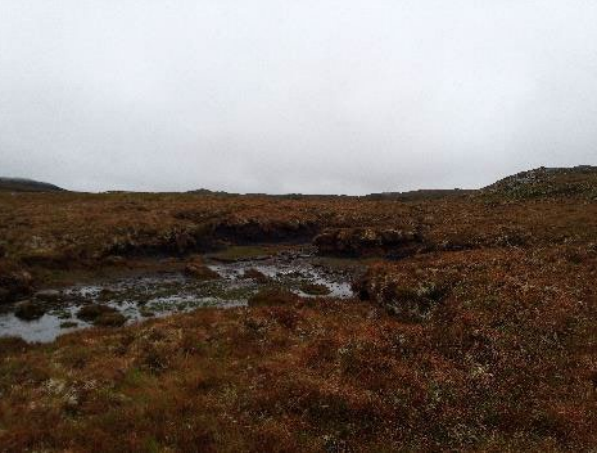
Area ID and Description	Recommended Restoration Techniques	Images	
<p>Area ID: 88</p> <p>Location: NH 41053 21929</p> <p>Description: Erosional gullies eroding to lochan north-west of area. Eroded to bedrock and grit substrate in places with visible surface water drainage in base of features.</p> <p>Area: 3,339 m²</p>	<p>Repair of eroded / bare areas using hand techniques and helicoptered materials</p> <p>Personnel access via argocat</p>

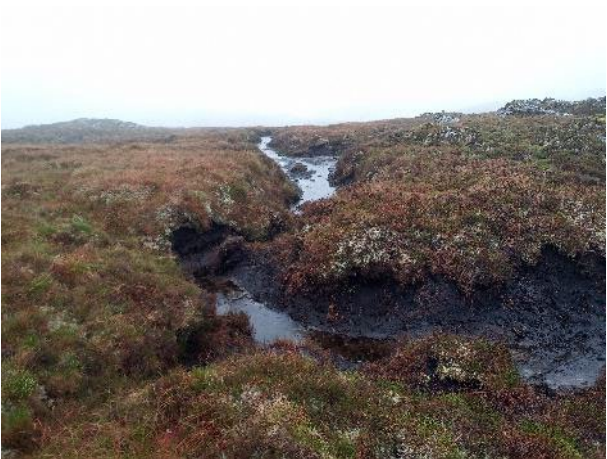
<p>Area ID: 101 Location: NH 40741 22500 Description: Erosional gully with bare peat exposures over 1 m deep. Area: 158 m²</p>	<p>Repair of eroded / bare areas using hand techniques and helicoptered materials Personnel access via argocat</p>

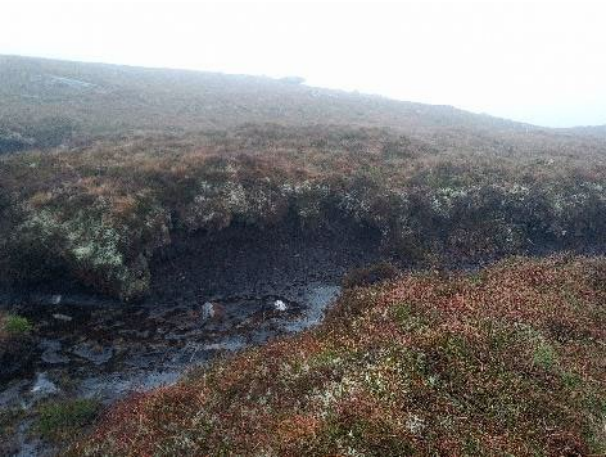
Area ID and Description	Recommended Restoration Techniques	Images	
<p>Area ID: 102 Location: NH 40484 22329 Description: Eroded area on deep peat draining via erosional gullies with exposed bare peat within features. Area: 486 m²</p>	<p>Repair of eroded / bare areas using hand techniques and helicoptered materials Personnel access via argocat</p>

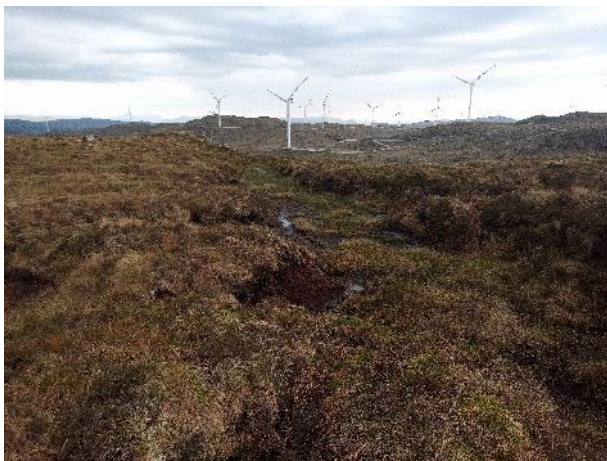
Area ID and Description	Recommended Restoration Techniques	Images	
<p>Area ID: 108</p> <p>Location: NH 38387 22699</p> <p>Description: Erosional channels in valley between rock outcrops with bare peat exposures and evidence of ongoing erosion.</p> <p>Area: 1,404 m²</p>	<p>Repair of eroded / bare areas using machine-based techniques</p> <p>Access via non wind farm tracks</p>

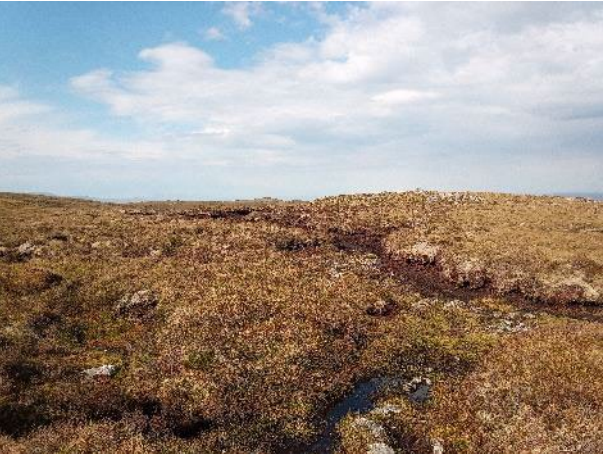
Area ID and Description	Recommended Restoration Techniques	Images	
<p>Area ID: 118</p> <p>Location: NH 37401 25055</p> <p>Description: Peat haggling within valley between rock outcrops.</p> <p>Area: 583 m²</p>	<p>Repair of eroded / bare areas using machine-based techniques</p> <p>Access via wind farm track network</p>

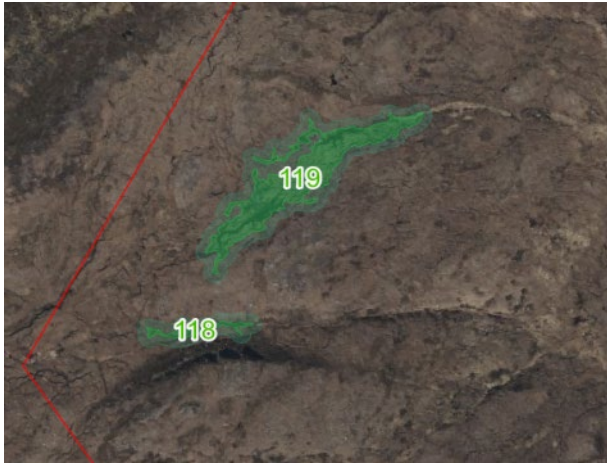
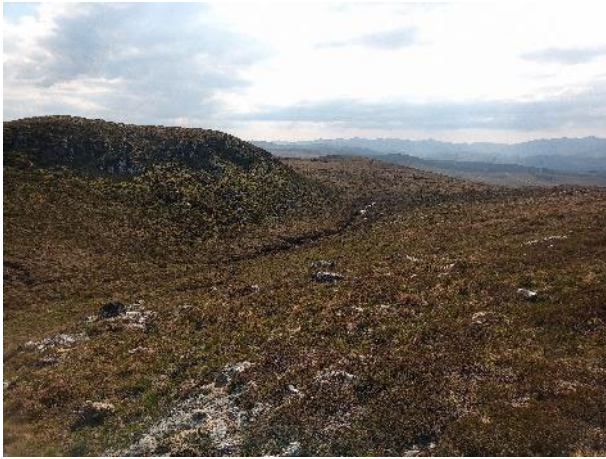
<p>Area ID: 119</p> <p>Location: NH 37521 25236</p> <p>Description: Extensive bare peat areas drained by erosional gullies with evidence of surface water drainage at base of features.</p> <p>Area: 8,970 m²</p>	<p>Repair of eroded / bare areas using machine-based techniques</p> <p>Access via wind farm track network</p>

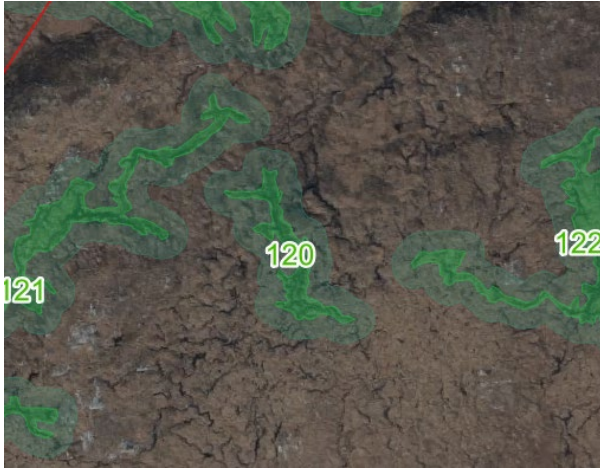
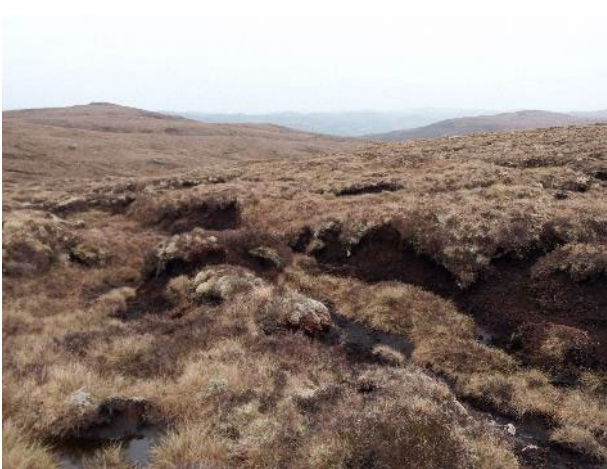
<p>Area ID: 121</p> <p>Location: NH 37721 25746</p> <p>Description: Erosional features with bare peat exposures extending downslope towards saddle in ridge. Bare peat area exposures up to 1.5m depth, eroded to grit and bedrock substrate in places.</p> <p>Area: 3,707 m²</p>	<p>Repair of eroded / bare areas using machine-based techniques</p> <p>Access via wind farm track network</p>

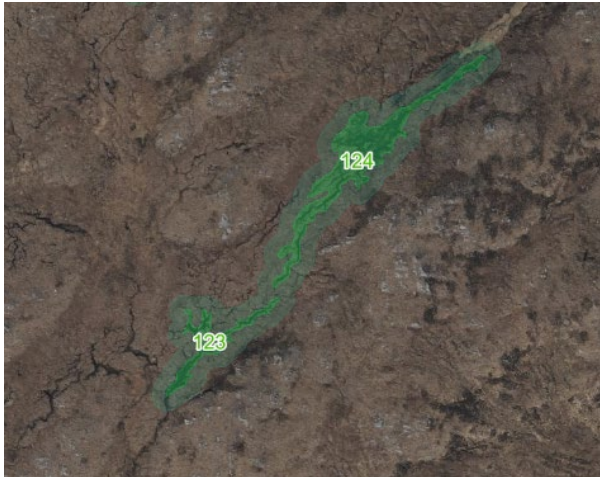
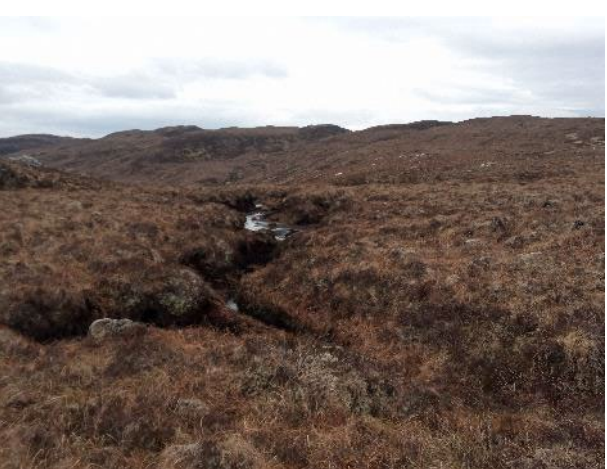
Area ID and Description	Recommended Restoration Techniques	Images	
<p>Area ID: 124 Location: NH 38189 25597 Description: Network of erosional features with extensive bare peat above headwaters of unnamed tributary to Allt Seanabhaile. Area: 2,742 m²</p>	<p>Repair of eroded / bare areas using machine-based techniques Access via wind farm track network</p>

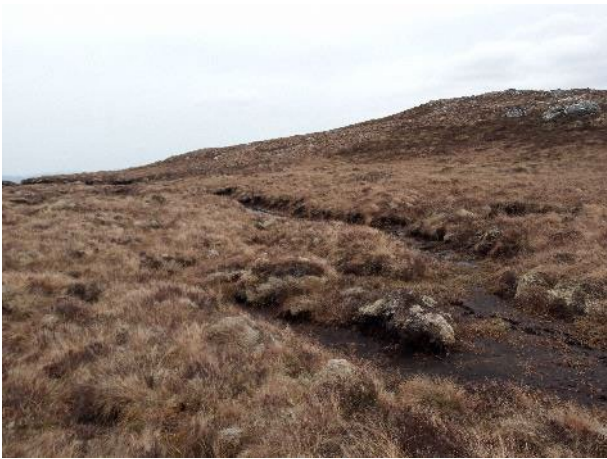
<p>Area ID: 125 Location: NH 38179 25133 Description: Continuation of area identified within original EIA Report. Area contains bog pools with sphagnum species and some near natural features that now have areas of bare peat exposure are undergoing erosion via erosional gullies due to grazing pressure altering vegetation structure. Area: 904 m²</p>	<p>Repair of eroded / bare areas using machine-based techniques Access via wind farm track network</p>

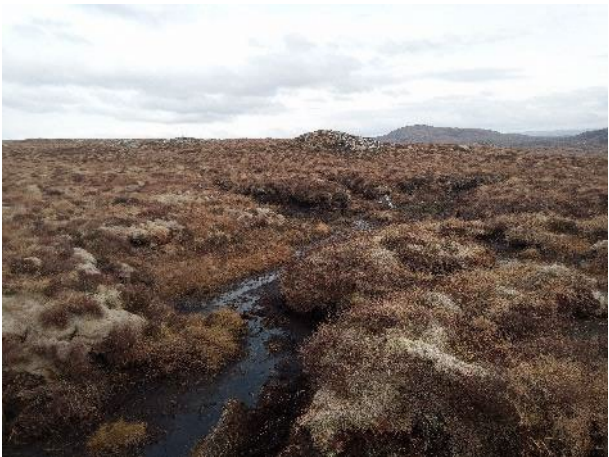
<p>Area ID: 155</p> <p>Location: NH 39895 25106</p> <p>Description: Dendritic erosional features with bare peat and erosional gullies lowering water table. Peat exposures up to 1.5 m deep in erosional gullies.</p> <p>Area: 3,167 m²</p>	<p>Repair of eroded / bare areas using machine-based techniques</p> <p>Access via non wind farm tracks</p>

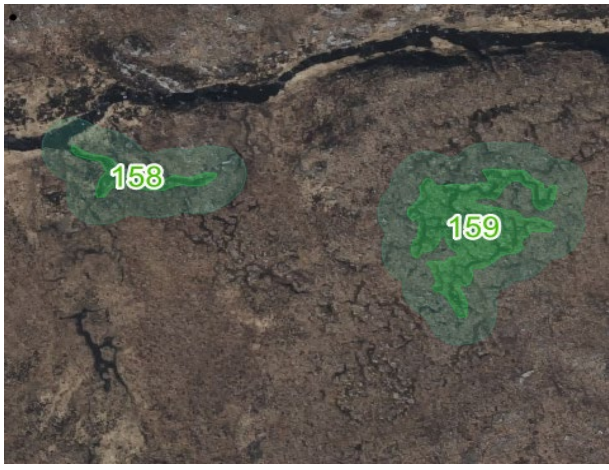
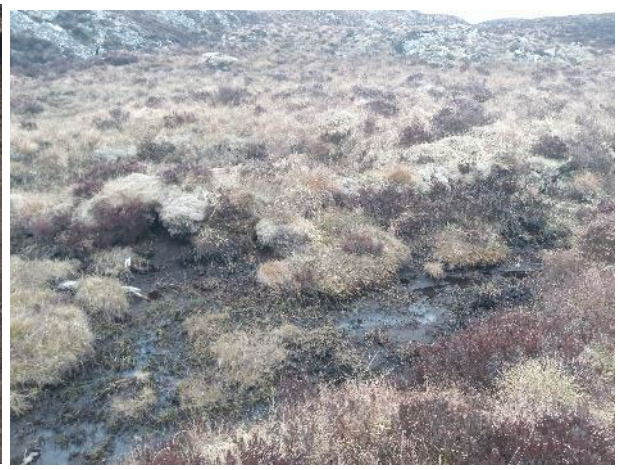
<p>Area ID: 159 Location: NH 39401 25929 Description: Bog pool network eroding via shallow erosional features with bare peat visible. Area: 1,260 m²</p>	<p>Repair of eroded / bare areas using machine-based techniques Access via non wind farm tracks</p>

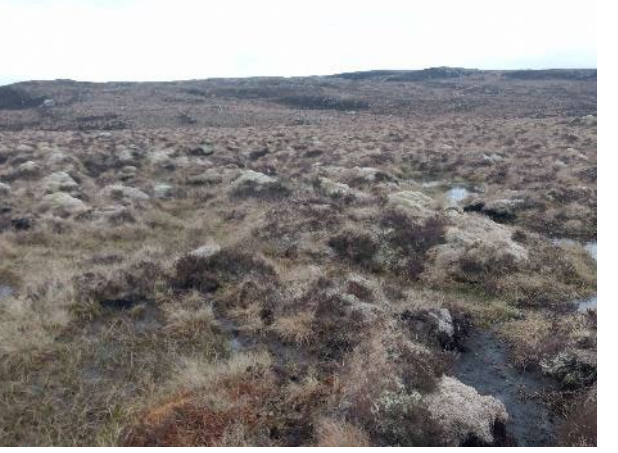
Area ID and Description	Recommended Restoration Techniques	Images	
<p>Area ID: 163</p> <p>Location: NH 40006 26726</p> <p>Description: Network of erosional features with extensive bare peat areas at break in slope at transition to wetter habitat on saddle of ridge.</p> <p>Area: 582 m²</p>	<p>Repair of eroded / bare areas using machine-based techniques</p> <p>Access via non wind farm tracks</p>

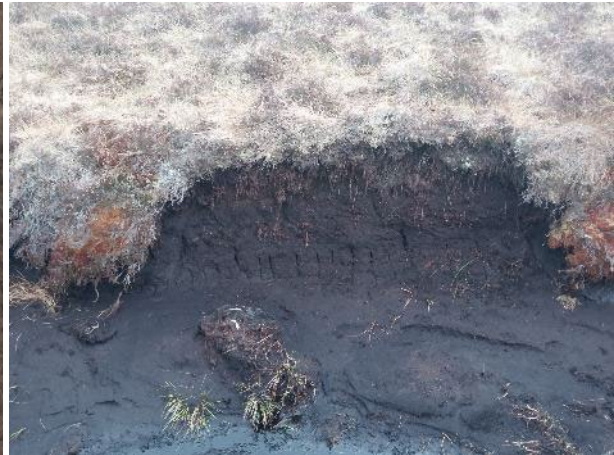
<p>Area ID: 170 Location: NH 40601 26967 Description: Large eroded area with extensive bare peat exposures and ongoing lowering of water table via erosional gullies around periphery of area. Area: 37,217 m²</p>	<p>Repair of eroded / bare areas using machine-based techniques Access via non wind farm tracks</p>

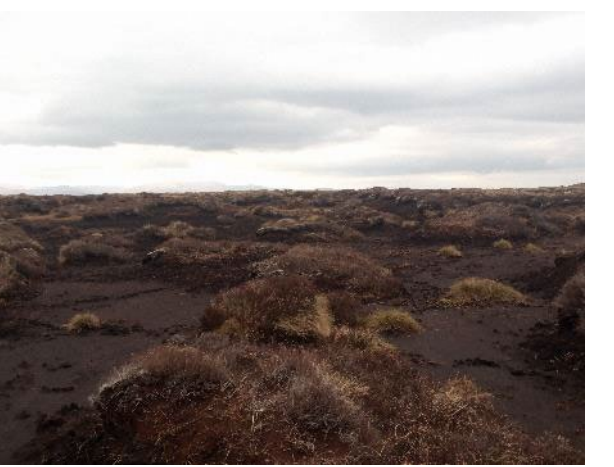
Area ID and Description	Recommended Restoration Techniques	Images	
<p>Area ID: 171 Location: NH 40725 26766 Description: Dendritic network of erosional features with bare peat exposures. Area: 2,056 m²</p>	<p>Repair of eroded / bare areas using machine-based techniques Access via non wind farm tracks</p>
