Appendix 7.1: Watercourse Crossings and Buffers

Appendix 7.1: An Carr Dubh Wind Farm - Watercourse Crossings and Buffers

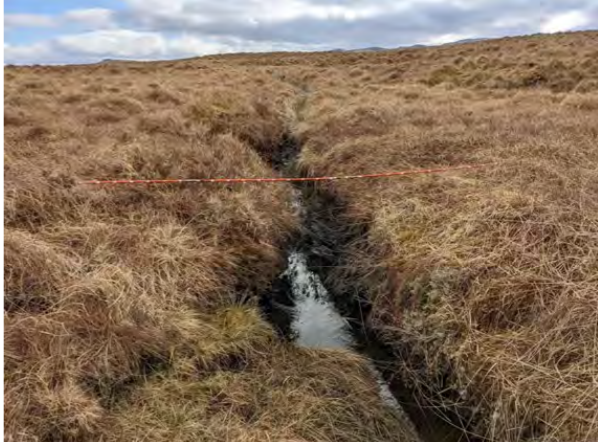
8	Unnamed	202126	712686	-	0.6	Silt	N	Y	Due to proximity of T10 hardstanding, this small watercourse will be diverted round the infrastructure to avoid a long culvert under the hardstanding. This will maintain hydrological connectivity downstream.	N/A	0.01	Yes	No

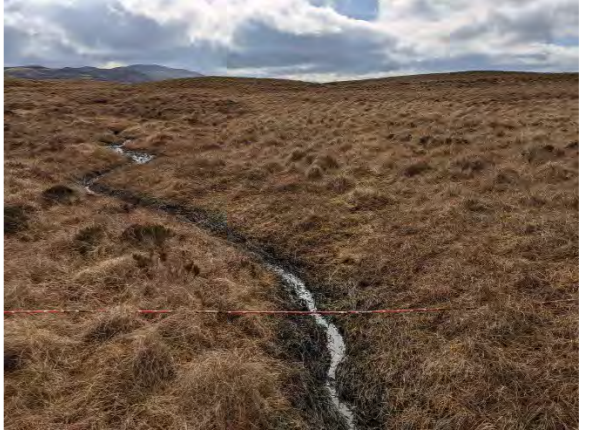
9	Unnamed	202138	712688	-	0.2	Silt	N	Y	Due to proximity of T10 hardstanding, this small watercourse will be diverted round the infrastructure to avoid a long culvert under the hardstanding. This will maintain hydrological connectivity downstream.	N/A	0.01	Yes	No

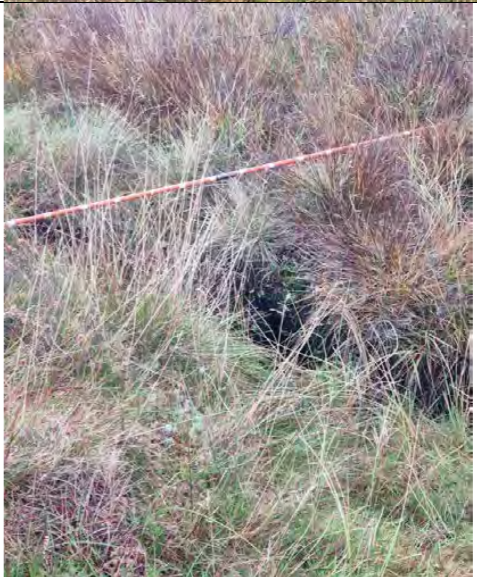
11	Unnamed	201392	711239	Watercourse goes underground through peat pipe at crossing location	1	Silt, peat	N	Y	Proposed	N/A	0.03	Yes	No

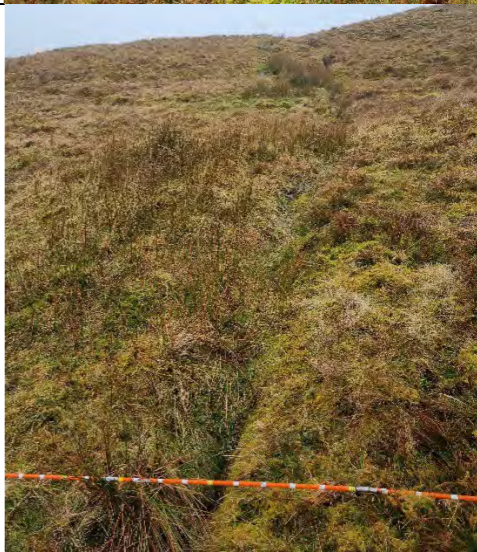
35	Unnamed	204441	711394	-	0.2	Gravel	N	Y	Due to proximity of T01 hardstanding, this runoff will be diverted round the infrastructure to avoid a long culvert under the hardstanding. This will maintain hydrological connectivity downstream	N/A	<0.01	Yes	No

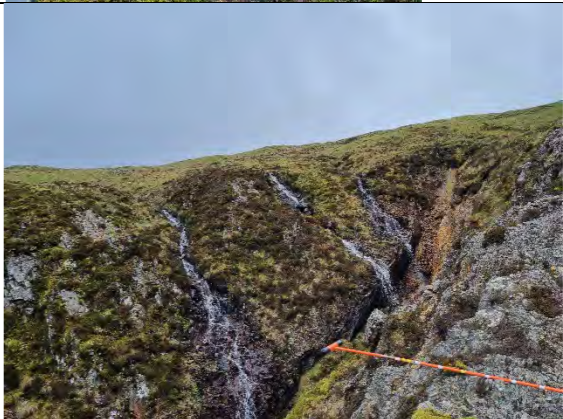
45	Unnamed	204674	710616	Large waterfall valley and gully (pictured). Track position has been moved south to avoid the deep gully.	1.5	Mixed to cobble	Y	Y	Proposed	N/A	0.04	Yes	No

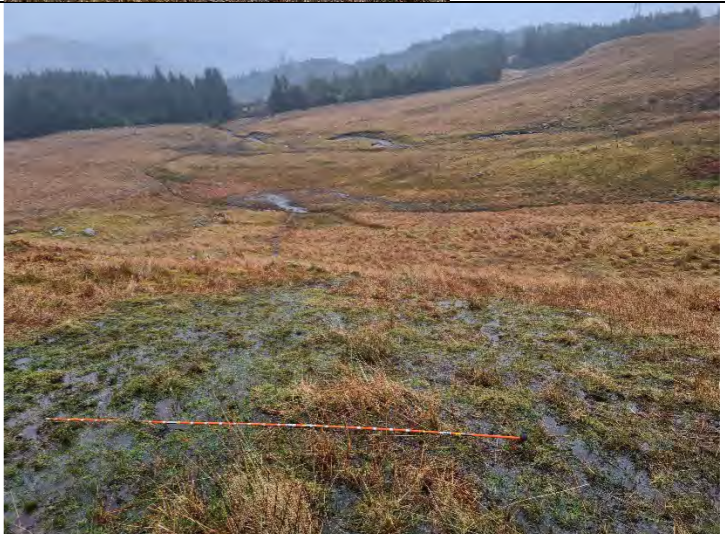
69	Unnamed	206815	710269	Large spring gushing water over wide area. No defined channel.	-	-	N	Y	Proposed	N/A	<0.01	Yes	No

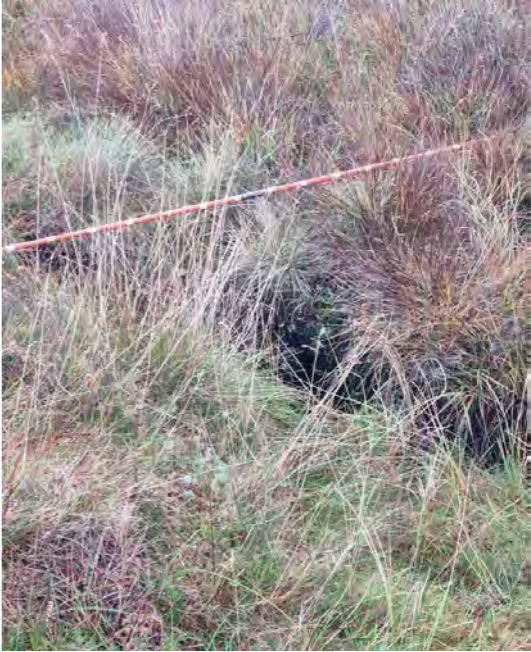
G	Unnamed	n/a (waterbody)	Small waterbody	Track (floating)	Permanent	43m	Upgradient	<p>This is a small waterbody (lochan) that sits at a slightly higher elevation than the proposed track. Run-off from the track will not flow towards the waterbody and there is no flood risk from the waterbody.</p> <p>Embedded mitigation (i.e. SuDS) around the track will be included in the design.</p> <p>Buffer width is considered adequate for size of water feature.</p>	None

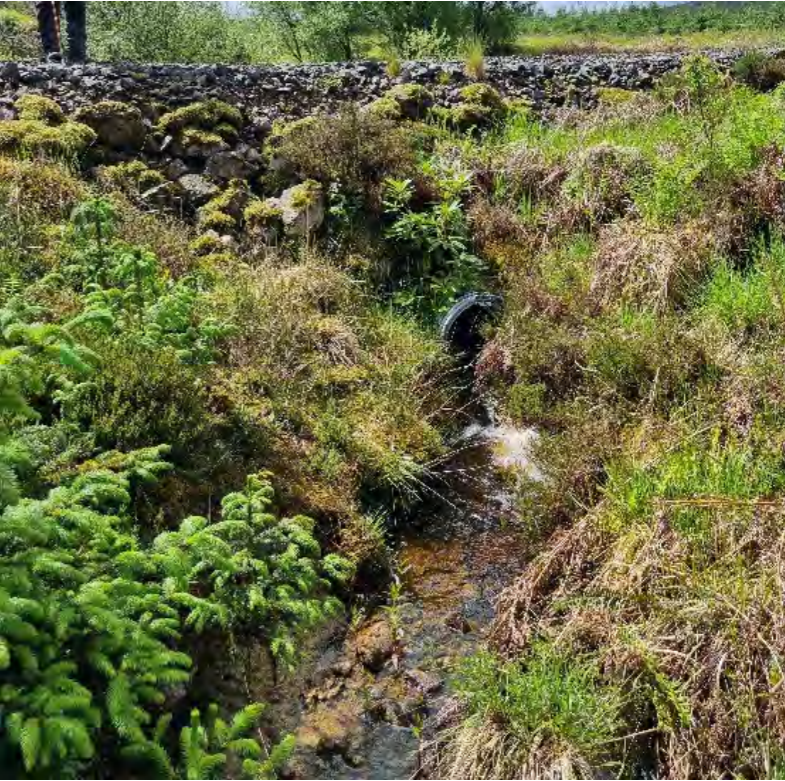
I	Unnamed	1.2m	Small watercourse within afforested area	Borrow Pit 2	Temporary	10m	Upgradient	<p>The watercourse is located within an afforested area and is higher than the existing quarried area.</p> <p>Given the elevation difference it is considered unlikely that use of the borrow pit will affect water quality at the watercourse.</p> <p>There is a small area of ponded surface water within the low part of the quarry; and care should be taken if dewatering the quarry prior to excavation.</p>	<p>No works will be undertaken within 10m of the watercourse and additional mitigation (e.g. silt fences, settlement ponds) will be put in place to prevent silt run-off to the watercourse.</p> <p>Dewatering will be avoided where possible and permanent physical cut-offs will be avoided</p>
