Appendix 7.4: Peat Landslide Hazard and Risk Assessment

Appendix 7.4 - Peat Landslide Hazard and Risk Assessment
An Càrr Dubh Wind Farm

Argyll & Bute
Car Duibh Wind Farm Ltd

20-LUC-010-D-001v02

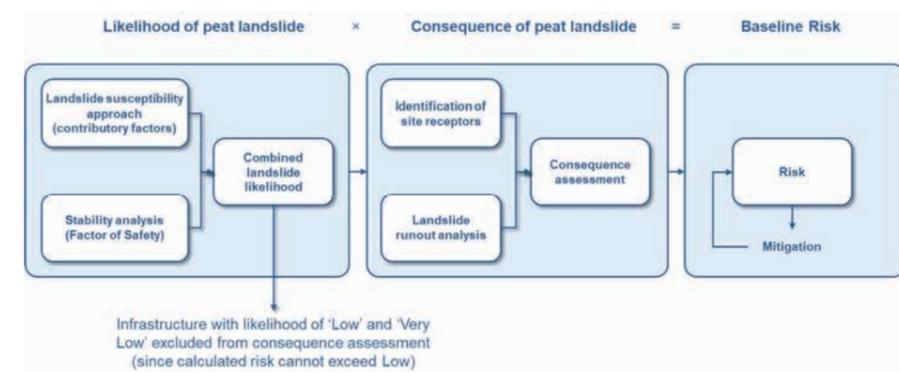
Plate 1.2 Risk assessment approach

To reflect these limitations, both approaches are adopted and outputs from each approach integrated in the assessment of landslide likelihood. Plate 1.2 shows the approach:

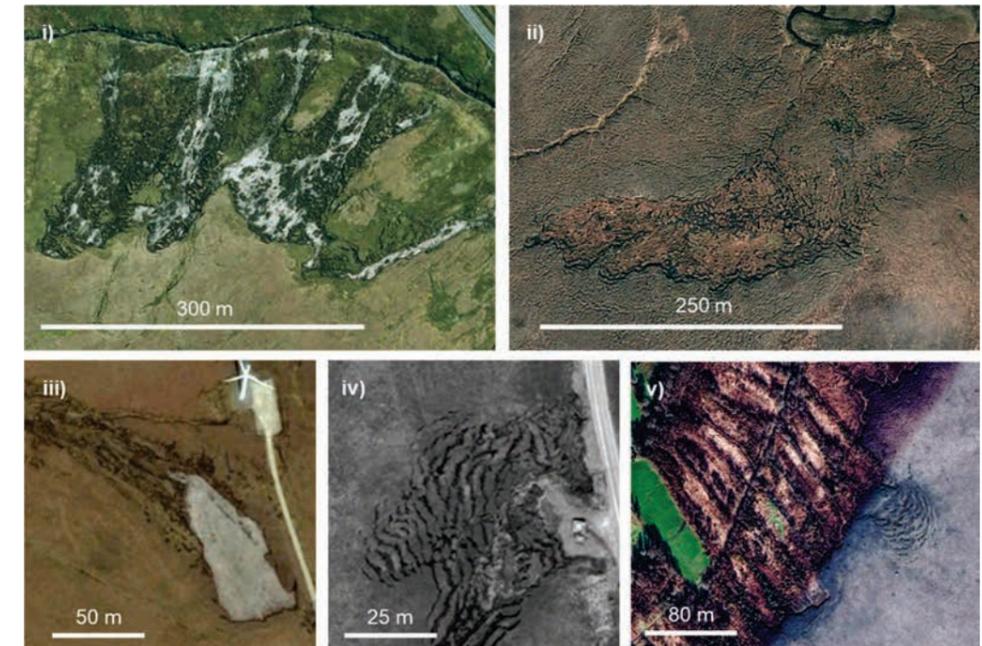
Plate 2.1 Characteristic peat landslide types in UK and Irish peat uplands: Top row - natural failures: i) multiple peat slides with displaced slabs and exposed substrate, ii) retrogressive bog burst with peat retained within the failed area; Bottom row - failures possibly induced by human activity: iii) peat slide adjacent to turbine foundation, iv) spreading around foundation, v) spreading upslope of cutting

For the purposes of this assessment, landslide classification is simplified and split into three main types, typical examples of which are shown in Plate 2.1. Dimensions, slope angles and peat depths are drawn from charts presented in Evans and Warburton (2007). The term “peat slide” is used to refer to large-scale (typically less than 10,000 of cubic metres) landslides in which failure initiates as large rafts of material which subsequently break down into smaller blocks and slurry. Peat slides occur ‘top-down’ from the point of initiation on a slope in thinner peats (between 0.5 m and 1.5 m) and on moderate slope angles (typically 5°-15°, see Plate 2.2).

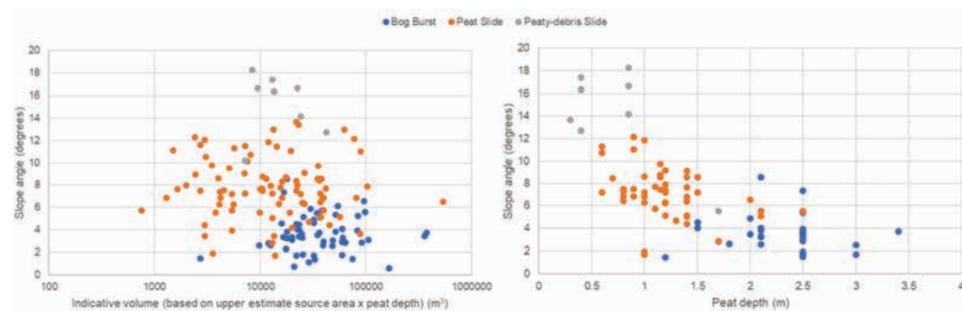
Plate 2.2 Reported slope angles and peat depths associated with peat slides and bog bursts (from literature review of locations, depths and slope angles, after Mills, 2002)

Due to the combination of moderate slopes and thinner peat at this site, the most likely mode of failure is peat slides, and this is the failure mechanism considered in this report. This is in keeping with the most likely mode of failure for the peat depths and slope angles present at the Site (see Plate 2.2 and Figures 7.3.2 and 7.3.5).

landslides rather than a simplistic assumption that 'the steeper a slope, the more likely it is to fail' (e.g. Plate 2.2). A differentiation in scores is applied for peat slides and bog bursts reflecting the shallower slopes on which the latter are most frequently observed.

Slope range (°)	Association with instability	Peat slide
≤2.5	Slope angle ranges for peat slides are based on lower and upper limiting angles for observations of occurrence (see Plate 2.2 and increase with increasing slope angle until the upper limiting angle e.g. peat slides are not observed on slopes <2.5°	0
2.5 - 5.0		1
5.0 – 7.5		3
7.5 - 10.0		3
10 – 15.0		3
>15.0		3

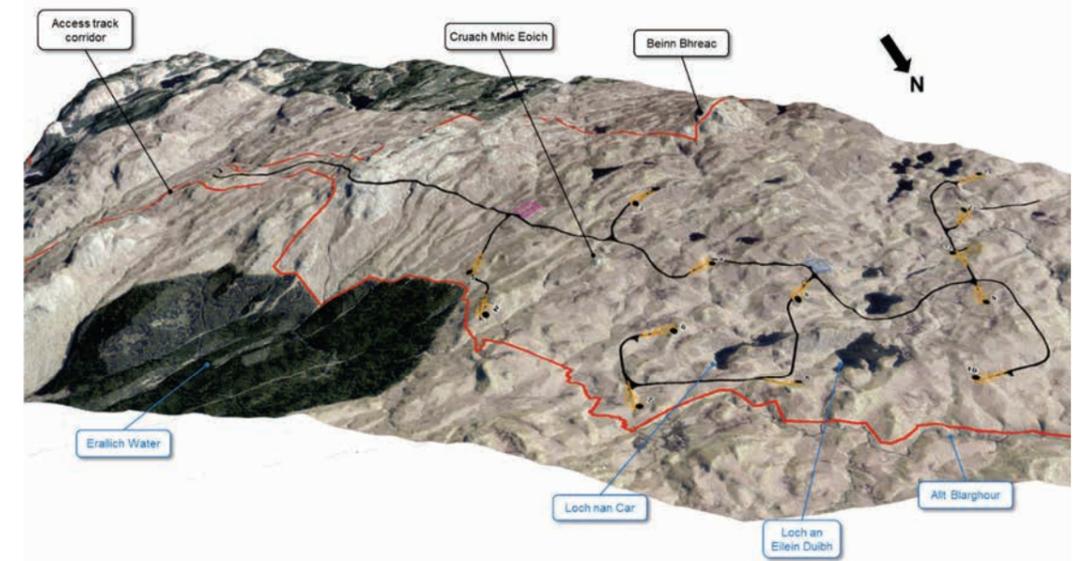
Plate 3.1 Perspective view of Proposed Development (note 2x vertical exaggeration)

The Proposed Development straddles the hills to the north of Beinn Bhreac (526 m) and surrounds Cruach Mhic Eoich (444 m), the access track falling to the southeast into commercial forestry above Inveraray before connecting to the public road. Much of the main turbine area lies over strongly northeast-southwest aligned ridges with intervening troughs (Figure 7.4.1). This topography has a strong influence on the position of major water bodies and deeper peat deposits (see Plate 3.1 below and section 3.5).

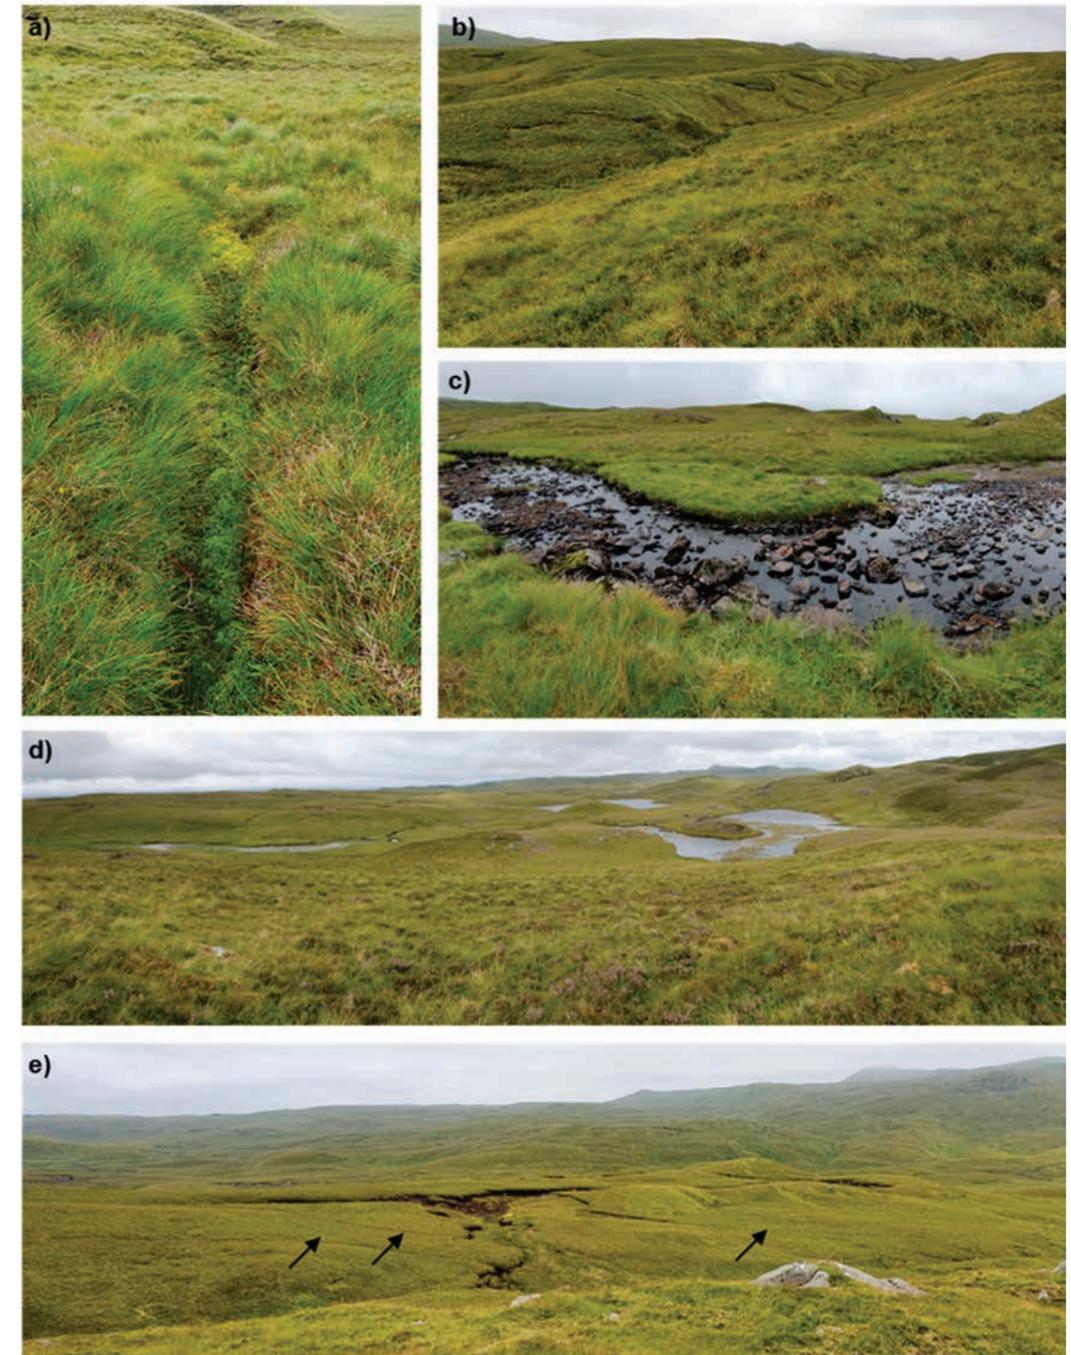
Plate 3.1 a) a partially recovered moor drain infilled by *Sphagnum*, b) one of a number of parallel linear tributaries to the Erallich River in the vicinity of Turbine 1, c) the Eas an Amair (a tributary of Allt Blarghour) to the south of Turbine 11, d) lochans in the central part of the main turbine area, e) active drains (arrowed)

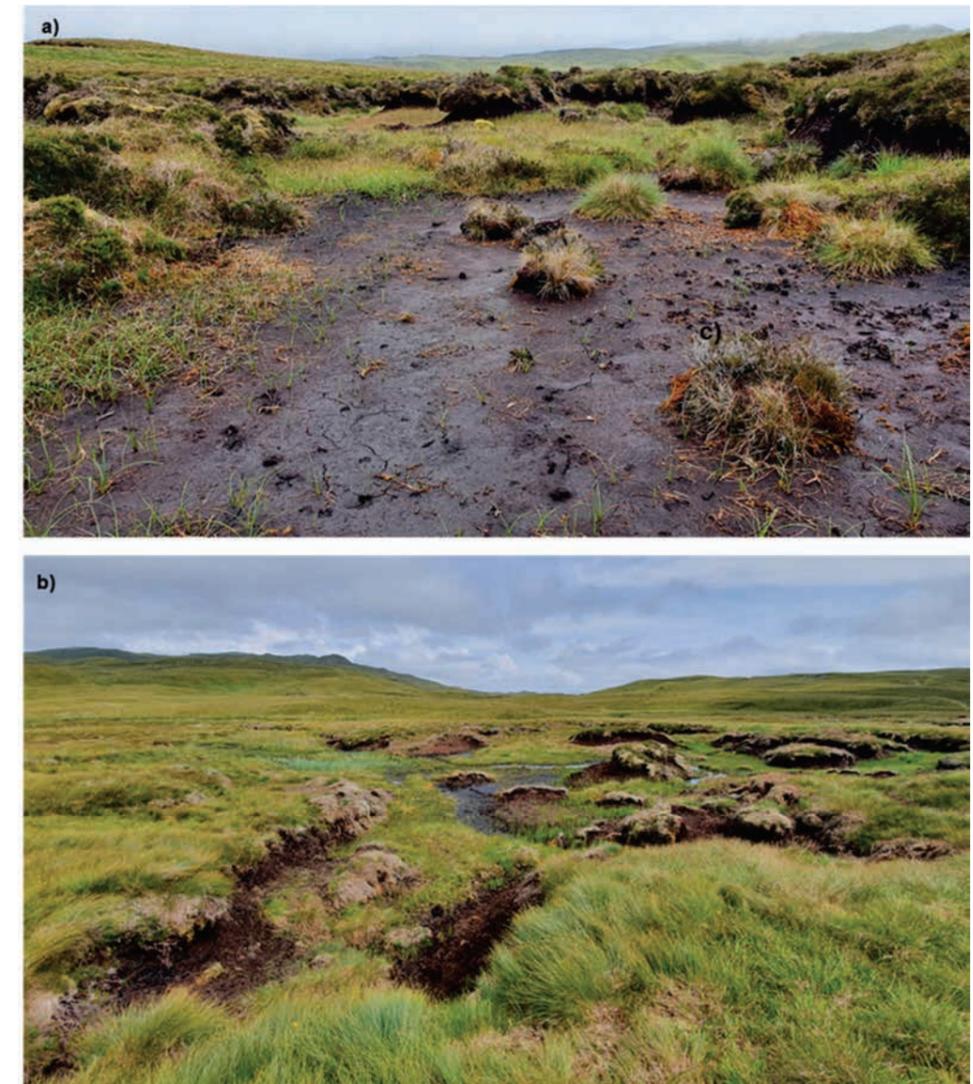
Plate 3.2 a) bare peat in an actively eroding haggged area, b) recovered hagsgs with only bare sidewalls now visible

features. The resulting geomorphological map, shown on Figure 7.4.4, was subsequently verified during a site walkover undertaken in July 2021 by a Chartered Geologist / peatland geomorphologist with over 25 years' experience of assessing peat landslides. Plates 3.2 and 3.3 show typical features identified during the walkovers.

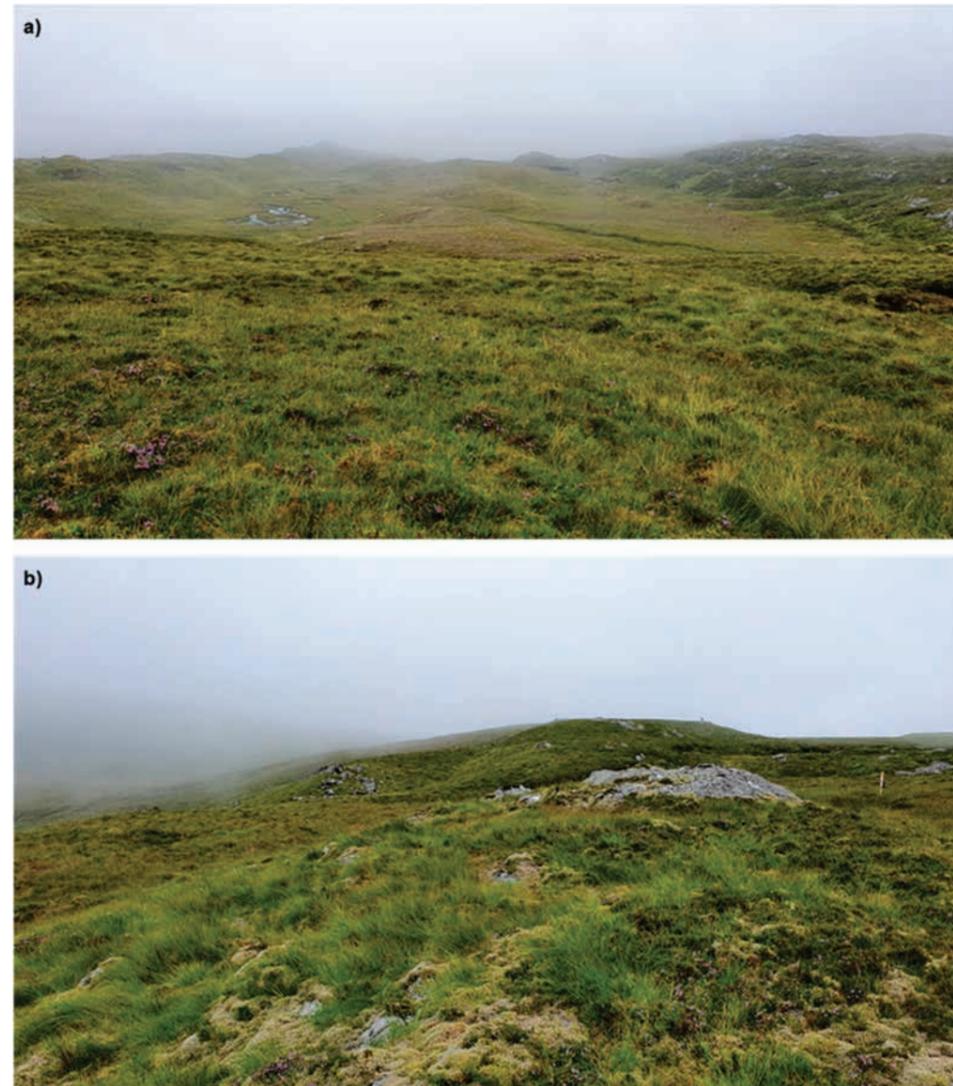
Plate 3.3 a) typical ridge and trough topography with blanket bog habitats, b) typical ridge top conditions with local rock outcrops

The Site is characterised by ridge and trough topography, with deeper peat tending to occur in troughs or on gently southeast facing slopes in the centre of the Site. Where peat is deepest, it is often eroded, with areas of bare and drying peat pans, hagged margins and isolated acrotelm-topped islands of intact peat. There are also many areas of apparently recovered hagged peat, where the lower ground between peat islands is now well vegetated. There was very limited evidence for instability on the Site, with only very minor gully head or gully sidewall collapses evident in one or two locations (and away from proposed infrastructure).

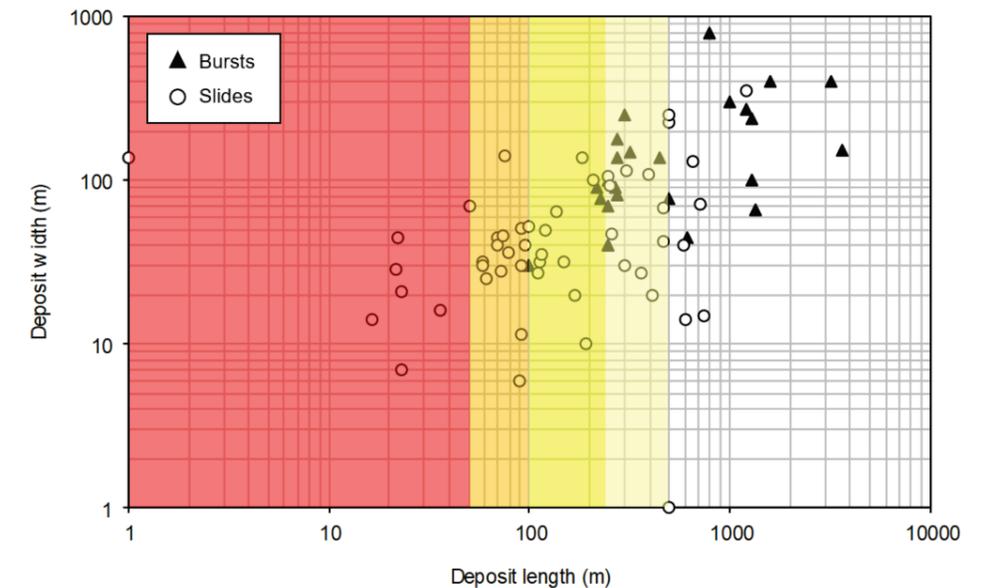
Plate 5.1 Runout distances for published peat landslides (after Mills, 2002), colours on the plot correspond to runout pathway zones on the left inset zoom Figure 7.4.9

Plate 5.1 shows runout distances based on published literature. Typically, runout distances would be expected to be less where slope angles decline with distance from the source zone (i.e. on concave slopes) whereas the full runout lengths shown on Plate 5.1 may be achievable on steepening (convex) slopes or rectilinear slopes. The slope below the source zone down to the minor watercourse is relatively continuous and no restrictions on runout from topography are expected.

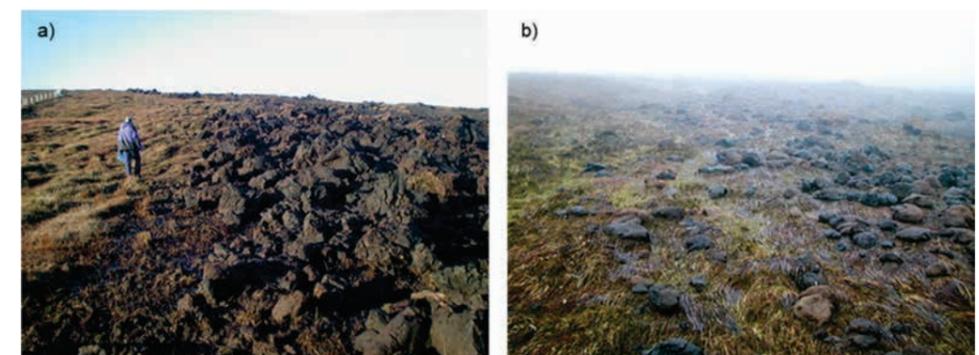
Plate 5.1 Examples of landslide runout (Dooncarton, Co. Mayo): a) blocky debris mid-slope, b) abraded and rolled blocks in lower slope

Landslide runout may be “supply-limited” by the availability of peat material generated in the failure or source zone. Typically, mobilised material thins with increasing distance from the source zone as rafts of landslide material break down into blocks, and blocks become abraded and roll, breaking down further into a blocky slurry (Plate 5.1).

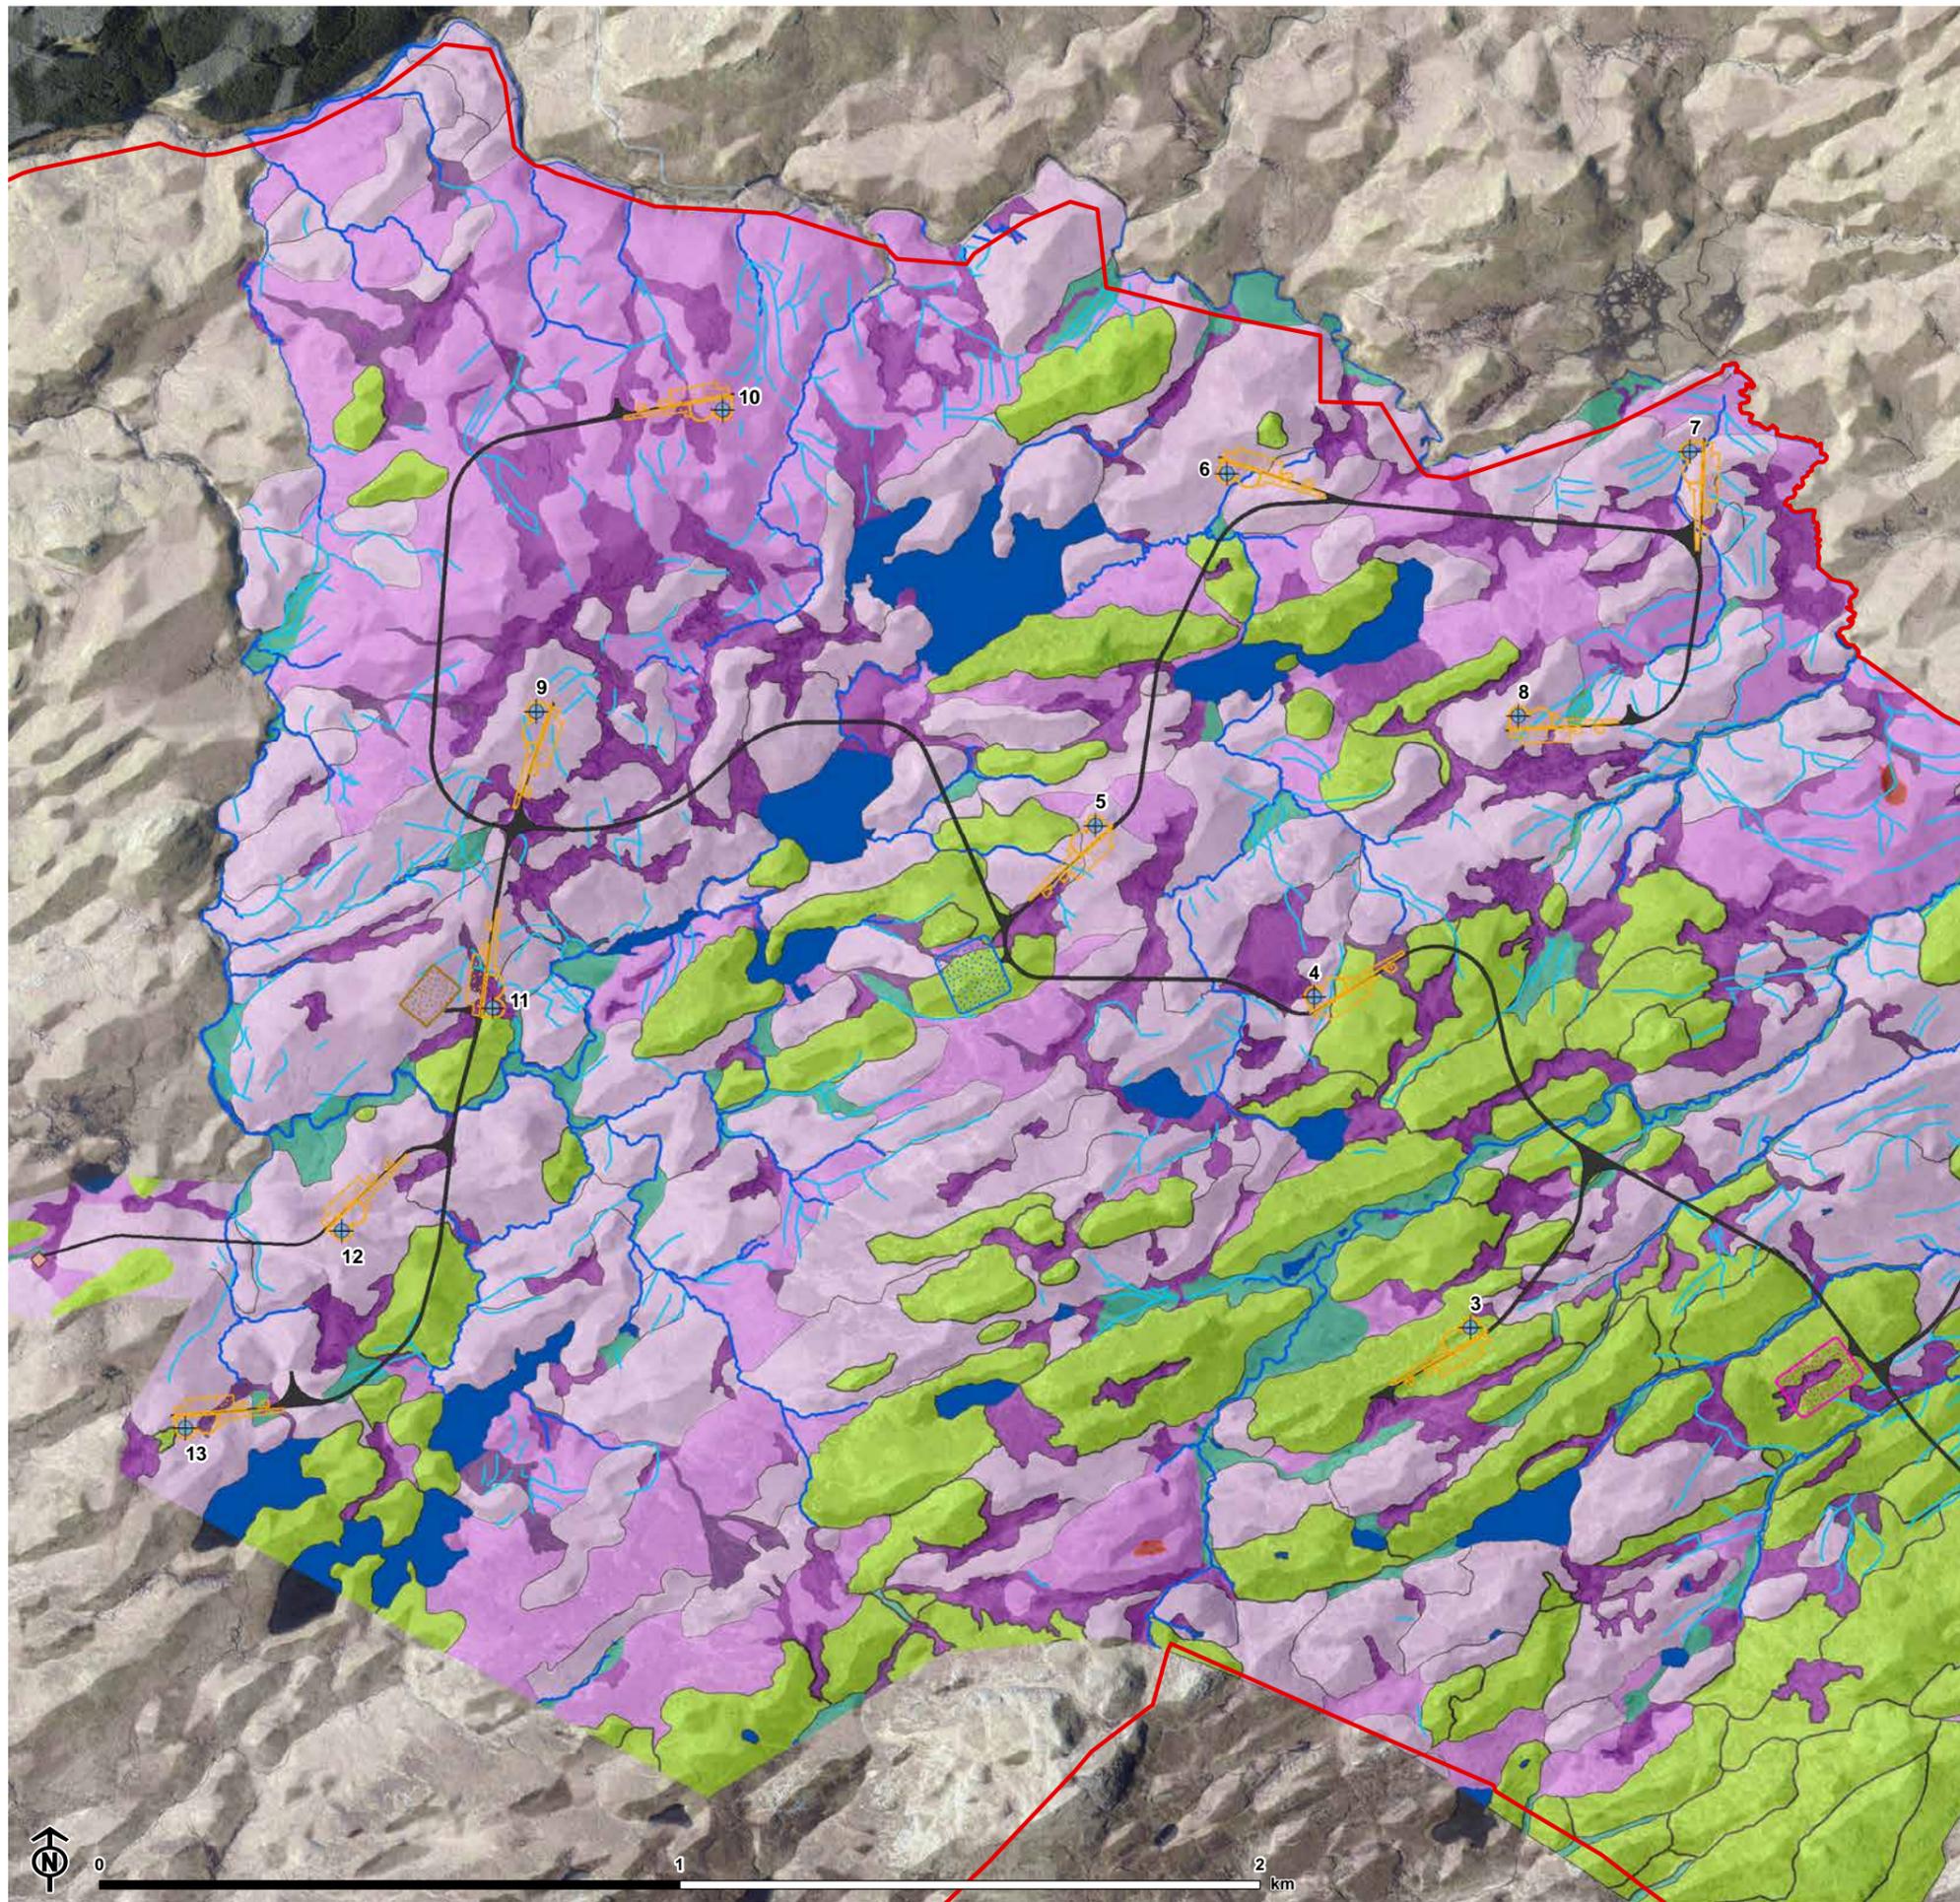
Figure 7.4.4: Geomorphology, Hydrology and Land Use (Sheet A)

Figure 7.4.4 shows the key features of the Site. The presence, characteristics and distribution of these features are helpful in understanding the hydrological function of a peatland, the balance of erosion and peat accumulation (or condition), and the sensitivity of a peatland to potential land-use changes.

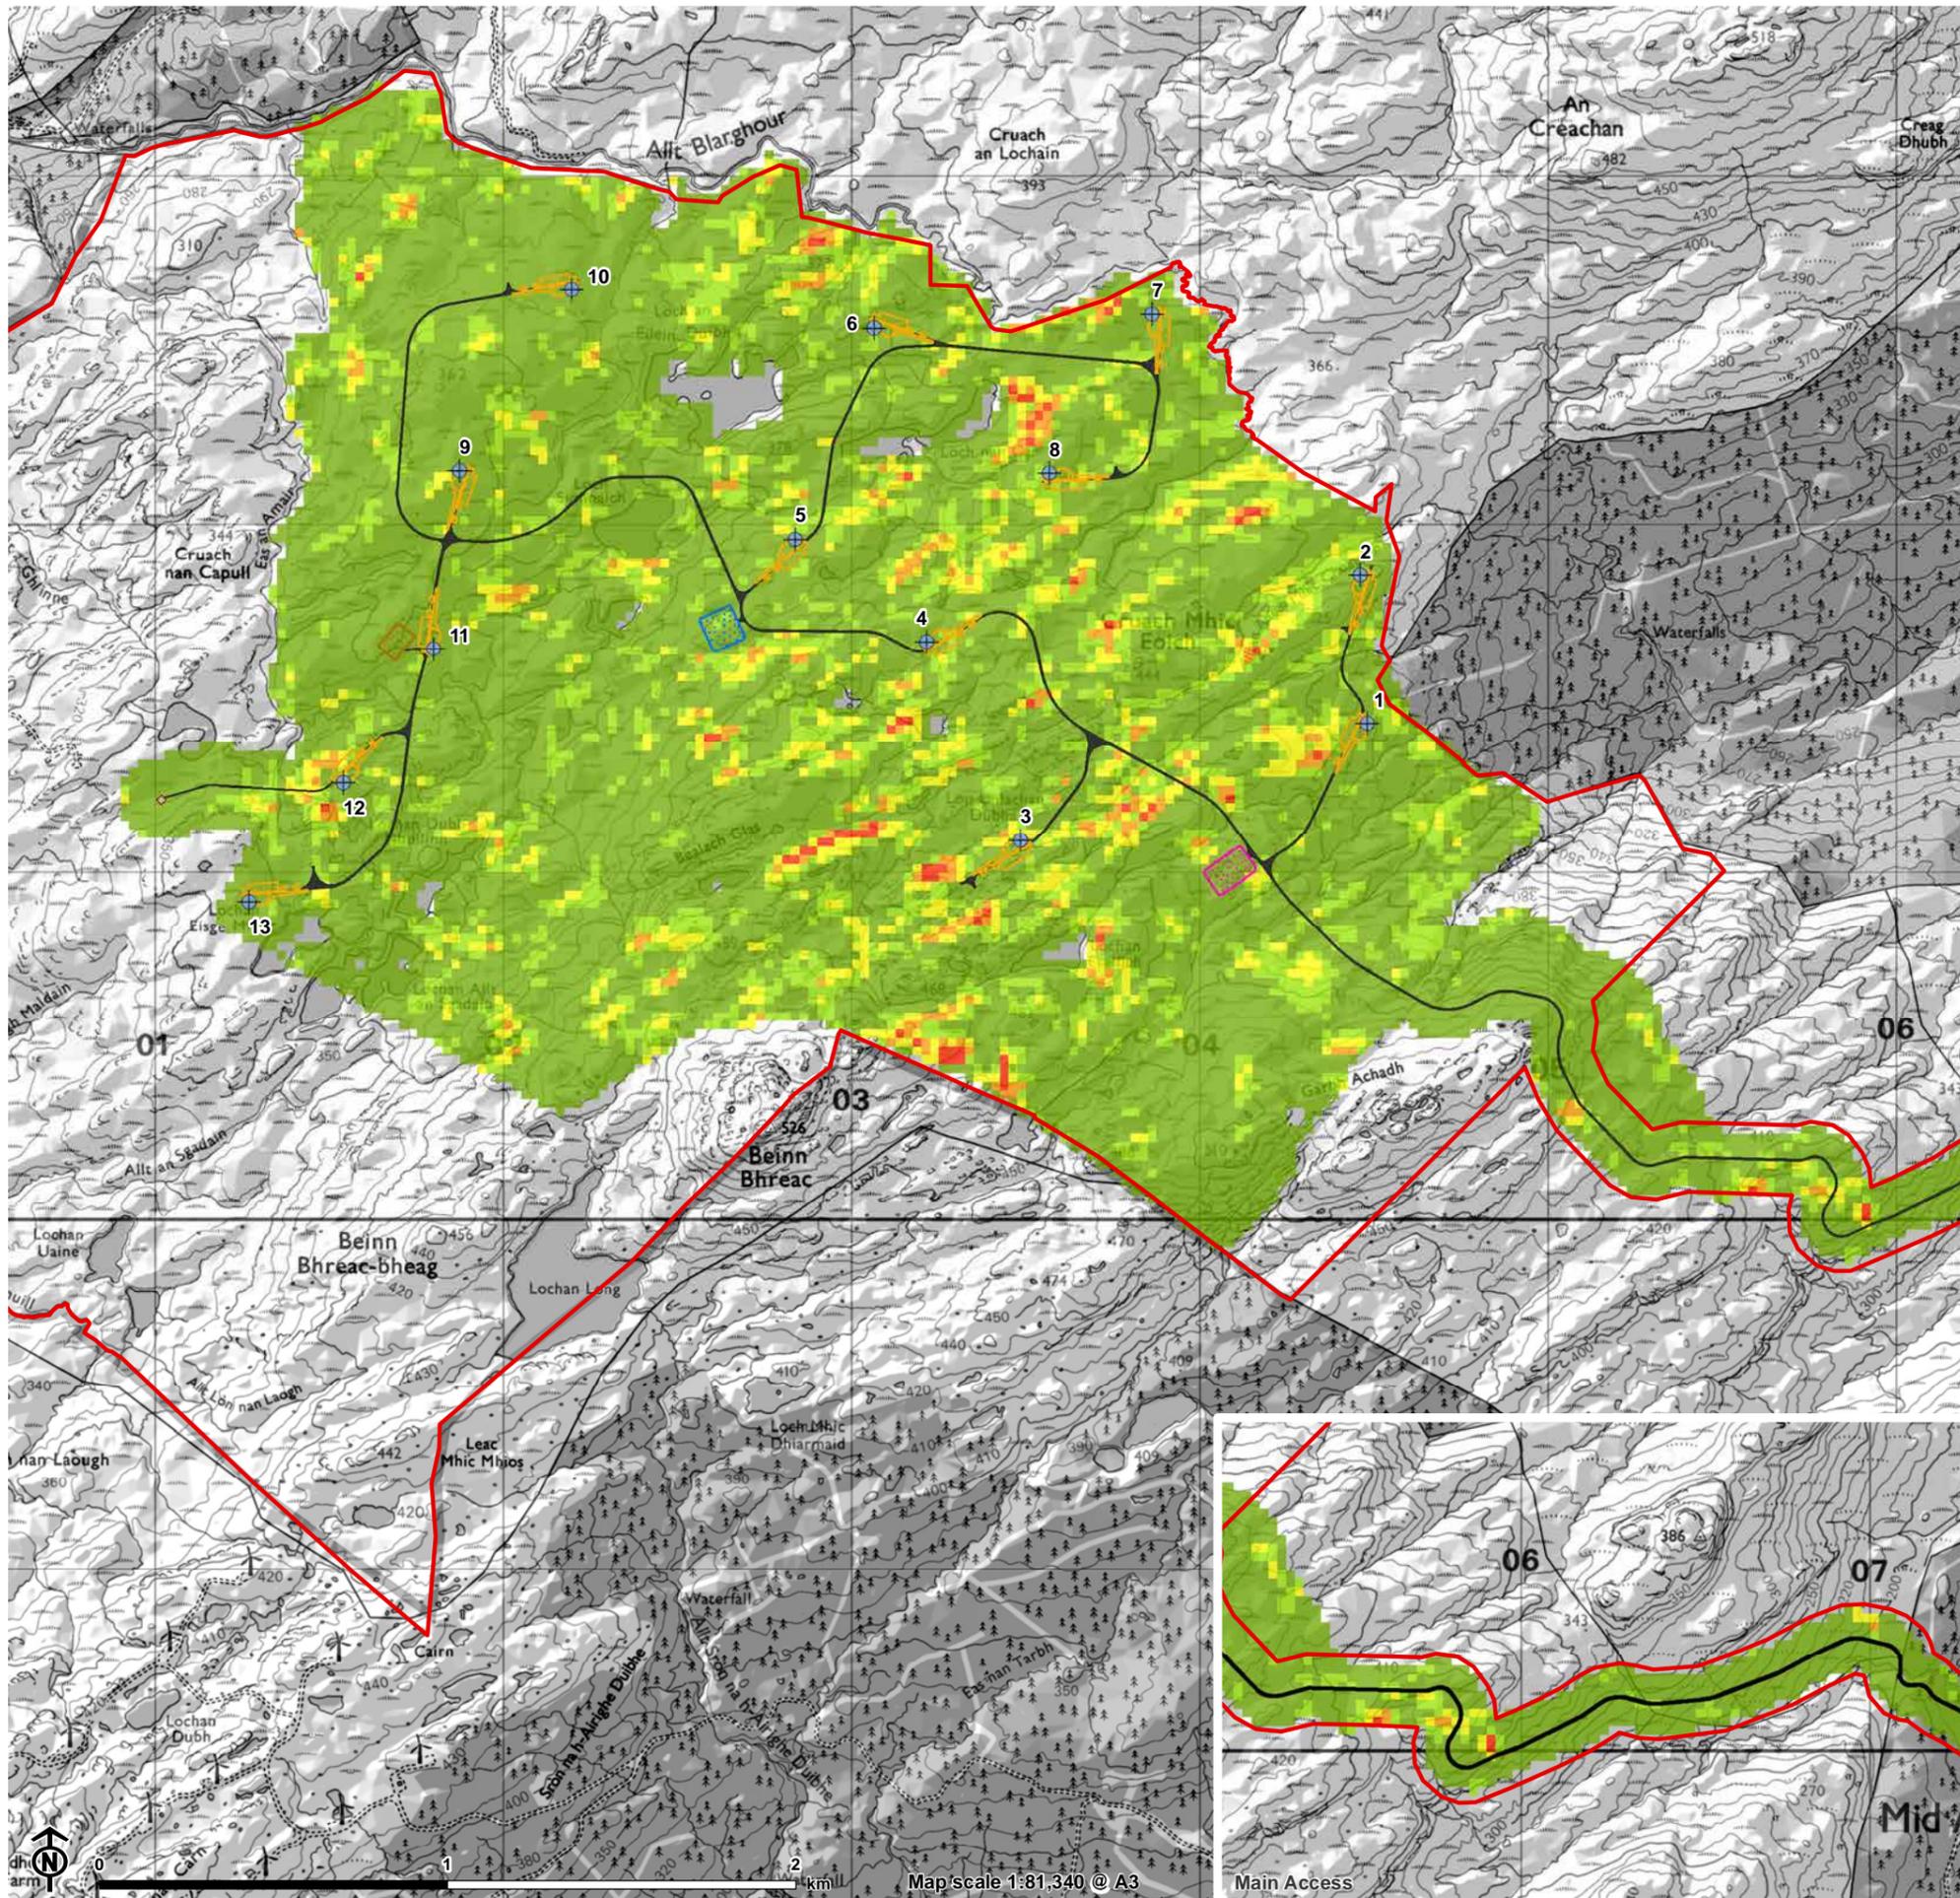
Figure 7.4.6: Factor of Safety

- Factor of Safety**
- 0.0 - 1.0 "Unstable"
 - 1.0 - 1.4 "Marginally Stable"
 - 1.4 - 2.0 "Stable"
 - 2.0 - 3.0 "Stable"
 - > 3.0 "Stable"

Factor of Safety (conservative parameters)

Stability analysis has been undertaken using the infinite slope model to determine the Factor of Safety (FoS) for a series of 25 m x 25 m grid cells within the Proposed Development boundary. This is the most frequently cited approach to quantitatively assessing the stability of peat slopes (e.g. Scottish Government, 2017; Boylan et al, 2008; Evans and Warburton, 2007; Dykes and Warburton, 2007; Creighton, 2006; Warburton et al, 2003; Carling, 1986). The approach assumes that failure occurs by shallow translational landsliding, which is the mechanism usually interpreted for peat slides. Due to the relative length of the slope and depth to the failure surface, end effects are considered negligible and the safety of the slope against sliding may be determined from analysis of a 'slice' of the material within the slope.

of the soil, depth to failure, etc). Slopes with a factor of safety greater than 1.4 are generally considered to be stable.

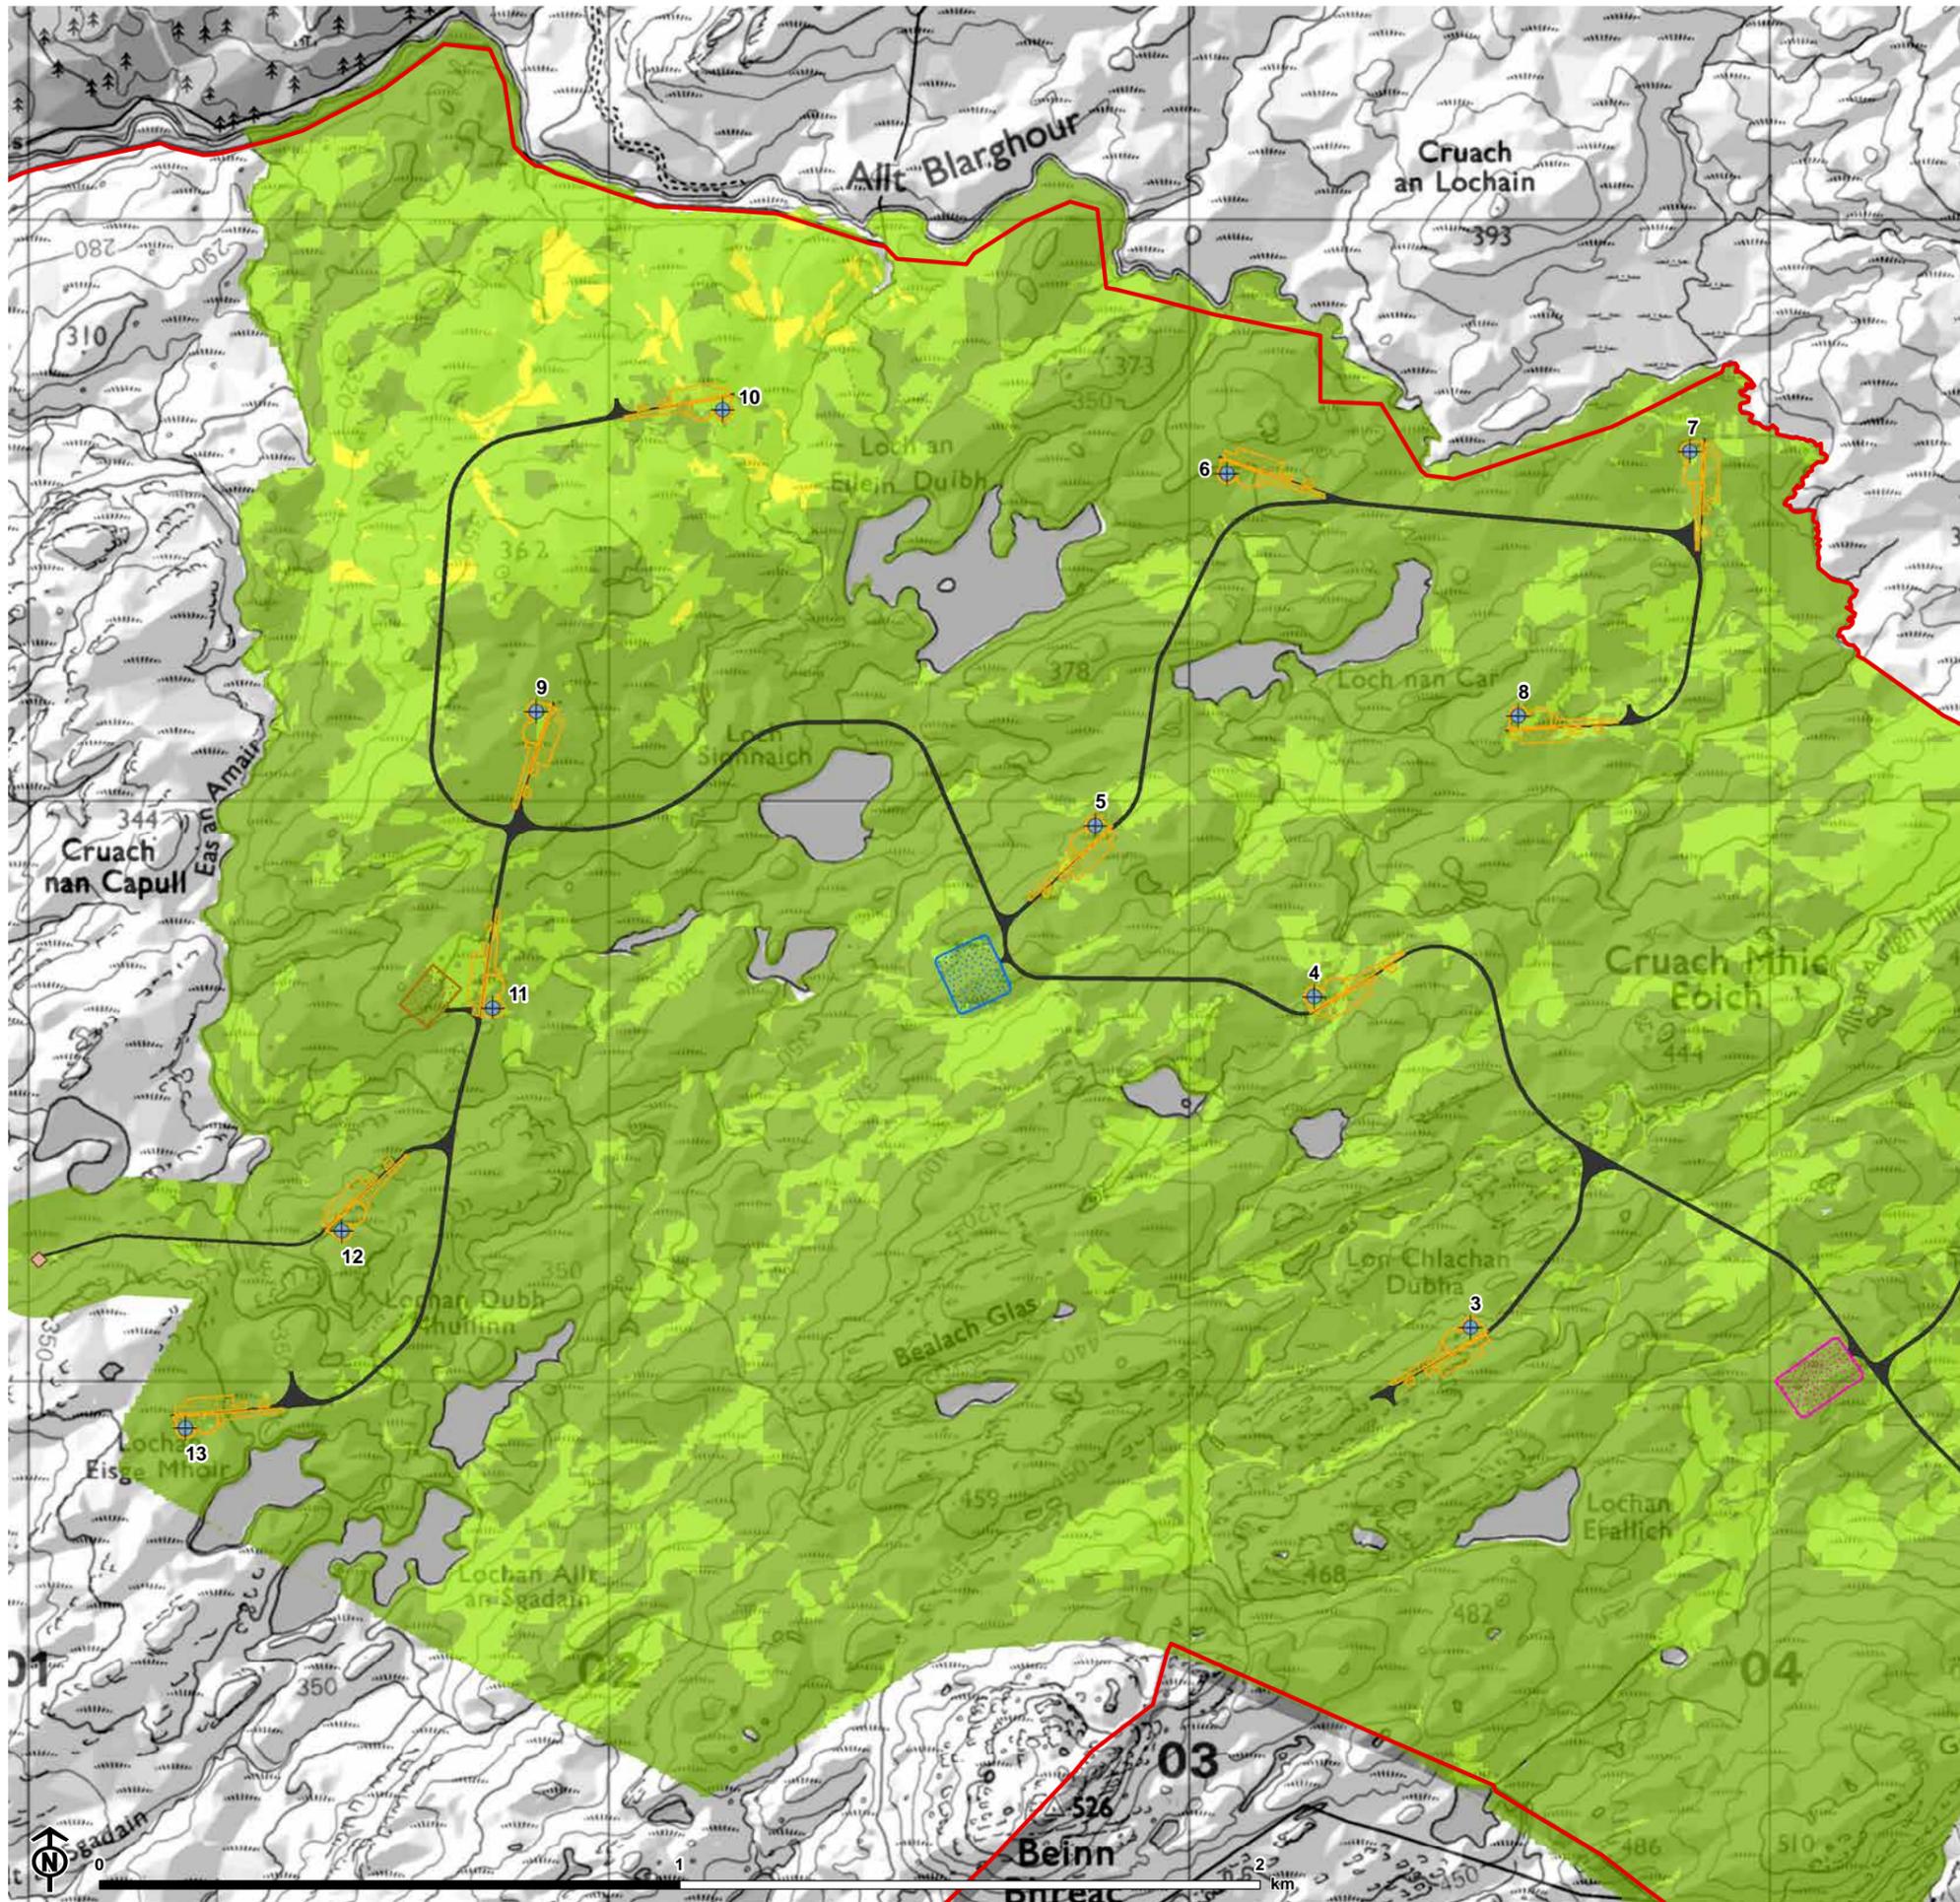
Figure 7.4.8: Peat Slide Likelihood (Sheet A)

- <= 7 (Very Low)
- 8 - 12 (Low)
- 13 - 17 (Moderate)
- 18 - 21 (High)
- > 21 (Very High)

Note: there are no High or Very High likelihood areas present within the Site
