Appendix 7.4: Peat Landslide Hazard and Risk Assessment

Appendix 7.4 - Peat Landslide Hazard and Risk Assessment
An Càrr Dubh Wind Farm

Argyll & Bute
Car Duibh Wind Farm Ltd

20-LUC-010-D-001v02

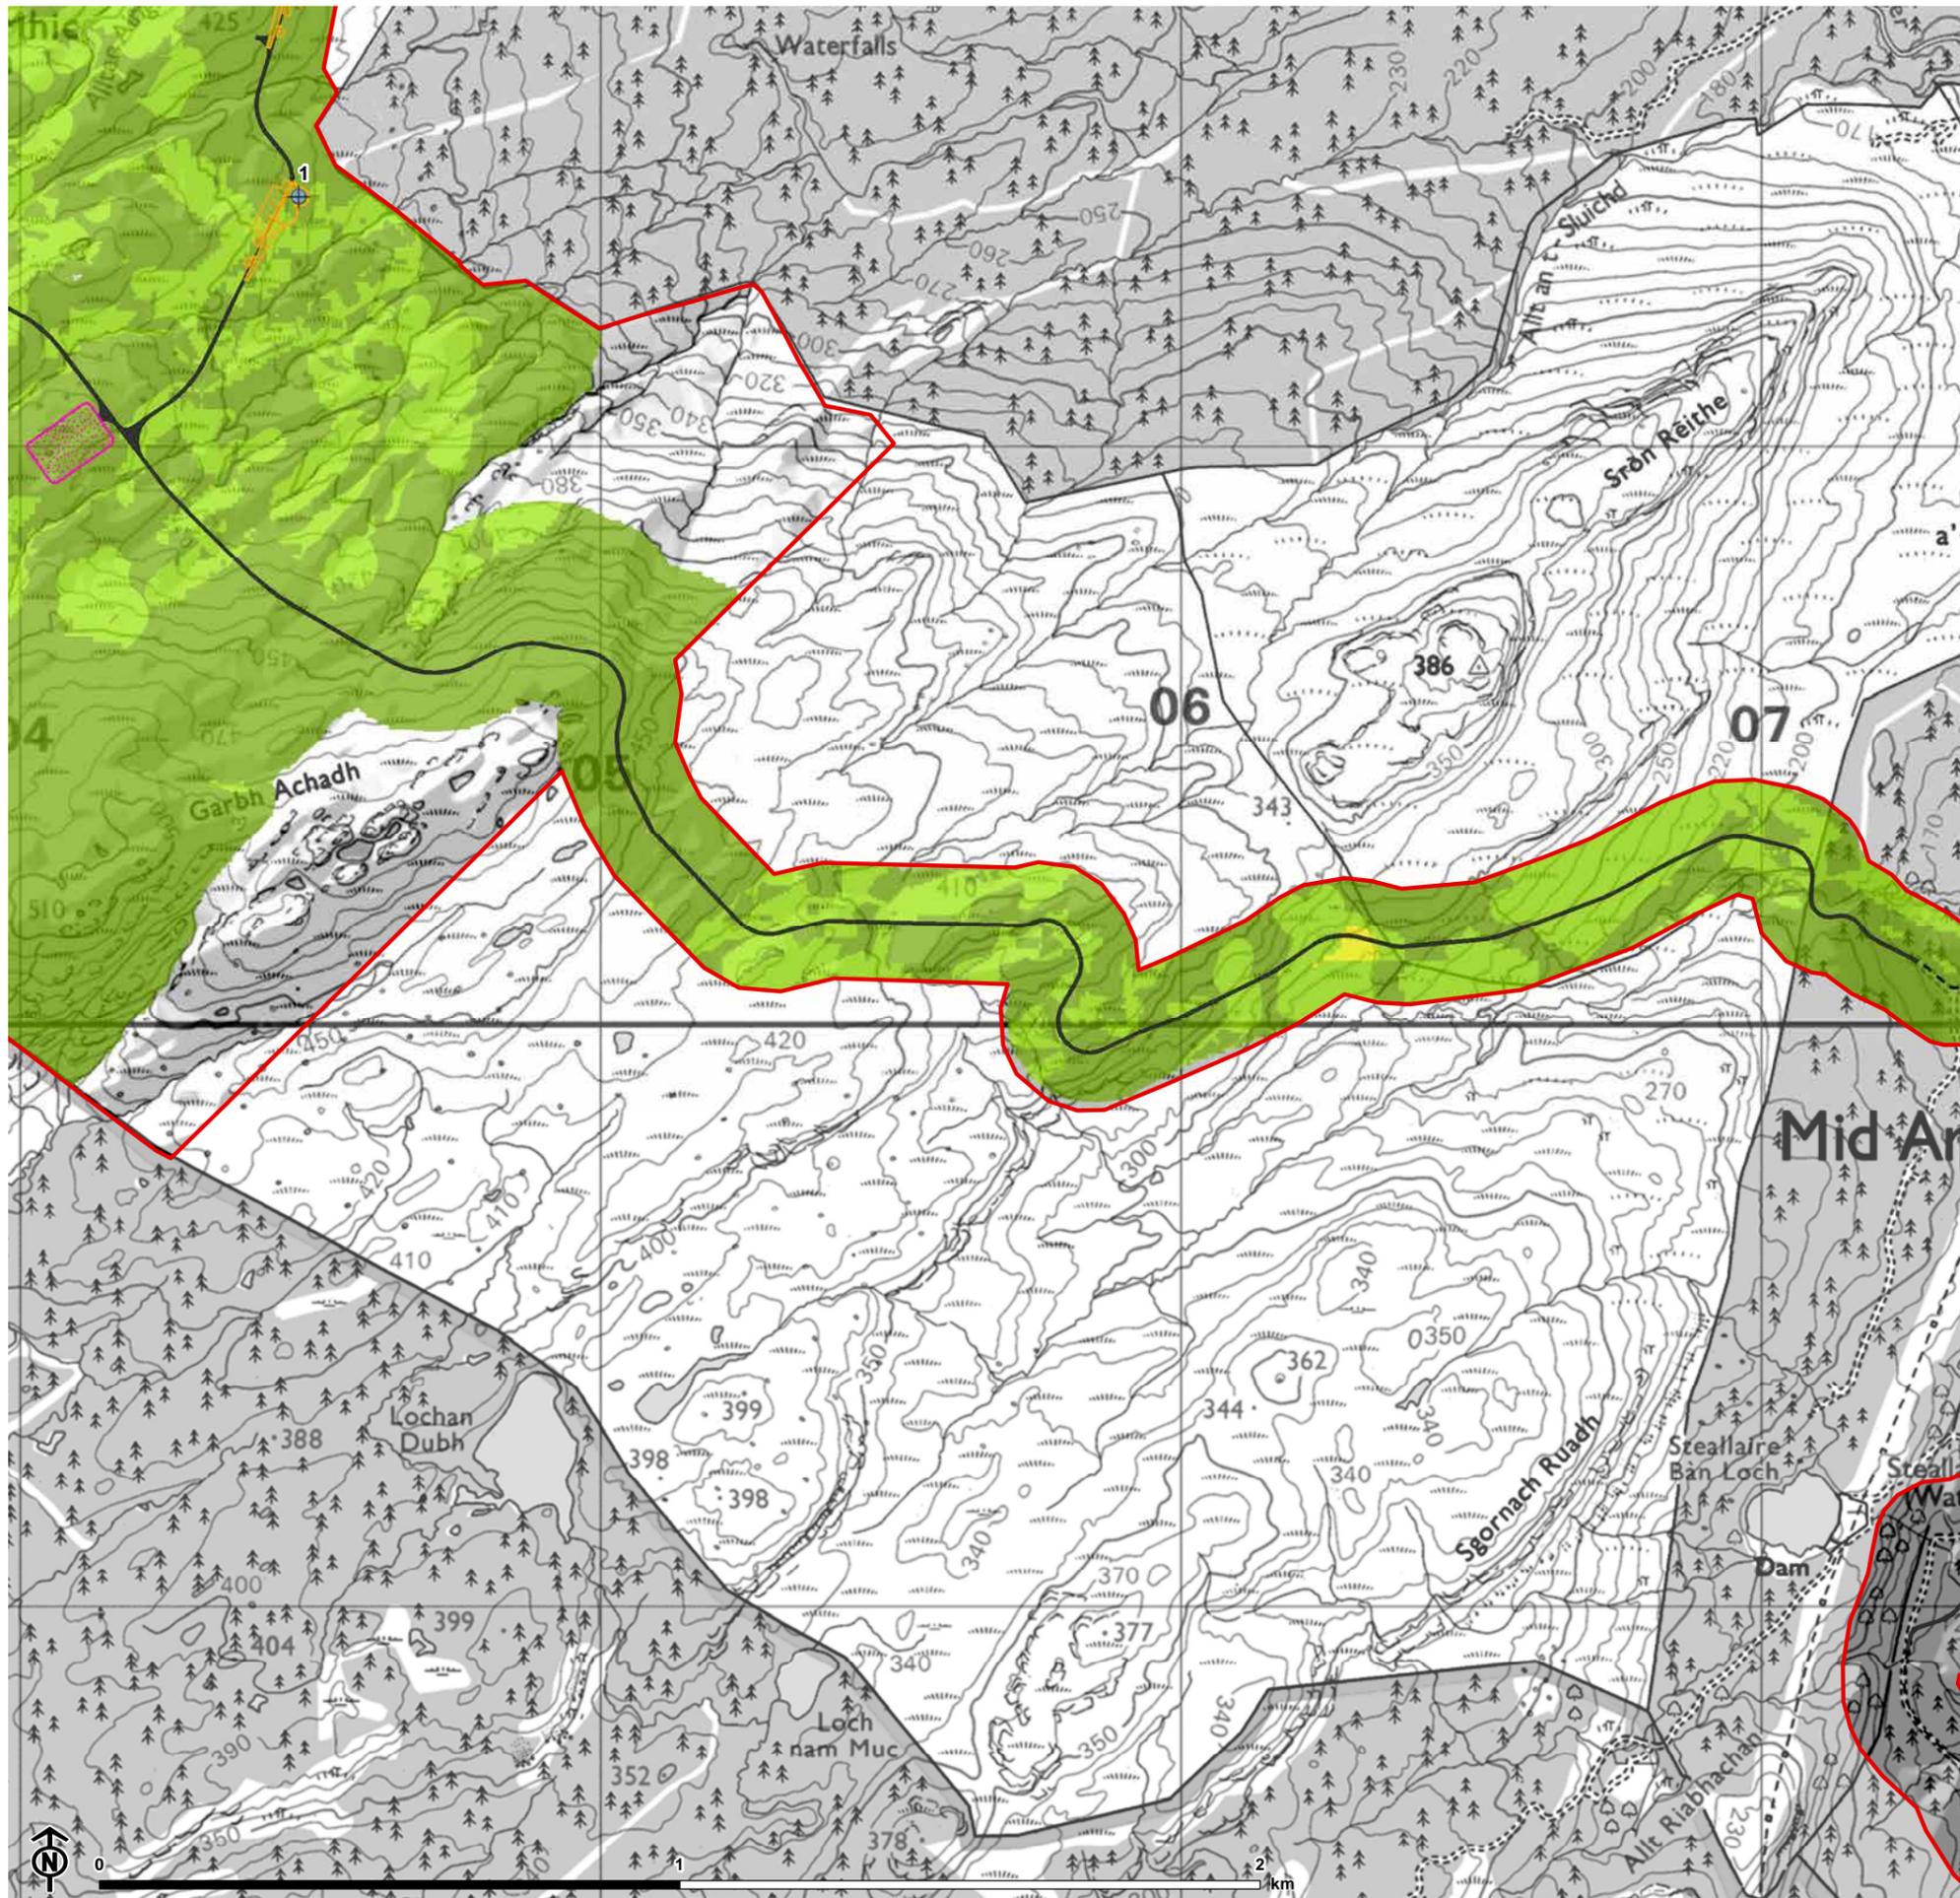
Figure 7.4.8: Peat Slide Likelihood (Sheet B)

- <= 7 (Very Low)
- 8 - 12 (Low)
- 13 - 17 (Moderate)
- 18 - 21 (High)
- > 21 (Very High)

Note: there are no High or Very High likelihood areas present within the Site
