## Technical Appendix 6.1: Watercourse Crossing and Buffer Assessment

This appendix should be read in conjunction with **Chapter 6: Geology, Hydrology and Peat** and **Chapter 4: Description of Proposed Development** of the Environmental Impact Assessment (EIA) Report for full details of the Proposed Development.

### Watercourse Crossings

### Watercourse Buffer Encroachment

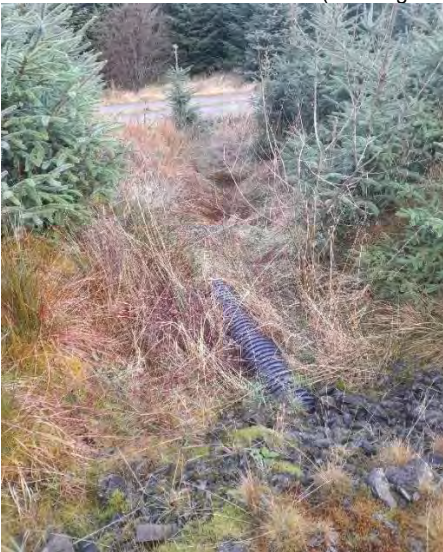
ID - 1	Unnamed watercourse
Existing track crossing	
<u>Description:</u> Unnamed watercourse culverted underneath existing forestry track. Drains to Magmallach Burn, flowing north-east. The small watercourse is crossed twice by existing track. Track crossing ID1 can be seen in the distance of the photo.	
NGR Ref: 273212 596799	
Photo - watercourse (culvert) viewed from crossing ID2 looking north-east to track in the distance (crossing ID1)

Width of watercourse (m)	0.3
Bed sediment	Gravel
Bank erosion	No
Natural channel	Yes
Crossing type	Existing track crossing with pipe culvert, ~300 mm in size
Additional mitigation	Additional SuDS and pollution control measures (e.g. silt fences) at this location during construction phase.
Catchment (km²)	< 0.01
Minor watercourse¹	Yes
Main river catchment	Appin Burn
CAR authorisation required	No

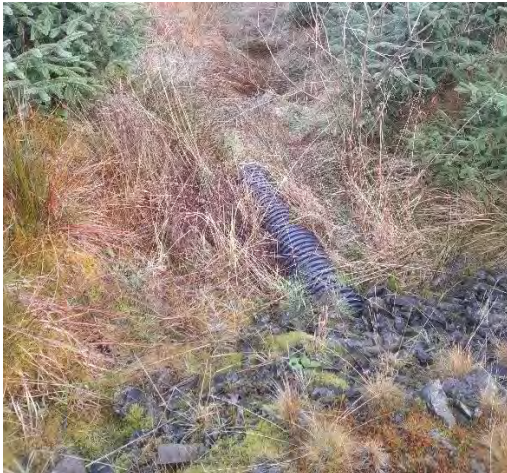
ID - 2	Unnamed watercourse
Existing track crossing	
<p>Description: Unnamed watercourse culverted underneath existing forestry track. Drains to Magmallach Burn, flowing north-east. The small watercourse is crossed twice by existing track.</p>	
NGR Ref: 273213 596785	
Photo - watercourse viewed downstream of track (crossing ID2) to the north-east

Width of watercourse (m)	0.3
Bed sediment	Gravel
Bank erosion	No
Natural channel	Yes
Crossing type	Existing track crossing with pipe culvert, ~300 mm in size
Additional mitigation	Additional SuDS and pollution control measures (e.g. silt fences) at this location during construction phase.
Catchment (km²)	< 0.01
Minor watercourse	Yes
Main river catchment	Appin Burn
CAR authorisation required	No

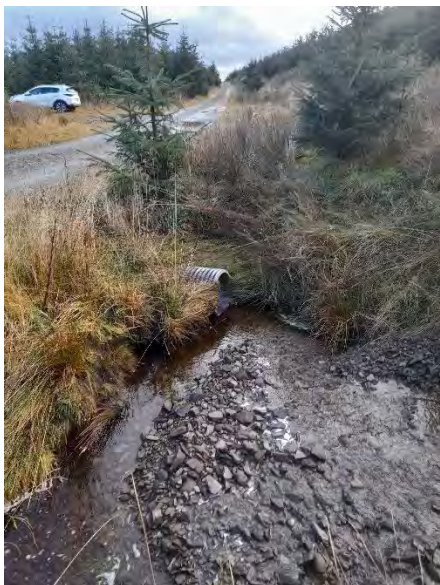
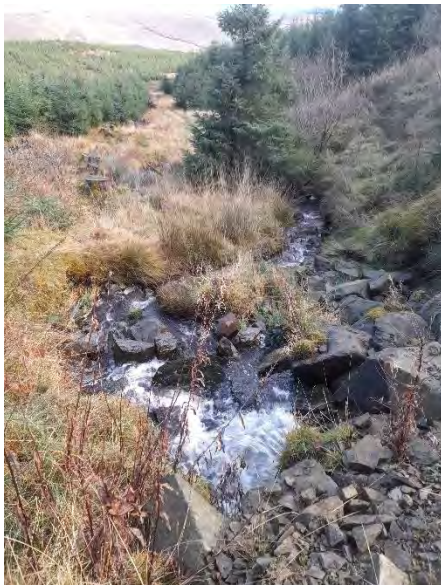
ID - 3	Magmallach Burn
Existing track crossing	
Description: The Magmallach Burn is crossed by existing access track as it flows to the north-west. The watercourse lies in a small, well-defined valley upstream of the track, becoming less defined downstream.	
NGR Ref: 273096 596871	
Photo – Culvert upstream of track	Photo – Watercourse downstream of track

Width of watercourse (m)	1.2
Bed sediment	Cobble and gravel
Bank erosion	No
Natural channel	Yes
Crossing type	Existing track crossing with pipe culvert, ~300 mm in size
Additional mitigation	Additional SuDS and pollution control measures (e.g. silt fences) at this location during construction phase.
Catchment (km²)	0.27
Minor watercourse	No
Main river catchment	Appin Burn
CAR authorisation required	No

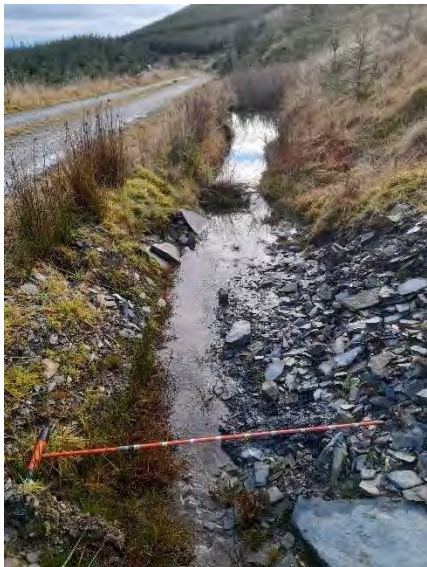
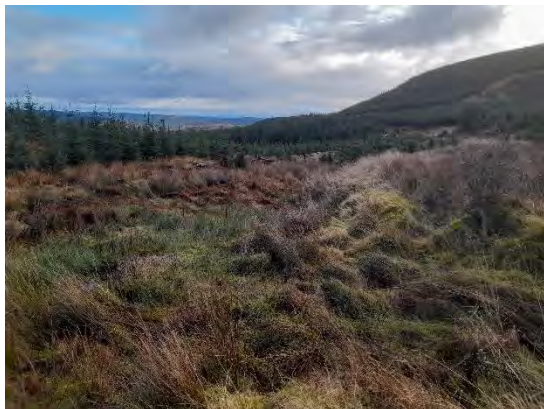
ID - 4	Unnamed tributary of Magmallaich Burn
Existing track crossing	
<p>Description: Unnamed Tributary of the Magmallaich Burn flowing from west to east. A surface water pathway originates in steep forestry to the west before passing through a culvert under the existing track. The watercourse becomes undefined and diffuse after the culvert.</p>	
NGR Ref: 273018 596958	
Photo – Watercourse intercepted by existing track	Photo – diffuse surface flow – marked on OS maps as tributary to Magmallaich Burn

Width of watercourse (m)	5.0 (diffuse flow)
Bed sediment	Gravel
Bank erosion	No
Natural channel	Yes
Crossing type	Existing track crossing with pipe culvert, ~200 mm in size
Additional mitigation	Additional SuDS and pollution control measures (e.g. silt fences) at this location during construction phase.
Catchment (km²)	< 0.01
Minor watercourse	No
Main river catchment	Appin Burn
CAR authorisation required	No

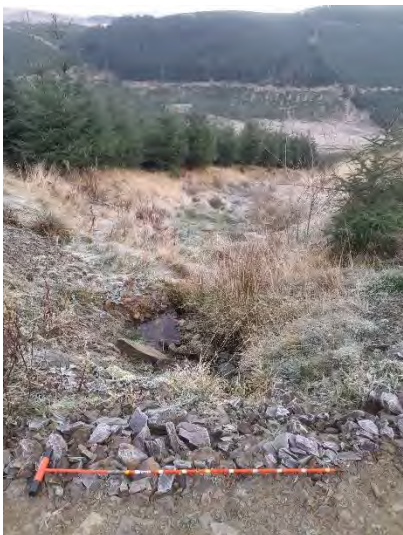
ID - 5	Unnamed tributary of Appin Burn
Existing track crossing	
<u>Description:</u> Unnamed Tributary of the Appin Burn flowing north. The watercourse lies in a steep, well-defined valley and is culverted under the existing track.	
NGR Ref: 272776 597208	
Photo – watercourse looking downstream towards Appin Burn

Width of watercourse (m)	0.4
Bed sediment	Gravel
Bank erosion	No
Natural channel	Yes
Crossing type	Existing track crossing with pipe culvert, ~200 mm in size
Additional mitigation	Additional SuDS and pollution control measures (e.g. silt fences) at this location during construction phase.
Catchment (km²)	0.05
Minor watercourse	No
Main river catchment	Appin Burn
CAR authorisation required	No

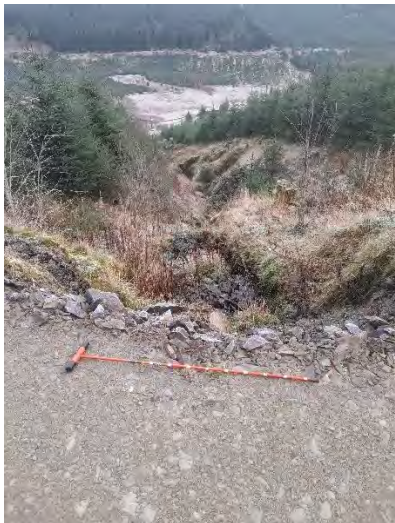
ID - 6	Unnamed tributary of Appin Burn
Existing track crossing	
<u>Description:</u> Unnamed Tributary of the Appin Burn flowing north. The watercourse lies in a steep, well-defined valley and is culverted under the existing track.	
NGR Ref: 272706 597266	
Photo - watercourse looking downstream towards Appin Burn

Width of watercourse (m)	1.0
Bed sediment	Gravel
Bank erosion	No
Natural channel	Yes
Crossing type	Existing track crossing with pipe culvert, ~300 mm in size
Additional mitigation	Additional SuDS and pollution control measures (e.g. silt fences) at this location during construction phase.
Catchment (km²)	0.09
Minor watercourse	No
Main river catchment	Appin Burn
CAR authorisation required	No

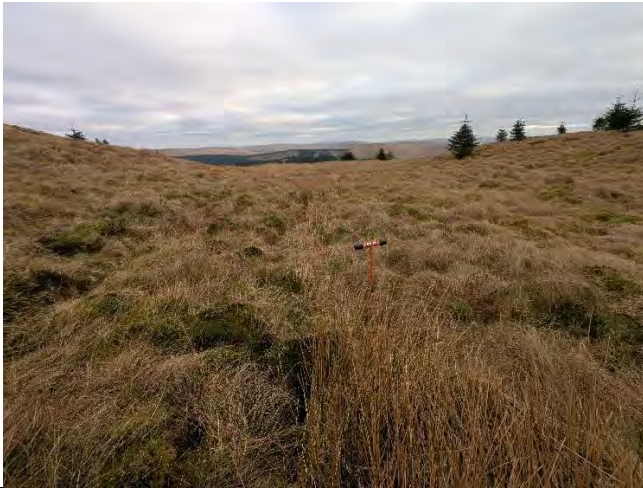
ID - 7	Headwater of Tributary of Appin Burn
New track crossing	
<u>Description:</u> Diffuse surface water pathway with artificial drainage in places, flowing north-east towards the Appin Burn.	
NGR Ref: 272434 596928	
Photo – Diffuse surface water flow path

Width of watercourse (m)	0.1 – 3.0
Bed sediment	Peat
Bank erosion	No
Natural channel	Yes
Crossing type	Proposed – Bottomless arch culvert, single span bridge or suitable drainage (e.g. numerous pipes) within the track.
Additional mitigation	Additional SuDS and pollution control measures (e.g. silt fences) at this location during construction phase.
Catchment (km²)	< 0.01
Minor watercourse	Yes
Main river catchment	Appin Burn
CAR authorisation required	No

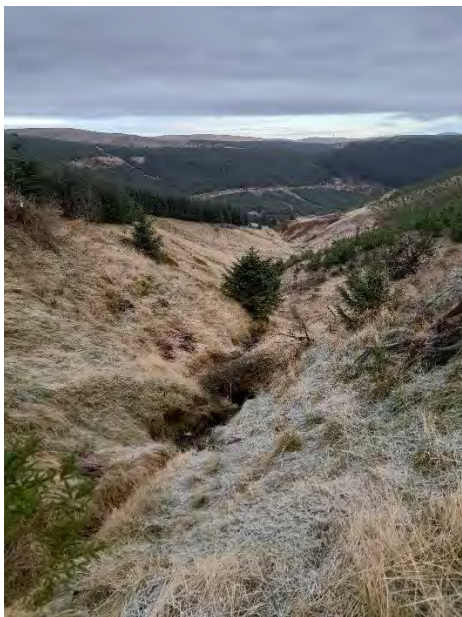
ID - 8	Unnamed tributary of Appin Burn
New track crossing	
<u>Description:</u> Unnamed Tributary of the Appin Burn flowing north-east in a steep, well-defined valley. The tributary is culverted under the existing access track to the south-west of the proposed new crossing.	
NGR Ref: 272109 597296	
Photo – Valley channel of unnamed tributary downstream of existing track.

Width of watercourse (m)	0.5
Bed sediment	Gravel
Bank erosion	No
Natural channel	Yes
Crossing type	Proposed – bottomless arch culvert or single span bridge set into re-profiled section of new track
Additional mitigation	Additional SuDS and pollution control measures (e.g. silt fences) at this location during construction phase.
Catchment (km²)	0.13
Minor watercourse	No
Main river catchment	Appin Burn
CAR authorisation required	Yes

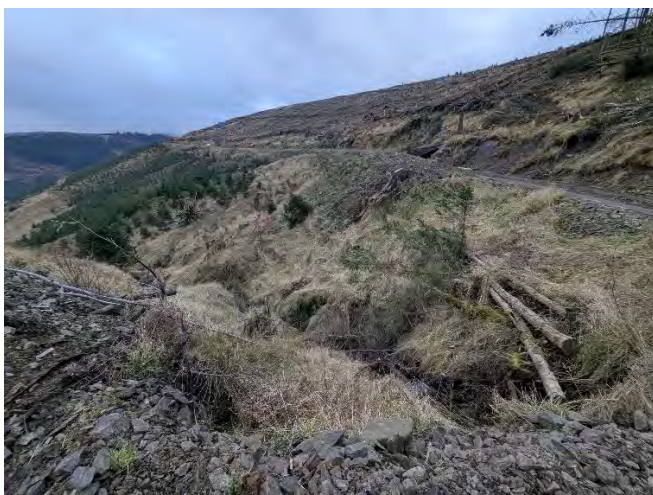
Photo – span of valley downstream of existing track.

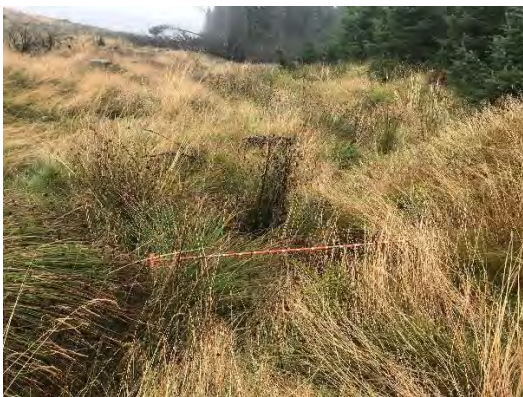
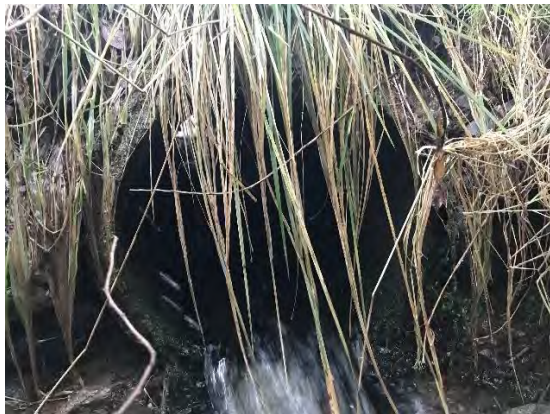
Width of watercourse (m)	0.2
Bed sediment	Gravel and sand
Bank erosion	No
Natural channel	No
Crossing type	Existing track crossing with pipe culvert, ~300 mm in size
Additional mitigation	Additional SuDS and pollution control measures (e.g. silt fences) at this location during construction phase.
Catchment (km²)	< 0.01
Minor watercourse	Yes
Main river catchment	Appin Burn
CAR authorisation required	No

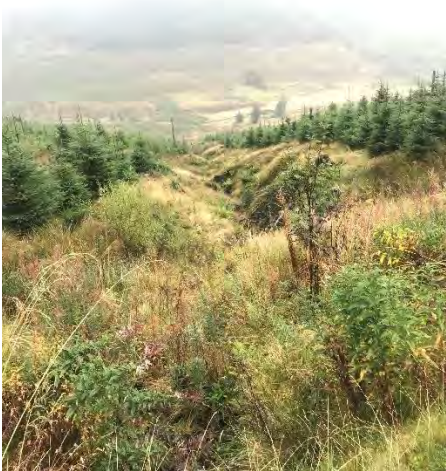
ID - 11	Unnamed watercourse
Existing track crossing	
<u>Description:</u> Unnamed watercourse originating in steep forestry drainage to the west. Travels through commercial forestry before eventually reaching the Appin Burn.	
NGR Ref: 272105 597754	
Photo – Valley channel of the watercourse looking downstream

Width of watercourse (m)	0.1
Bed sediment	Gravel
Bank erosion	Yes
Natural channel	No
Crossing type	Existing track crossing with pipe culvert, variable in size
Additional mitigation	Additional SuDS and pollution control measures (e.g. silt fences) at this location during construction phase.
Catchment (km²)	< 0.01
Minor watercourse	Yes
Main river catchment	Appin Burn
CAR authorisation required	No

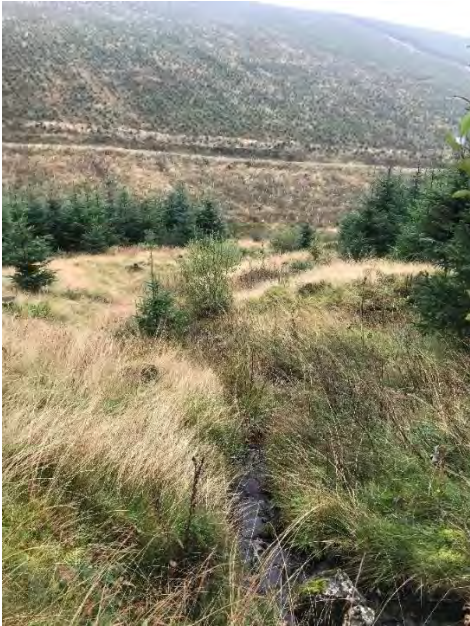
ID - 12	Unnamed tributary of Appin Burn
Existing track crossing	
<u>Description:</u> Unnamed Tributary of the Appin Burn flowing north to the Appin Burn. Culverted under existing track.	
NGR Ref: 271689 598013	
Photo – Unnamed tributary viewed downstream

Width of watercourse (m)	2.1
Bed sediment	Cobble and gravel
Bank erosion	No
Natural channel	Yes
Crossing type	Existing track crossing with pipe culvert, variable in size
Additional mitigation	Additional SuDS and pollution control measures (e.g. silt fences) at this location during construction phase.
Catchment (km²)	0.09
Minor watercourse	No
Main river catchment	Appin Burn
CAR authorisation required	No

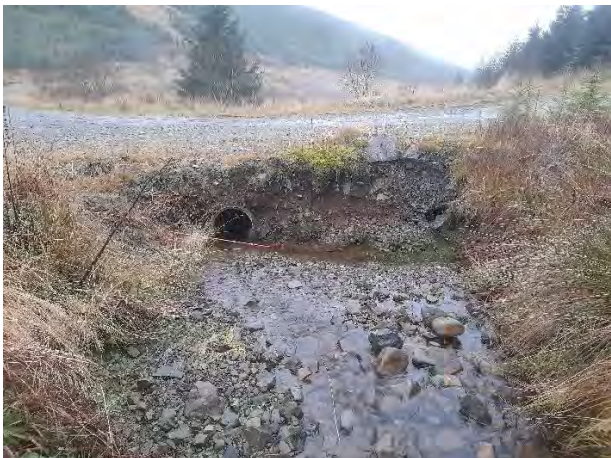
ID - 13	Unnamed tributary of Appin Burn
Existing track crossing	
<u>Description:</u> Unnamed Tributary of the Appin Burn flowing west to the Appin Burn. The tributary is culverted under the existing access track.	
NGR Ref: 271573 598098	
Photo – Tributary viewed north, flowing downstream to existing culvert

Width of watercourse (m)	2.0
Bed sediment	Gravel
Bank erosion	Yes
Natural channel	Yes
Crossing type	Existing track crossing with pipe culvert, variable in size
Additional mitigation	Additional SuDS and pollution control measures (e.g. silt fences) at this location during construction phase.
Catchment (km²)	0.07
Minor watercourse	No
Main river catchment	Appin Burn
CAR authorisation required	No

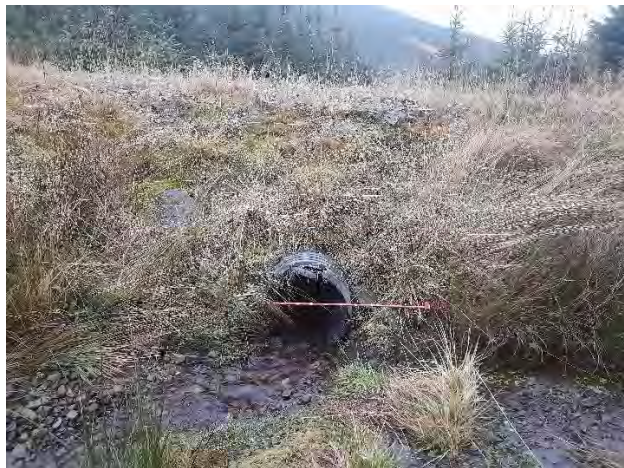
ID - 14	Unnamed tributary of Appin Burn
Existing track crossing	
<u>Description:</u> Unnamed Tributary of the Appin Burn flowing north-west. Culverted under existing access track.	
NGR Ref: 271446 598133	
Photo – Tributary viewed downstream, culverted underneath existing access track.

Width of watercourse (m)	2.0
Bed sediment	Gravel
Bank erosion	No
Natural channel	Yes
Crossing type	Existing track crossing with pipe culvert, ~600 mm in size
Additional mitigation	Additional SuDS and pollution control measures (e.g. silt fences) at this location during construction phase.
Catchment (km²)	0.27
Minor watercourse	No
Main river catchment	Appin Burn
CAR authorisation required	No

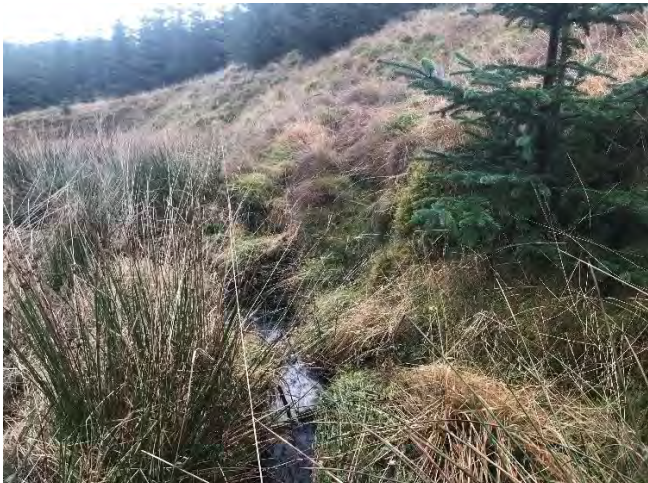
ID - 15	Unnamed watercourse
New track crossing	
<u>Description:</u> Unnamed watercourse flowing to the south-east to join a tributary of the Appin Burn.	
NGR Ref: 271140 598083	
Photo – unnamed watercourse viewed downstream

Width of watercourse (m)	0.4
Bed sediment	Cobble and silt
Bank erosion	Yes
Natural channel	Yes
Crossing type	Proposed – bottomless arch culvert or single span bridge
Additional mitigation	Additional SuDS and pollution control measures (e.g. silt fences) at this location during construction phase.
Catchment (km²)	< 0.01
Minor watercourse	No
Main river catchment	Appin Burn
CAR authorisation required	Yes

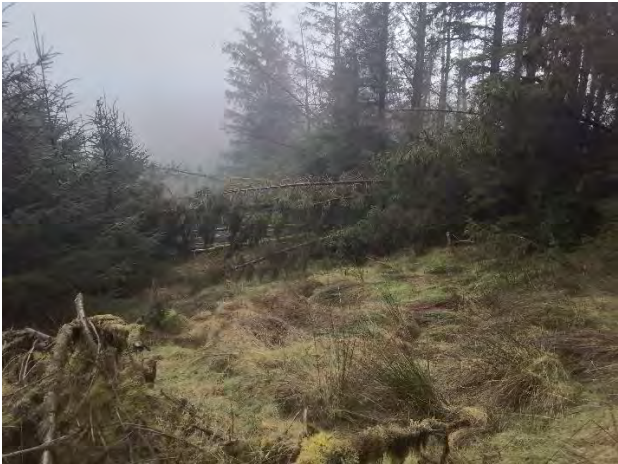
ID - 16	Conrick Burn
New track crossing	
<u>Description:</u> The Conrick Burn is a tributary of the Dalwhat Water and originates on the south-east slope of Blackcraig Hill. The watercourse flows to the south-east and is a diffuse surface water pathway at the proposed crossing location.	
NGR Ref: 270871 597927	
Photo – Conrick Burn originating as a diffuse surface water pathway

Width of watercourse (m)	0.2
Bed sediment	Gravel
Bank erosion	No
Natural channel	No
Crossing type	Proposed – bottomless arch culvert or single span bridge
Additional mitigation	Additional SuDS and pollution control measures (e.g. silt fences) at this location during construction phase.
Catchment (km²)	0.04
Minor watercourse	No
Main river catchment	Appin Burn
CAR authorisation required	Yes

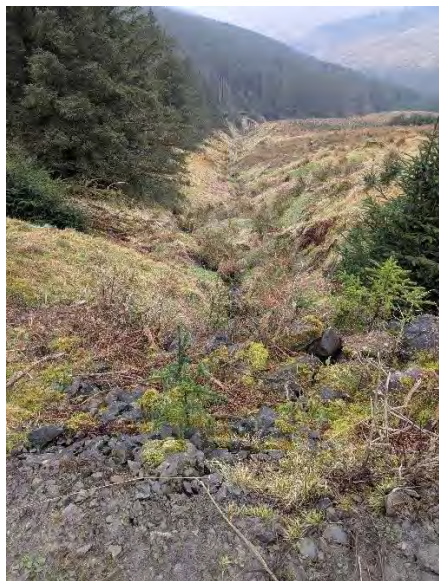
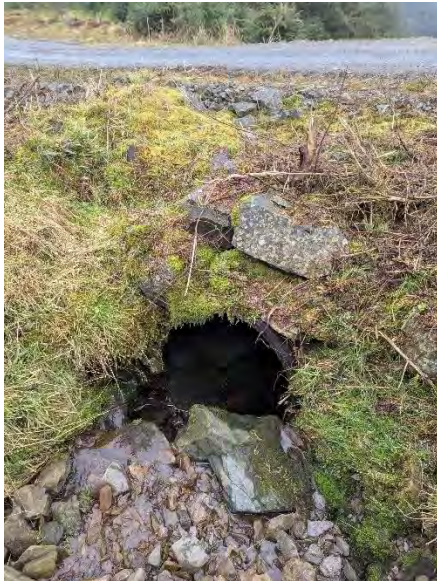
ID - 17	Unnamed tributary of Conrick Burn
Existing track crossing	
<u>Description:</u> Unnamed Tributary of the Conrick Burn flows south in a steep, tightly meandering valley. Culverted where crossed by the existing track.	
NGR Ref: 270534 597722	
Photo – Valley channel of the watercourse after track crossing.	Photo – Watercourse culverted underneath existing track.

Width of watercourse (m)	0.4
Bed sediment	Gravel
Bank erosion	No
Natural channel	Yes
Crossing type	Existing track crossing with pipe culvert, ~1 m in size
Additional mitigation	Additional SuDS and pollution control measures (e.g. silt fences) at this location during construction phase.
Catchment (km²)	0.08
Minor watercourse	No
Main river catchment	Dalwhat Water
CAR authorisation required	No

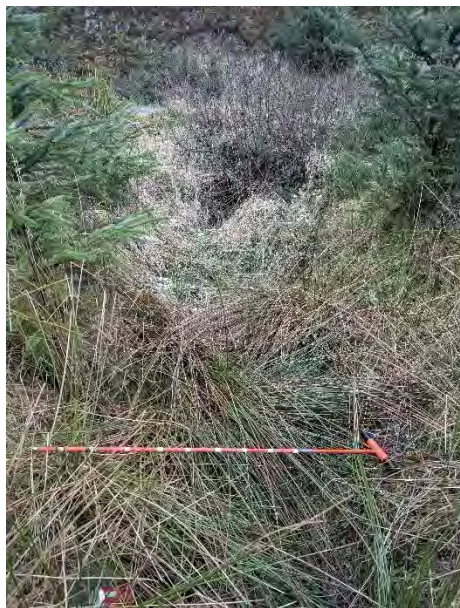
ID - 18	Unnamed tributary of Lagdubh Burn
Existing track crossing	
<u>Description:</u> Road drainage along the existing access track joins an OS marked, unnamed tributary of the Lagdubh Burn.	
NGR Ref: 270140 598122	
Photo – Heavily vegetated tributary channel.

Width of watercourse (m)	0.2
Bed sediment	Gravel
Bank erosion	No
Natural channel	No
Crossing type	Existing track crossing with pipe culvert, ~300 mm in size
Additional mitigation	Additional SuDS and pollution control measures (e.g. silt fences) at this location during construction phase.
Catchment (km²)	0.04
Minor watercourse	Yes
Main river catchment	Dalwhat Water
CAR authorisation required	No

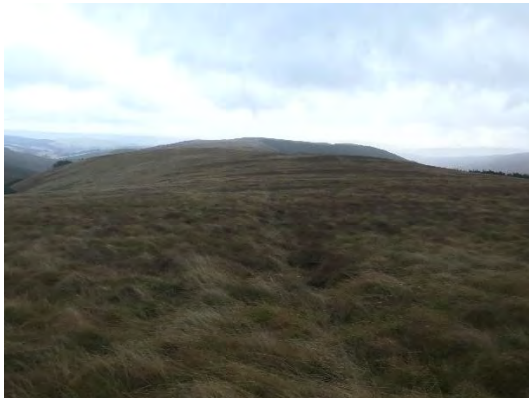
Width of watercourse (m)	0.3
Bed sediment	Peat
Bank erosion	No
Natural channel	No
Crossing type	Proposed – Bottomless arch culvert
Additional mitigation	Additional SuDS and pollution control measures (e.g. silt fences) at this location during construction phase.
Catchment (km²)	< 0.01
Minor watercourse	Yes
Main river catchment	Appin Burn
CAR authorisation required	No

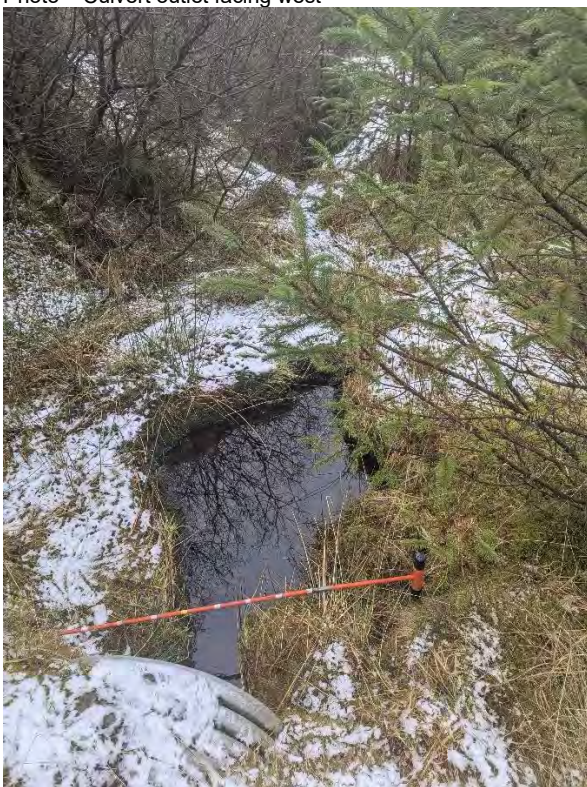
ID - 20	Unnamed tributary of Fingland Burn
Existing track crossing	
<u>Description:</u> Unnamed Tributary of the Fingland Burn crossed by existing track.	
NGR Ref: 269229 598991	
Photo – Culvert outlet facing west

Width of watercourse (m)	0.8
Bed sediment	Gravel and silt
Bank erosion	No
Natural channel	No
Crossing type	Existing track crossing with pipe culvert, ~600 mm in size
Additional mitigation	Additional SuDS and pollution control measures (e.g. silt fences) at this location during construction phase.
Catchment (km²)	< 0.01
Minor watercourse	Yes
Main river catchment	Dalwhat Water
CAR authorisation required	No

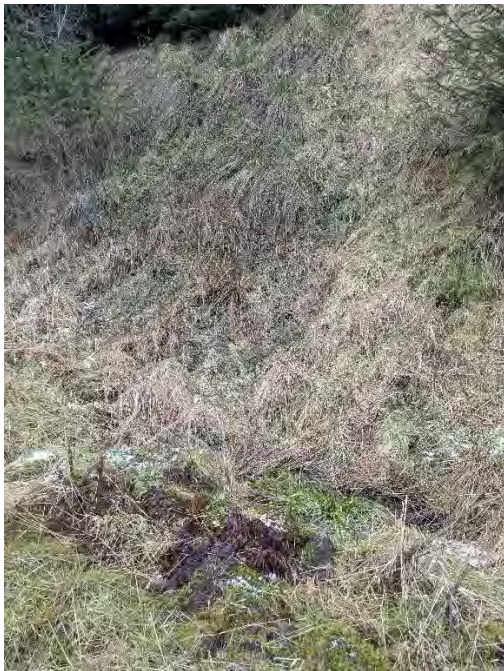
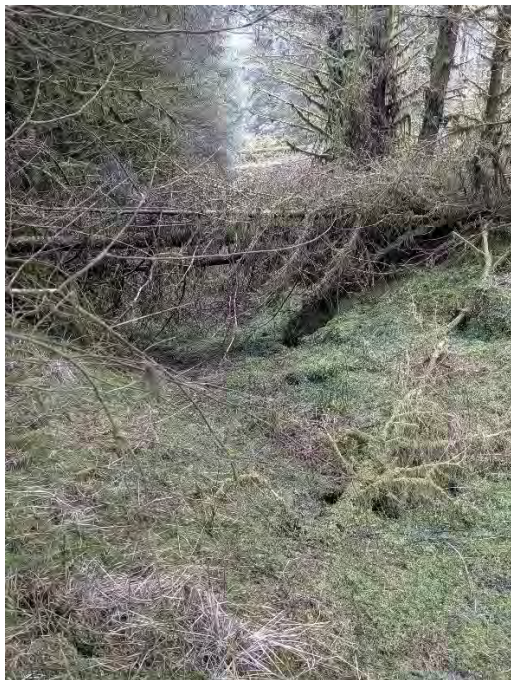
ID - 22	Unnamed tributary of Fingland Burn
Existing track crossing	
<u>Description:</u> An OS marked tributary of the Fingland Burn is crossed by the existing track. Upstream of the crossing sheet flow enters a 600 mm culvert, for which a downstream outlet could not be identified. Downstream of the track, diffuse surface water flows to the east to eventually join the Fingland Burn.	
NGR Ref: 269077 598394	
Photo – Culvert inlet above track	Photo – Downstream of track – no culvert outlet identified, however flow path still established.

Width of watercourse (m)	0.5 – 2.0
Bed sediment	Clay
Bank erosion	No
Natural channel	Yes
Crossing type	Existing pipe in poor condition – no obvious outlet but inlet identified.
Additional mitigation	Additional SuDS and pollution control measures (e.g. silt fences) at this location during construction phase.
Catchment (km²)	0.04
Minor watercourse	No
Main river catchment	Dalwhat Water

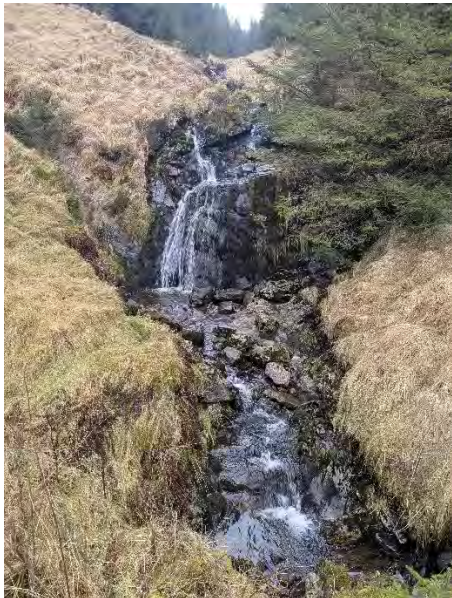
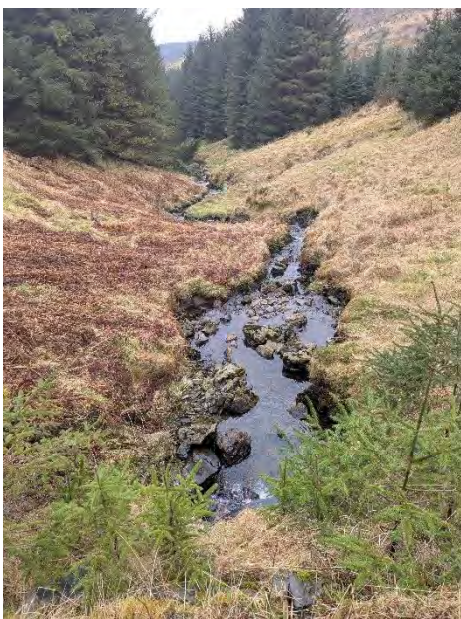
Width of watercourse (m)	2.0
Bed sediment	Bedrock
Bank erosion	Yes
Natural channel	Yes
Crossing type	Existing track crossing with pipe culvert, ~2 m in size.  Proposed new crossing – Bottomless arch culvert or single span bridge
Additional mitigation	Additional SuDS and pollution control measures (e.g. silt fences) at this location during construction phase.
Catchment (km²)	0.81
Minor watercourse	No
Main river catchment	Dalwhat Water
CAR authorisation required	Yes

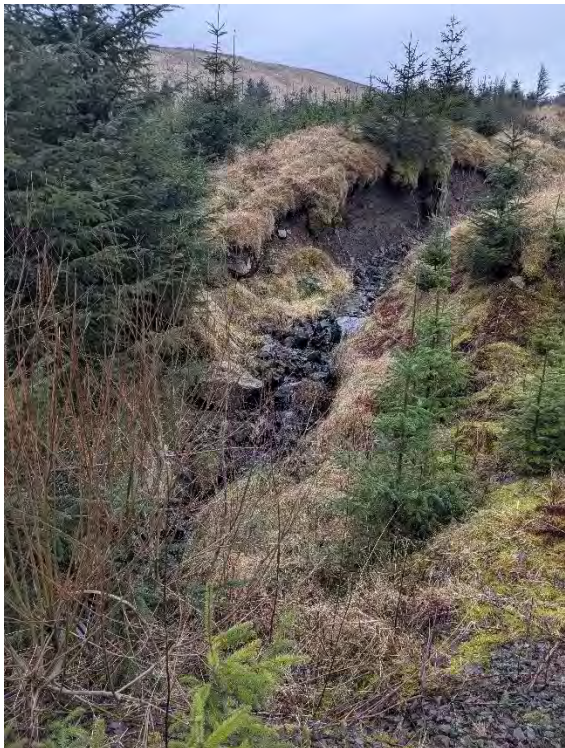
Width of watercourse (m)	0.8
Bed sediment	Gravel
Bank erosion	Yes
Natural channel	Yes
Crossing type	Existing track crossing with pipe culvert, ~600 mm in size
Additional mitigation	Additional SuDS and pollution control measures (e.g. silt fences) at this location during construction phase.
Catchment (km²)	0.13
Minor watercourse	No
Main river catchment	Dalwhat Water
CAR authorisation required	No

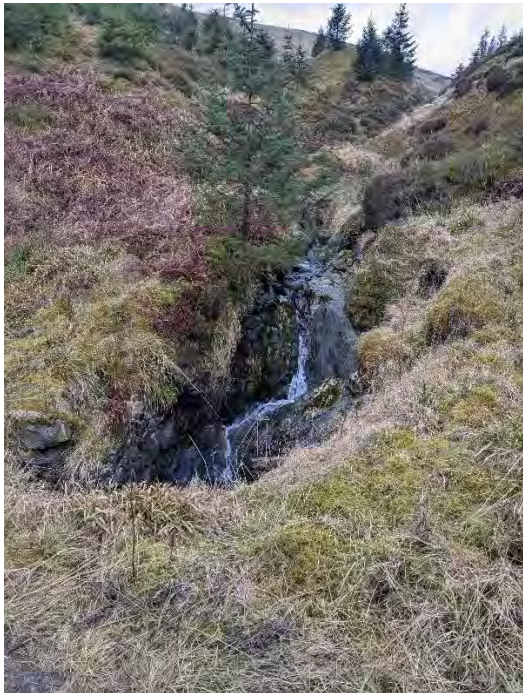
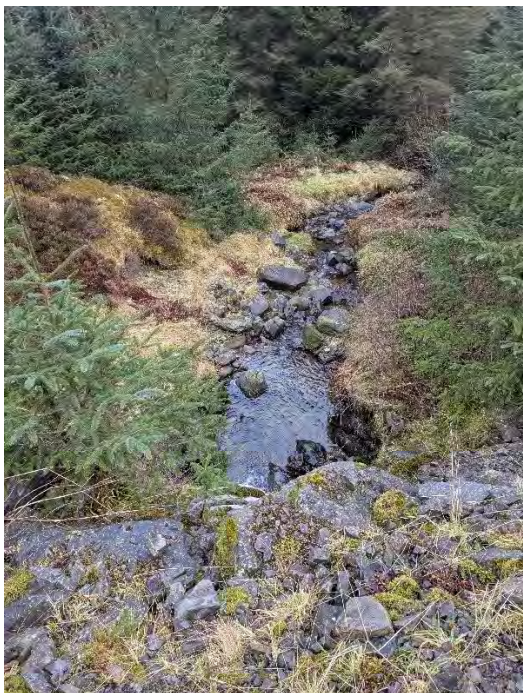
ID - 25	Ramscleuch Burn
Existing track crossing	
<u>Description:</u> The Ramscleuch Burn is a tributary of the Dalwhat Water that flows to the north-east and is crossed by the existing track.	
NGR Ref: 268727 597685	
Photo – Ramscleuch Burn viewed upstream to the west	Photo – Ramscleuch Burn culvert mouth downstream of the existing crossing.

Width of watercourse (m)	2.0
Bed sediment	Gravel
Bank erosion	No
Natural channel	Yes
Crossing type	Existing track crossing with pipe culvert, ~600 mm in size
Additional mitigation	Additional SuDS and pollution control measures (e.g. silt fences) at this location during construction phase.
Catchment (km²)	0.32
Minor watercourse	No
Main river catchment	Dalwhat Water
CAR authorisation required	No

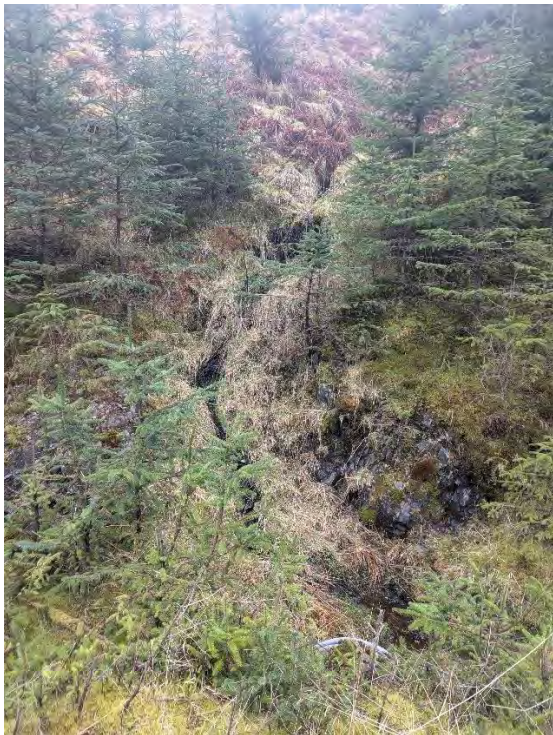
ID - 26	Unnamed tributary of the Dalwhat Water
Existing track crossing	
<u>Description:</u> Unnamed Tributary of the Dalwhat Water that flows to the north-east and is crossed by the existing track.	
NGR Ref: 269153 597514	
Photo – Unnamed tributary viewed upstream to the west

Width of watercourse (m)	0.1
Bed sediment	Gravel
Bank erosion	No
Natural channel	Yes
Crossing type	Existing track crossing with pipe culvert, ~600 mm in size
Additional mitigation	Additional SuDS and pollution control measures (e.g. silt fences) at this location during construction phase.
Catchment (km²)	< 0.01
Minor watercourse	No
Main river catchment	Dalwhat Water
CAR authorisation required	No

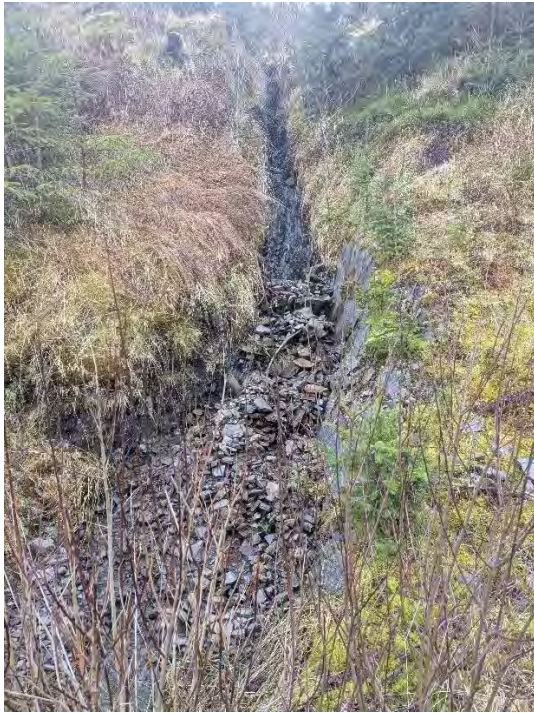
ID - 27	Unnamed tributary of the Dalwhat Water
Existing track crossing	
<u>Description:</u> Unnamed Tributary of the Dalwhat Water that flows to the north-east and is crossed by the existing track.	
NGR Ref: 269261 597441	
Photo – Unnamed tributary viewed upstream to the west

Width of watercourse (m)	0.4
Bed sediment	Gravel
Bank erosion	No
Natural channel	Yes
Crossing type	Existing track crossing with pipe culvert, ~600 mm in size
Additional mitigation	Additional SuDS and pollution control measures (e.g. silt fences) at this location during construction phase.
Catchment (km²)	< 0.01
Minor watercourse	No
Main river catchment	Dalwhat Water
CAR authorisation required	No

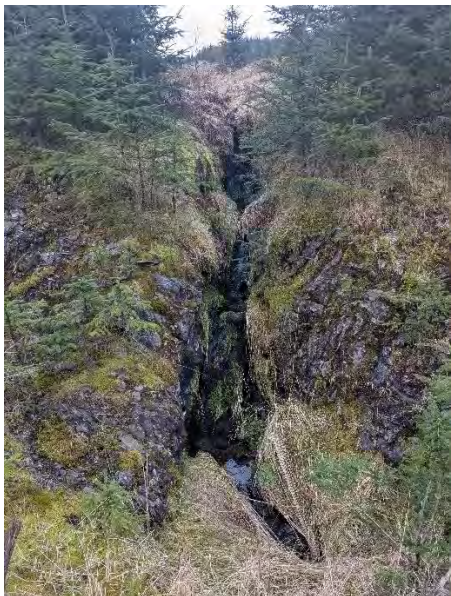
ID – 28	Unnamed tributary of the Dalwhat Water
Existing track crossing	
<u>Description:</u> Unnamed Tributary of the Dalwhat Water that flows to the north-east and is crossed by the existing track.	
NGR Ref: 269362 597288	
Photo – Unnamed tributary viewed upstream to the west

Width of watercourse (m)	0.4
Bed sediment	Gravel
Bank erosion	No
Natural channel	Yes
Crossing type	Existing track crossing with pipe culvert, ~600 mm in size
Additional mitigation	Additional SuDS and pollution control measures (e.g. silt fences) at this location during construction phase.
Catchment (km²)	< 0.01
Minor watercourse	No
Main river catchment	Dalwhat Water
CAR authorisation required	No

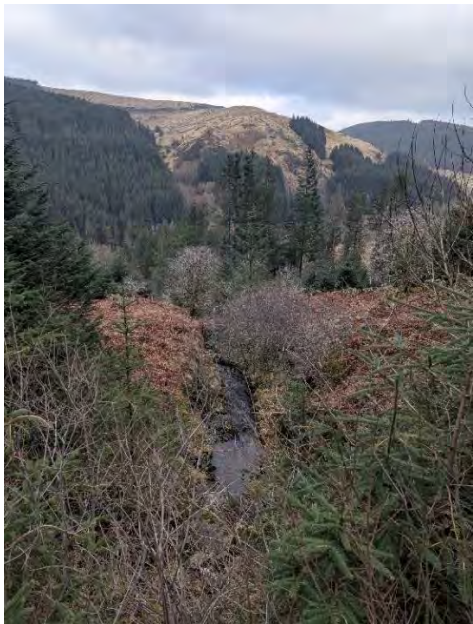
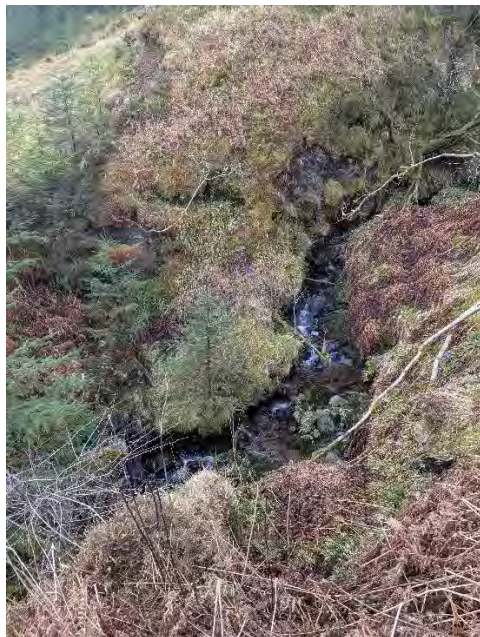
ID - 30	Back Burn
Existing track crossing	
<u>Description:</u> The Back Burn flows to the east in a steep valley and is a tributary of the Dalwhat Water. The watercourse is crossed by the existing track.	
NGR Ref: 269430 597141	
Photo – Back Burn viewed downstream of existing crossing.	Photo – Back Burn in steep valley above track

Width of watercourse (m)	2.8
Bed sediment	Gravel
Bank erosion	Yes
Natural channel	Yes
Crossing type	Existing track crossing with pipe culvert, ~300 mm in size
Additional mitigation	Additional SuDS and pollution control measures (e.g. silt fences) at this location during construction phase.
Catchment (km²)	0.6
Minor watercourse	No
Main river catchment	Dalwhat Water
CAR authorisation required	No

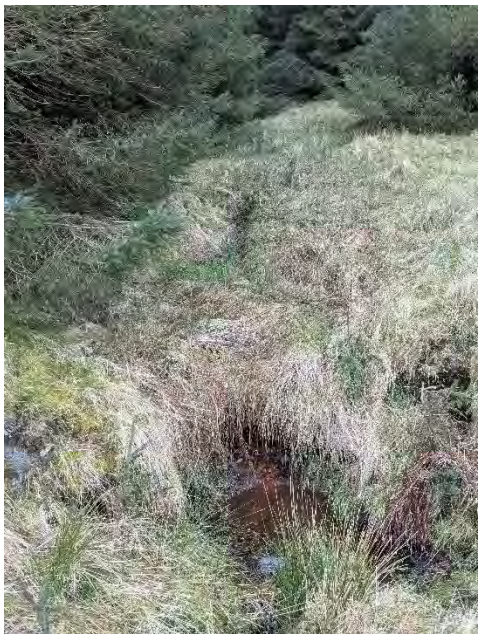
ID - 32	Unnamed Watercourse
Existing track crossing	
<u>Description:</u> Unnamed watercourse with heavily vegetated channel and low flow. Crossed by existing track.	
NGR Ref: 268261 596131	
Photo – unnamed watercourse viewed upstream to the north

Width of watercourse (m)	0.2
Bed sediment	Gravel
Bank erosion	Yes
Natural channel	Yes
Crossing type	Existing track crossing with pipe culvert, ~200 mm in size
Additional mitigation	Additional SuDS and pollution control measures (e.g. silt fences) at this location during construction phase.
Catchment (km²)	< 0.01
Minor watercourse	Yes
Main river catchment	Dalwhat Water
CAR authorisation required	No

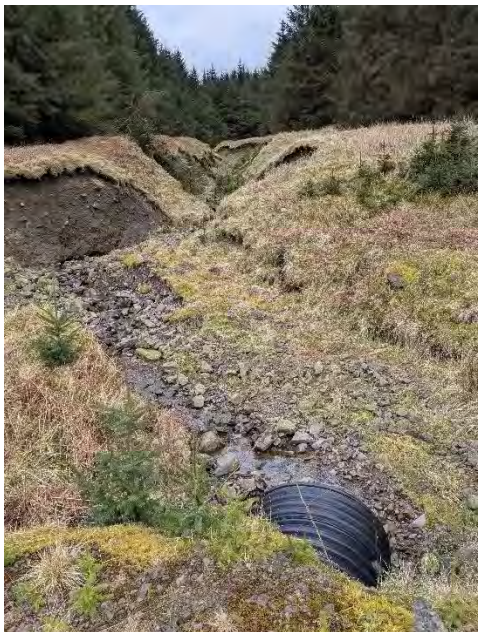
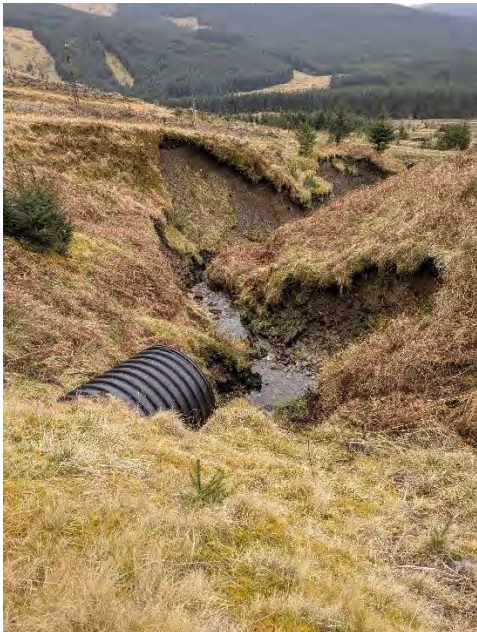
ID - 33	Unnamed Watercourse
Existing track crossing	
<u>Description:</u> Unnamed watercourse lying in steep, highly eroded, tightly meandering valley. Crossed by existing track.	
NGR Ref: 268210 596147	
Photo – unnamed watercourse viewed upstream to the north	Photo – unnamed watercourse culvert outlet

Width of watercourse (m)	3
Bed sediment	Gravel and cobble
Bank erosion	Yes
Natural channel	Yes
Crossing type	Existing track crossing with pipe culvert, ~1.2 m in size
Additional mitigation	Additional SuDS and pollution control measures (e.g. silt fences) at this location during construction phase.
Catchment (km²)	0.31
Minor watercourse	No
Main river catchment	Dalwhat Water
CAR authorisation required	No

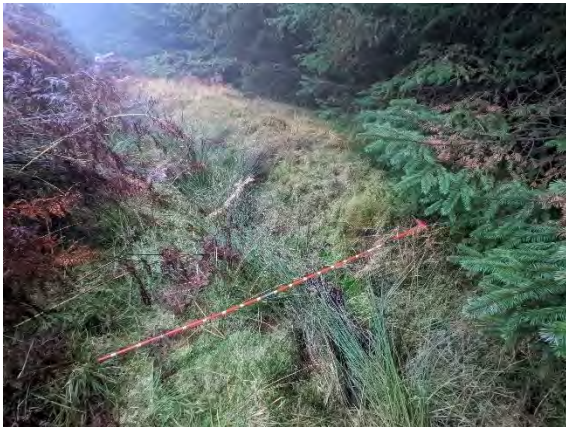
ID - 34	Unnamed Watercourse
Existing track crossing	
<u>Description:</u> Road drainage is passed under the existing track through a culvert which leads to a vegetated channel with minimal flow.	
NGR Ref: 268053 596144	
Photo – unnamed watercourse viewed downstream to the south

Width of watercourse (m)	0.8
Bed sediment	Silt
Bank erosion	No
Natural channel	No
Crossing type	Existing track crossing with pipe culvert, ~250 mm in size
Additional mitigation	Additional SuDS and pollution control measures (e.g. silt fences) at this location during construction phase.
Catchment (km²)	< 0.01
Minor watercourse	Yes
Main river catchment	Dalwhat Water
CAR authorisation required	No

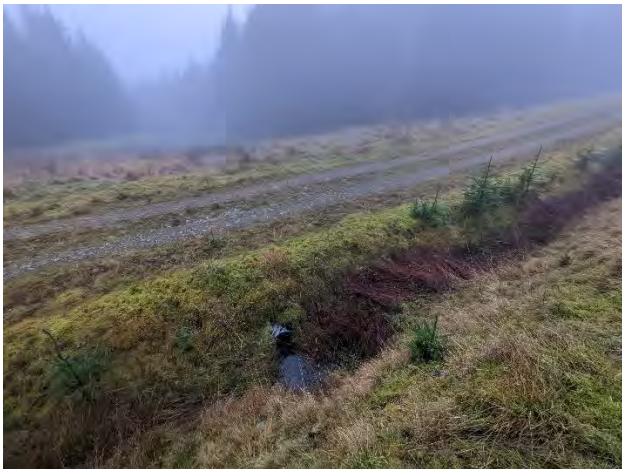
ID - 35	Unnamed Watercourse
Existing track crossing	
<u>Description:</u> Road drainage is passed under the existing track through a culvert which leads to a vegetated channel with low flow.	
NGR Ref: 267827 596148	
Photo – unnamed watercourse viewed downstream to the south

Width of watercourse (m)	0.35
Bed sediment	Silt
Bank erosion	No
Natural channel	No
Crossing type	Existing track crossing with pipe culvert, ~250 mm in size
Additional mitigation	Additional SuDS and pollution control measures (e.g. silt fences) at this location during construction phase.
Catchment (km²)	< 0.01
Minor watercourse	Yes
Main river catchment	Dalwhat Water
CAR authorisation required	No

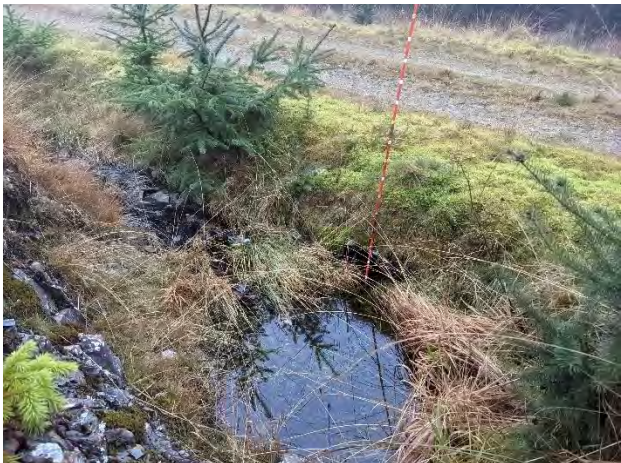
ID - 36	Unnamed Watercourse
Existing track crossing	
<u>Description:</u> Road drainage is passed under the existing track through a culvert which leads to a vegetated channel with low flow.	
NGR Ref: 267665 596119	
Photo – unnamed watercourse viewed downstream to the south

Width of watercourse (m)	0.35
Bed sediment	Silt
Bank erosion	No
Natural channel	No
Crossing type	Existing track crossing with pipe culvert, ~250 mm in size
Additional mitigation	Additional SuDS and pollution control measures (e.g. silt fences) at this location during construction phase.
Catchment (km²)	< 0.01
Minor watercourse	Yes
Main river catchment	Stroanfreggan Burn
CAR authorisation required	No

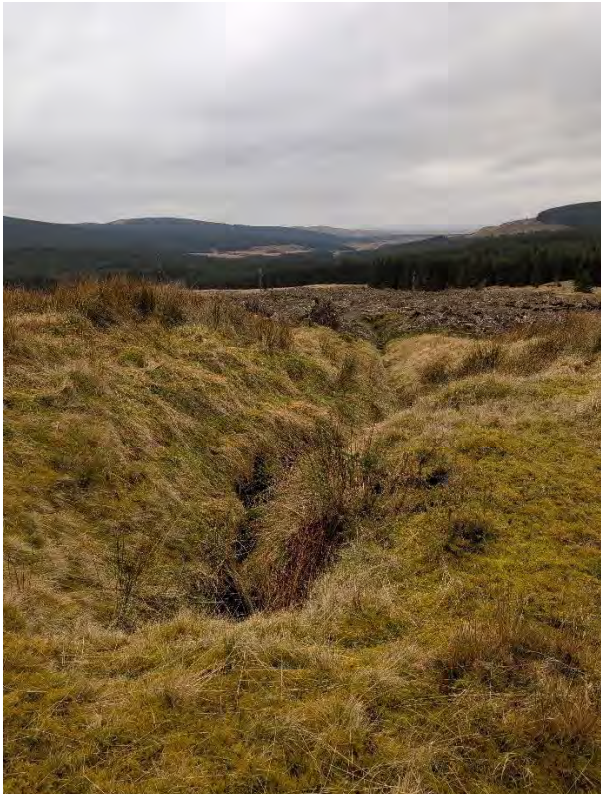
ID - 37	Unnamed Watercourse
Existing track crossing	
<p><u>Description:</u> Road drainage is passed under the existing track through a culvert which leads to a vegetated channel with low flow.</p>	
NGR Ref: 267665 596119	
<p>Photo – unnamed watercourse viewed downstream to the south</p>

Width of watercourse (m)	0.35
Bed sediment	Silt
Bank erosion	No
Natural channel	No
Crossing type	Existing track crossing with pipe culvert, ~ 350 mm in size
Additional mitigation	Additional SuDS and pollution control measures (e.g. silt fences) at this location during construction phase.
Catchment (km²)	< 0.01
Minor watercourse	Yes
Main river catchment	Stroanfreggan Burn
CAR authorisation required	No

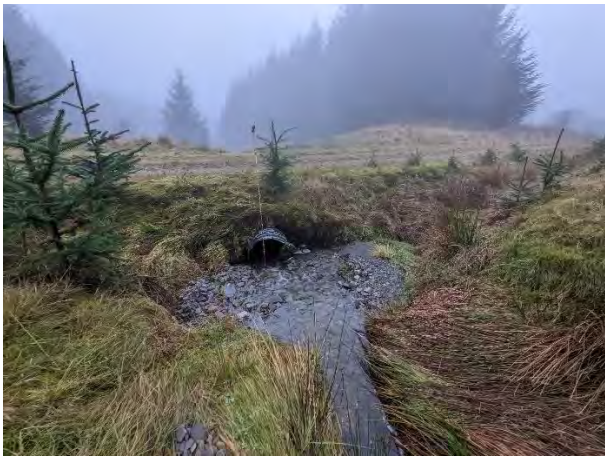
ID - 38	Unnamed Watercourse
Existing track crossing	
Description: The unnamed watercourse originating from high ground to the north is passed under the existing track through a culvert which leads to a vegetated channel.	
NGR Ref: 267441 596141	
Photo – unnamed watercourse viewed downstream to the south

Width of watercourse (m)	0.5
Bed sediment	Gravel
Bank erosion	No
Natural channel	Yes
Crossing type	Existing track crossing with pipe culvert, ~350 mm in size
Additional mitigation	Additional SuDS and pollution control measures (e.g. silt fences) at this location during construction phase.
Catchment (km²)	0.37
Minor watercourse	No
Main river catchment	Stroanfreggan Burn
CAR authorisation required	No

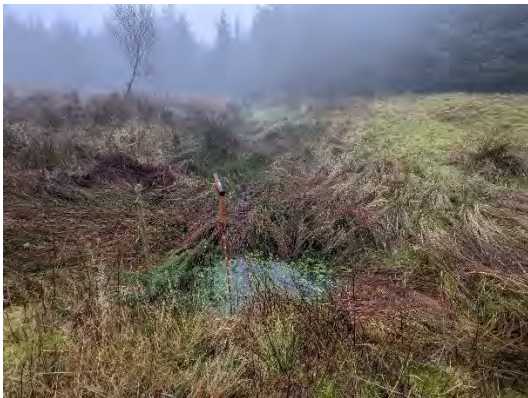
ID – 39	Unnamed Watercourse
Existing track crossing	
<u>Description:</u> The unnamed watercourse is passed under the existing track through a culvert which leads to a vegetated channel.	
NGR Ref: 267327 596110	
Photo – unnamed watercourse viewed downstream to the south

Width of watercourse (m)	0.35
Bed sediment	Silt
Bank erosion	No
Natural channel	No
Crossing type	Existing track crossing with pipe culvert, ~350 mm in size
Additional mitigation	Additional SuDS and pollution control measures (e.g. silt fences) at this location during construction phase.
Catchment (km²)	< 0.01
Minor watercourse	No
Main river catchment	Stroanfreggan Burn
CAR authorisation required	No

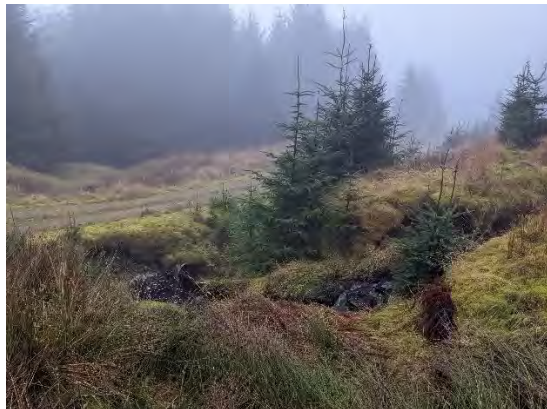
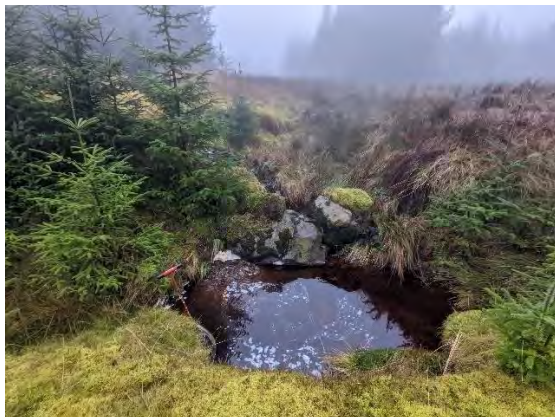
ID - 40	Unnamed Watercourse
Existing track crossing	
<p><u>Description:</u> The unnamed watercourse is passed under the existing track through a culvert which leads to a vegetated channel.</p>	
NGR Ref: 267255 596064	
Photo – unnamed watercourse viewed upstream of existing track	Photo – unnamed watercourse viewed downstream of existing track.

Width of watercourse (m)	0.6
Bed sediment	Gravel
Bank erosion	No
Natural channel	Yes
Crossing type	Existing track crossing with pipe culvert, ~600 mm in size
Additional mitigation	Additional SuDS and pollution control measures (e.g. silt fences) at this location during construction phase.
Catchment (km²)	0.26
Minor watercourse	No
Main river catchment	Stroanfreggan Burn
CAR authorisation required	No

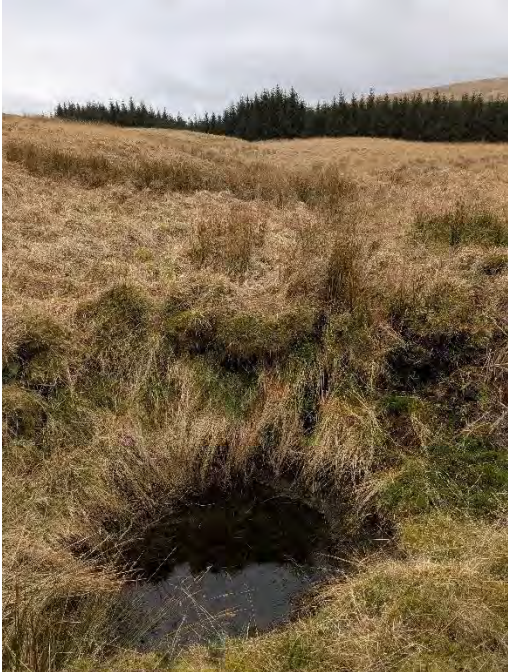
ID - 42	Unnamed Watercourse
Existing track crossing	
<u>Description:</u> A highly vegetated channel leads to a culvert under the existing track	
NGR Ref: 267044 595910	
Photo - Unnamed watercourse upstream of existing culvert

Width of watercourse (m)	0.35
Bed sediment	Silt
Bank erosion	No
Natural channel	No
Crossing type	Existing track crossing with pipe culvert, ~350 mm in size
Additional mitigation	Additional SuDS and pollution control measures (e.g. silt fences) at this location during construction phase.
Catchment (km²)	< 0.01
Minor watercourse	Yes
Main river catchment	Stroanfreggan Burn
CAR authorisation required	No

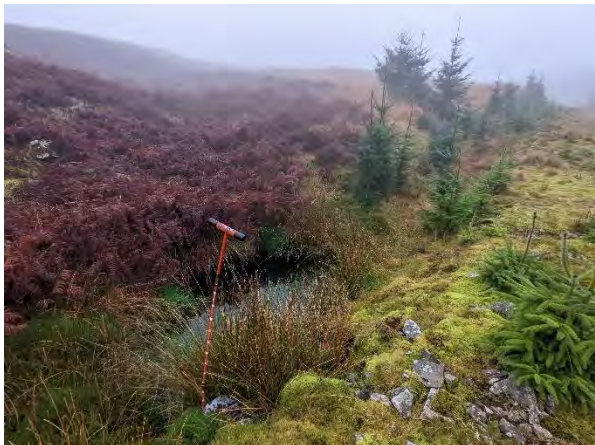
ID - 43	Unnamed Watercourse
Existing track crossing	
<u>Description:</u> A highly vegetated channel leads to a culvert under the existing track	
NGR Ref: 266961 595898	
Photo - Unnamed watercourse upstream of existing culvert

Width of watercourse (m)	0.35
Bed sediment	Silt
Bank erosion	No
Natural channel	Yes
Crossing type	Existing track crossing with pipe culvert, ~350 mm in size
Additional mitigation	Additional SuDS and pollution control measures (e.g. silt fences) at this location during construction phase.
Catchment (km²)	< 0.01
Minor watercourse	Yes
Main river catchment	Stroanfreggan Burn
CAR authorisation required	No

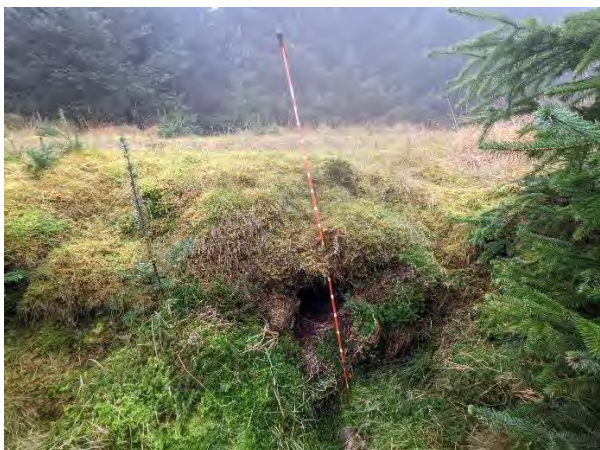
ID - 44	Unnamed Watercourse
Existing track crossing	
<p><u>Description:</u> A highly vegetated channel leads to a culvert under the existing track</p>	
NGR Ref: 266826 595861	
Photo - Unnamed watercourse upstream of existing culvert

Width of watercourse (m)	0.35
Bed sediment	Silt
Bank erosion	No
Natural channel	No
Crossing type	Existing track crossing with pipe culvert, ~350 mm in size
Additional mitigation	Additional SuDS and pollution control measures (e.g. silt fences) at this location during construction phase.
Catchment (km²)	< 0.01
Minor watercourse	Yes
Main river catchment	Stroanfreggan Burn
CAR authorisation required	No

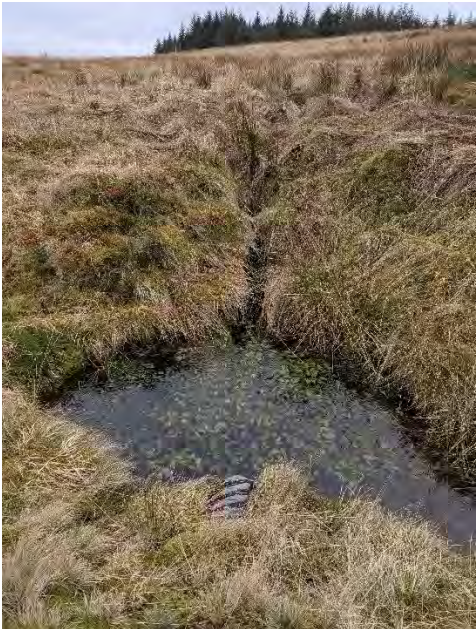
ID - 47	Unnamed Watercourse
Existing track crossing	
<p><u>Description:</u> Flows from a highly vegetated channel are intercepted by road drainage before being passed under the existing track by a culvert.</p>	
NGR Ref: 266445 595330	
Photo – Unnamed watercourse to the southeast, upstream of culvert

Width of watercourse (m)	0.2
Bed sediment	Gravel
Bank erosion	No
Natural channel	Yes
Crossing type	Existing track crossing with pipe culvert, ~300 mm in size
Additional mitigation	Additional SuDS and pollution control measures (e.g. silt fences) at this location during construction phase.
Catchment (km²)	< 0.01
Minor watercourse	Yes
Main river catchment	Water of Ken
CAR authorisation required	No
