## Technical Appendix 6.1: Watercourse Crossing and Buffer Assessment

This appendix should be read in conjunction with **Chapter 6: Geology, Hydrology and Peat** and **Chapter 4: Description of Proposed Development** of the Environmental Impact Assessment (EIA) Report for full details of the Proposed Development.

### Watercourse Crossings

### Watercourse Buffer Encroachment

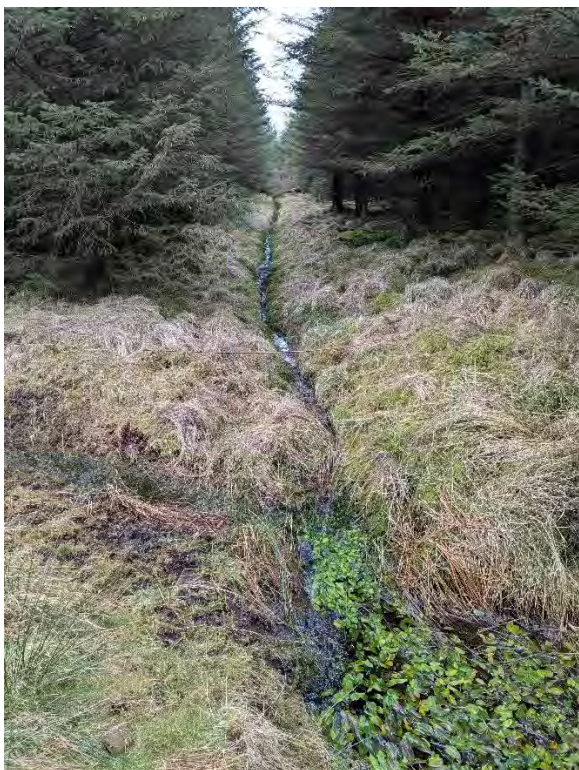
ID - 48	Artificial drainage
Existing track crossing	
<u>Description:</u> Artificial forestry drainage with low flow and peaty water quality	
NGR Ref: 265573 594942	
Photo – Forestry drainage viewed upstream from existing culvert

Width of watercourse (m)	0.2
Bed sediment	Peat
Bank erosion	No
Natural channel	No
Crossing type	Existing track crossing with pipe culvert, variable in size
Additional mitigation	Additional SuDS and pollution control measures (e.g. silt fences) at this location during construction phase.
Catchment (km²)	< 0.01
Minor watercourse	Yes
Main river catchment	Water of Ken
CAR authorisation required	No

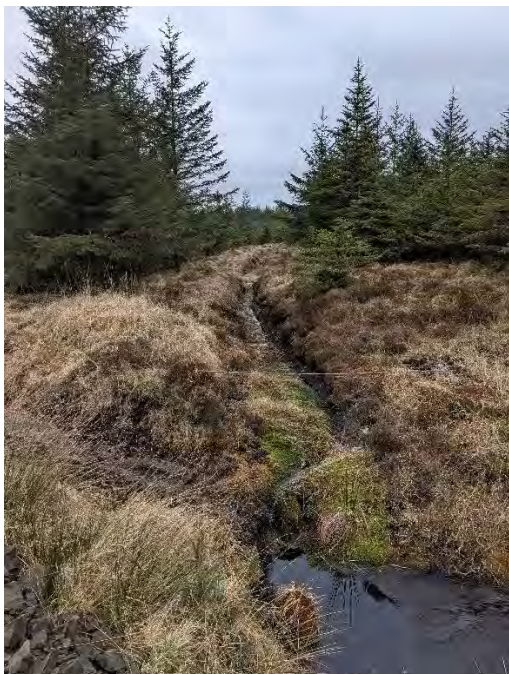
ID - 49	Artificial drainage
Existing track crossing	
Description: Artificial drainage through heavily modified peatland area. Intercepted by existing track, with all flow diverted north-west towards the Auchrae Burn. Existing culvert passes no flow.	
NGR Ref: 265550 594967	
Photo – Artificial drainage channel viewed upstream

Width of watercourse (m)	2.0
Bed sediment	Peat
Bank erosion	Yes
Natural channel	No
Crossing type	Existing track crossing with pipe culvert, variable in size
Additional mitigation	Additional SuDS and pollution control measures (e.g. silt fences) at this location during construction phase.
Catchment (km²)	< 0.01
Minor watercourse	No
Main river catchment	Water of Ken
CAR authorisation required	No

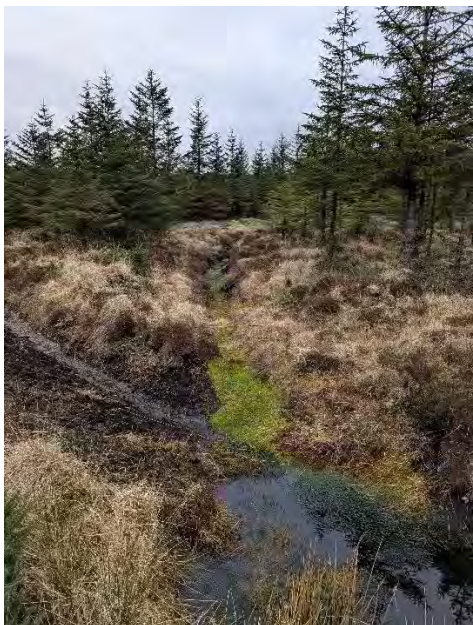
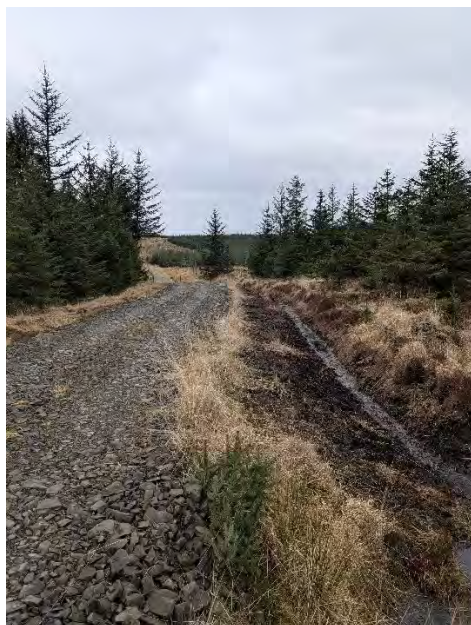
ID - 50	Artificial drainage
Existing track crossing	
<p><u>Description:</u> Artificial drainage through heavily modified peatland area. Intercepted by existing track, with all flow diverted north-west towards the Auchrae Burn. Existing culvert passes no flow.</p>	
NGR Ref: 265505 595030	
Photo – Artificial drainage viewed upstream to the north	Photo – Track redirecting flows towards the Auchrae Burn

Width of watercourse (m)	1.1
Bed sediment	Peat
Bank erosion	No
Natural channel	No
Crossing type	Existing track crossing with pipe culvert, variable in size
Additional mitigation	Additional SuDS and pollution control measures (e.g. silt fences) at this location during construction phase.
Catchment (km²)	< 0.01
Minor watercourse	No
Main river catchment	Water of Ken
CAR authorisation required	No

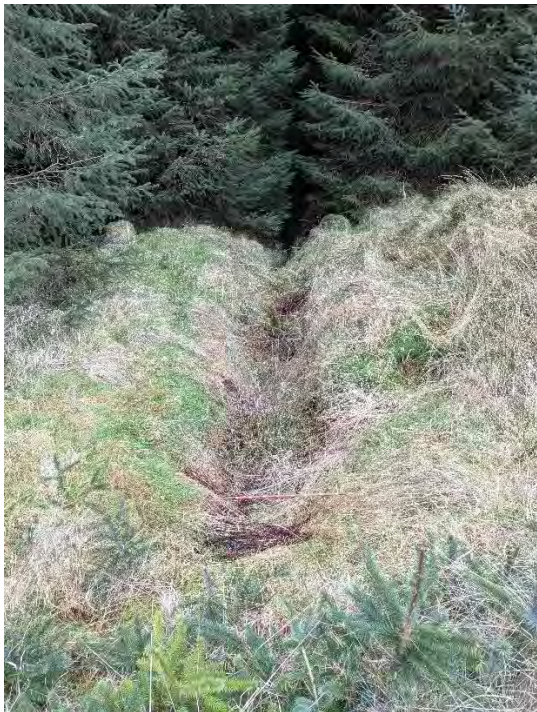
ID - 53	Unnamed Watercourse
Existing track crossing	
<u>Description:</u> An unnamed watercourse flows through a heavily vegetated channel with low flow. The watercourse is crossed by the existing track.	
NGR Ref: 265346 595189	
Photo – unnamed watercourse viewed downstream to the south

Width of watercourse (m)	0.8
Bed sediment	Gravel
Bank erosion	No
Natural channel	No
Crossing type	Existing track crossing with pipe culvert, variable in size
Additional mitigation	Additional SuDS and pollution control measures (e.g. silt fences) at this location during construction phase.
Catchment (km²)	< 0.01
Minor watercourse	Yes
Main river catchment	Water of Ken
CAR authorisation required	No

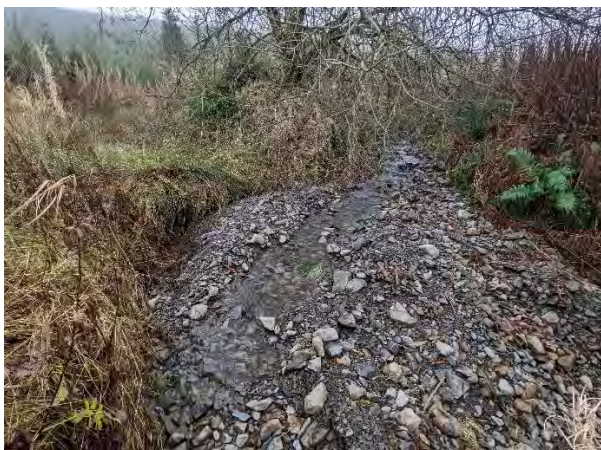
ID - 54	Artificial Drainage
Existing track crossing	
<p><u>Description:</u> Artificial road drainage is crossed by the existing track before joining a forestry drain that enters the Water of Ken. Culvert ~50% blocked.</p>	
NGR Ref: 264823 595846	
Photo – Highly sedimented drainage channel

Width of watercourse (m)	2.0
Bed sediment	Gravel
Bank erosion	No
Natural channel	No
Crossing type	Existing track crossing with pipe culvert, 450 mm in size
Additional mitigation	Additional SuDS and pollution control measures (e.g. silt fences) at this location during construction phase.
Catchment (km²)	< 0.01
Minor watercourse	Yes
Main river catchment	Water of Ken
CAR authorisation required	No

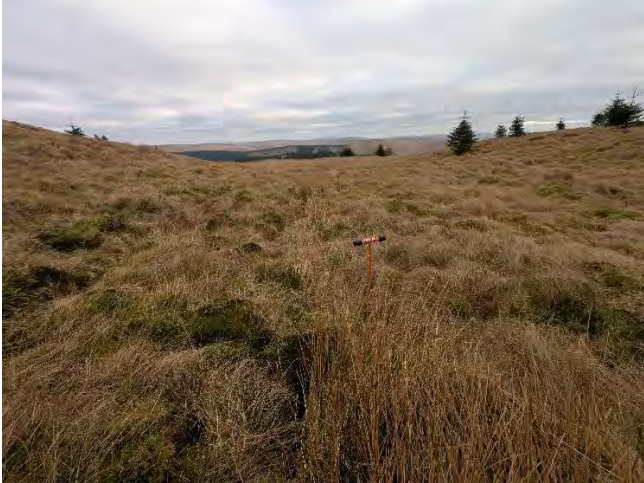
Width of watercourse (m)	0.1 – 3.0
Infrastructure and Ancillary Works Description	Access Track, Turbine 8 hardstanding and fill earthworks for Turbine 8 hardstanding
Temporary or Permanent	Permanent
Width of Buffer Strip Achieved (m)	21 m from hardstanding
Water feature upgradient or downgradient of proposed infrastructure	Downgradient ~ 0.3 m elevation difference
Main river catchment	Appin Water
Potential Effect/Comment	<p>Flow path analysis indicates that surface water runoff paths are from the infrastructure towards the headwater.</p> <p>Embedded Mitigation (i.e. construction and permanent SuDS) will be included in the design.</p> <p>Surface water runoff will be treated and attenuated.</p> <p>The Proposed Development is higher than the drain and is not considered to be at flood risk. Flood flows would flow down gradient and away from the Proposed Development.</p> <p>Buffer width is considered adequate for size of water feature.</p>

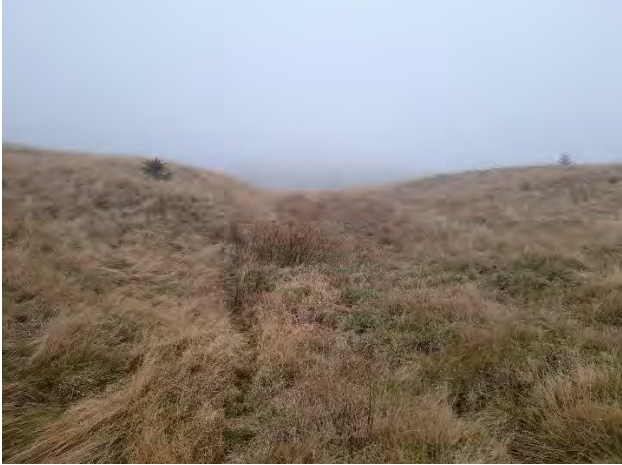
Width of watercourse (m)	0.1 – 2.5
Infrastructure and Ancillary Works Description	Fill earthworks for Turbine 6 hardstanding
Temporary or Permanent	Permanent
Width of Buffer Strip Achieved (m)	39 m
Water feature upgradient or downgradient of proposed infrastructure	Downgradient ~ 3 m elevation difference
Main river catchment	Appin Water
Potential Effect/Comment	Flow path analysis indicates that surface water runoff paths are from the infrastructure towards the drain. Embedded Mitigation (i.e. construction and permanent SuDS) will be included in the design. Surface water runoff will be treated and attenuated. Buffer width is considered adequate for size of water feature.

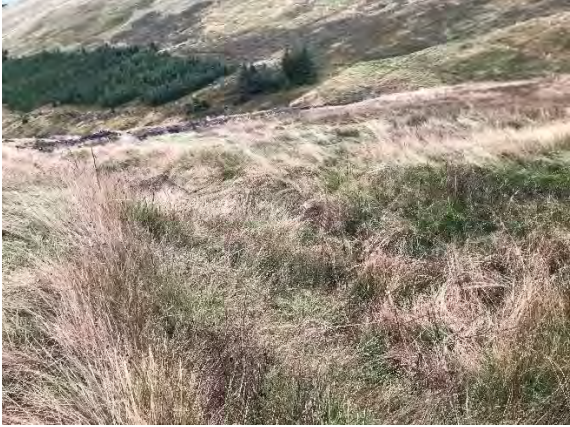
Width of watercourse (m)	0.9
Infrastructure and Ancillary Works Description	Fill earthworks for Turbine 2 hardstanding
Temporary or Permanent	Permanent
Width of Buffer Strip Achieved (m)	42
Water feature upgradient or downgradient of proposed infrastructure	Downgradient ~ 10 m elevation difference
Main river catchment	Appin Water
Potential Effect/Comment	<p>Flow path analysis indicates that surface water runoff paths are from the infrastructure towards the drain. Embedded Mitigation (i.e. construction and permanent SuDS) will be included in the design. Surface water runoff will be treated and attenuated.</p> <p>The Proposed Development is higher than the drain and is not considered to be at flood risk. Flood flows would flow down gradient and away from the Proposed Development. Buffer width is considered adequate for size of water feature.</p>

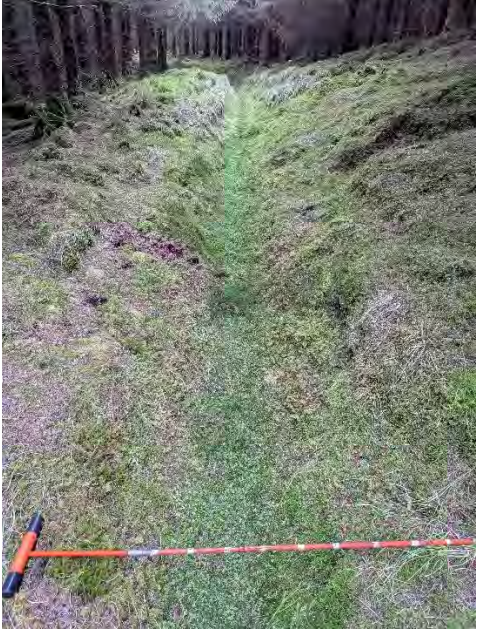
ID – E	Headwater of unnamed tributary of Appin Burn
<p><u>Description:</u> OS marked artificial forestry drainage which leads north towards the Auchrae Burn. During hydrological survey, this watercourse was noted to be dry. The heavily vegetated, unsaturated channel indicates that there is typically minimal flow in this portion of the watercourse.</p>	
NGR Ref: 272109 597296	
<p>Photo – channel viewed at origin looking north</p>

Width of watercourse (m)	0.4
Infrastructure and Ancillary Works Description	Proposed new access Track
Temporary or Permanent	Permanent
Width of Buffer Strip Achieved (m)	35
Water feature upgradient or downgradient of proposed infrastructure	Downgradient ~ 6 m elevation difference
Main river catchment	Water of Ken
Potential Effect/Comment	<p>Flow path analysis indicates that surface water runoff paths are from the infrastructure towards the drain.</p> <p>Embedded Mitigation (i.e. construction and permanent SuDS) will be included in the design. Surface water runoff will be treated and attenuated.</p> <p>The Proposed Development is higher than the drain and is not considered to be at flood risk. Flood flows would flow down gradient and away from the Proposed Development.</p> <p>Buffer width is considered adequate for size of water feature.</p>

Additional Mitigation	Additional Mitigation (e.g. silt fences) will be installed between the track and the watercourse to reduce the risk of sediment/silt runoff during construction.
