Technical Appendix 6.4: Peat Landslide Hazard and Risk Assessment

Technical Appendix 6.4 - Peat Landslide Hazard and Risk Assessment Appin Wind Farm

Dumfries and Galloway, Scotland
Statkraft

O-NR-R14-0045-D-001v01

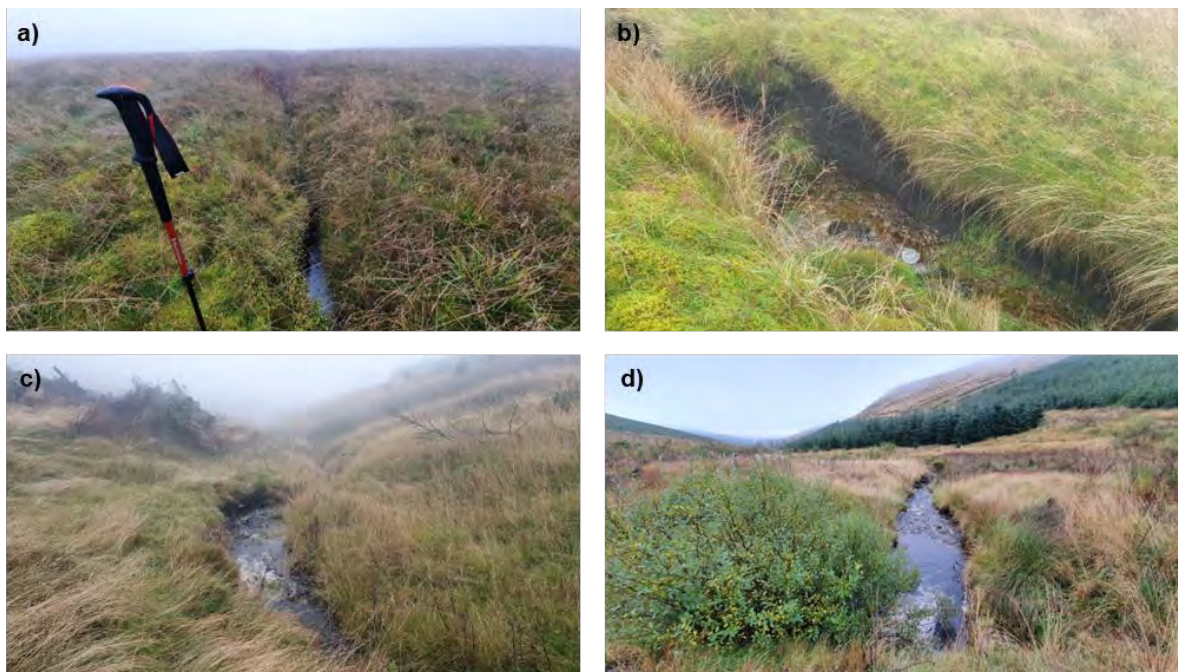
Plate 3.2 Typical hydrological features: a) an active artificial drain on the northern valley side, b) the eroding floor of a widening active drain, c) the Appin Burn in its upper reaches, d) the Appin Burn in the wider valley floor

There are numerous watercourses draining the Site. Minor watercourses fall from the summit ridge to the main west-to-east flowing watercourses in the valley floor (see **Figure 6.4.4**). **Plate 3.2** shows typical hydrological features at the Site.

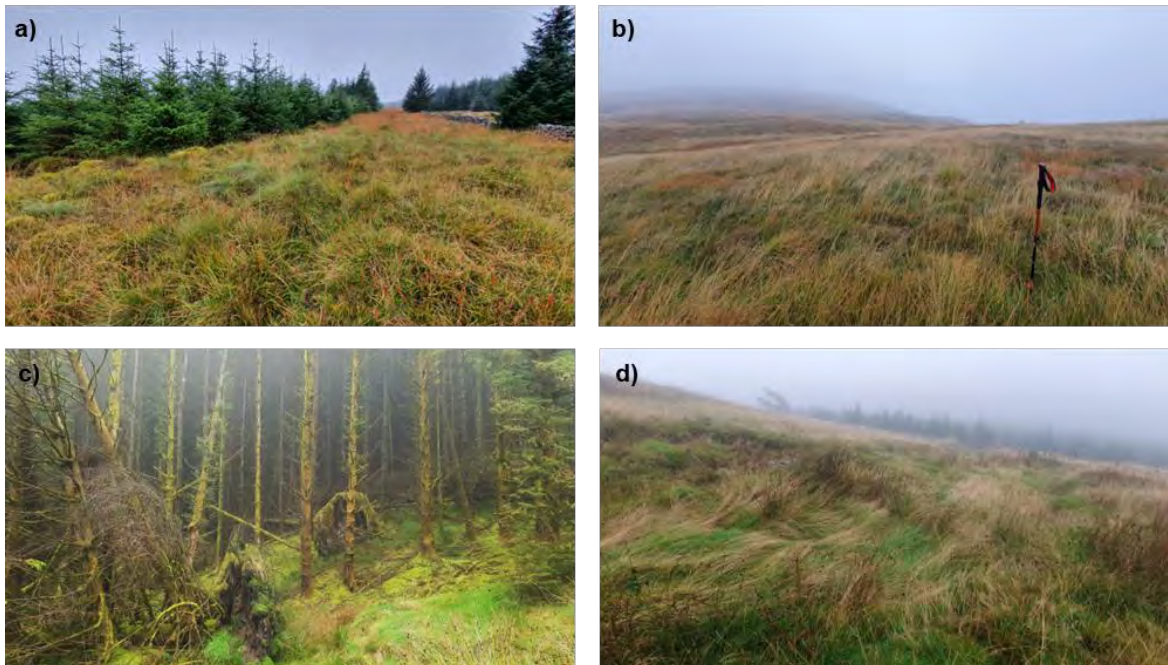
Plate 3.3 Typical terrain features: a) Better quality habitat within forest rides east of Turbine 1 (and away from infrastructure), b) typical exposed and featureless planar summit, c) dense forest on moderate sideslopes, d) flush zone with flattened grasses amongst rushes on moderate slope
