Technical Appendix 10.3: Schedule of Watercourse Crossings

Carn Fearna Wind Farm

Carn Fearna Wind Farm Limited

13 December 2024

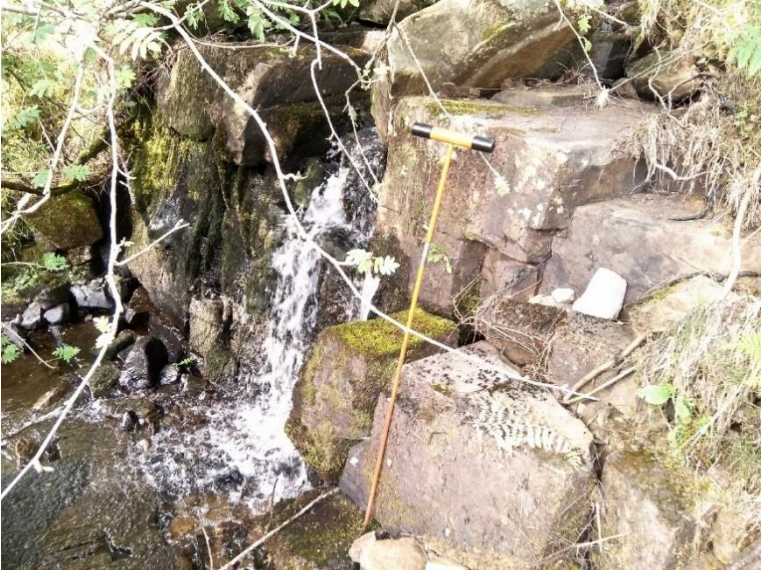
Watercourse Crossing ID	WX01
Watercourse Crossing Details	<p>Grid Reference: E 240423 / N 864097</p> <p>Status: Existing</p> <p>Crossing Type: Circular metal culvert</p> <p>Crossing Size: 1.7 m</p> <p>Watercourse Width: 1.75 m</p> <p>Watercourse Depth: 0.2 m</p> <p>Notes: Watercourse incised in bedrock. Small watercourse / knickpoint is noted upstream of the crossing which is approximately 2 m high.</p>
Photograph Looking Upstream

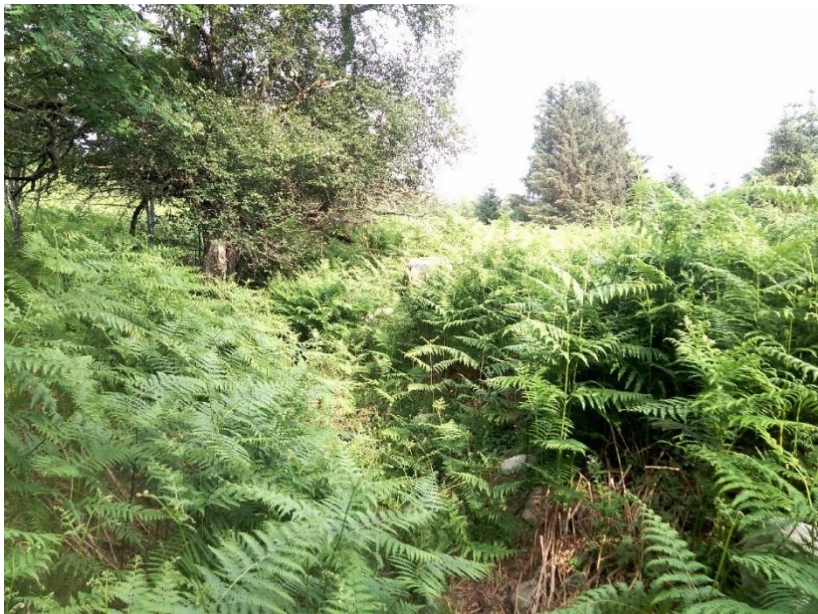
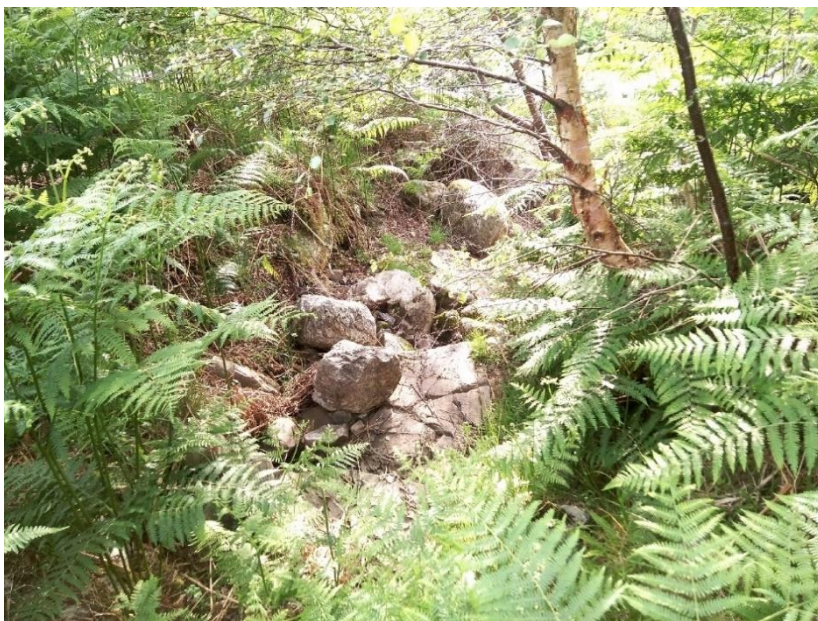
Watercourse Crossing ID		WX02
Watercourse Details	Crossing	<p>Grid Reference: E 240427 / N 864092</p> <p>Status: Existing</p> <p>Watercourse Width: N/A</p> <p>Watercourse Depth: N/A</p> <p>Notes: Watercourse was dry during survey and large boulders were noted in the channel bed. Channel is up to 2 m wide and 1 m deep. Watercourse joins Allt Cnoc nan Cleirach upstream of the existing track and crosses the existing track at WX01.</p>
Photograph Upstream	Looking

Potential Crossing Type Likely Required Authorisation	CAR	<p>Culvert Registration</p>

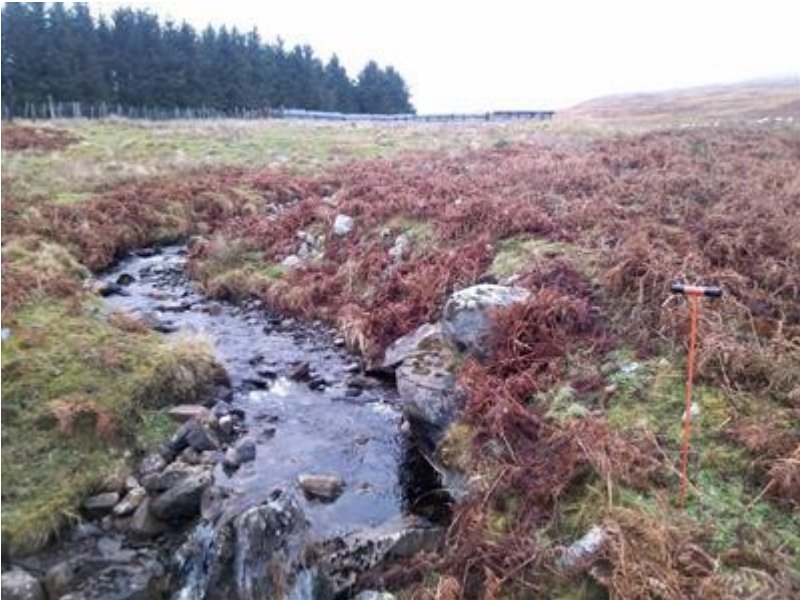
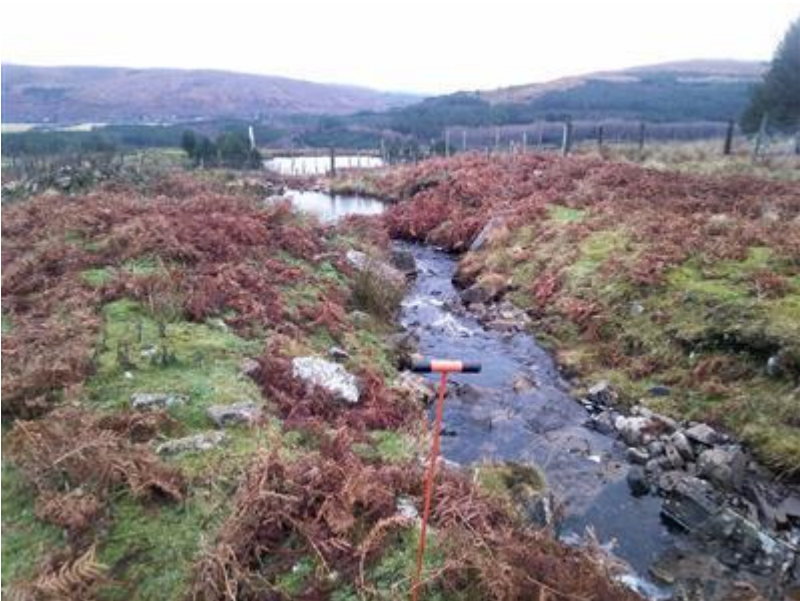
Watercourse Crossing ID	WX03
Watercourse Crossing Details	<p>Grid Reference: E 240820 / N 864118</p> <p>Status: Existing</p> <p>Watercourse Width: 2 m</p> <p>Watercourse Depth: 0.3 m</p> <p>Notes: Watercourse is located adjacent to existing track which is scheduled to be upgraded. Watercourse is incised in bedrock and located within a larger channel which is 4m wide and 1.5m depth.</p>
Photograph Looking Upstream

Potential Crossing Type Likely Required CAR Authorisation	Culvert Licence

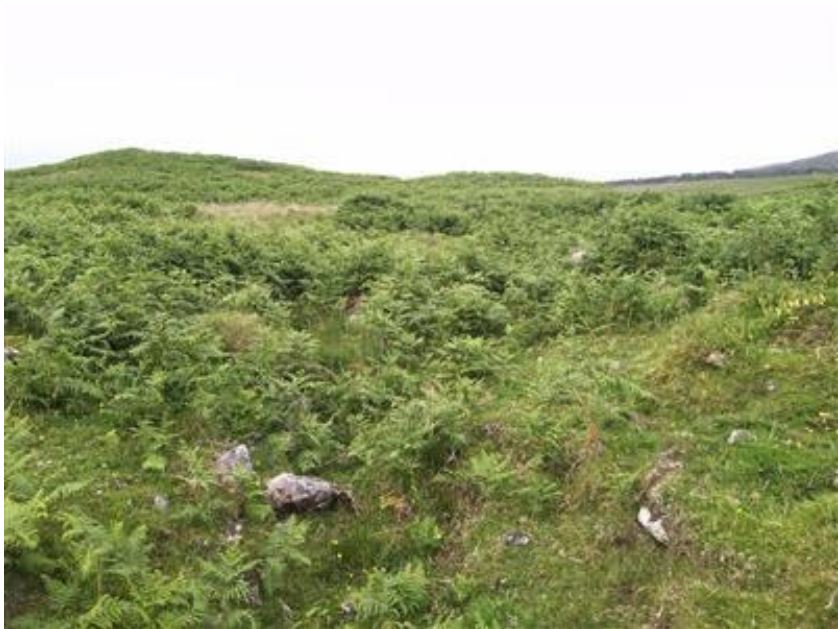
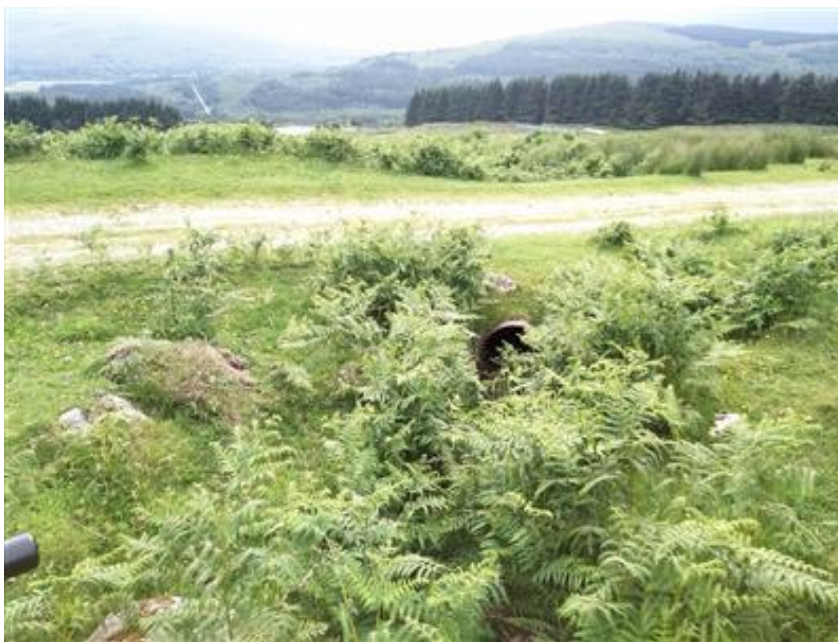
Watercourse Crossing ID		WX04
Watercourse Details	Crossing	<p>Grid Reference: E 241085 / N 864251</p> <p>Status: New</p> <p>Watercourse Width: N/A</p> <p>Watercourse Depth: N/A</p> <p>Notes: Watercourse was dry during survey. Watercourse is located in a channel which is approximately 0.4m deep and up to 1.5m wide. A 0.4m diameter circular metal culvert is noted downstream of proposed crossing point at the existing track.</p>
Photograph Upstream	Looking

Potential Crossing Type Likely Required CAR Authorisation		<p>Culvert Registration</p>

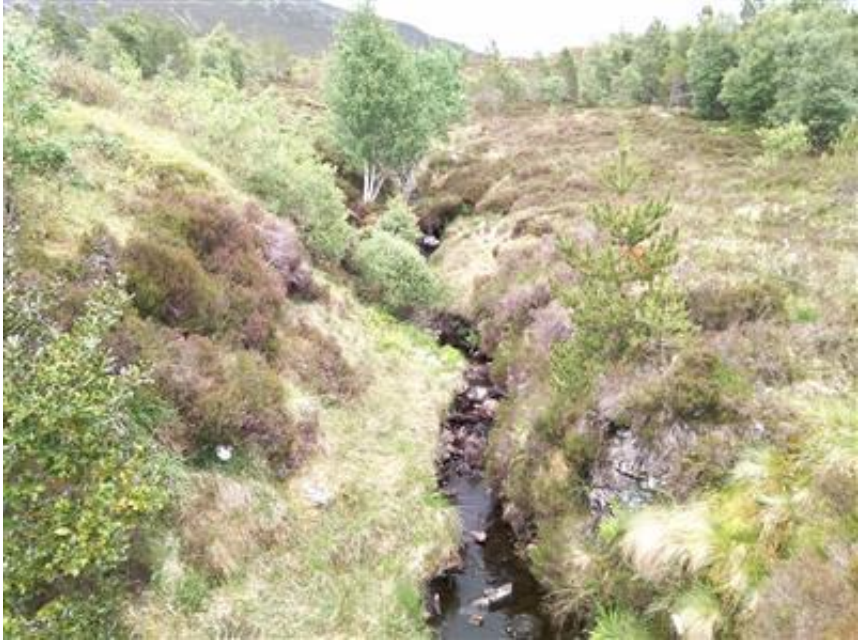
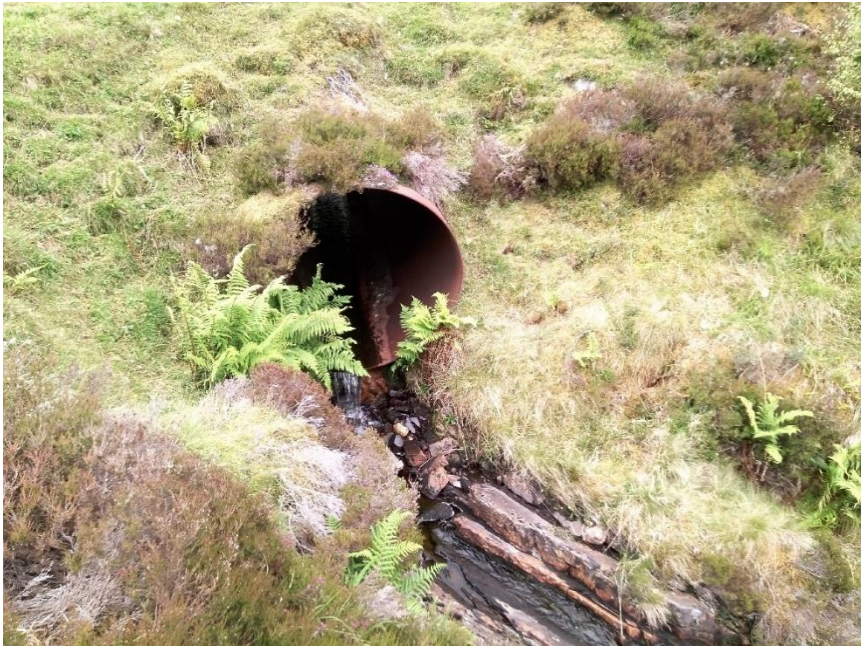
Watercourse ID	Crossing	WX05
Watercourse Details	Crossing	<p>Grid Reference: E 241843 / N 863977</p> <p>Status: Existing</p> <p>Crossing Type: Circular metal culvert</p> <p>Crossing Size: 1.7m diameter</p> <p>Watercourse Width: 0.3 to 0.7 m</p> <p>Watercourse Depth: 0.3 m</p> <p>Notes: Watercourse located in incised gulley which is approximately 5 m wide and 3 m deep.</p>
Photograph Upstream	Looking

Photograph of Culvert Exit from Downstream

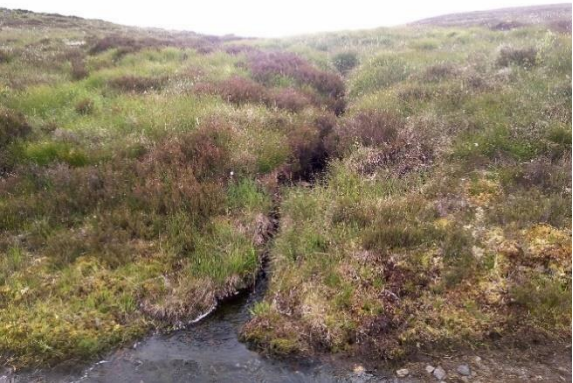
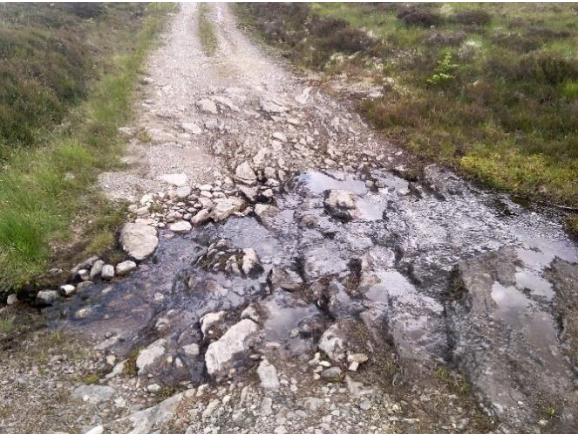
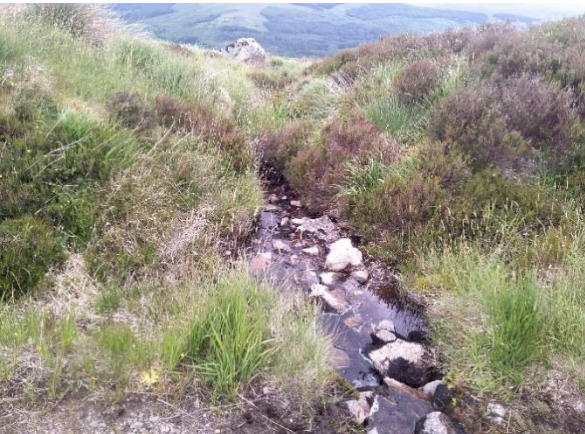
Watercourse Crossing ID	WX06
Watercourse Crossing Details	<p>Grid Reference: E 241247 / N 862473</p> <p>Status: Existing</p> <p>Crossing Type: Ford</p> <p>Watercourse Width: 0.5 m</p> <p>Watercourse Depth: 0.1 m</p> <p>Notes: No formal infrastructure. Watercourse incised in bedrock and ponds up to 2m wide at ford crossing. Road drainage in the area is diverted to ford crossing.</p>
Photograph Looking Upstream

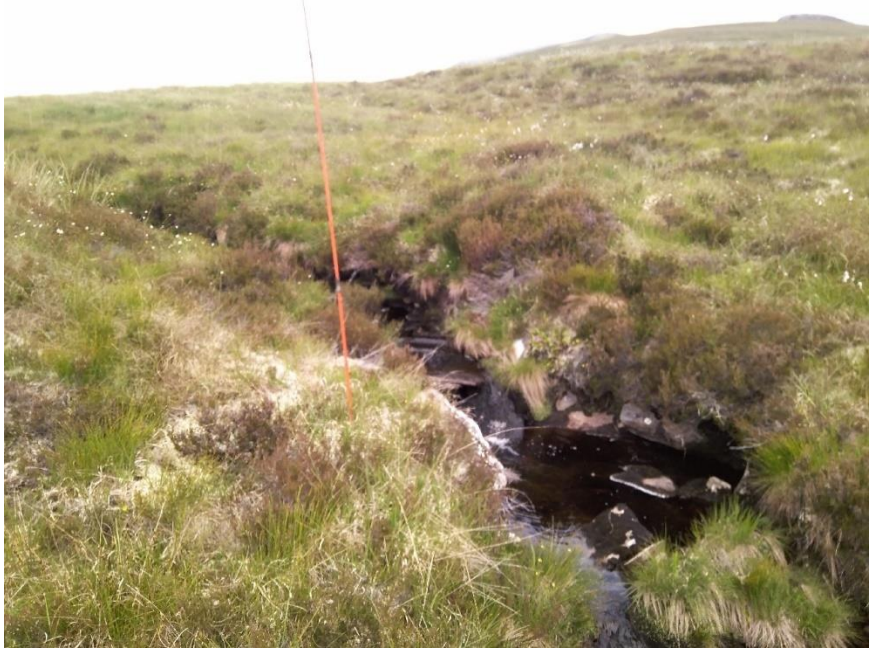
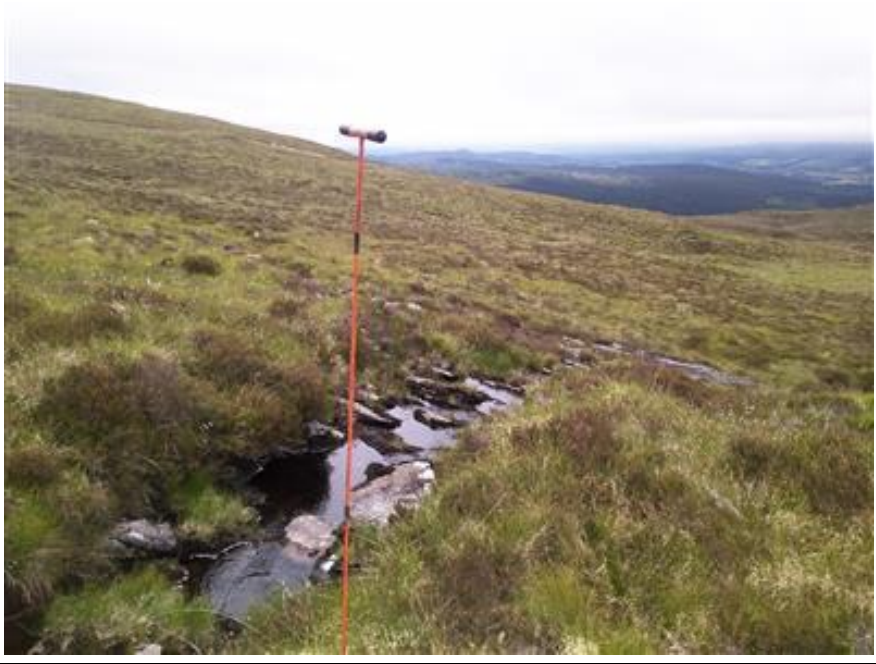
Watercourse Crossing ID	WX08	
Watercourse Crossing Details	Grid Reference: E 243154 / N 862105 Status: New Watercourse Width: 1.2 m Watercourse Depth: 0.3 m Notes: Watercourse incised in bedrock.	
Photograph Upstream

Potential Crossing Type Likely Required CAR Authorisation	Culvert Registration

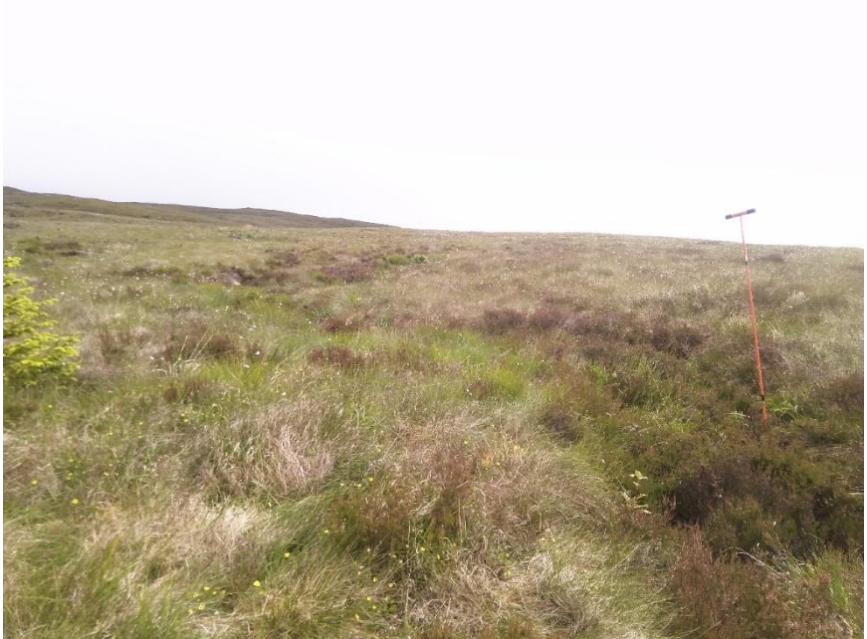
Watercourse Crossing ID	WX09
Watercourse Crossing Details	Grid Reference: E 243478 / N 862116 Status: New Watercourse Width: 0.4 m Watercourse Depth: 0.5 m Notes: None
Photograph Looking Upstream

Potential Crossing Type Likely Required CAR Authorisation	Culvert Registration

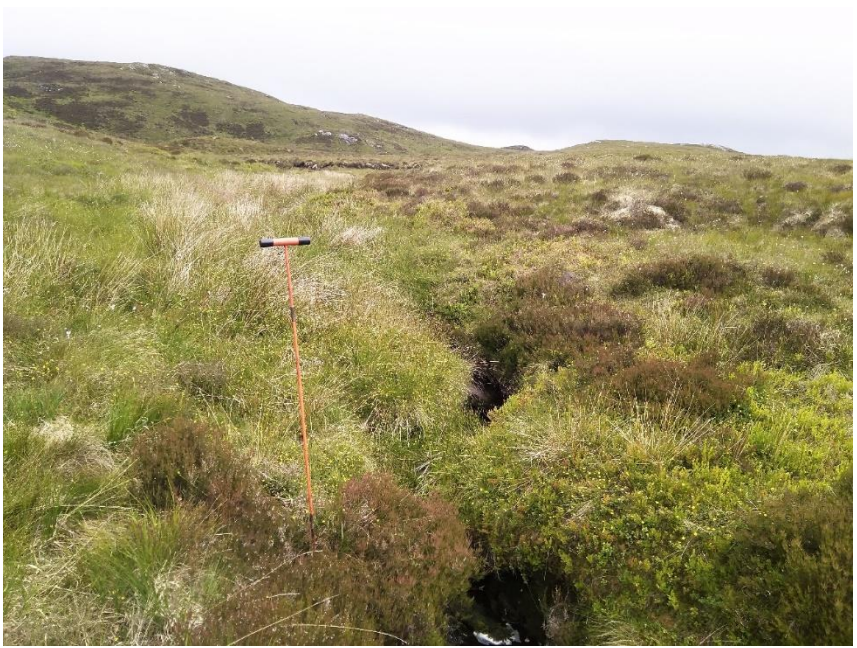
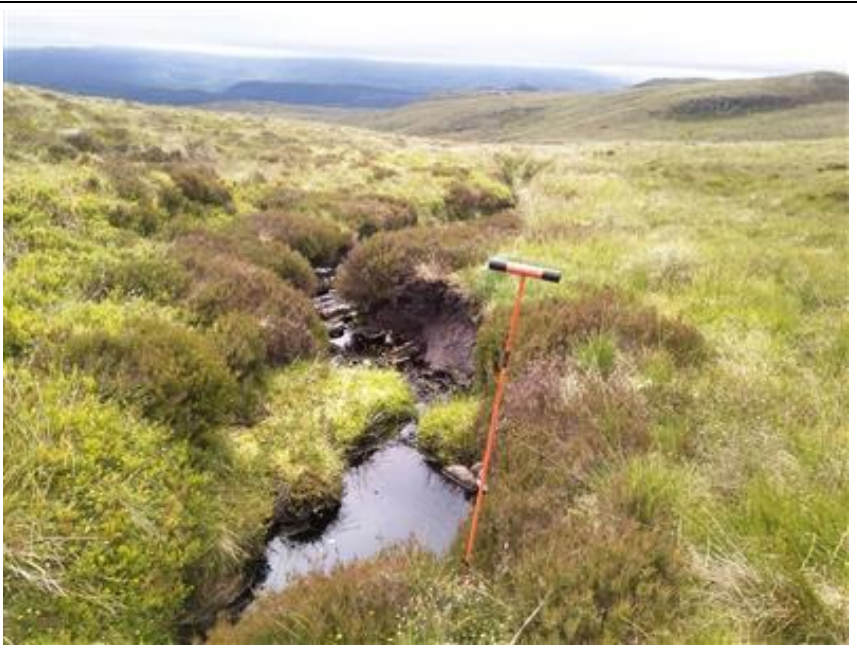
Watercourse ID	Crossing	WX11
		Watercourse Depth: 0.2 m Notes: Watercourse located in a channel which is approximately 1.8 m wide and 1 m deep. Bedrock noted along the watercourse bed.
Photograph Upstream	Looking

Potential Crossing Type Likely Required CAR Authorisation		Culvert Registration

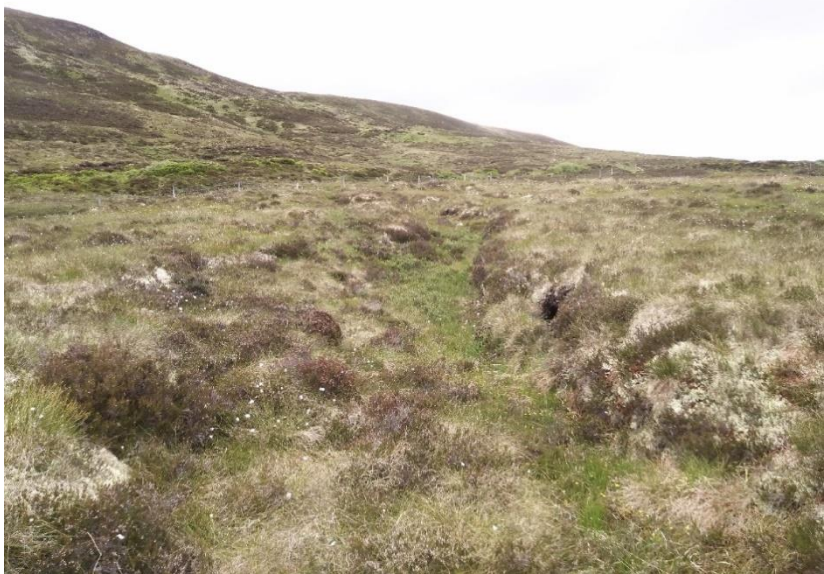
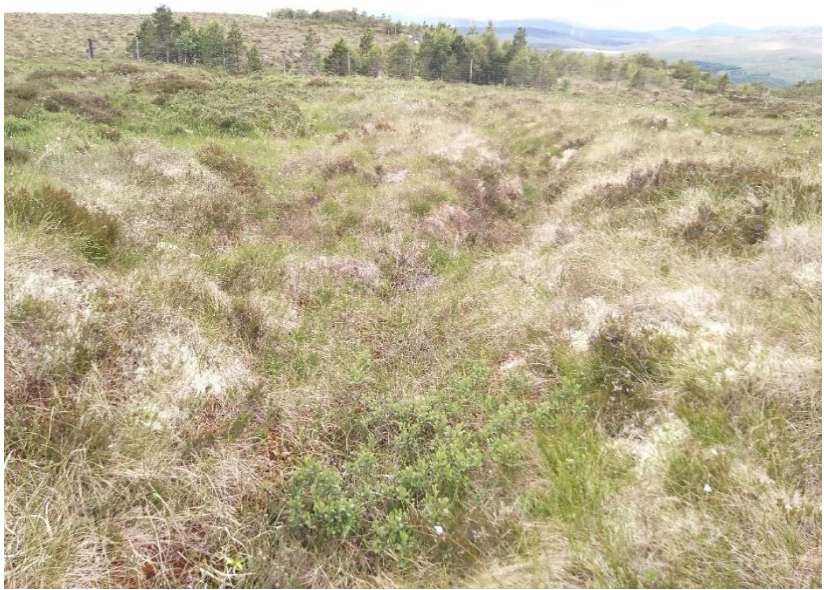
Watercourse Crossing ID		WX16
Watercourse Details	Crossing	<p>Grid Reference: E 242366 / N 863760</p> <p>Status: New</p> <p>Watercourse Width: N/A</p> <p>Watercourse Depth: N/A</p> <p>Notes: No flowing watercourse observed during the survey. Watercourse located in a channel incised in peat which is approximately 0.7m deep and 2m wide.</p>
Photograph Upstream	Looking

Potential Crossing Type		Culvert
Likely Required Authorisation	CAR	Registration
