# Coille Beith Wind Farm

## Technical Appendix 8.4: Peat Landslide Hazard and Risk Assessment (PLHRA)

June 2025

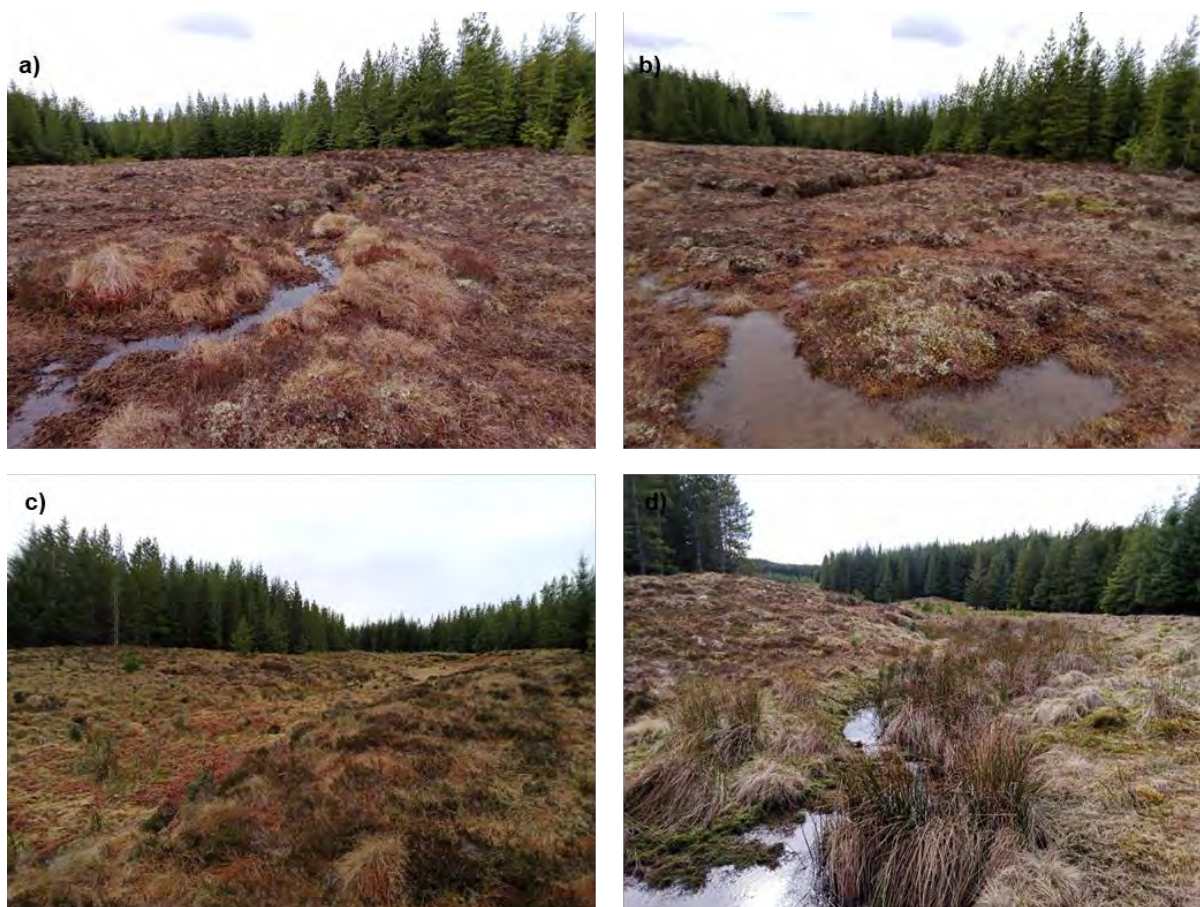
#### Plate 3.2: Typical Features On-site

Notes: a) diffuse surface drainage adjacent to upper tree line at higher elevation, b) bog pool near a), c) watercourse within ride in centre of Site, d) headwater tributary of Allt Mor near Cnoc nan Con

- 3.6.3 The Site is dominated by afforested peatland within which the peat surface has been ploughed into ridges and furrows to enable tree planting and encourage tree growth through dewatering the shallowest horizons. The majority of the proposed turbines are located entirely, or at least partially in afforested areas (the exceptions being turbines T2 and T7). This has helped keep impacts on peat to areas that have already been degraded through forestry. Rides between forest coupes still retain vegetation that might have been typical of the pre-forestry conditions (e.g. **Plate 3.2c**), but are present only intermittently, typically around watercourses (e.g. **Plate 3.2d**).

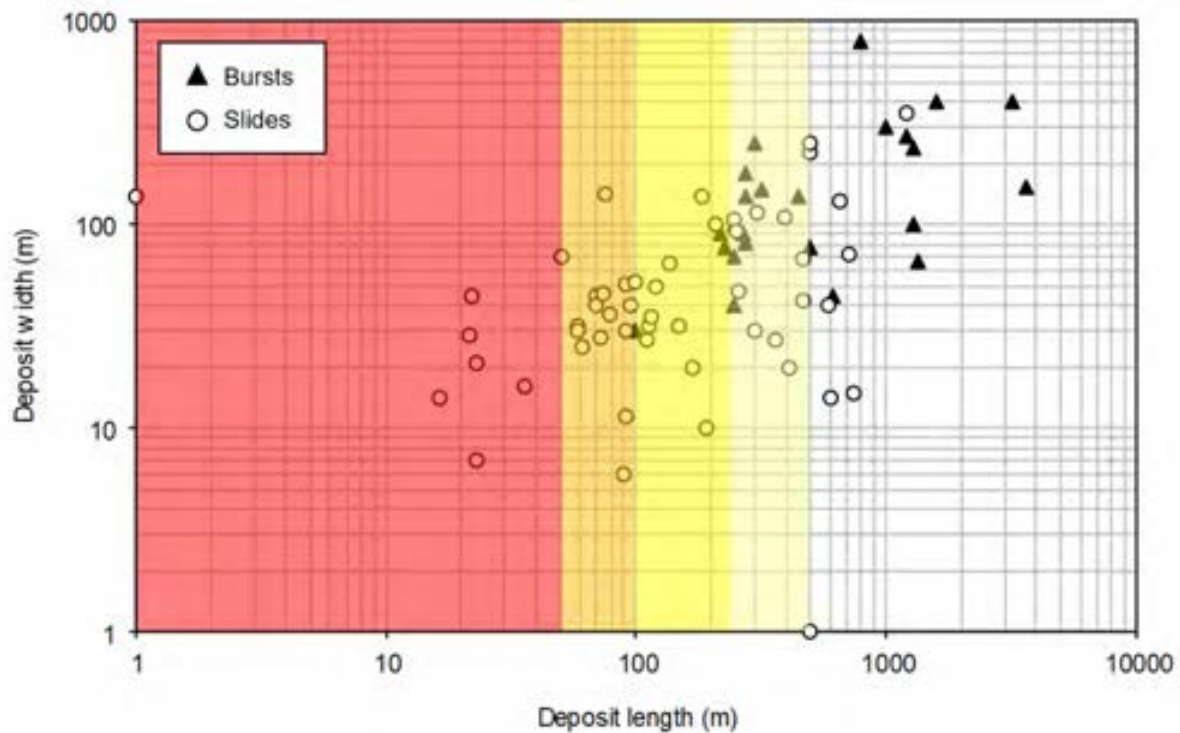
**Plate 5.1 Runout Distances for Published Peat Landslides (after Mills, 2002) (colours on the plot correspond to runout zones on Figure 8.4.9)**

- 5.3.6 **Plate 5.1** shows runout distances based on published literature. Typically, runout distances would be expected to be less where slope angles decline with distance from the source zone (i.e. on concave slopes) whereas the full runout lengths shown on **Plate 5.1** may be achievable on steepening (convex) slopes or rectilinear slopes. Slopes at the Site are relatively continuous, and therefore this constraint does not apply.
