Knockcronal Wind Farm
Environmental Impact Assessment Report
Appendix 3.2

Figure C.1

Photographs - Sheet 1

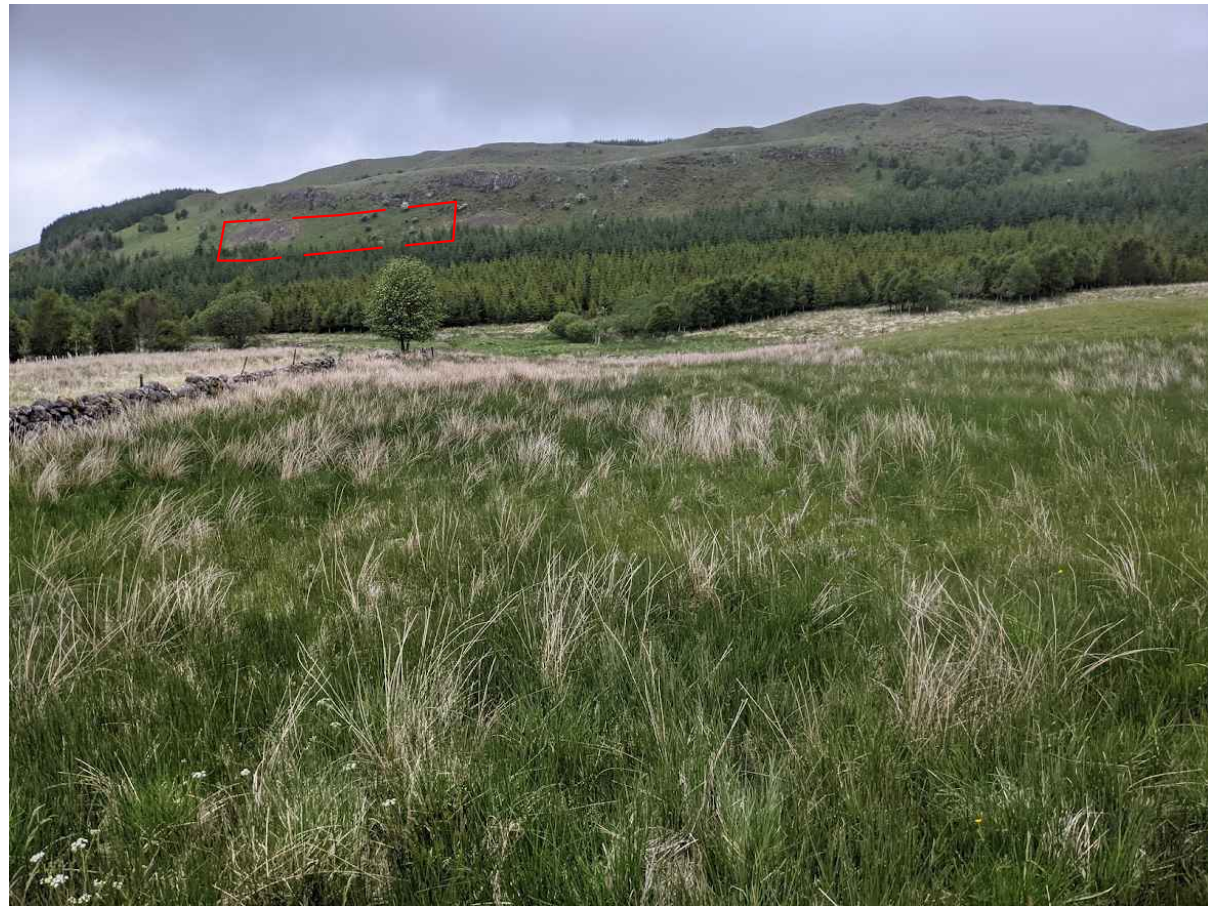
Borrow Pit A
Approximate extent marked with red dash. Steeply sloping ground and rock outcropping at the surface observed at this location

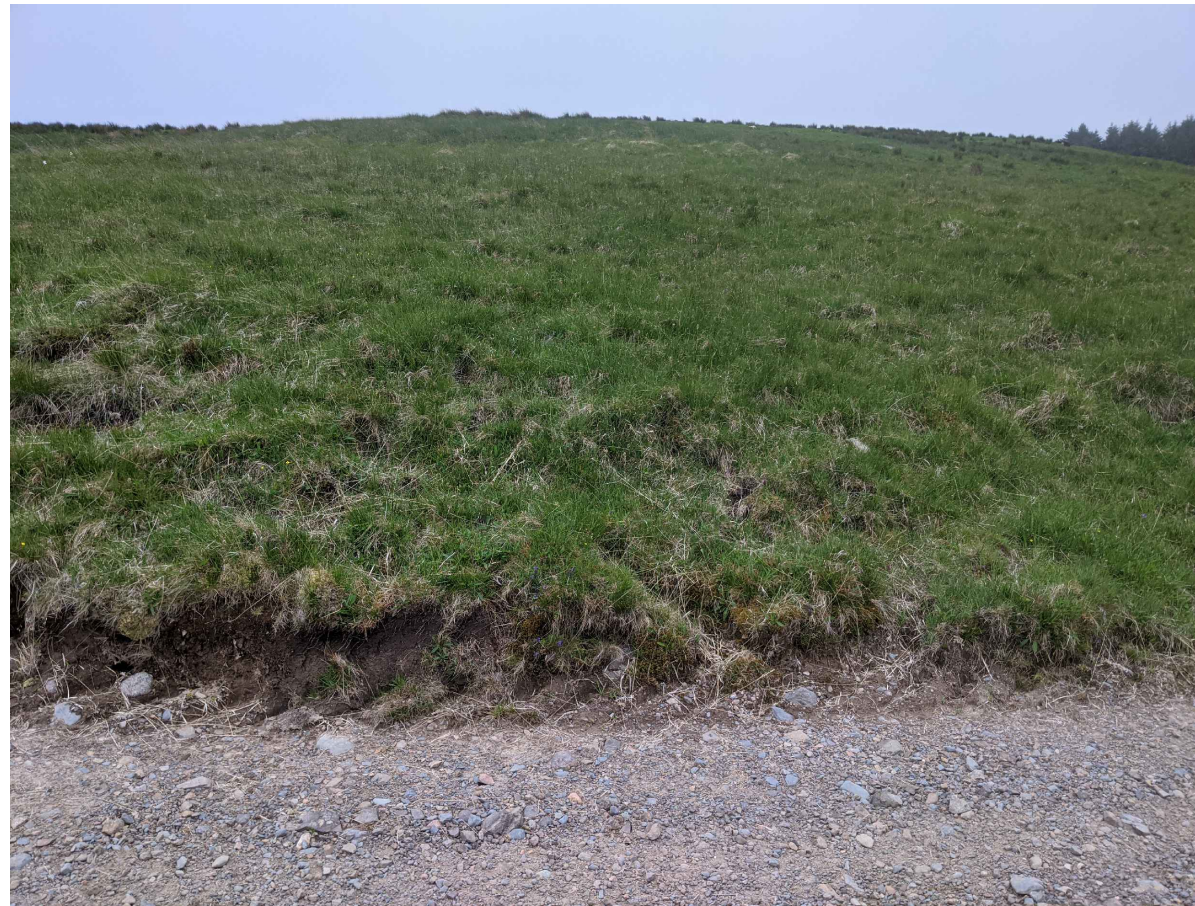
Borrow Pit B
Relatively steeply sloping ground observed at this location. Borrow pit may be accessed via a short stretch of existing farm track.

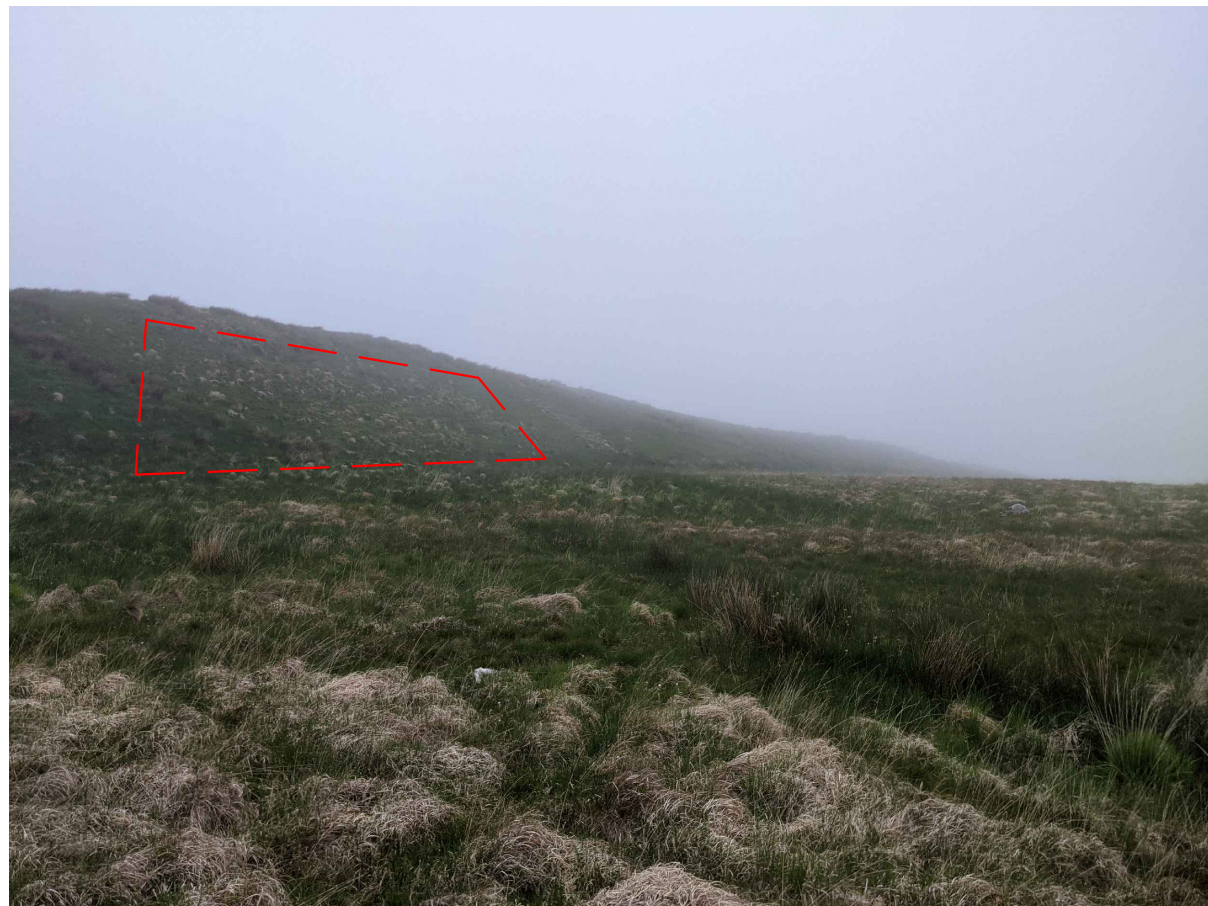
Borrow Pit D
Approximate location marked with red dash. Steeply sloping ground observed at this location

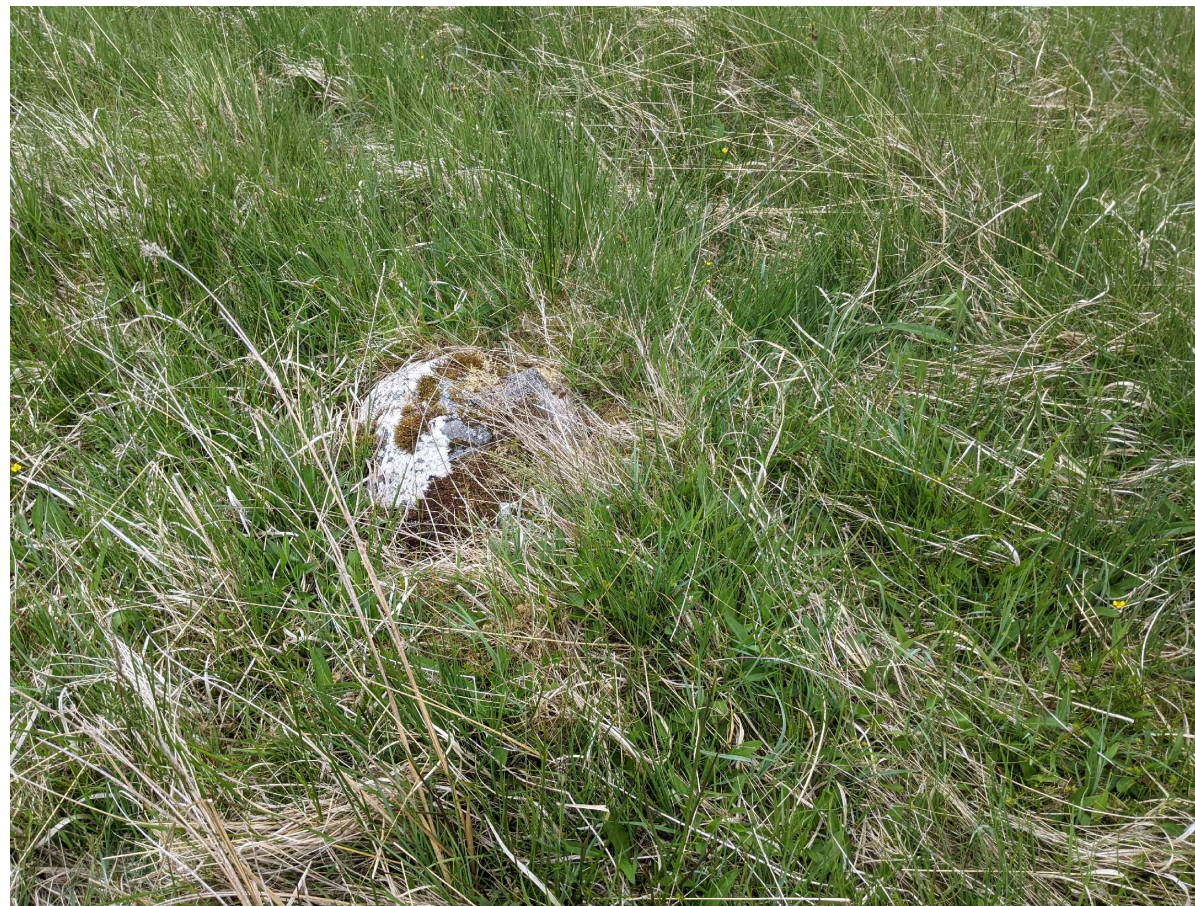
Borrow Pit B
Rocks at the ground surface observed.
