Knockcronal Wind Farm
 Environmental Impact Assessment Report
 Appendix 3.2

Figure C.2

Photographs - Sheet 2

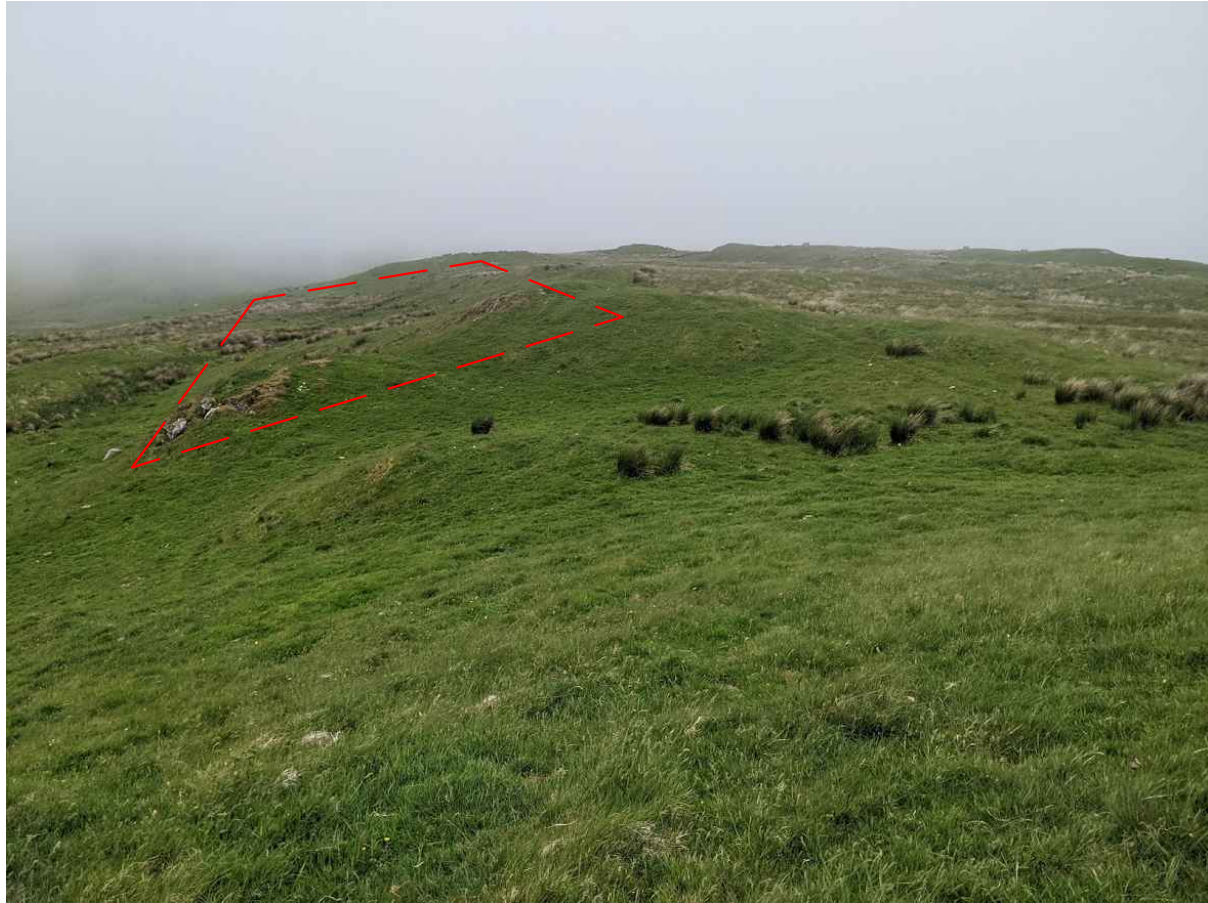
Borrow Pit C
 Approximate location marked with red dash. Steeply sloping ground and rock outcropping at the surface observed at this location. Photograph taken from east side of borrow pit.

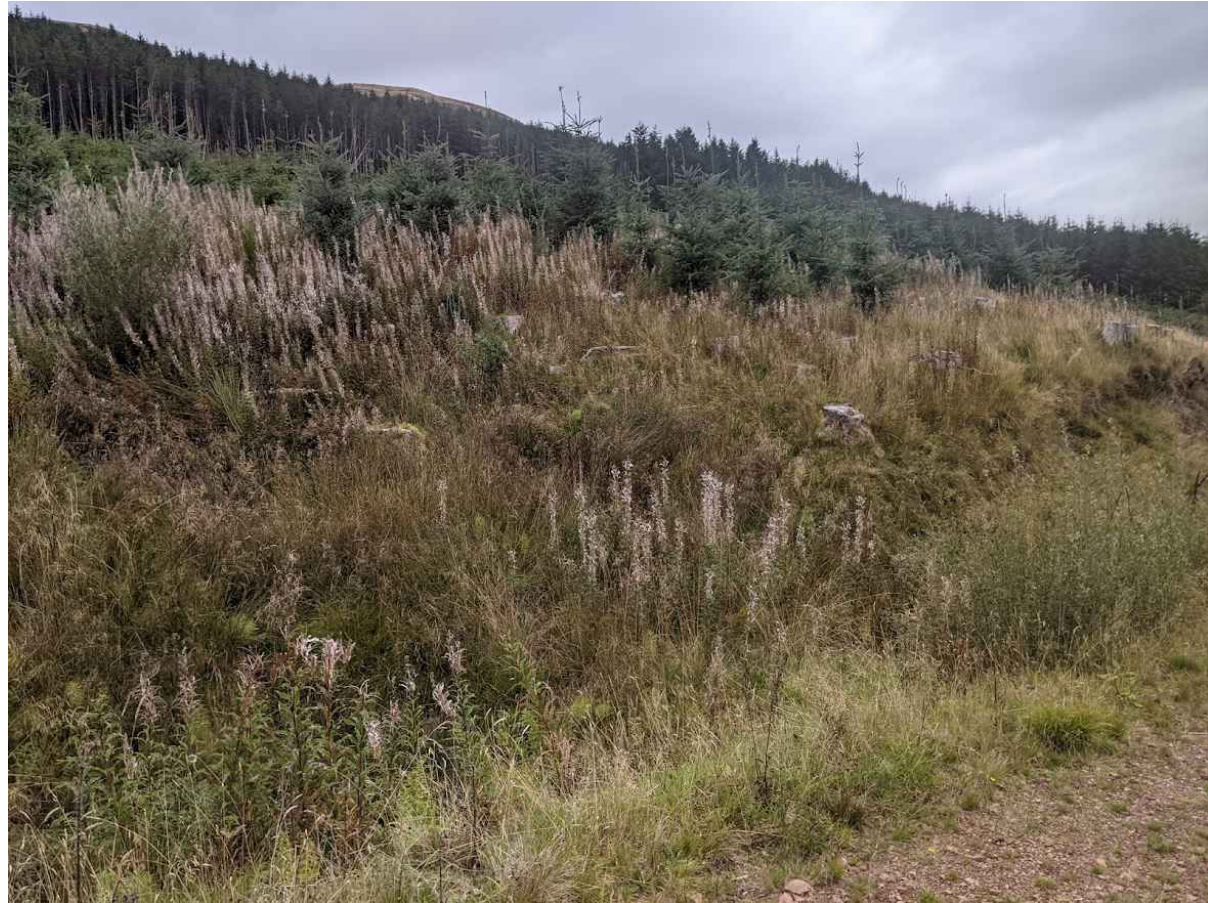
Borrow Pit E
 Relatively steeply sloping ground observed at this location. Borrow pit may be accessed via existing track. Some natural forestry regeneration

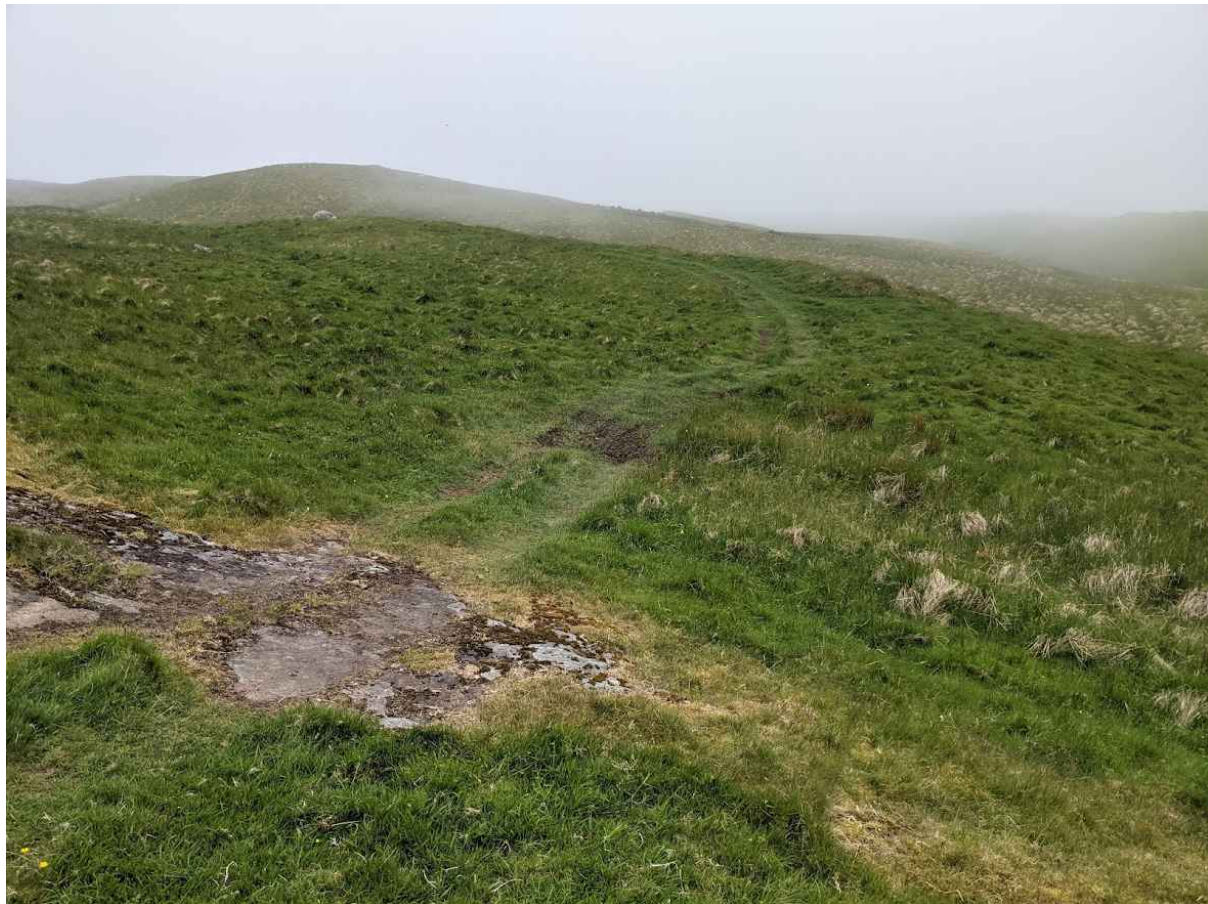
Borrow Pit C
 General photo at borrow pit location

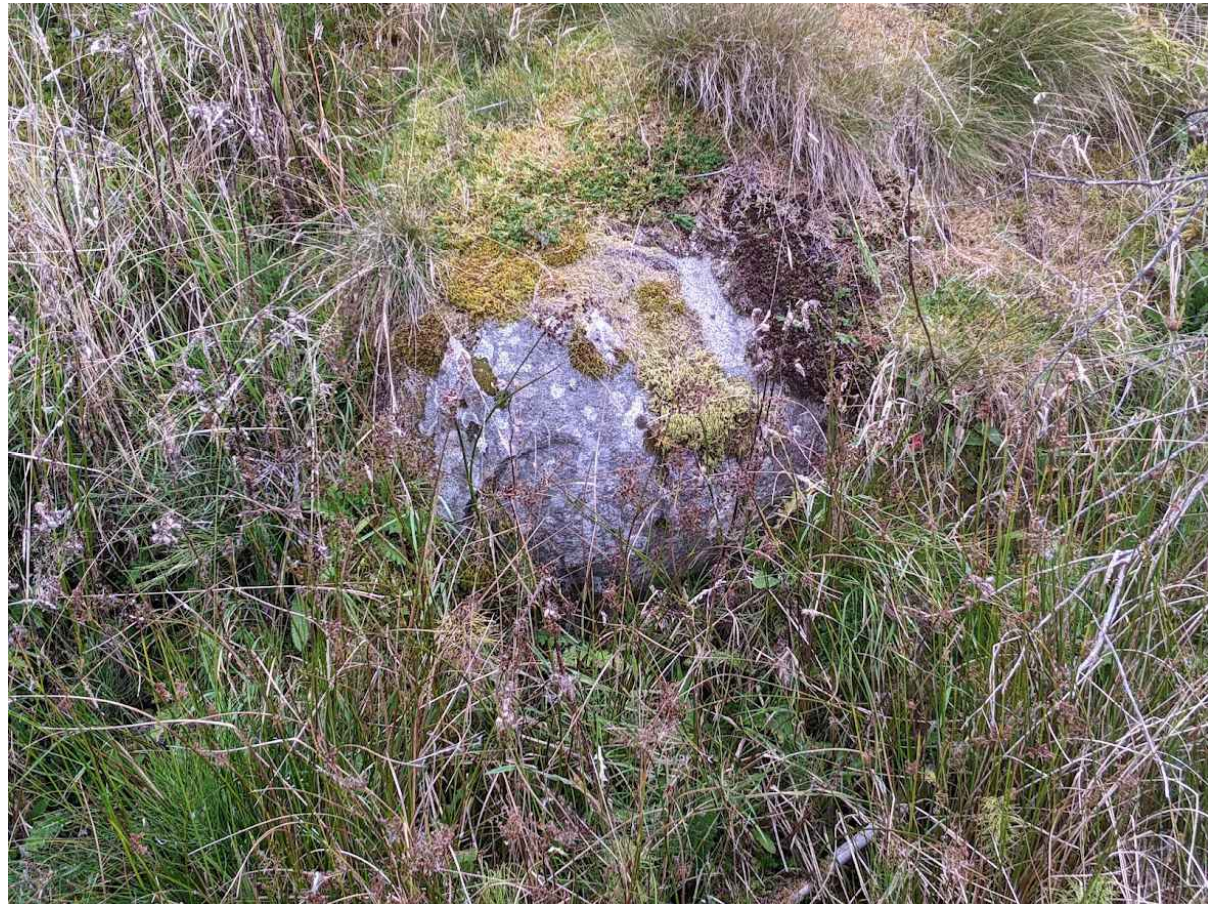
Borrow Pit E
 Rocks at the ground surface observed.
