SEI Appendix D: Additional Potential Restoration Areas

Table 1 – Summary of Additional Potential Restoration Areas

Table 2 – Additional Potential Restoration Areas

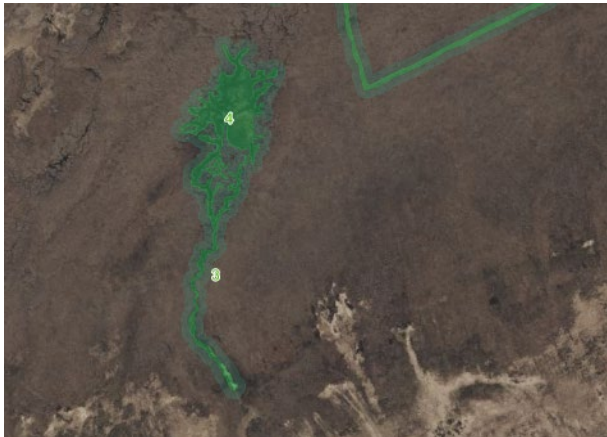
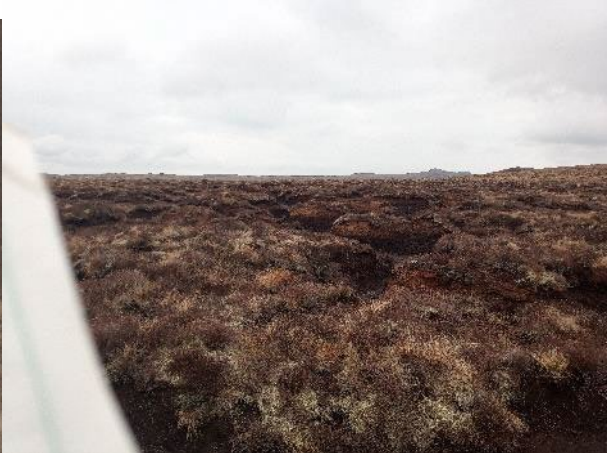
<p>Area ID: 4 Location: NH 42651 25910 Description: Large area of eroded peat lying across broad ridgeline and draining south and north via erosional gullies. Bare peat present across majority of area in dendritic erosional patterns. Area (m²): 7,698</p>	<p>Repair of eroded / bare areas using machine-based techniques Access via non wind farm tracks</p>

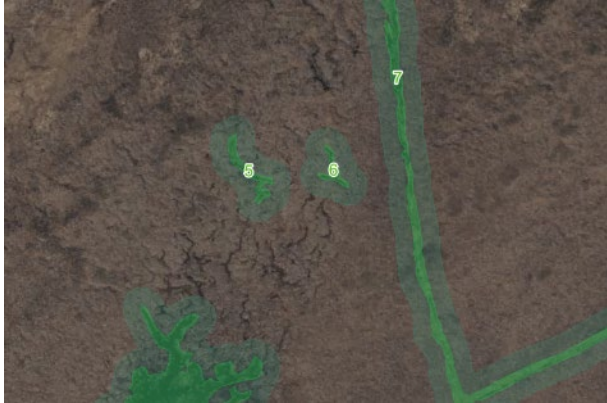
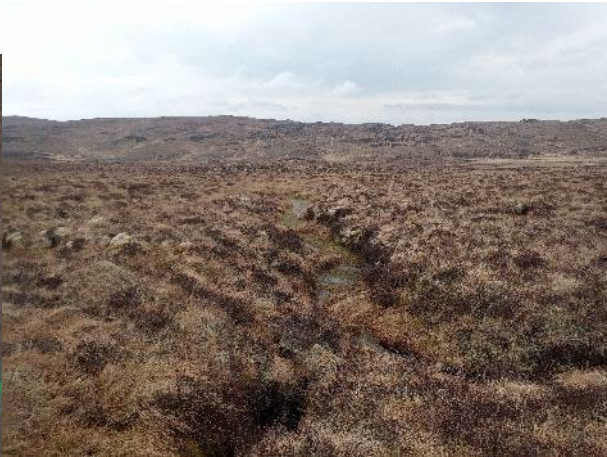
Area ID and Description	Recommended Restoration Techniques	Images	
<p>Area ID: 5 Location: NH 42704 26079 Description: Area contains some near natural features within depressions and hollows however is threatened by drainage to north via several small erosional gullies which are actively draining the area. Area (m²): 203</p>	<p>Repair of eroded / bare areas using machine-based techniques Access via non wind farm tracks</p>

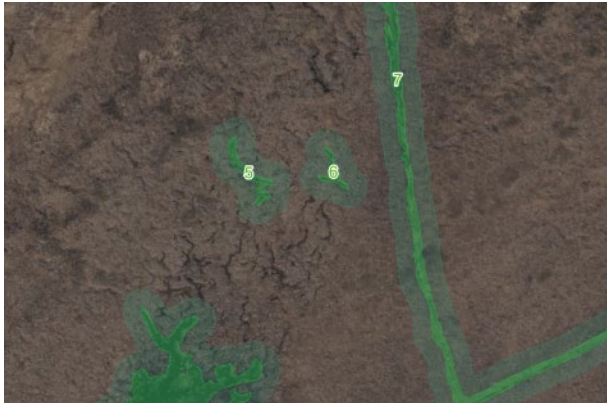
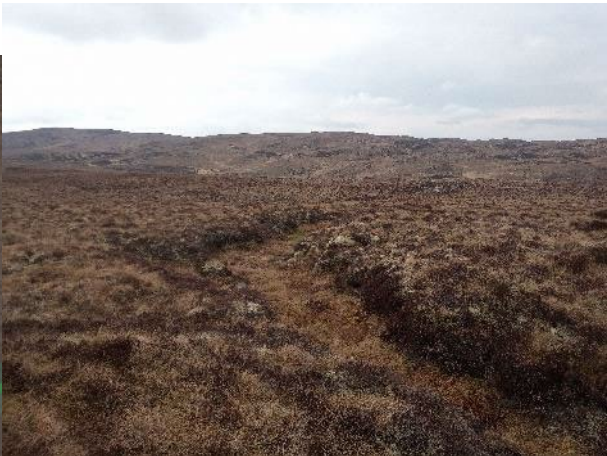
<p>Area ID: 6 Location: NH 42753 26080 Description: Area contains some near natural features within depressions and hollows however is threatened by drainage to north via several small erosional gullies which are actively draining the area. Area (m²): 101</p>	<p>Repair of eroded / bare areas using machine-based techniques Access via non wind farm tracks</p>

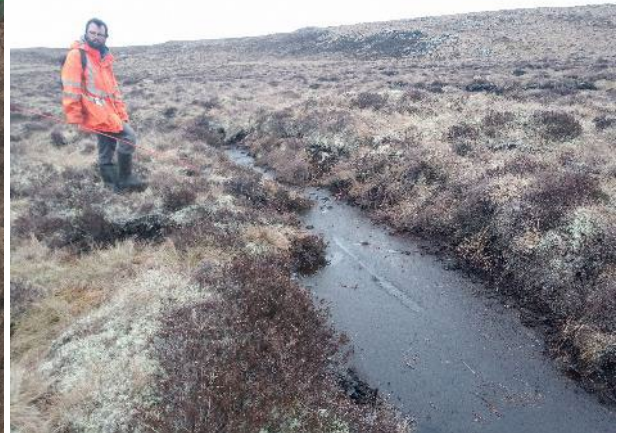
Area ID and Description	Recommended Restoration Techniques	Images	
<p>Area ID: 14</p> <p>Location: NH 43430 27600</p> <p>Description: Large network of dendritic erosional features with extensive bare peat and some surface water accumulation in basin of ridge adjacent to lochan. Drained via OS watercourse flowing south from Area 15 and by watercourse flowing south from lochan. Water table likely lowered by grazing and burning modifying influences on peatland.</p> <p>Area: 12,559 m²</p>	<p>Repair of eroded / bare areas using hand techniques and helicoptered materials</p> <p>Personnel access via argocat</p>

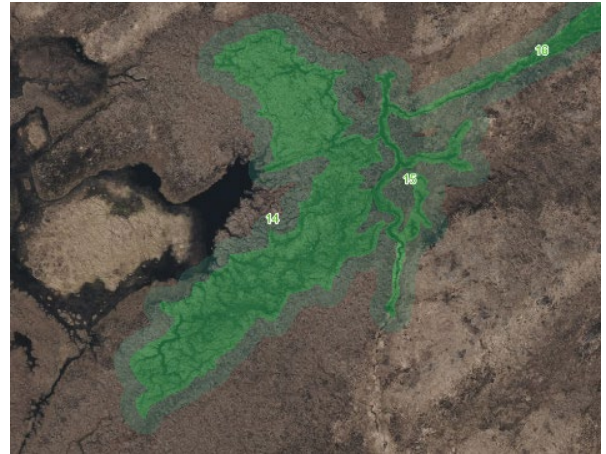
<p>Area ID: 15</p> <p>Location: NH 43517 27625</p> <p>Description: Surface water channel draining south with some bare peat exposed. Lowering of water table contributing to nearby peat erosion. Drained via OS watercourse flowing south from area.</p> <p>Area: 1,844 m²</p>	<p>Repair of eroded / bare areas using hand techniques and helicoptered materials</p> <p>Personnel access via argocat</p>

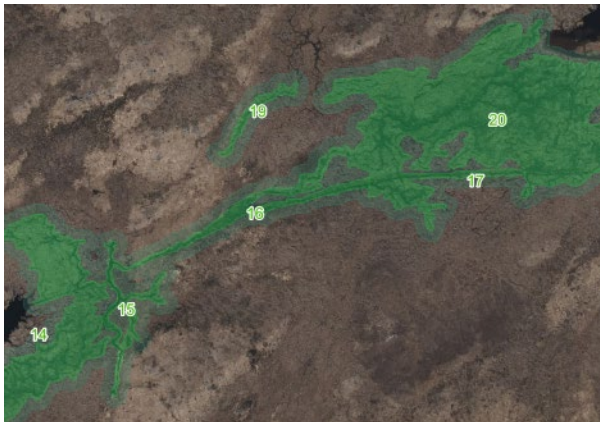
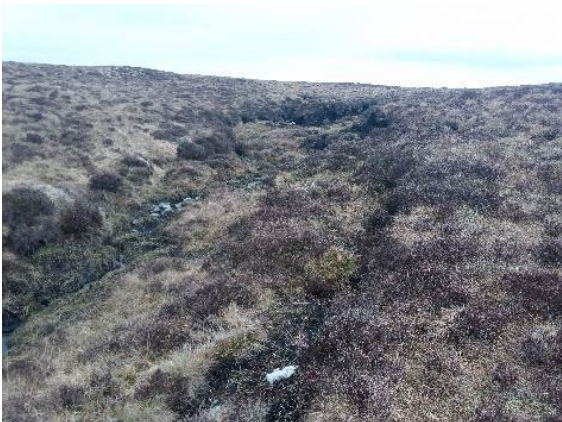
Area ID and Description	Recommended Restoration Techniques	Images	
<p>Area ID: 16</p> <p>Location: NH 43646 27722</p> <p>Description: Erosional channel centred on what was likely an artificial drain along ridgeline ridge running east to west for approximately 1.4 km encompassing areas 16, 17, 18, 23 and 25 as well as impacting adjacent areas 20, 21, 25 and 26. Ongoing bare peat erosion and collapse across majority of its length.</p> <p>Area: 1,952 m²</p>	<p>Repair of eroded / bare areas using hand techniques and helicoptered materials</p> <p>Personnel access via argocat</p>

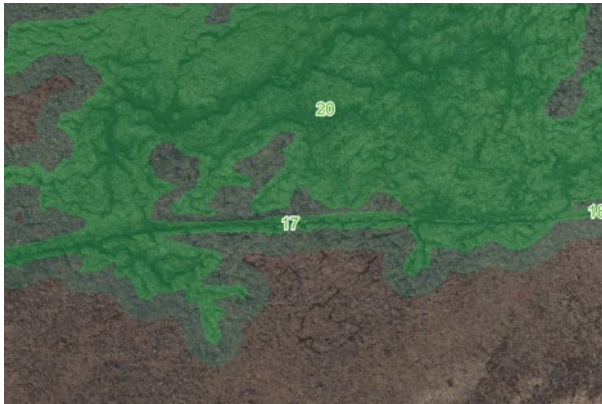
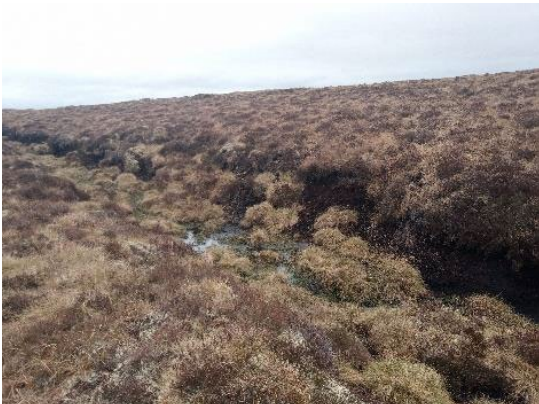
<p>Area ID: 17</p> <p>Location: NH 43858 27761</p> <p>Description: Continuation of erosional channel from Area 16.</p> <p>Area: 730 m²</p>	<p>Repair of eroded / bare areas using hand techniques and helicoptered materials</p> <p>Personnel access via argocat</p>

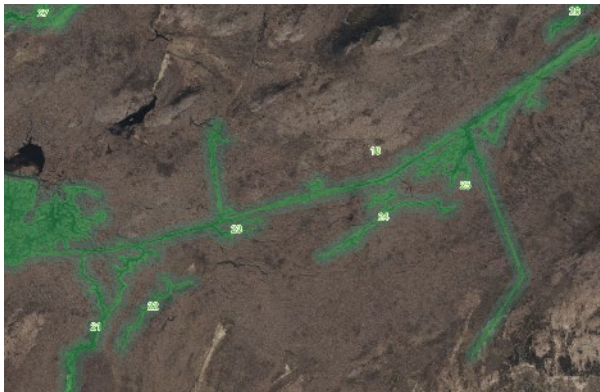
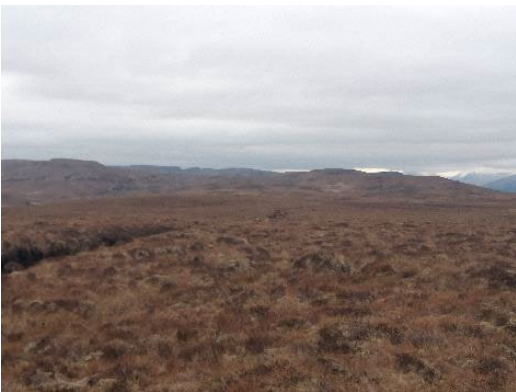
Area ID and Description	Recommended Restoration Techniques	Images	
<p>Area ID: 18</p> <p>Location: NH 44489 27916</p> <p>Description: Continuation of erosional channel from Area 16.</p> <p>Area: 9,791 m²</p>	<p>Repair of eroded / bare areas using hand techniques and helicoptered materials</p> <p>Personnel access via argocat</p>

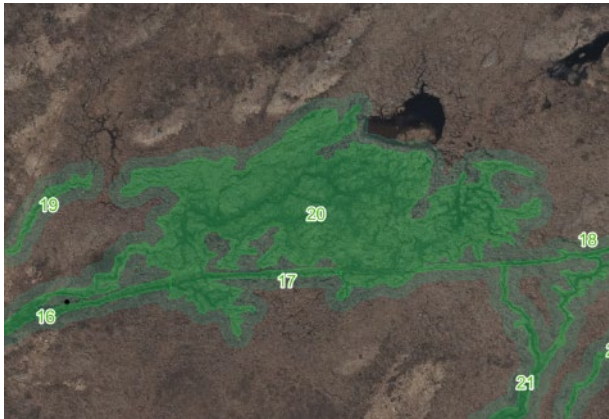
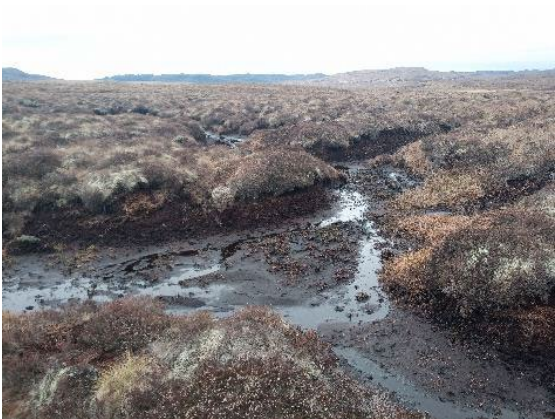
Area ID and Description	Recommended Restoration Techniques	Images	
<p>Area ID: 20 Location: NH 43894 27815 Description: Large area of extensive dendritic bare peat erosion, bounded by lochan to north-east and drained via artificial drainage channel described in Area 16. Area: 35,120 m²</p>	<p>Repair of eroded / bare areas using hand techniques and helicoptered materials Personnel access via argocat</p>

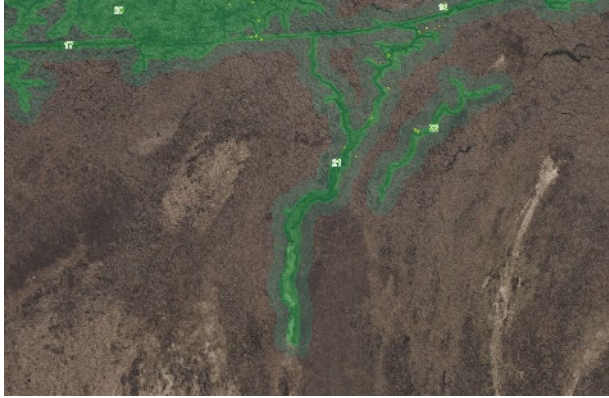
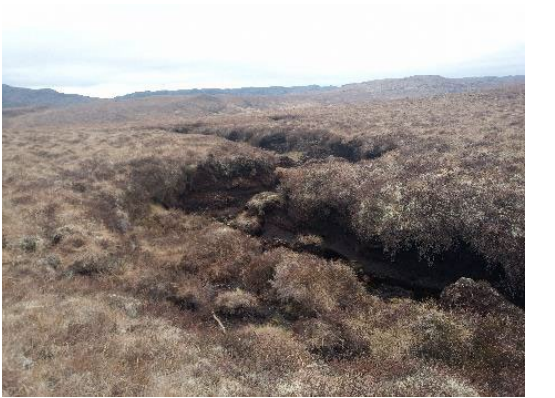
<p>Area ID: 21 Location: NH 44085 27661 Description: Wide erosional gully with flow to south, connected to large artificial drainage channel described in Area 16. Eroded in places to rock substrate with channel and surface flow. Bare peat exposures up to 2 m deep. Area: 4,107 m²</p>	<p>Repair of eroded / bare areas using hand techniques and helicoptered materials Personnel access via argocat</p>

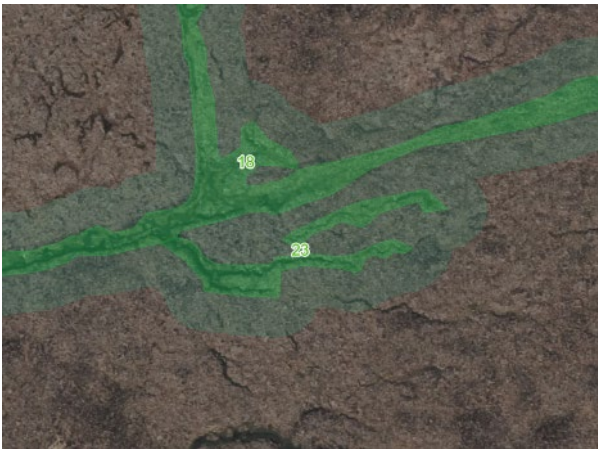
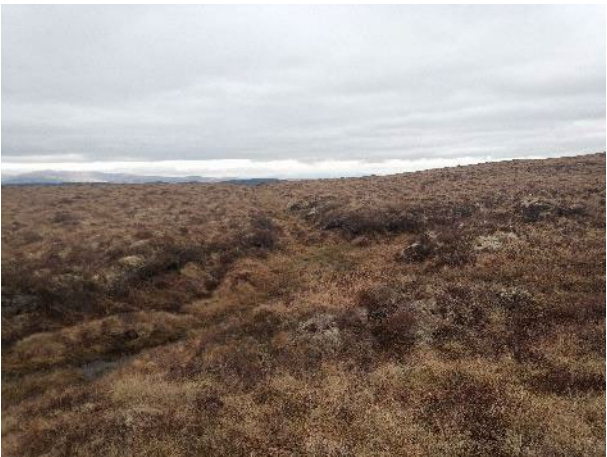
Area ID and Description	Recommended Restoration Techniques	Images	
<p>Area ID: 23</p> <p>Location: NH 44288 27802</p> <p>Description: Erosional feature up to 1.5 m deep connected to artificial drain described in Area 16.</p> <p>Area: 485 m²</p>	<p>Repair of eroded / bare areas using hand techniques and helicoptered materials</p> <p>Personnel access via argocat</p>

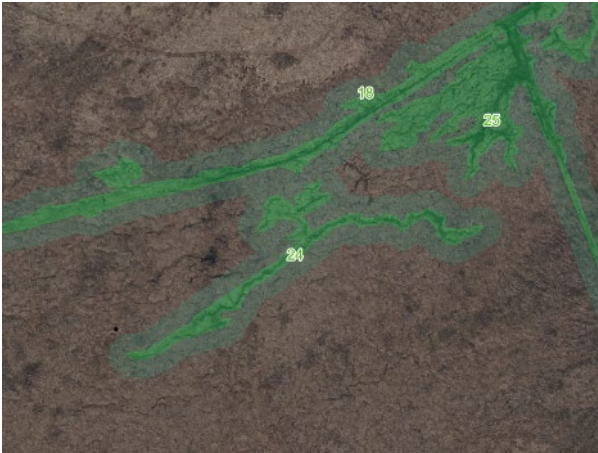
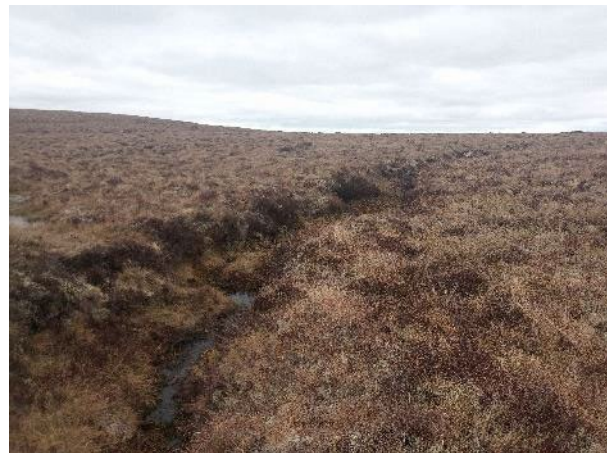
<p>Area ID: 24</p> <p>Location: NH 44501 27820</p> <p>Description: Erosional gully with flushy surface flow and some bare peat at base.</p> <p>Area: 1,892 m²</p>	<p>Repair of eroded / bare areas using hand techniques and helicoptered materials</p> <p>Personnel access via argocat</p>

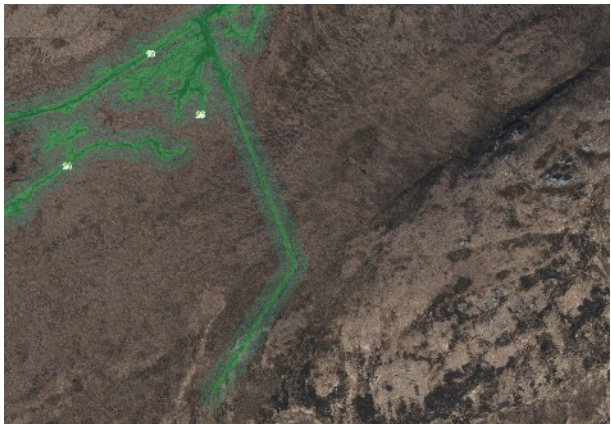
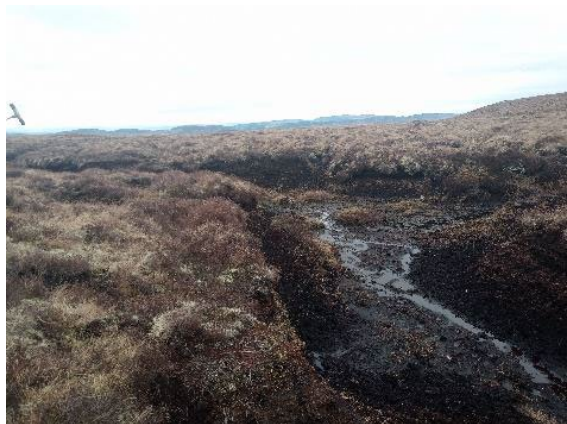
Area ID and Description	Recommended Restoration Techniques	Images	
<p>Area ID: 25</p> <p>Location: NH 44619 27866</p> <p>Description: Erosional features up to 2 m deep and linked to land described in Area 16. Drains south downgradient via artificial drainage channel.</p> <p>Area: 4,211 m²</p>	<p>Repair of eroded / bare areas using hand techniques and helicoptered materials</p> <p>Personnel access via argocat</p>

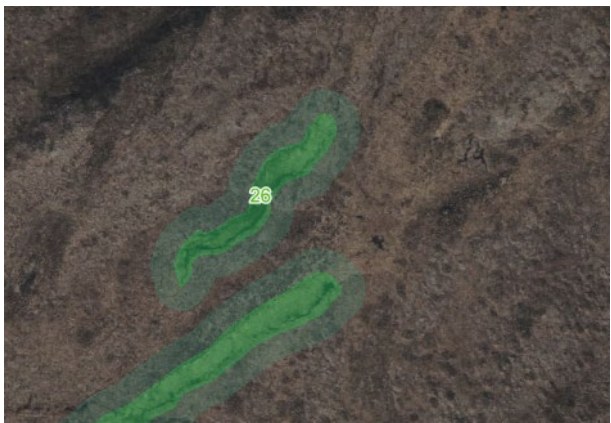
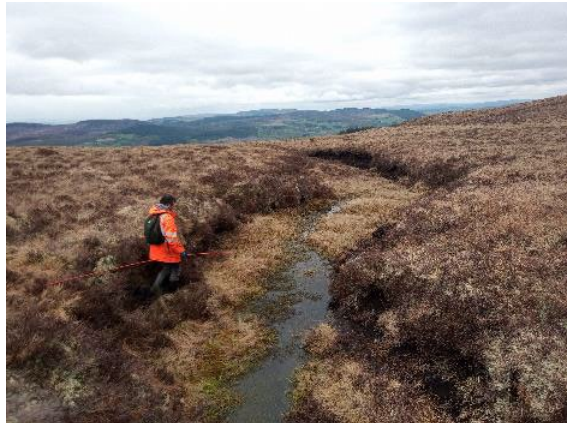
<p>Area ID: 26</p> <p>Location: NH 44777 28117</p> <p>Description: Deep erosional feature up to 1.5 m deep. Connects to artificial drain feature described in Area 16 via peat pipe. Recent collapse of gully sides visible within feature.</p> <p>Area: 1,031 m²</p>	<p>Repair of eroded / bare areas using hand techniques and helicoptered materials</p> <p>Personnel access via argocat</p>

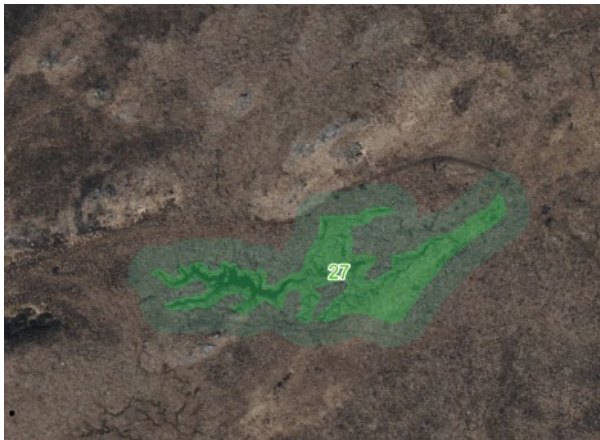
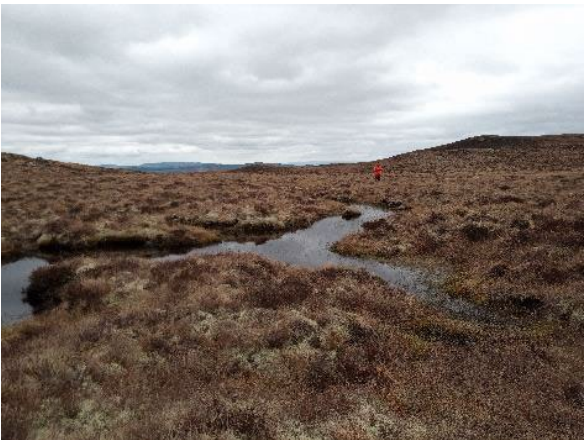
Area ID and Description	Recommended Restoration Techniques	Images	
<p>Area ID: 27 Location: NH 44009 28115 Description: Surface water and near natural bog pool features undergoing modification by draining of habitat via erosional channels to north and north-east. Evidence that ongoing erosion is lowering water table as bare peat exposures visible at periphery of area. Area: 2,553 m²</p>	<p>Repair of eroded / bare areas using hand techniques and helicoptered materials Personnel access via argocat</p>

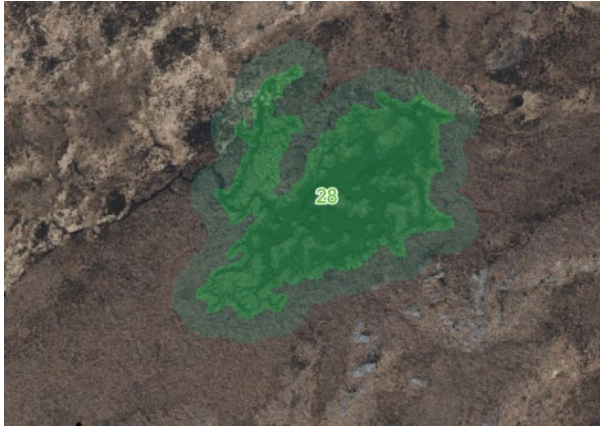
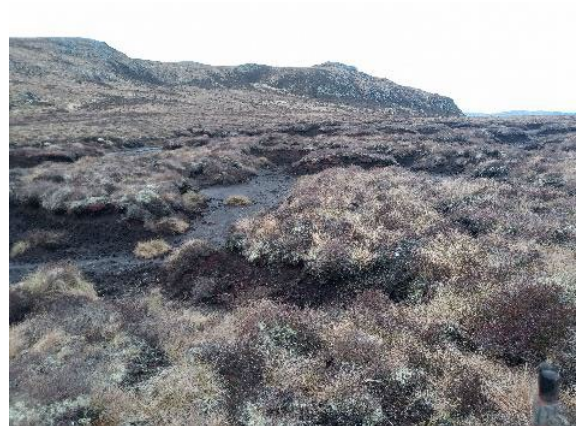
<p>Area ID: 28 Location: NH 45051 27575 Description: Large eroded area on deep peat >3 m depth. Drains via channels to east which links to area 29 down gradient to east. Area: 5,786 m²</p>	<p>Repair of eroded / bare areas using hand techniques and helicoptered materials Personnel access via argocat</p>

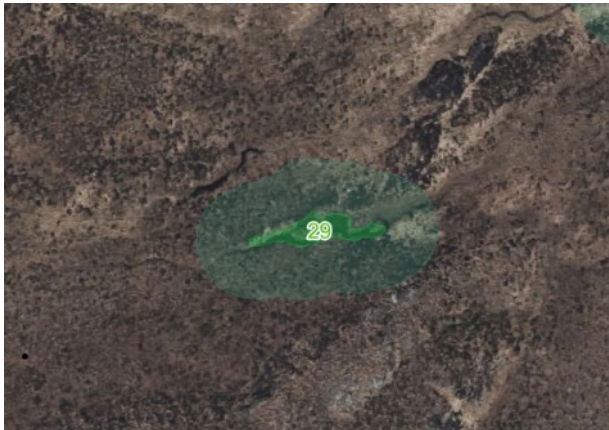
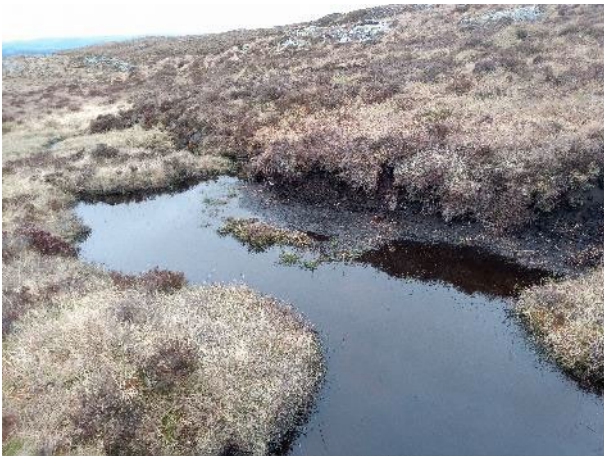
Area ID and Description	Recommended Restoration Techniques	Images	
<p>Area ID: 29</p> <p>Location: NH 45204 27611</p> <p>Description: Bare peat area downgradient of Area 29 with peat haggings up to 1.5 m deep and some surface water accumulation. Drains north-east towards Area 30.</p> <p>Area: 85 m²</p>	<p>Repair of eroded / bare areas using hand techniques and helicoptered materials</p> <p>Personnel access via argocat</p>

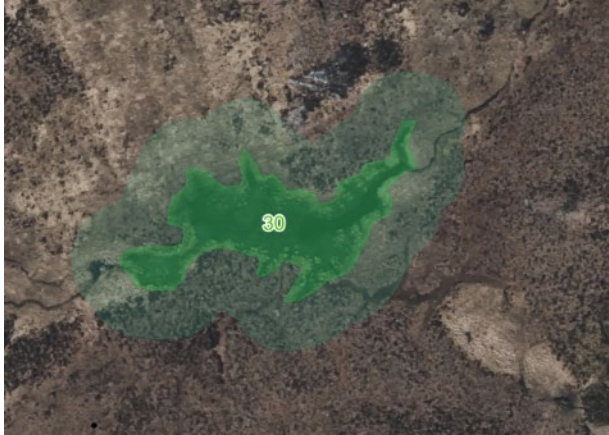
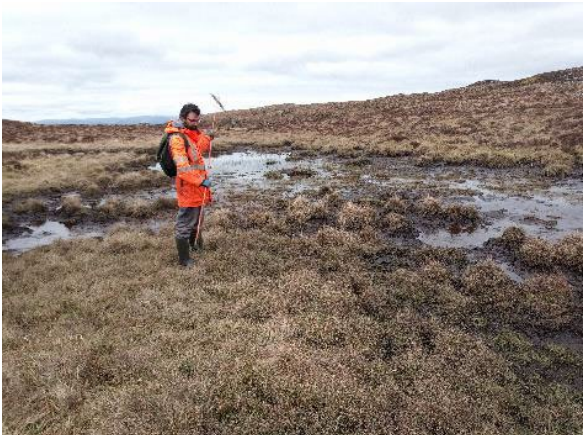
<p>Area ID: 30</p> <p>Location: NH 45292 27669</p> <p>Description: Bare peat area. Evidence of heavy grazing and poaching in area. Likely a minor lochan in the past, drains south-east via surface water channel.</p> <p>Area: 891 m²</p>	<p>Repair of eroded / bare areas using hand techniques and helicoptered materials</p> <p>Personnel access via argocat</p>

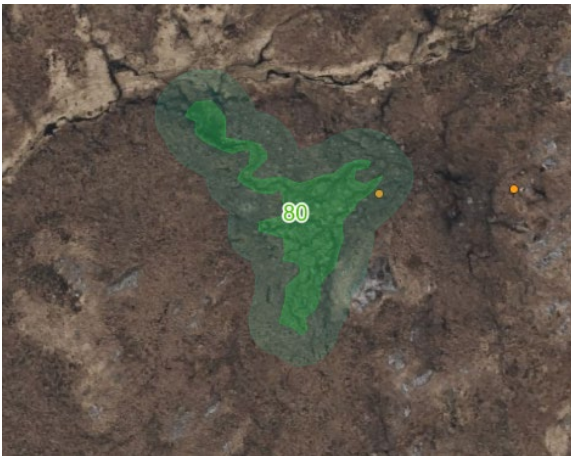
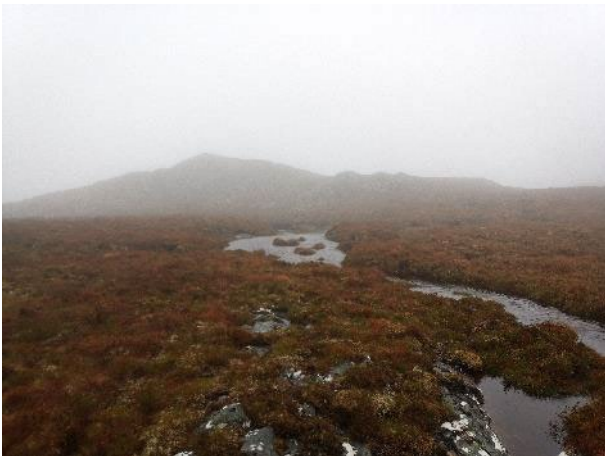
Area ID and Description	Recommended Restoration Techniques	Images	
<p>Area ID: 80</p> <p>Location: NH 43149 22286</p> <p>Description: Eroded bare peat area exposures with dendritic patterns of erosion on shoulder of hill and some near natural features retained draining north-east and north-west to watercourse. Bare peat exposures up to 1.2m with some surface water accumulation in base of features.</p> <p>Area: 1,142 m²</p>	<p>Repair of eroded / bare areas using hand techniques</p> <p>Personnel and materials access via argocat</p>

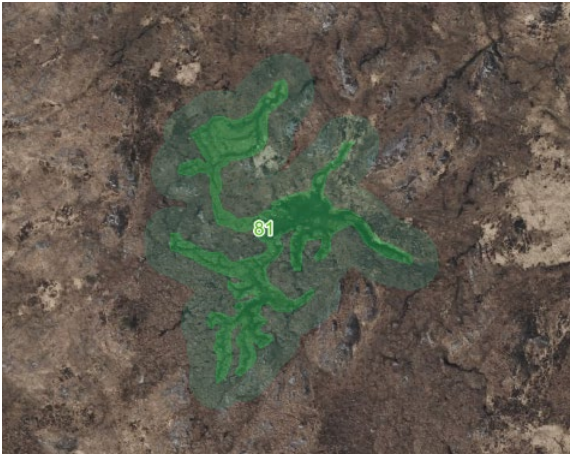
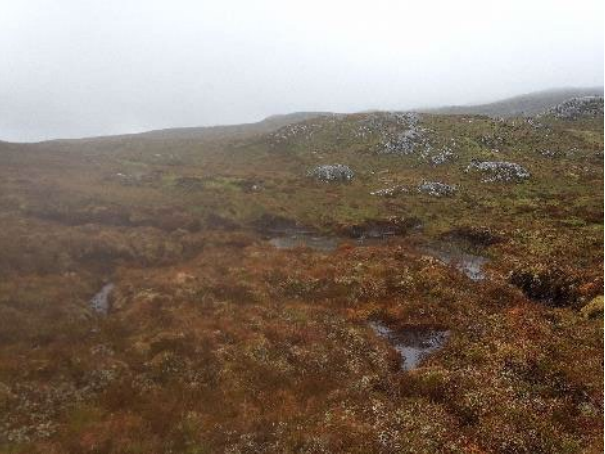
<p>Area ID: 81</p> <p>Location: NH 43476 22096</p> <p>Description: Network of bog pools with some near natural features retained however evidence of grazing impact. Near natural features are threatened by lowering of water table via erosional features draining west towards lochan as a result of grazing impacts on vegetation structure. Peat erosion up to 1 m deep.</p> <p>Area: 2,400 m²</p>	<p>Repair of eroded / bare areas using hand techniques</p> <p>Personnel and materials access via argocat</p>

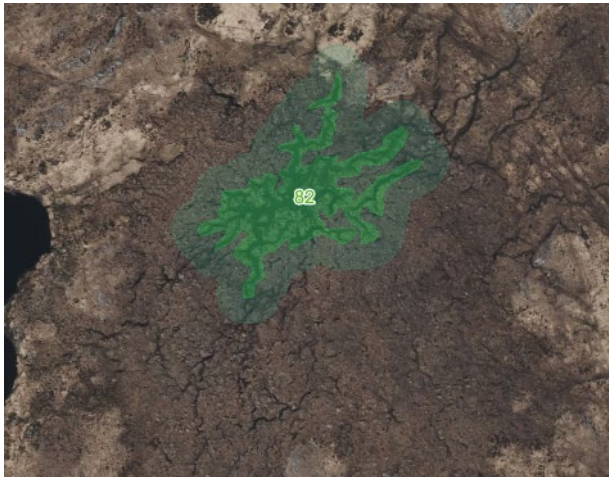
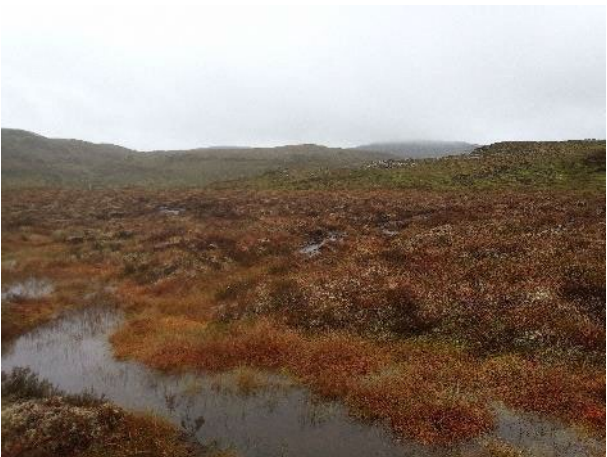
Area ID and Description	Recommended Restoration Techniques	Images	
<p>Area ID: 82</p> <p>Location: NH43477 21726</p> <p>Description: Large eroded area with some near natural features retained, threatened by ongoing lowering of water table. Evidence of burning and grazing.</p> <p>Area: 2,106 m²</p>	<p>Repair of eroded / bare areas using hand techniques</p> <p>Personnel and materials access via argocat</p>

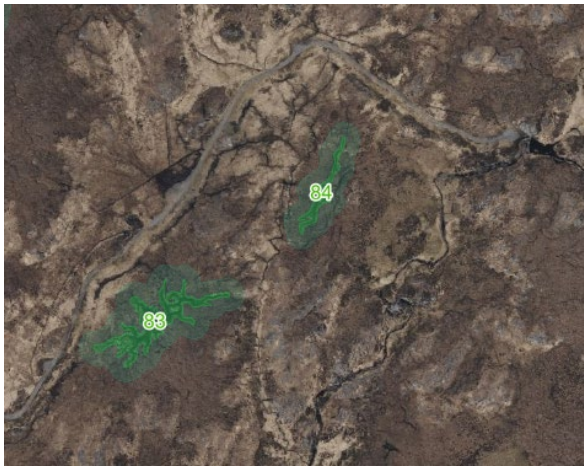
Area ID and Description	Recommended Restoration Techniques	Images	
<p>Area ID: 84</p> <p>Location: NH 43742 21587</p> <p>Description: Bog pools and some near natural features within modified bog habitat are threatened by peat erosional gully, pictured.</p> <p>Area: 333 m²</p>	<p>Repair of eroded / bare areas using hand techniques</p> <p>Personnel and materials access via argocat</p>

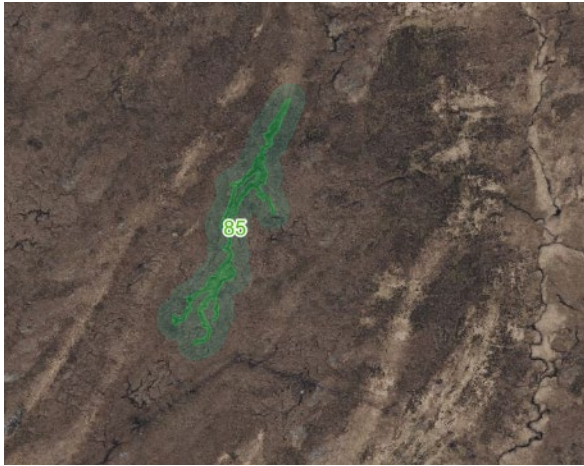
<p>Area ID: 85</p> <p>Location: NH 42081 20887</p> <p>Description: Erosional gully retaining some surface water and bog vegetation but actively eroding with some bare peat exposure.</p> <p>Area: 1,337 m²</p>	<p>Repair of eroded / bare areas using hand techniques and helicoptered materials</p> <p>Personnel access via argocat</p>

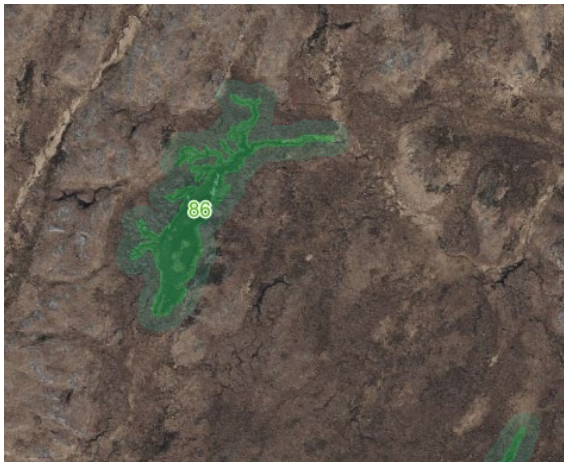
Area ID and Description	Recommended Restoration Techniques	Images	
<p>Area ID: 86</p> <p>Location: NH 41888 21133</p> <p>Description: Small lochan being drained by erosional gully to north-east. Ongoing peat erosion visible as bare peat exposures where water table has lowered around lochan and in walls of gully downgradient.</p> <p>Area: 3,952 m²</p>	<p>Repair of eroded / bare areas using hand techniques and helicoptered materials</p> <p>Personnel access via argocat</p>

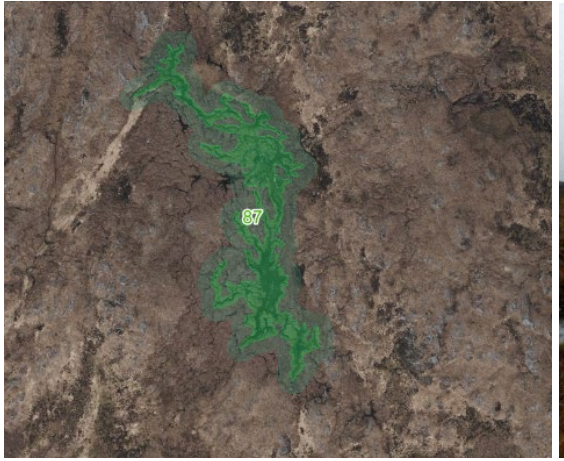
<p>Area ID: 87</p> <p>Location: NH 41346 21592</p> <p>Description: Extensive bare peat area draining via dendritic erosional gullies, with bare peat exposures up to 2 m deep.</p> <p>Area: 6,833 m²</p>	<p>Repair of eroded / bare areas using hand techniques and helicoptered materials</p> <p>Personnel access via argocat</p>

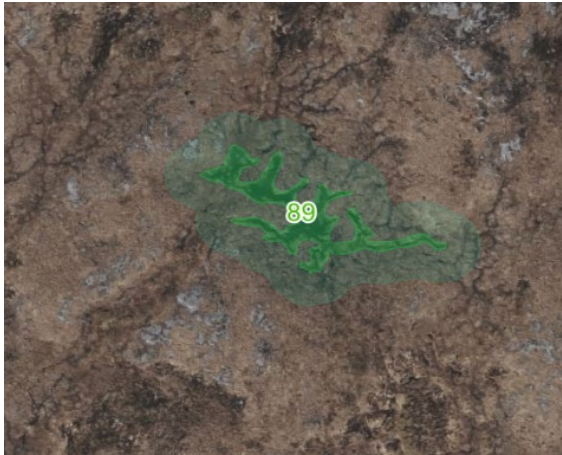
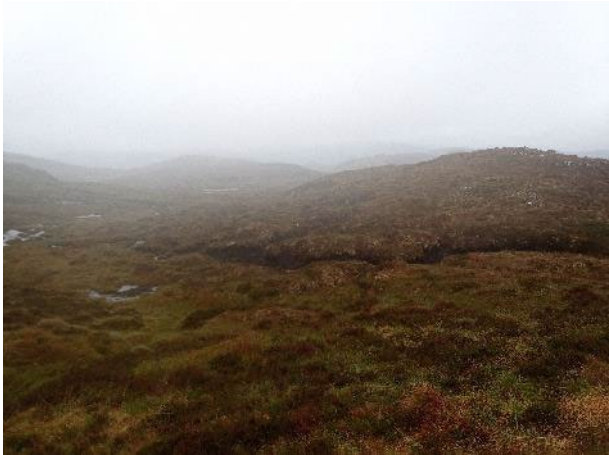
<p>Area ID: 89</p> <p>Location: NH 41484 21948</p> <p>Description: Erosional gullies with bare peat exposures up to 0.8 m depth.</p> <p>Area: 632 m²</p>	<p>Repair of eroded / bare areas using hand techniques and helicoptered materials</p> <p>Personnel access via argocat</p>

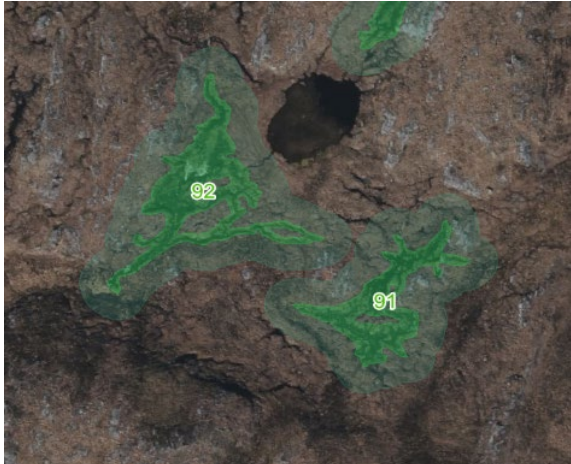
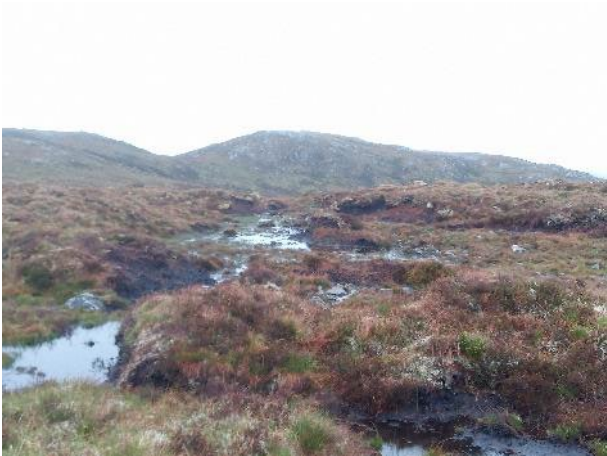
<p>Area ID: 91</p> <p>Location: NH 41545 22147</p> <p>Description: Extensive bare peat area draining to numerous erosional gullies with bare peat exposures up to 1 m deep.</p> <p>Area: 898 m²</p>	<p>Repair of eroded / bare areas using hand techniques and helicoptered materials</p> <p>Personnel access via argocat</p>

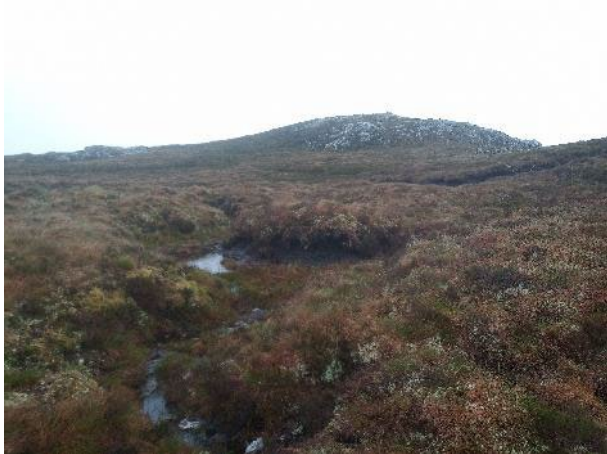
Area ID and Description	Recommended Restoration Techniques	Images	
<p>Area ID: 92</p> <p>Location: NH 41479 22189</p> <p>Description: Erosional features with bare peat exposures up to 2 m depth located in basin south-east of surface water body.</p> <p>Area: 1,326 m²</p>	<p>Repair of eroded / bare areas using hand techniques and helicoptered materials</p> <p>Personnel access via argocat</p>

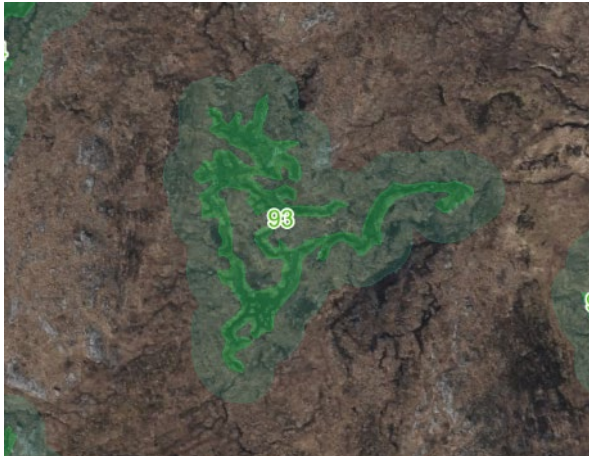
<p>Area ID: 93</p> <p>Location: NH 41655 22246</p> <p>Description: Minor dendritic erosional features with bare peat areas where water table has lowered. Some near natural features in area threatened by drainage via erosional features as a result of grazing impacts on vegetation structure.</p> <p>Area: 1,540 m²</p>	<p>Repair of eroded / bare areas using hand techniques and helicoptered materials</p> <p>Personnel access via argocat</p>

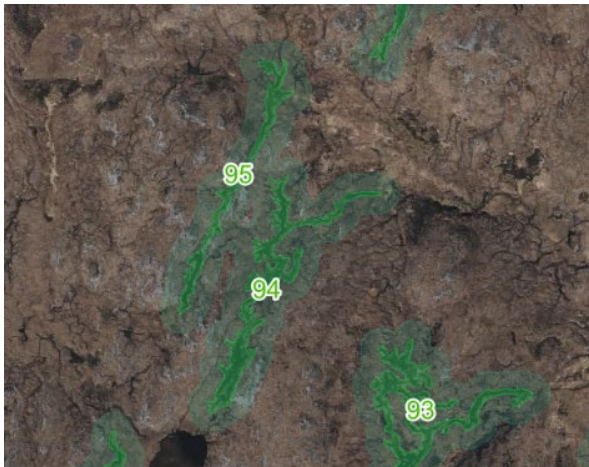
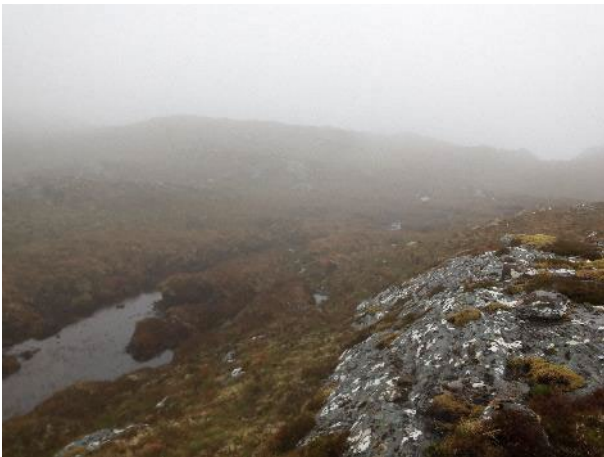
Area ID and Description	Recommended Restoration Techniques	Images	
<p>Area ID: 94</p> <p>Location: NH 41568 22315</p> <p>Description: Bare peat exposures up to 1.5 m deep in basin below rock outcrops. Erosional features form surface water body towards south-east end of area; bare peat erosional visible in walls of surface water body as a result of ongoing drainage.</p> <p>Area: 1,460 m²</p>	<p>Repair of eroded / bare areas using hand techniques and helicoptered materials</p> <p>Personnel access via argocat</p>

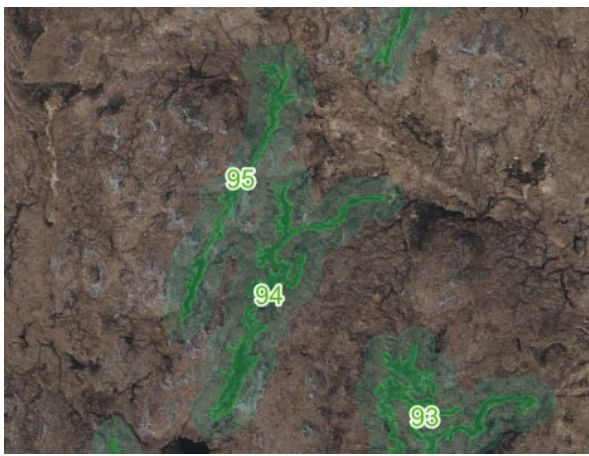
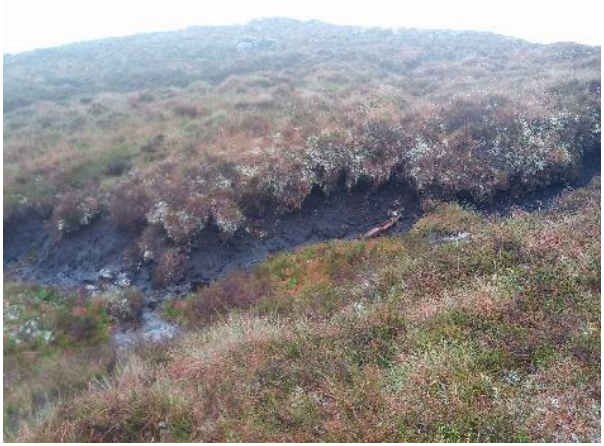
<p>Area ID: 95</p> <p>Location: NH 41552 22380</p> <p>Description: Bare peat exposures up to 1.5 m deep between rock outcrops.</p> <p>Area: 775 m²</p>	<p>Repair of eroded / bare areas using hand techniques and helicoptered materials</p> <p>Personnel access via argocat</p>

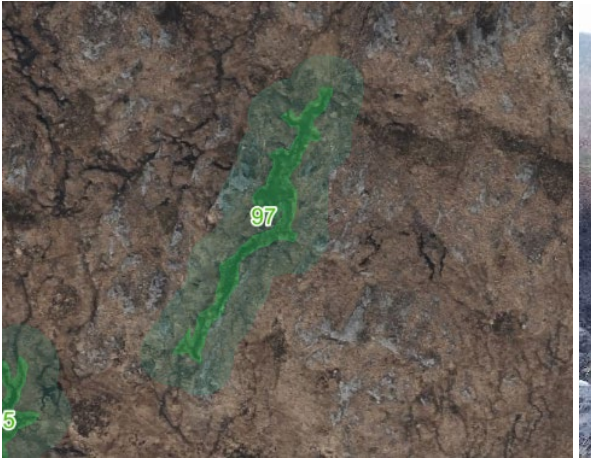
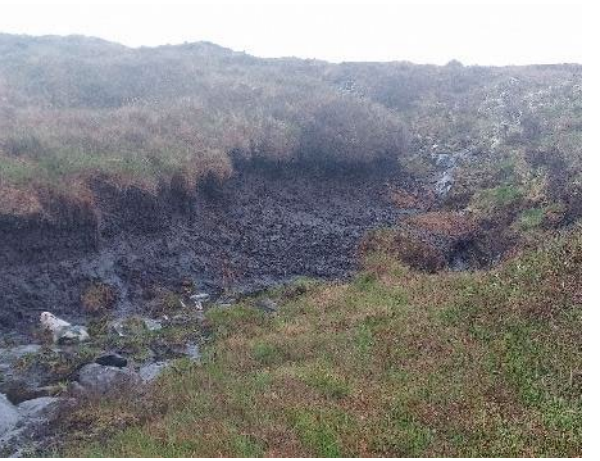
<p>Area ID: 97 Location: NH 41656 22490 Description: Erosional gully with bare peat exposures up to 1.6 m deep. Area: 584 m²</p>	<p>Repair of eroded / bare areas using hand techniques and helicoptered materials Personnel access via argocat</p>

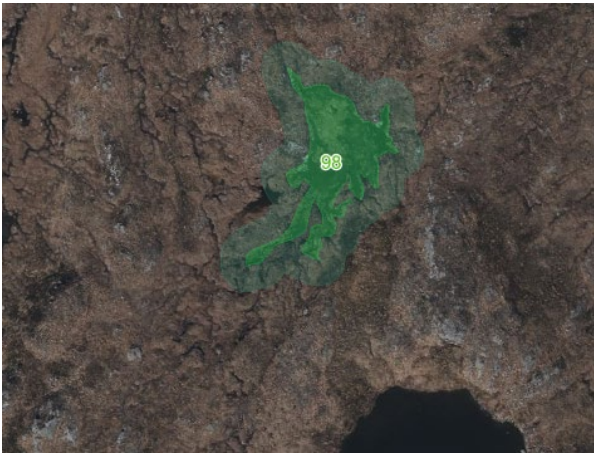
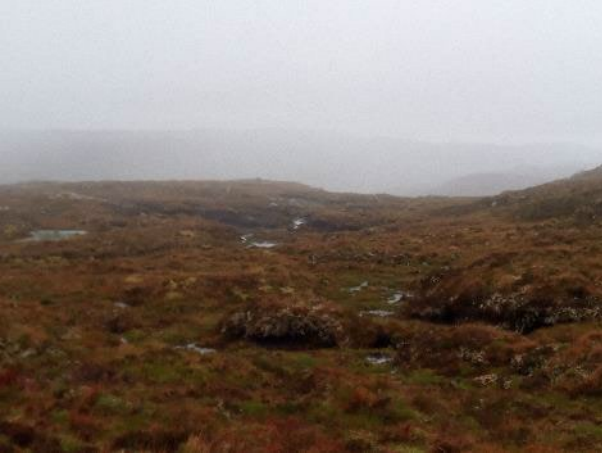
Area ID and Description	Recommended Restoration Techniques	Images	
<p>Area ID: 98</p> <p>Location: NH 41465 22761</p> <p>Description: Dendritic erosional features up to 1.3 m depth with bare peat in base on flat ground above surface water body.</p> <p>Area: 1,501 m²</p>	<p>Repair of eroded / bare areas using hand techniques and helicoptered materials</p> <p>Personnel access via argocat</p>

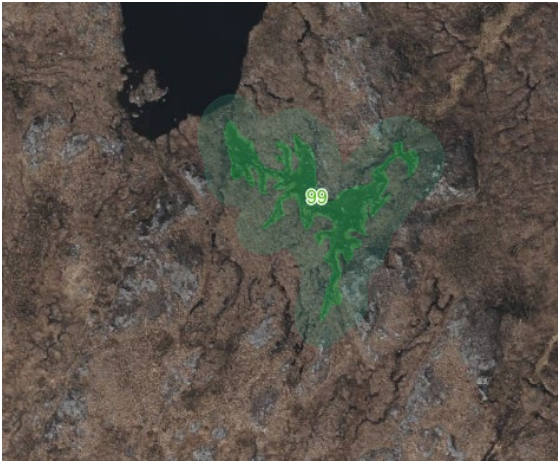
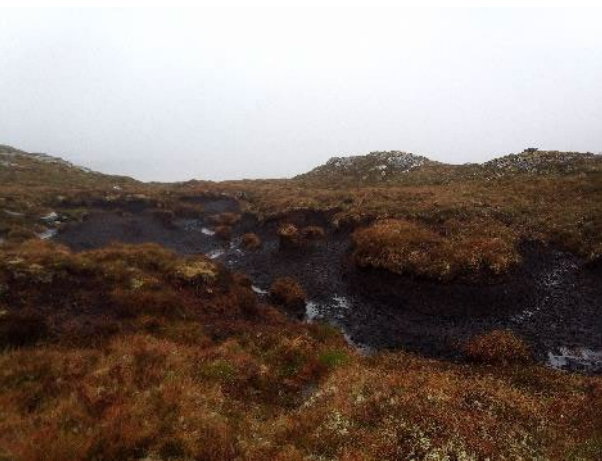
<p>Area ID: 99</p> <p>Location: NH 41198 22680</p> <p>Description: Erosional gullies with extensive bare peat exposures up to 1.6 m deep and evidence of recent wall collapse draining north-west towards lochan.</p> <p>Area: 1,202 m²</p>	<p>Repair of eroded / bare areas using hand techniques and helicoptered materials</p> <p>Personnel access via argocat</p>

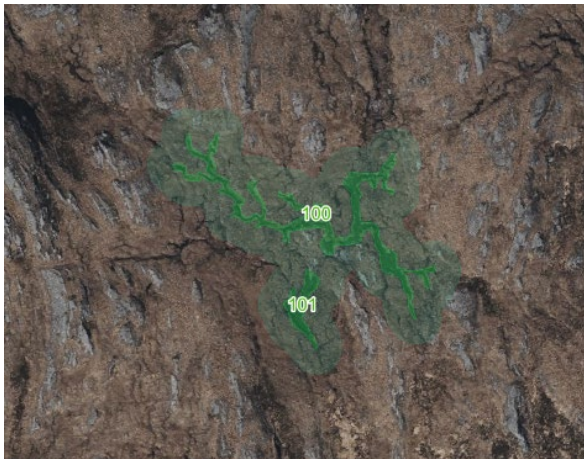
Area ID and Description	Recommended Restoration Techniques	Images	
<p>Area ID: 100 Location: NH 40746 22537 Description: Several erosional features on deep peat over bedrock with evidence of recent wall collapse and surface water drainage channels with base of features. Area: 832 m²</p>	<p>Repair of eroded / bare areas using hand techniques and helicoptered materials Personnel access via argocat</p>

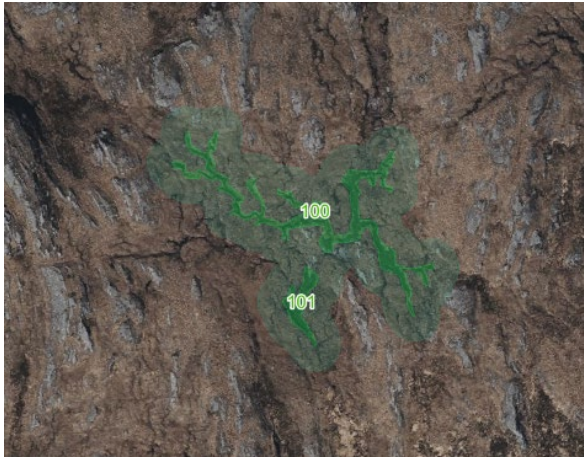
<p>Area ID: 101 Location: NH 40741 22500 Description: Erosional gully with bare peat exposures over 1 m deep. Area: 158 m²</p>	<p>Repair of eroded / bare areas using hand techniques and helicoptered materials Personnel access via argocat</p>

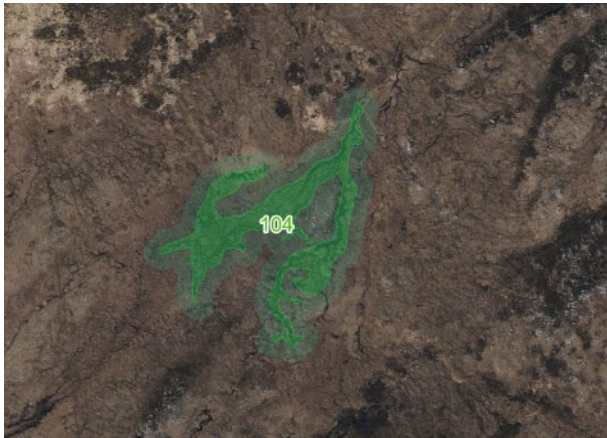
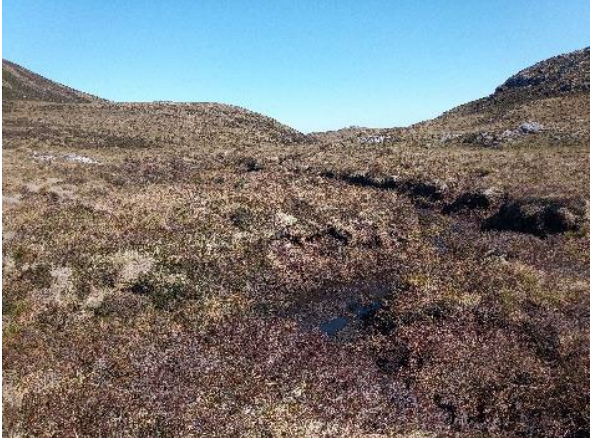
Area ID and Description	Recommended Restoration Techniques	Images	
<p>Area ID: 104 Location: NH 37272 22257 Description: Large network of peat erosional gullies with extensive bare peat and bare peat exposures up to 1.2 m depth. Evidence of recent wall collapse and surface water drainage within base of features. Area: 5,598 m²</p>	<p>Repair of eroded / bare areas using machine-based techniques Access via non wind farm tracks</p>

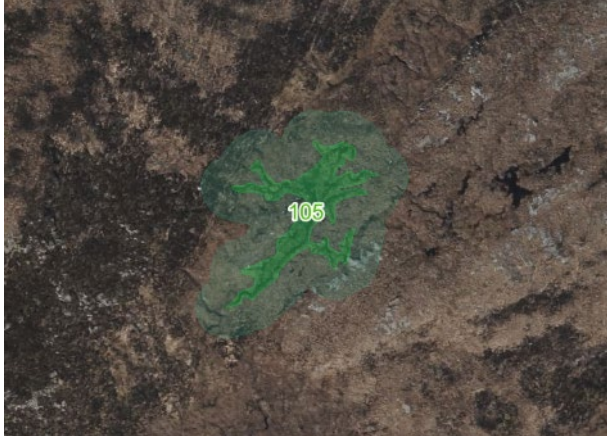
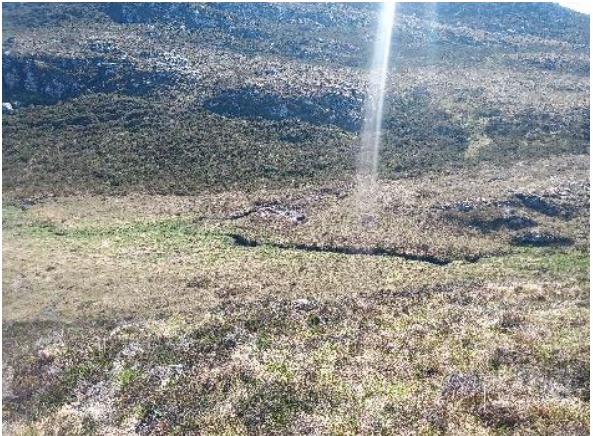
<p>Area ID: 105 Location: NH 37339 22520 Description: Erosional features within basin on slopes of Meall nan Oighreagan. Bare peat present within gullies, some of the surrounding vegetation has transitioned to acid grassland downgradient of feature. Area: 735 m²</p>	<p>Repair of eroded / bare areas using machine-based techniques Access via non wind farm tracks</p>

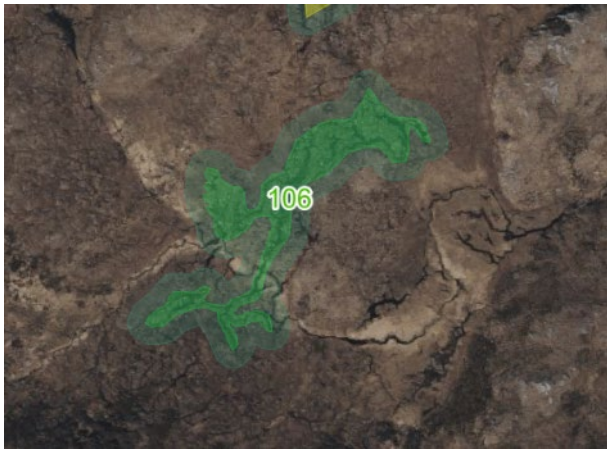
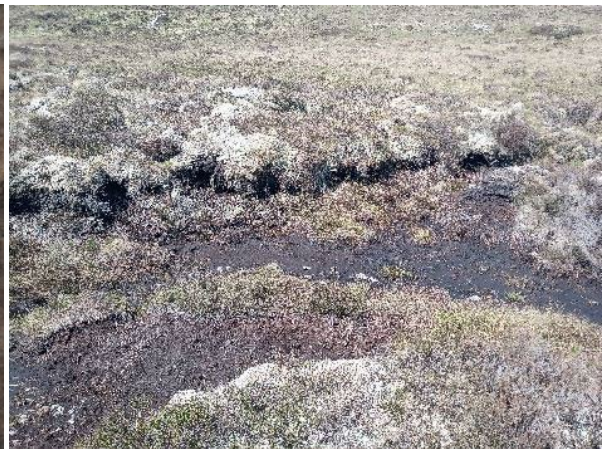
Area ID and Description	Recommended Restoration Techniques	Images	
<p>Area ID: 106 Location: NH 37722 22636 Description: Erosional features with extensive bare peat above unnamed OS mapped watercourse. Area: 4,095 m²</p>	<p>Repair of eroded / bare areas using machine-based techniques Access via non wind farm tracks</p>

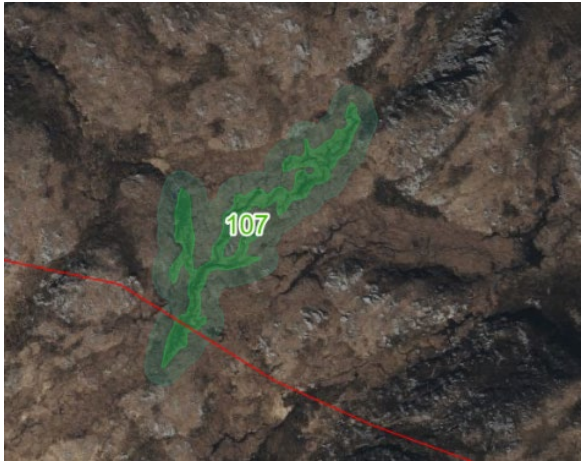
<p>Area ID: 107 Location: NH 38455 22338 Description: Erosional gullies up to 4 m wide with bare peat exposures. Area: 2,491 m²</p>	<p>Repair of eroded / bare areas using machine-based techniques Access via non wind farm tracks</p>

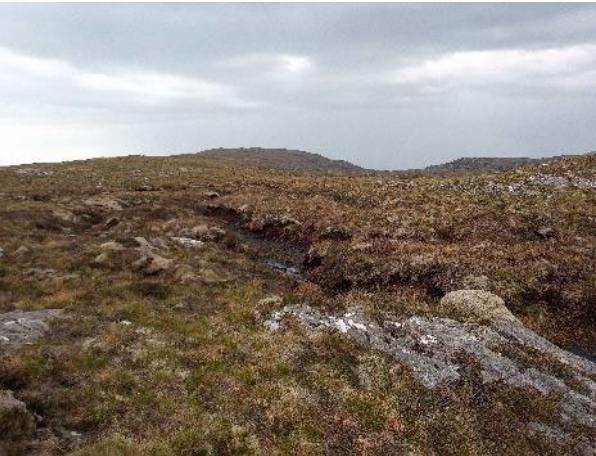
<p>Area ID: 109</p> <p>Location: NH 38313 22888</p> <p>Description: Erosional features situated in basin between rock outcrops with extensive bare peat draining west to lochan.</p> <p>Area: 4,956 m²</p>	<p>Repair of eroded / bare areas using machine-based techniques</p> <p>Access via non wind farm tracks</p>
