SEI Appendix D: Additional Potential Restoration Areas

Table 1 – Summary of Additional Potential Restoration Areas

Table 2 – Additional Potential Restoration Areas

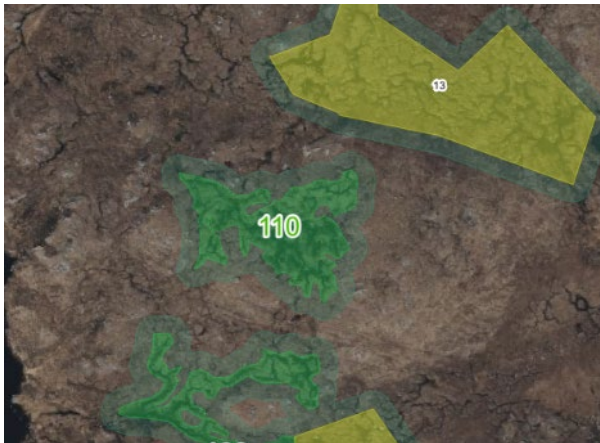
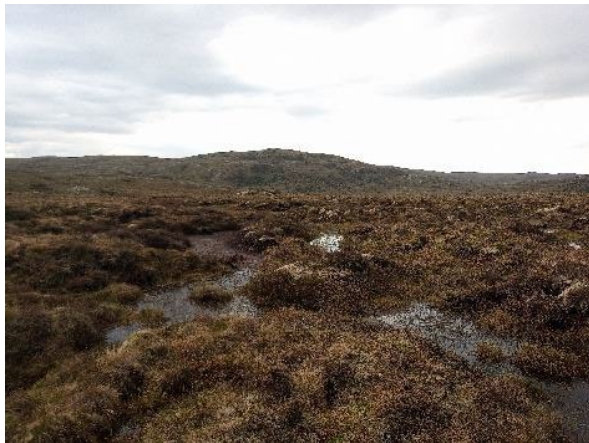
Area ID and Description	Recommended Restoration Techniques	Images	
<p>Area ID: 110</p> <p>Location: NH 38348 23030</p> <p>Description: Erosional features situated on summit of rock outcrop with bare peat exposures and evidence of grazing impact on vegetation structure leading to lowering of water table.</p> <p>Area: 3,686 m²</p>	<p>Repair of eroded / bare areas using machine-based techniques</p> <p>Access via wind farm track network</p>

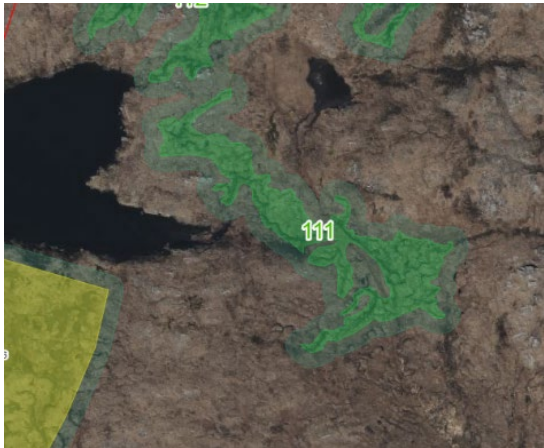
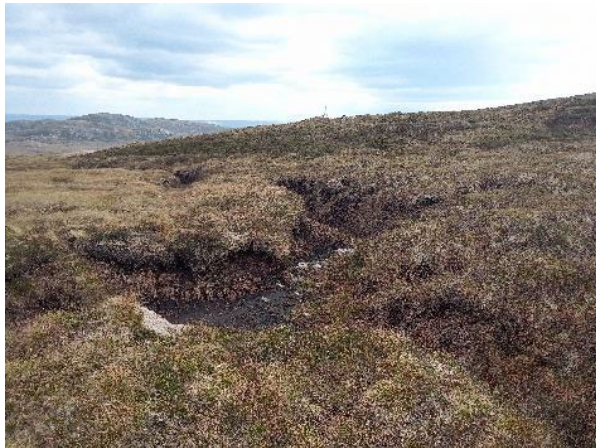
<p>Area ID: 111</p> <p>Location: NH 37400 23835</p> <p>Description: Erosional features adjacent to Loch nam Meirleach. Gullies with bare peat exposures up to 2 m deep, eroded to bedrock and grit substrate in places.</p> <p>Area: 6,409 m²</p>	<p>Repair of eroded / bare areas using machine-based techniques</p> <p>Access via wind farm track network</p>

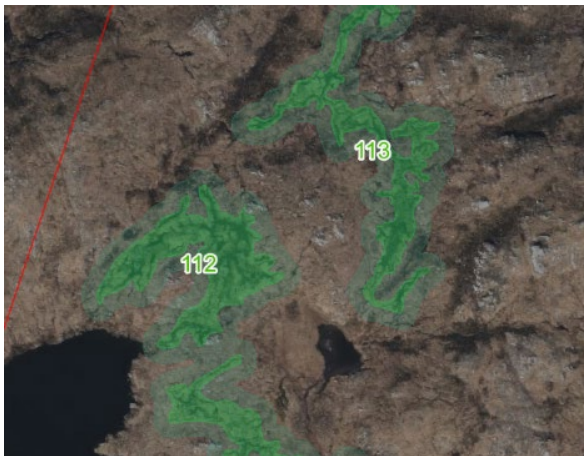
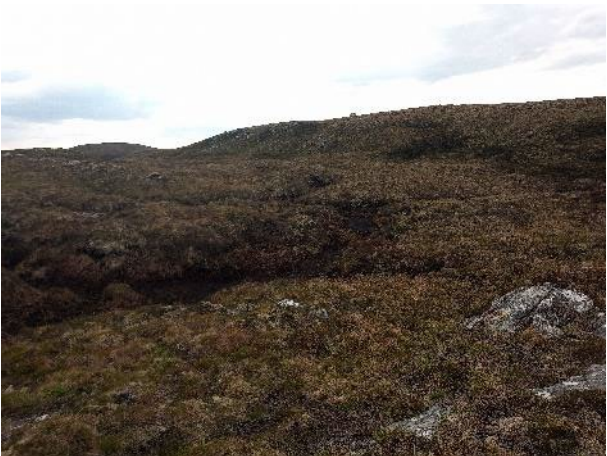
Area ID and Description	Recommended Restoration Techniques	Images	
<p>Area ID: 112 Location: NH 37313 23991 Description: Dendritic erosional channels with bare peat exposures and evidence of ongoing peat erosion lowering water table. Area: 4,724 m²</p>	<p>Repair of eroded / bare areas using machine-based techniques Access via wind farm track network</p>

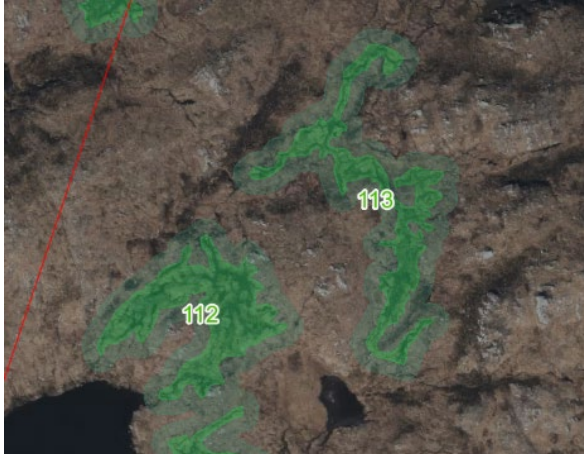
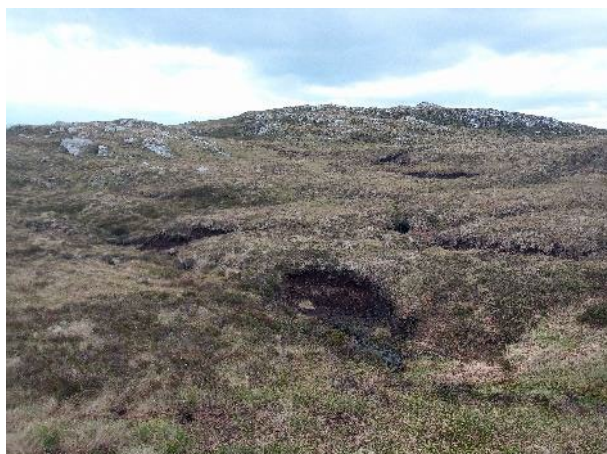
<p>Area ID: 113 Location: NH 37429 24067 Description: Erosional features within peat tongue between rock outcrops with bare peat exposures. Vegetation structure heavily impacted by grazing. Area: 4,045 m²</p>	<p>Repair of eroded / bare areas using machine-based techniques Access via wind farm track network</p>

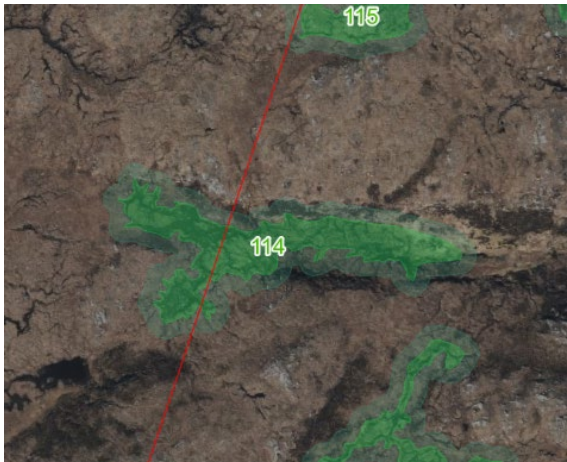
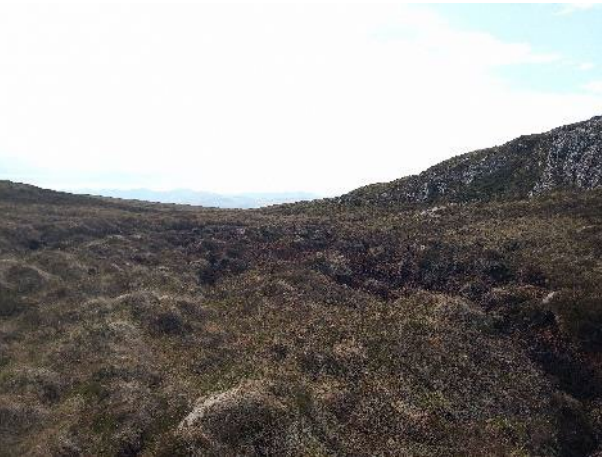
Area ID and Description	Recommended Restoration Techniques	Images	
<p>Area ID: 114</p> <p>Location: NH 37312 24234</p> <p>Description: Erosional features with extensive bare peat and peat exposures with evidence of recent wall collapse and dry, heavily modified peat.</p> <p>Area: 6,736</p>	<p>Repair of eroded / bare areas using machine-based techniques</p> <p>Access via wind farm track network</p>

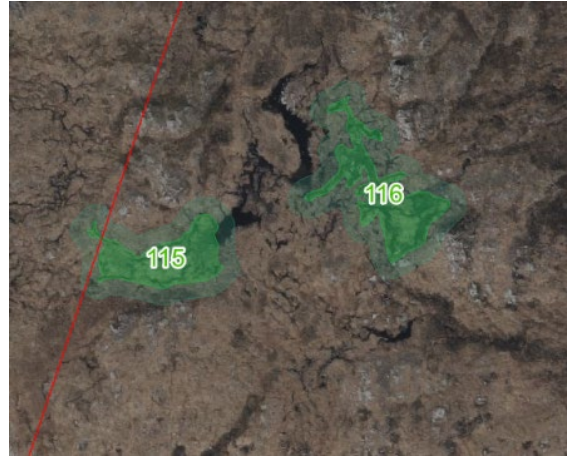
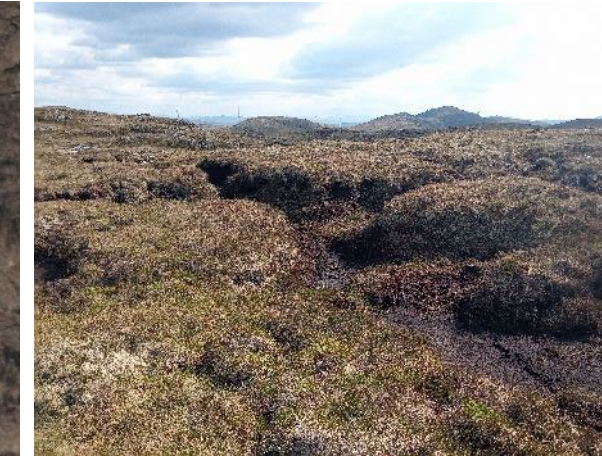
<p>Area ID: 115</p> <p>Location: NH 37376 24393</p> <p>Description: Erosional gullies up to 2 m deep.</p> <p>Area: 2,018 m²</p>	<p>Repair of eroded / bare areas using machine-based techniques</p> <p>Access via wind farm track network</p>

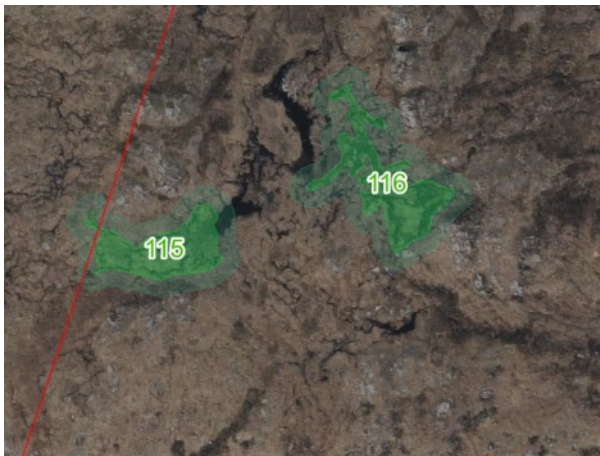
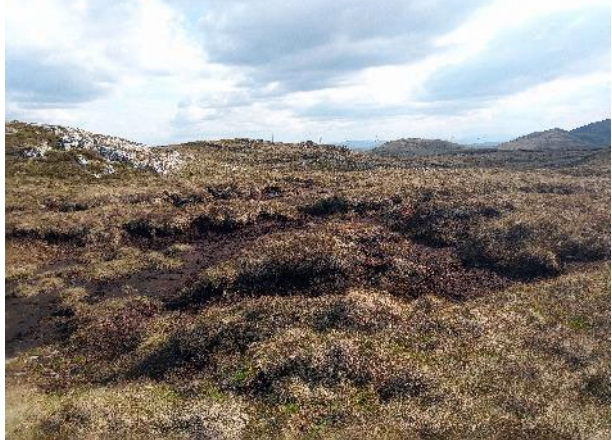
Area ID and Description	Recommended Restoration Techniques	Images	
<p>Area ID: 116 Location: NH 37511 24433 Description: Shallow erosional features with some bare peat located adjacent to surface water features. Evidence of large burning and grazing impact. Area: 2,344 m²</p>	<p>Repair of eroded / bare areas using machine-based techniques Access via wind farm track network</p>

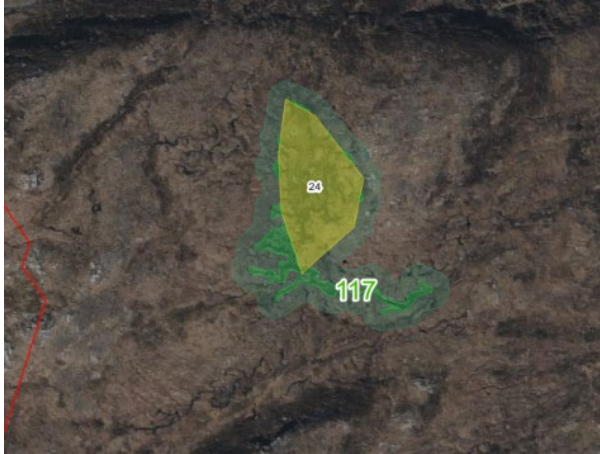
<p>Area ID: 117 Location: NH 37584 24695 Description: Continuation of area identified within original EIA Report. Network of erosional gullies with bare peat exposure and evidence of ongoing peat erosion contributing to drainage of original area. Area: 960 m²</p>	<p>Repair of eroded / bare areas using machine-based techniques Access via wind farm track network</p>

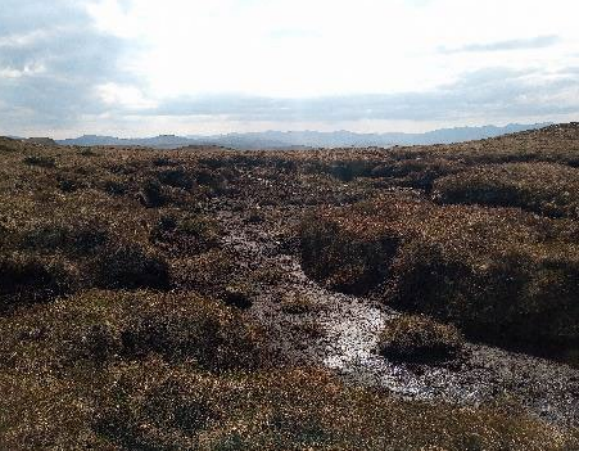
<p>Area ID: 119</p> <p>Location: NH 37521 25236</p> <p>Description: Extensive bare peat areas drained by erosional gullies with evidence of surface water drainage at base of features.</p> <p>Area: 8,970 m²</p>	<p>Repair of eroded / bare areas using machine-based techniques</p> <p>Access via wind farm track network</p>

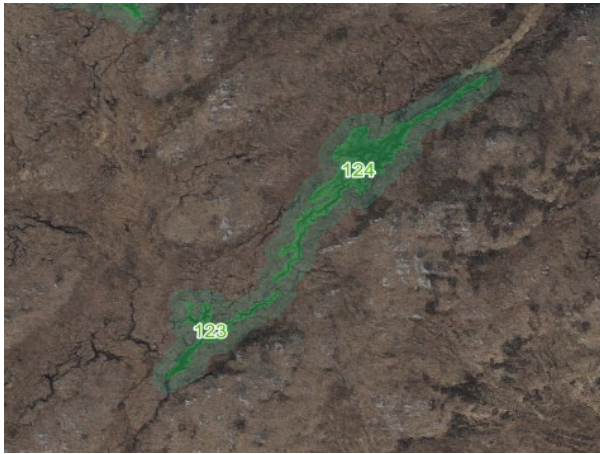
Area ID and Description	Recommended Restoration Techniques	Images	
<p>Area ID: 124 Location: NH 38189 25597 Description: Network of erosional features with extensive bare peat above headwaters of unnamed tributary to Allt Seanabhaile. Area: 2,742 m²</p>	<p>Repair of eroded / bare areas using machine-based techniques Access via wind farm track network</p>

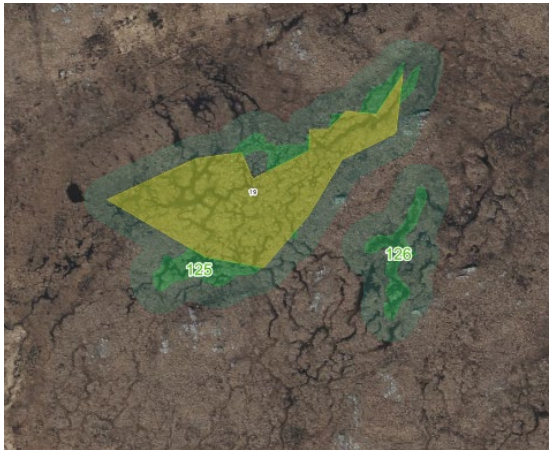
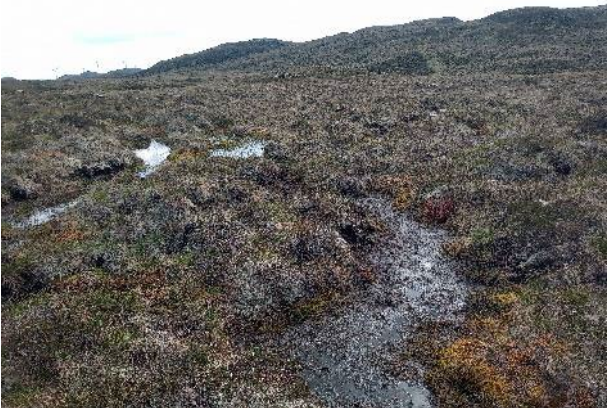
<p>Area ID: 125 Location: NH 38179 25133 Description: Continuation of area identified within original EIA Report. Area contains bog pools with sphagnum species and some near natural features that now have areas of bare peat exposure are undergoing erosion via erosional gullies due to grazing pressure altering vegetation structure. Area: 904 m²</p>	<p>Repair of eroded / bare areas using machine-based techniques Access via wind farm track network</p>

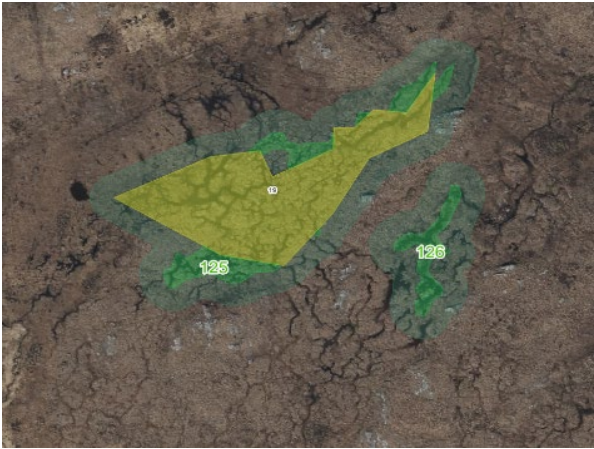
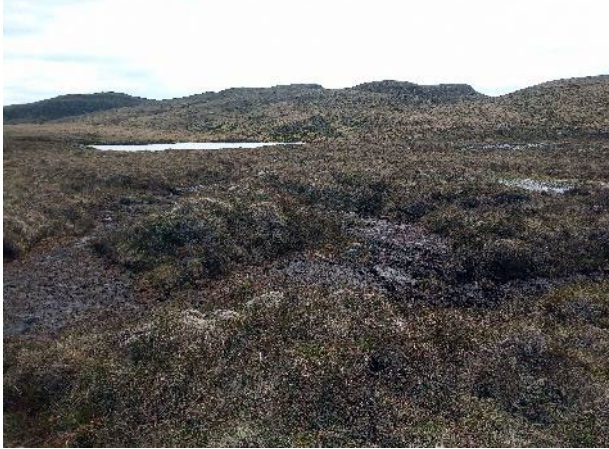
Area ID and Description	Recommended Restoration Techniques	Images	
<p>Area ID: 126</p> <p>Location: NH 38239 25106</p> <p>Description: Erosional gullies up to 1.5m deep and erosional features that appear to be previously sphagnum-rich bog pools, draining towards Loch a' Mhuilinn to south.</p> <p>Area: 425 m²</p>	<p>Repair of eroded / bare areas using machine-based techniques</p> <p>Access via wind farm track network</p>

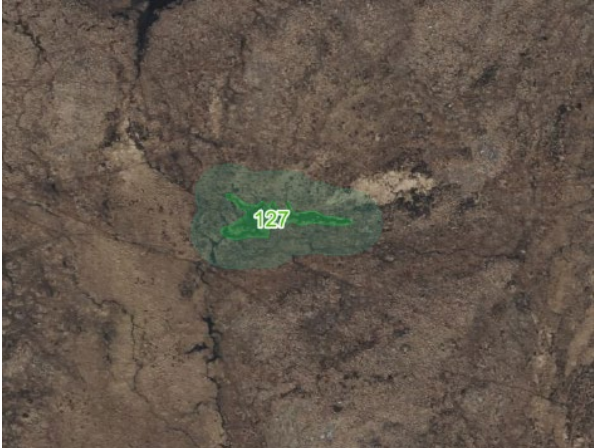
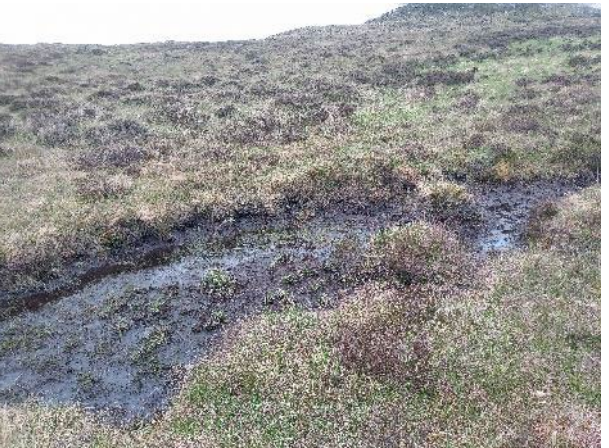
<p>Area ID: 127</p> <p>Location: NH 38190 24537</p> <p>Description: Small erosional feature with bare peat and visible surface water flow. No longer bog vegetation – acid grassland due to grazing pressure.</p> <p>Area: 252 m²</p>	<p>Repair of eroded / bare areas using machine-based techniques</p> <p>Access via wind farm track network</p>

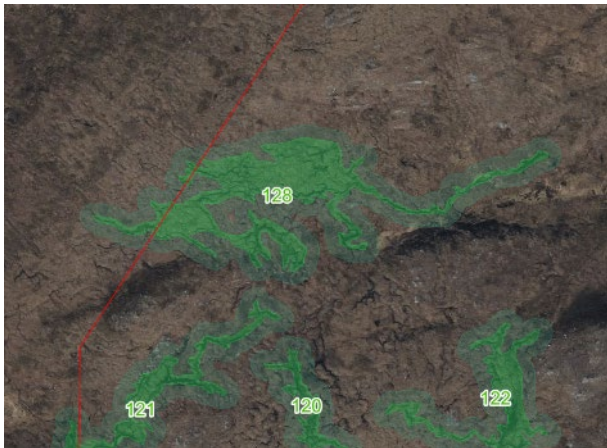
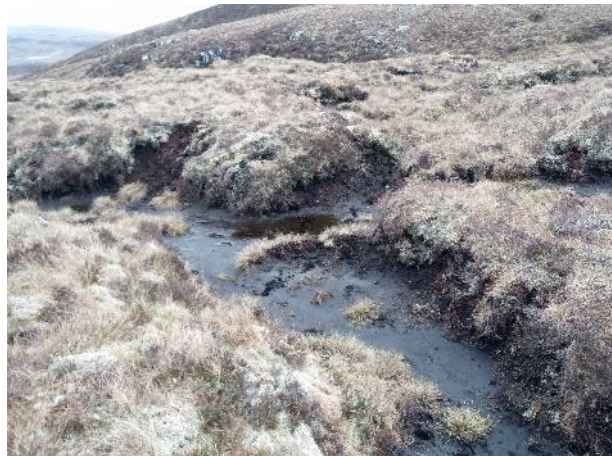
Area ID and Description	Recommended Restoration Techniques	Images	
<p>Area ID: 128</p> <p>Location: NH 37835 25930</p> <p>Description: Dendritic network of erosional gullies connected to large erosional gully extending east. Bog pools and hummocks within proximity of erosional features.</p> <p>Area: 8,207 m²</p>	<p>Repair of eroded / bare areas using machine-based techniques</p> <p>Access via wind farm track network</p>

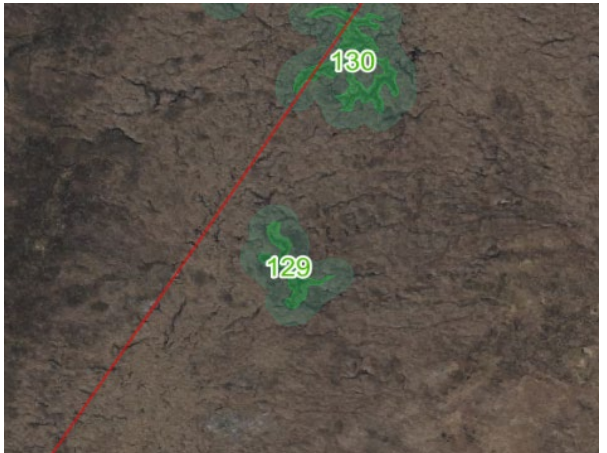
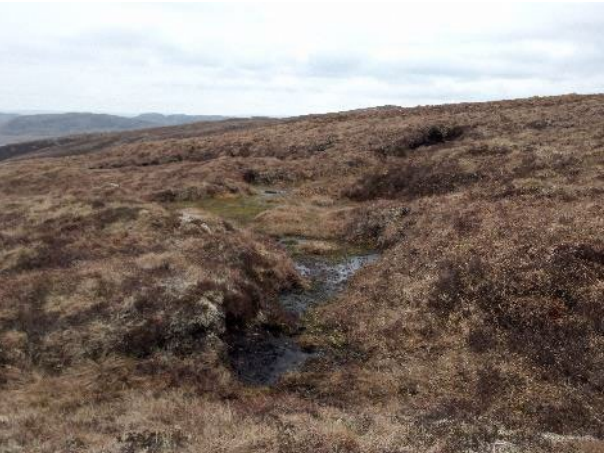
<p>Area ID: 129</p> <p>Location: NH 38015 26233</p> <p>Description: Small eroded area drained by minor drainage channels.</p> <p>Area: 457 m²</p>	<p>Repair of eroded / bare areas using machine-based techniques</p> <p>Access via wind farm track network</p>

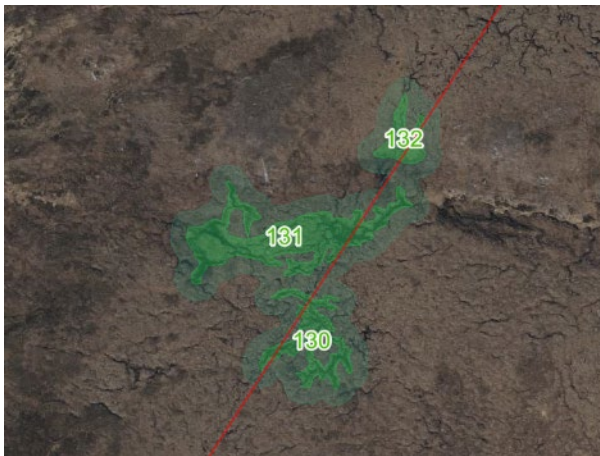
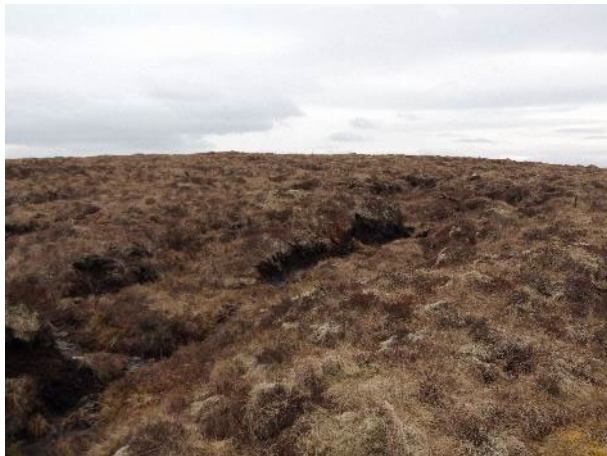
Area ID and Description	Recommended Restoration Techniques	Images	
<p>Area ID: 130 Location: NH 38051 26355 Description: Erosional gullies on ridgeline. Area: 1,145 m²</p>	<p>Repair of eroded / bare areas using machine-based techniques Access via wind farm track network</p>

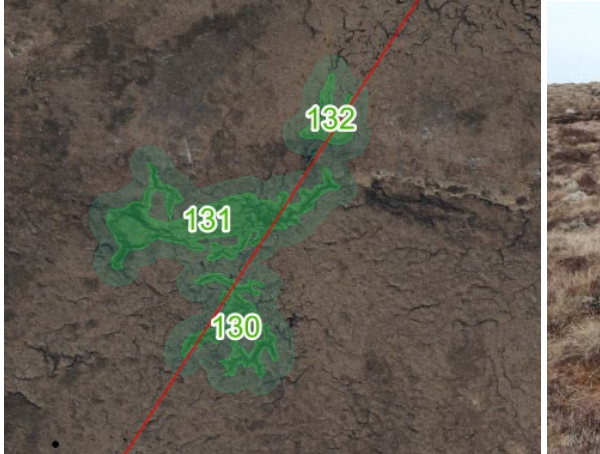
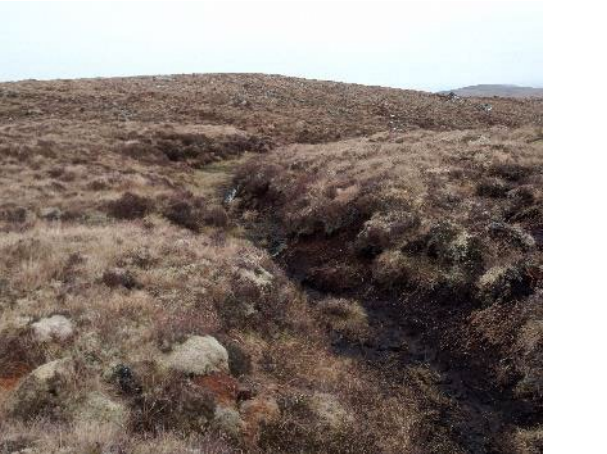
<p>Area ID: 131 Location: NH 38034 26421 Description: Deep gully with bare peat linked to bare peat areas and patterns of dendritic erosion. Area: 3,049 m²</p>	<p>Repair of eroded / bare areas using machine-based techniques Access via wind farm track network</p>

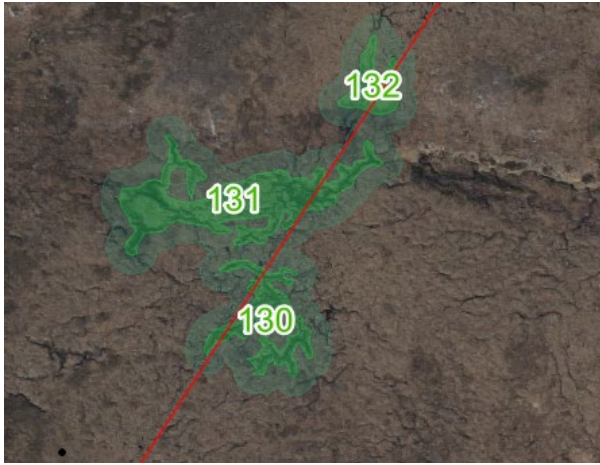
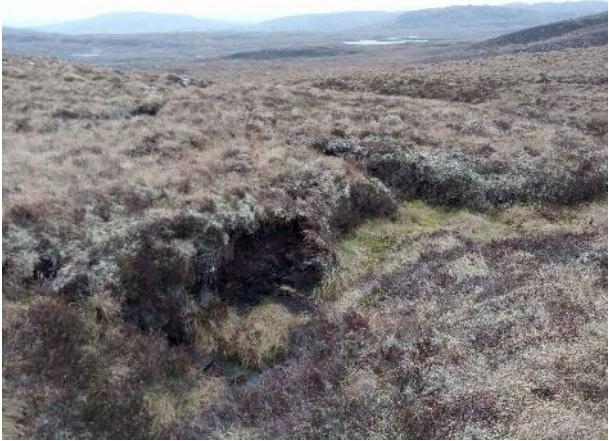
Area ID and Description	Recommended Restoration Techniques	Images	
<p>Area ID: 132</p> <p>Location: NH 38109 26482</p> <p>Description: Erosional gullies draining towards watercourse with dry bare peat exposures, eroded to bedrock in places.</p> <p>Area: 553 m²</p>	<p>Repair of eroded / bare areas using machine-based techniques</p> <p>Access via wind farm track network</p>

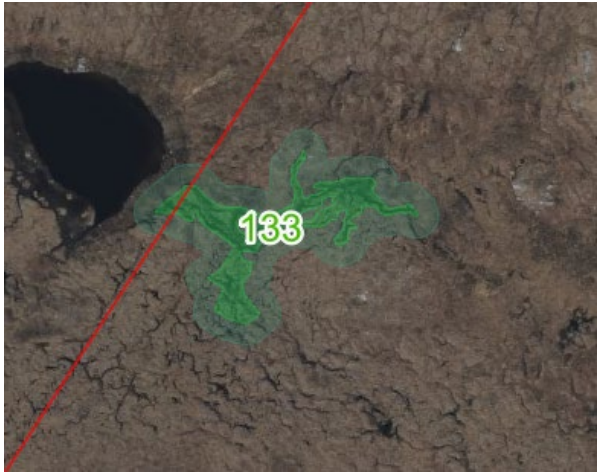
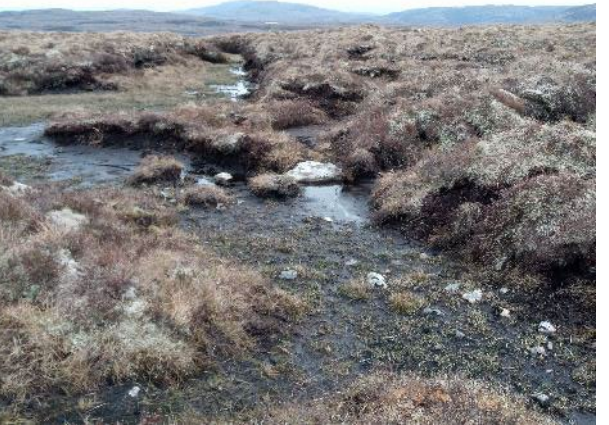
<p>Area ID: 133</p> <p>Location: NH 38256 26620</p> <p>Description: Eroded area with extensive bare peat areas, eroded down to grit and bedrock substrate and draining west to lochan.</p> <p>Area: 1,972 m²</p>	<p>Repair of eroded / bare areas using machine-based techniques</p> <p>Access via wind farm track network</p>

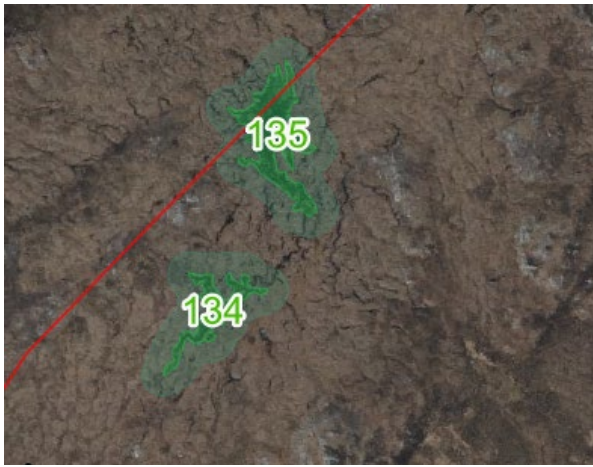
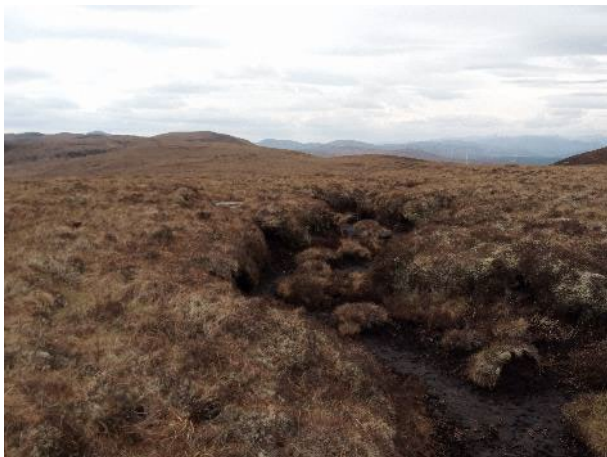
Area ID and Description	Recommended Restoration Techniques	Images	
<p>Area ID: 134</p> <p>Location: NH 38382 26776</p> <p>Description: 1.2 m deep erosional gully with signs of recent wall collapse draining bog pool north-east of area.</p> <p>Area: 518 m²</p>	<p>Repair of eroded / bare areas using machine-based techniques</p> <p>Access via wind farm track network</p>

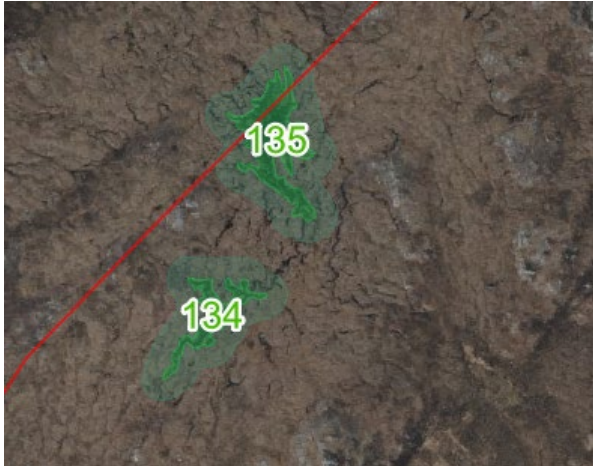
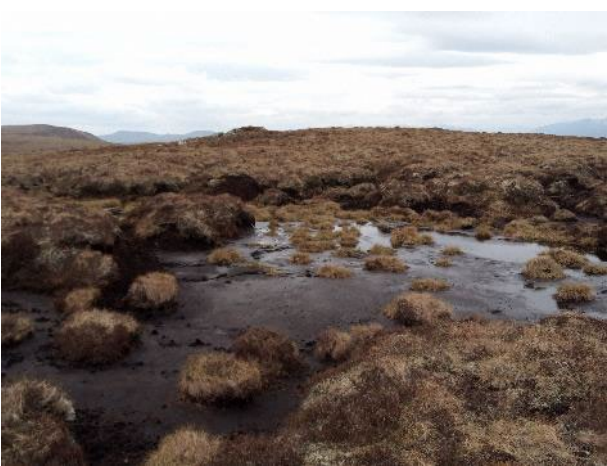
<p>Area ID: 135</p> <p>Location: NH 38413 26861</p> <p>Description: Erosional feature in saddle of ridge up to ~20 m wide with evidence of recent wall collapse.</p> <p>Area: 1,162 m²</p>	<p>Repair of eroded / bare areas using machine-based techniques</p> <p>Access via wind farm track network</p>

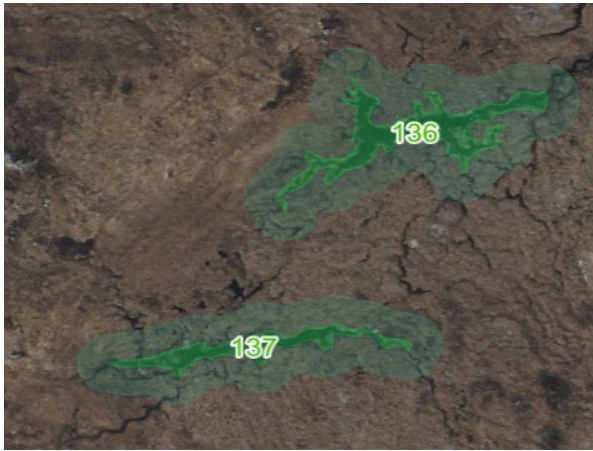
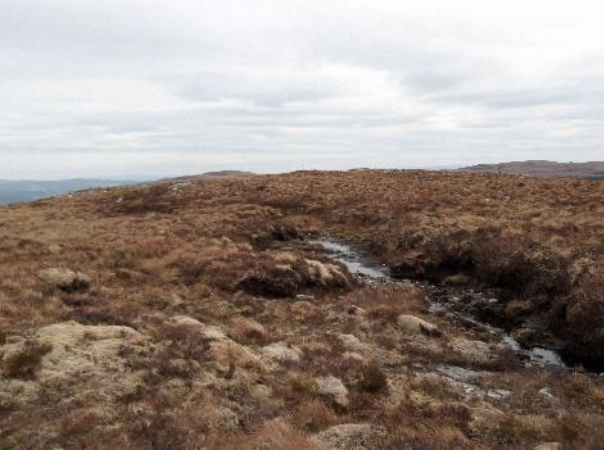
Area ID and Description	Recommended Restoration Techniques	Images	
<p>Area ID: 136 Location: NH 38747 26843 Description: Wide erosional gully with bare peat exposures up to 1.5 m deep and visible surface water drainage. Area: 856 m²</p>	<p>Repair of eroded / bare areas using machine-based techniques Access via wind farm track network</p>

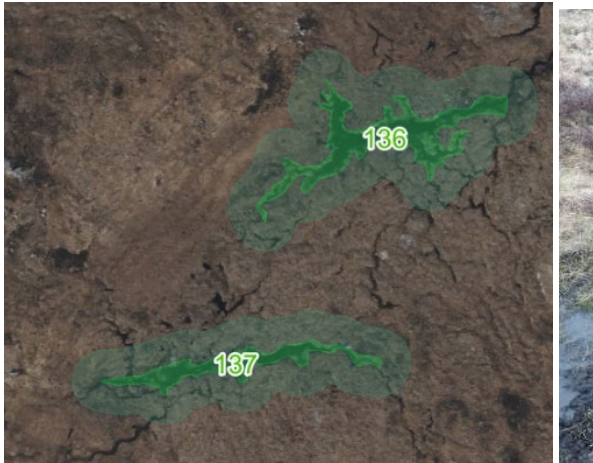
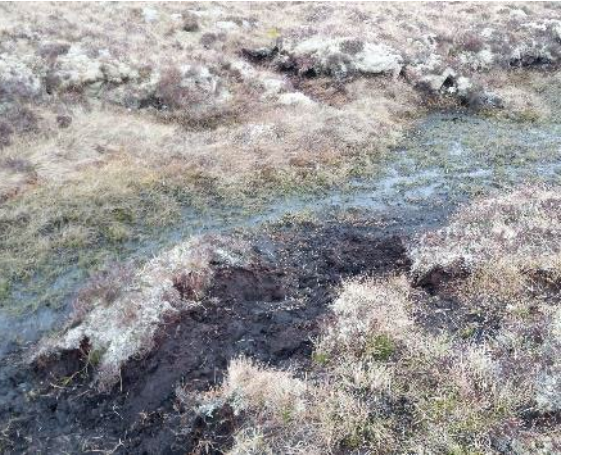
<p>Area ID: 137 Location: NH 38696 26765 Description: Eroded peat area with bare peat exposures up to 1.2 m deep. Some accumulation of surface water. Area: 410 m²</p>	<p>Repair of eroded / bare areas using machine-based techniques Access via wind farm track network</p>

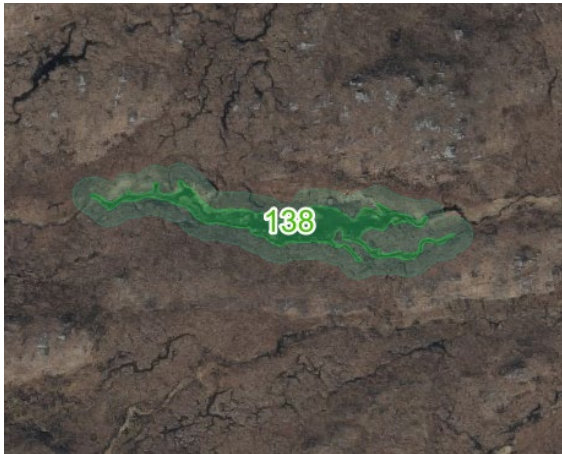
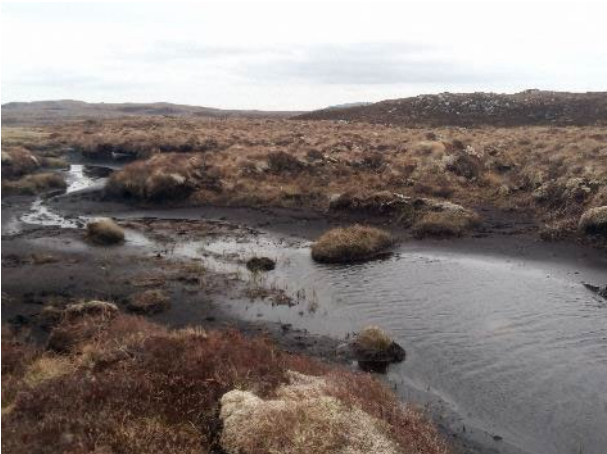
Area ID and Description	Recommended Restoration Techniques	Images	
<p>Area ID: 138</p> <p>Location: NH 38604 25973</p> <p>Description: Extensive bare peat area surrounding watercourse, actively eroding via watercourse channel.</p> <p>Area: 2,204 m²</p>	<p>Repair of eroded / bare areas using machine-based techniques</p> <p>Access via wind farm track network</p>

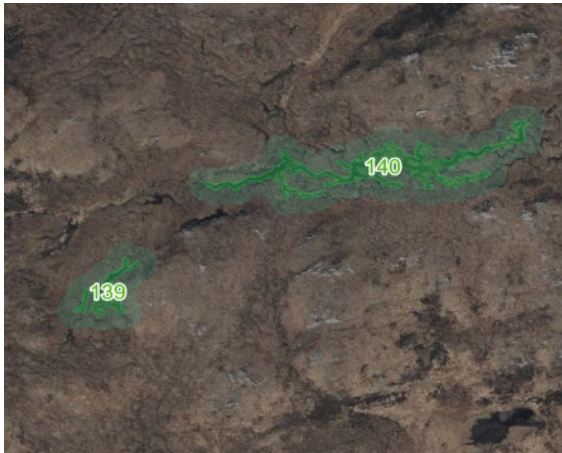
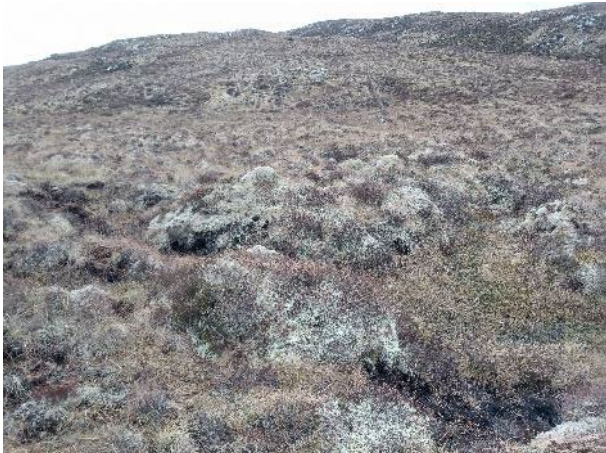
<p>Area ID: 139</p> <p>Location: NH 38555 25613</p> <p>Description: Shallow erosional features in early stages of erosion. Some near natural features, threatened by drainage of surface water via shallow erosional features.</p> <p>Area: 451 m²</p>	<p>Repair of eroded / bare areas using machine-based techniques</p> <p>Access via wind farm track network</p>

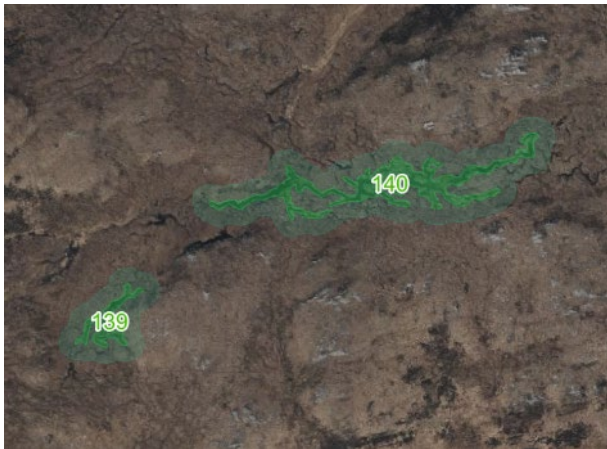
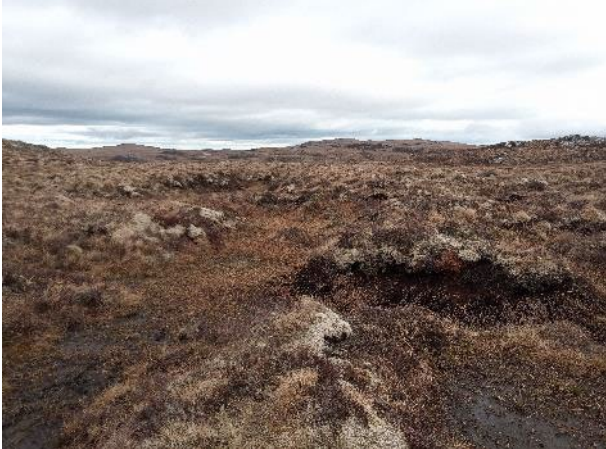
Area ID and Description	Recommended Restoration Techniques	Images	
<p>Area ID: 140 Location: NH 38733 25700 Description: Network of erosional gullies with extensive bare peat exposures. Area: 2,199 m²</p>	<p>Repair of eroded / bare areas using machine-based techniques Access via wind farm track network</p>

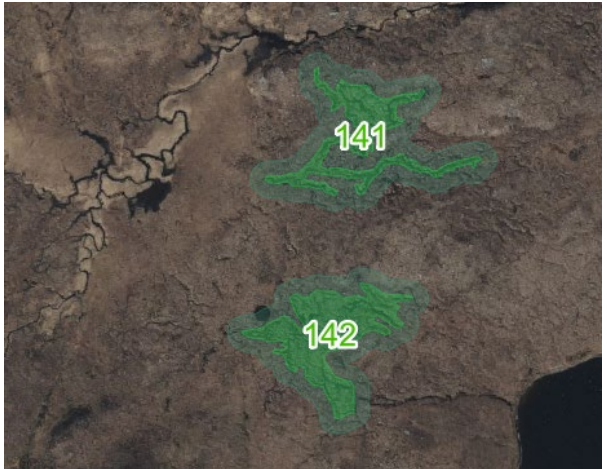
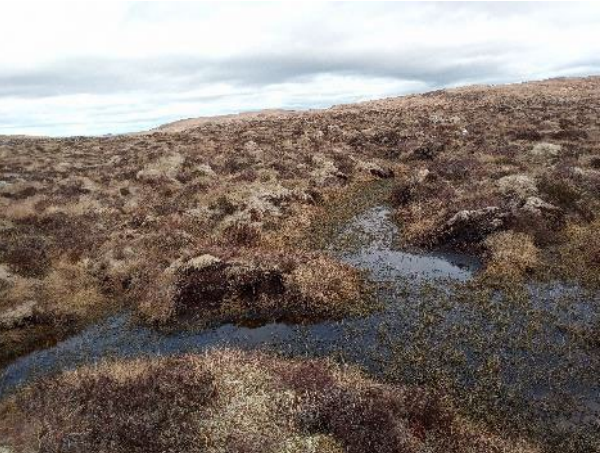
<p>Area ID: 141 Location: NH 38858 25350 Description: Bare peat erosional gullies draining bog pool habitat north towards watercourse. Area: 2,400 m²</p>	<p>Repair of eroded / bare areas using machine-based techniques Access via wind farm track network</p>

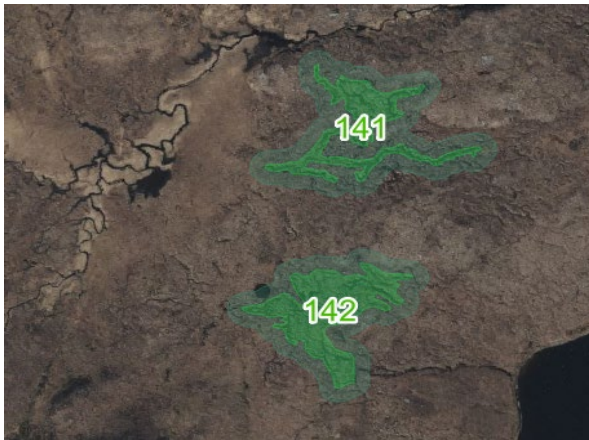
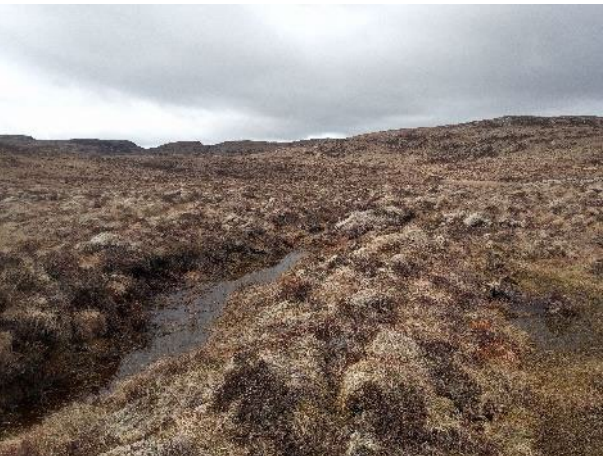
Area ID and Description	Recommended Restoration Techniques	Images	
<p>Area ID: 142 Location: NH 38837 25217 Description: Erosional features draining bog pool rich habitat east towards loch. Area: 3,568 m²</p>	<p>Repair of eroded / bare areas using machine-based techniques Access via wind farm track network</p>

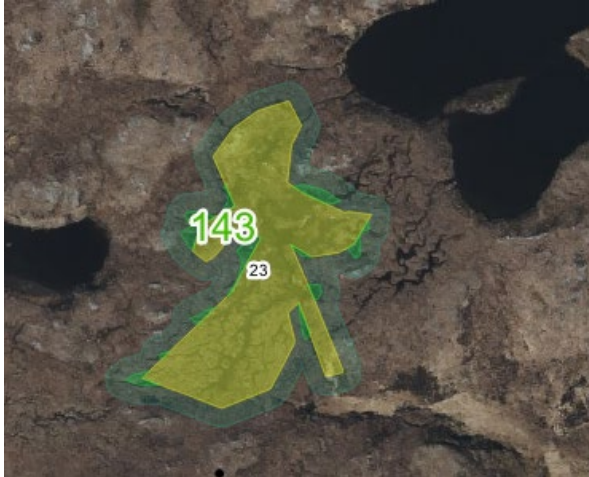
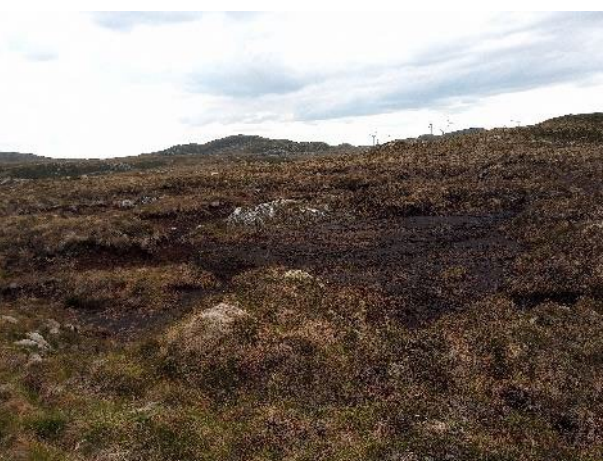
<p>Area ID: 143 Location: NH 38488 24351 Description: Continuation of habitat identified in EIA report. Extensive bare peat area drains north-east towards lochan. Area: 667 m²</p>	<p>Repair of eroded / bare areas using machine-based techniques Access via wind farm track network</p>

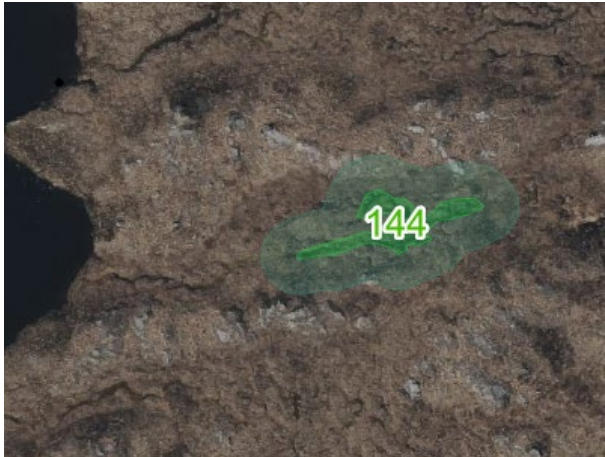
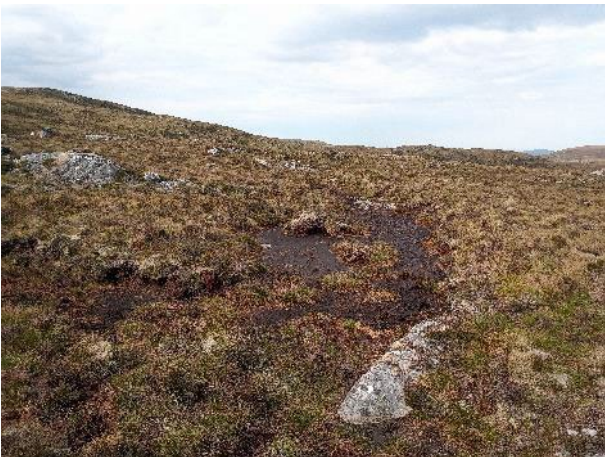
Area ID and Description	Recommended Restoration Techniques	Images	
<p>Area ID: 144 Location: NH 38770 24442 Description: Network of erosional gullies with bare peat exposed at base. Area: 328 m²</p>	<p>Repair of eroded / bare areas using machine-based techniques Access via wind farm track network</p>

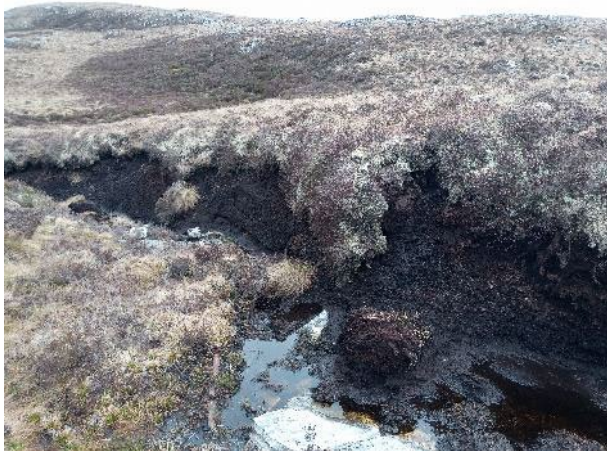
Area ID and Description	Recommended Restoration Techniques	Images	
<p>Area ID: 146 Location: NH 39041 23832 Description: Continuation of area identified in EIA report. Large erosional feature suitable for restoration with up to 2 m deep peat exposures. Area: 1,662 m²</p>	<p>Repair of eroded / bare areas using machine-based techniques Access via non wind farm tracks</p>

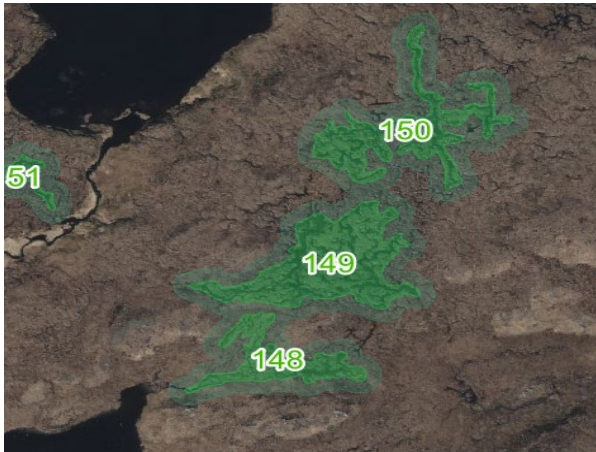
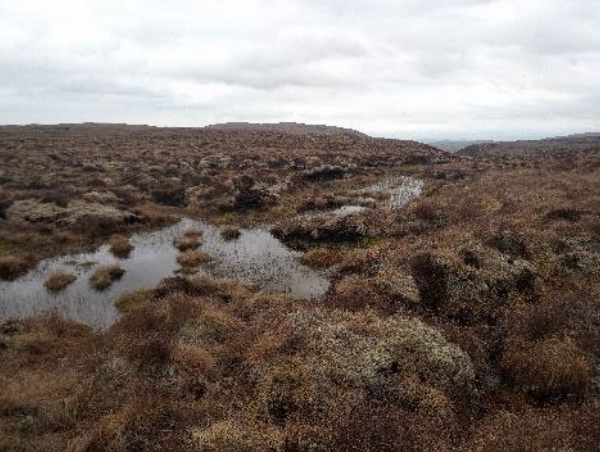
Area ID and Description	Recommended Restoration Techniques	Images	
<p>Area ID: 148</p> <p>Location: NH 39279 24434</p> <p>Description: Dendritic erosional features with large amount of bare peat present across area.</p> <p>Area: 2,269 m²</p>	<p>Repair of eroded / bare areas using machine-based techniques</p> <p>Access via non wind farm tracks</p>

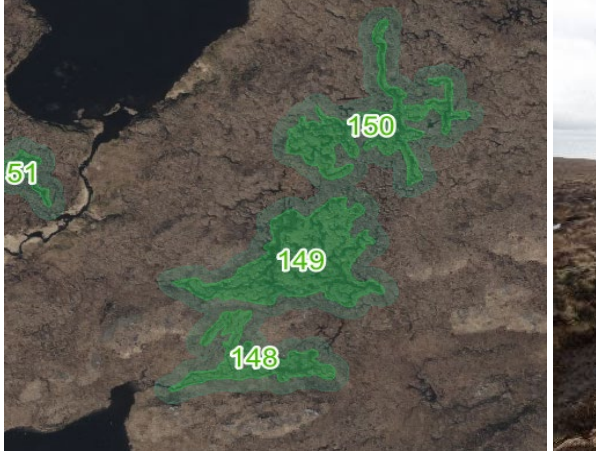
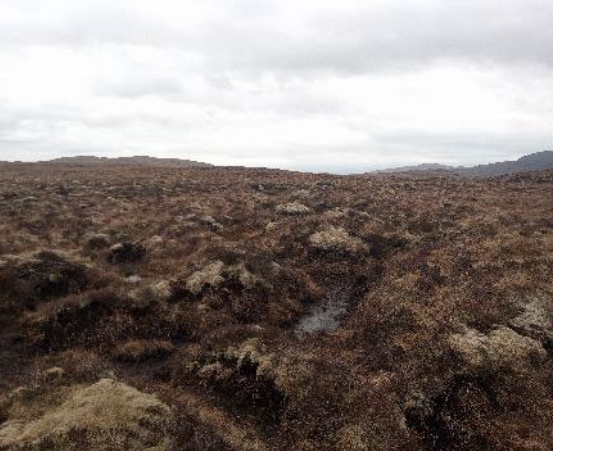
<p>Area ID: 149</p> <p>Location: NH 39314 24515</p> <p>Description: Dendritic erosional features with large amount of bare peat present across area.</p> <p>Area: 6,399 m²</p>	<p>Repair of eroded / bare areas using machine-based techniques</p> <p>Access via non wind farm tracks</p>

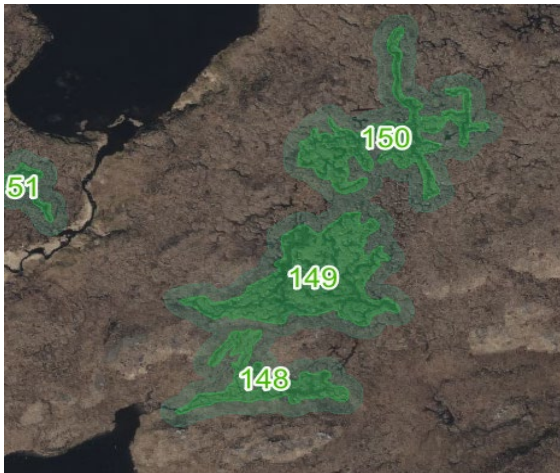
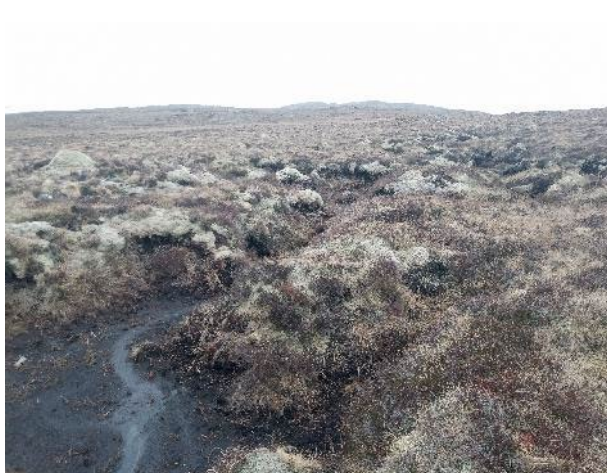
Area ID and Description	Recommended Restoration Techniques	Images	
<p>Area ID: 150 Location: NH 39366 24626 Description: Dendritic erosional features with large amount of bare peat present across area. Area: 4,344 m²</p>	<p>Repair of eroded / bare areas using machine-based techniques Access via non wind farm tracks</p>

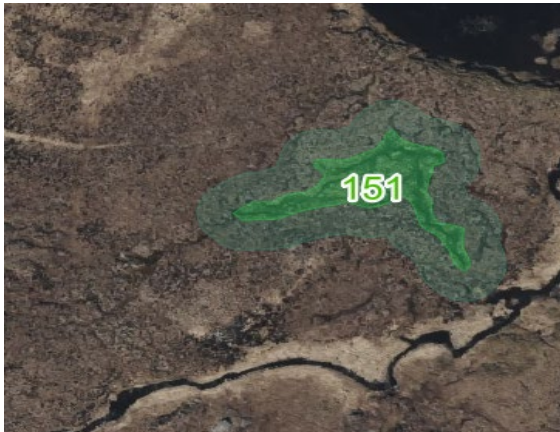
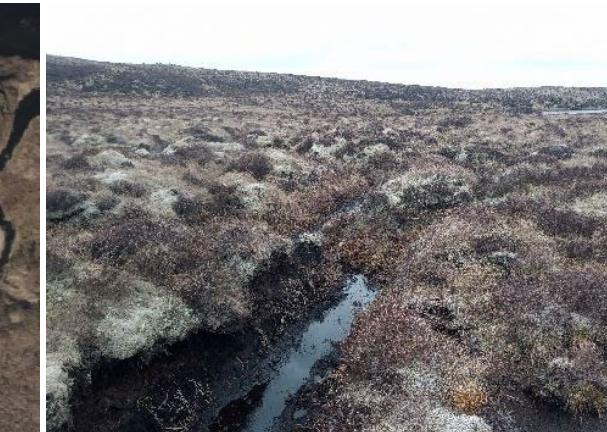
<p>Area ID: 151 Location: NH 39101 24587 Description: Dendritic erosional features with large amount of bare peat present across area. Area: 854 m²</p>	<p>Repair of eroded / bare areas using machine-based techniques Access via non wind farm tracks</p>

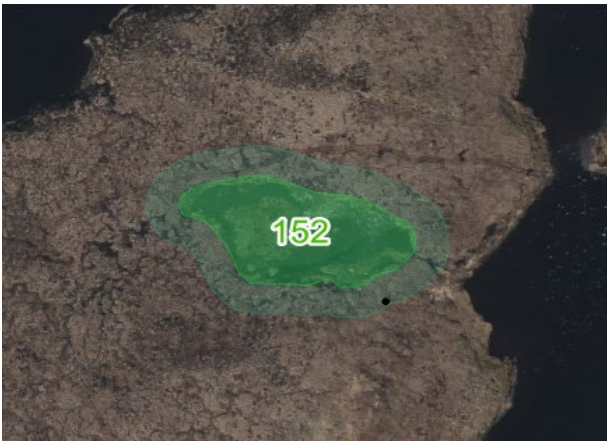
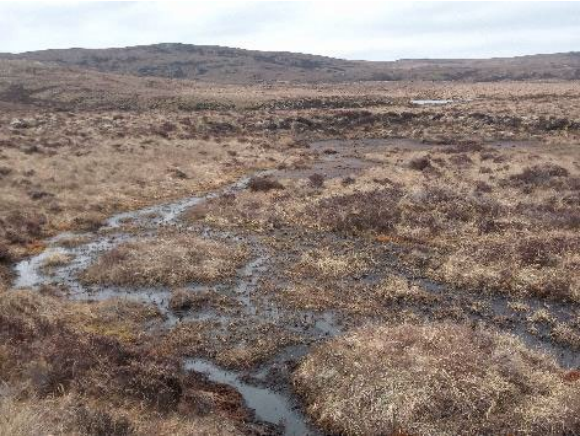
Area ID and Description	Recommended Restoration Techniques	Images	
<p>Area ID: 152</p> <p>Location: NH 39172 24907</p> <p>Description: Extensive bare peat area, likely former surface water body draining towards lochan via channel to east.</p> <p>Area: 1,859 m²</p>	<p>Repair of eroded / bare areas using machine-based techniques</p> <p>Access via non wind farm tracks</p>

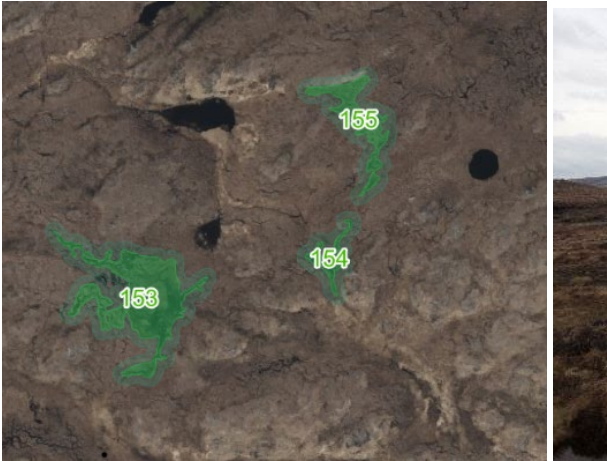
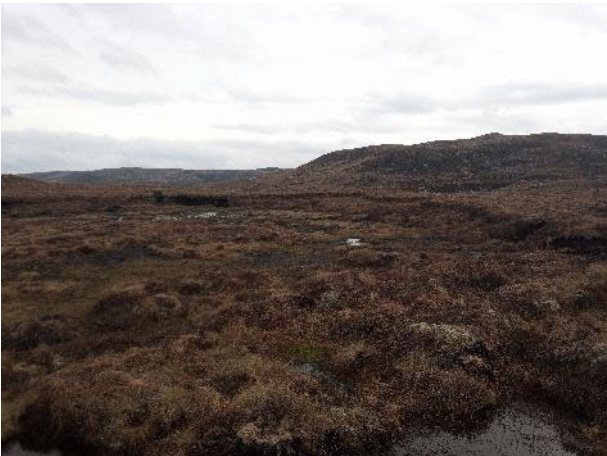
<p>Area ID: 153</p> <p>Location: NH 39630 24891</p> <p>Description: Large area impacted by peat erosion. Bog pool features present at west of area with dendritic erosional channels leading towards large bare peat area in east with peat exposures up to 2 m deep.</p> <p>Area: 9,263 m²</p>	<p>Repair of eroded / bare areas using machine-based techniques</p> <p>Access via non wind farm tracks</p>

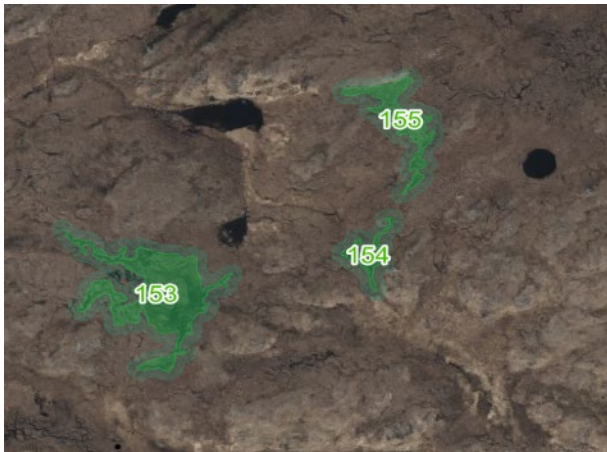
Area ID and Description	Recommended Restoration Techniques	Images	
<p>Area ID: 154</p> <p>Location: NH 39860 24939</p> <p>Description: Network of erosional features with extensive bare peat draining to south; drains bog pool network to west.</p> <p>Area: 950 m²</p>	<p>Repair of eroded / bare areas using machine-based techniques</p> <p>Access via non wind farm tracks</p>
