SEI Appendix D: Additional Potential Restoration Areas

Table 1 – Summary of Additional Potential Restoration Areas

Table 2 – Additional Potential Restoration Areas

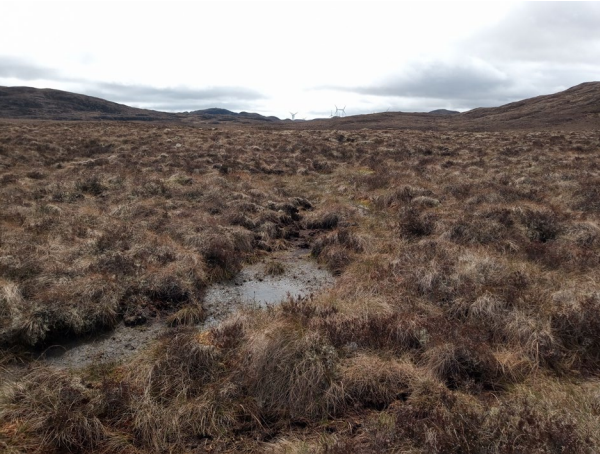
Area ID and Description	Recommended Restoration Techniques	Images	
<p>Area ID: 156</p> <p>Location: NH 39379 25415</p> <p>Description: Shallow dendritic erosional features drained by channel to north within dry modified bog. Some bog pools present in vicinity of features, threatened by ongoing erosion.</p> <p>Area: 1,863 m²</p>	<p>Repair of eroded / bare areas using machine-based techniques</p> <p>Access via non wind farm tracks</p>

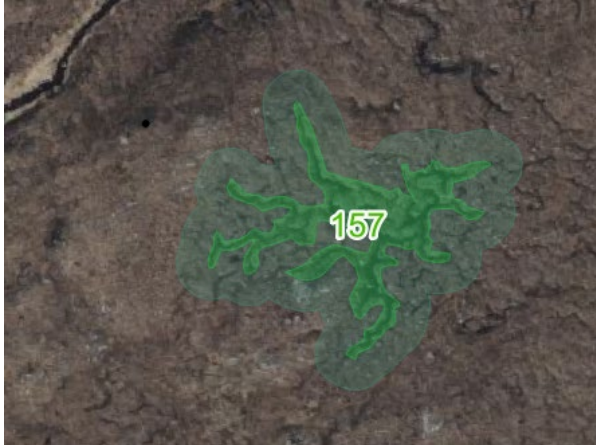
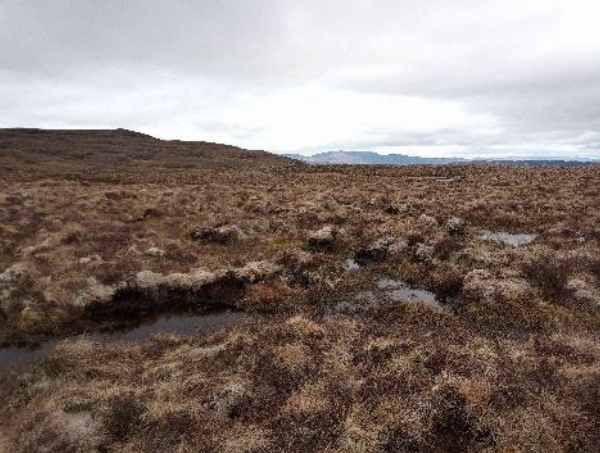
<p>Area ID: 157</p> <p>Location: NH 39481 25687</p> <p>Description: Erosional features in early stages of erosional; likely will form larger erosional gullies similar to those typical within Site without intervention. Bare peat visible in walls of drainage channels.</p> <p>Area: 1,721 m²</p>	<p>Repair of eroded / bare areas using machine-based techniques</p> <p>Access via non wind farm tracks</p>

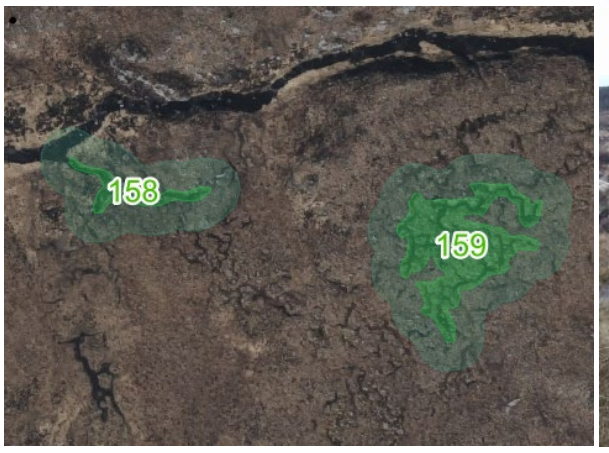
<p>Area ID: 159 Location: NH 39401 25929 Description: Bog pool network eroding via shallow erosional features with bare peat visible. Area: 1,260 m²</p>	<p>Repair of eroded / bare areas using machine-based techniques Access via non wind farm tracks</p>

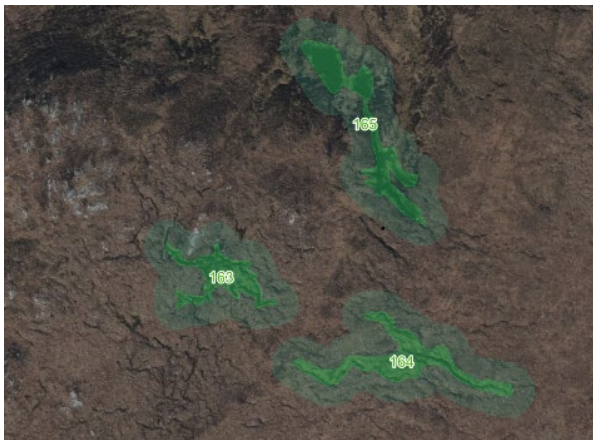
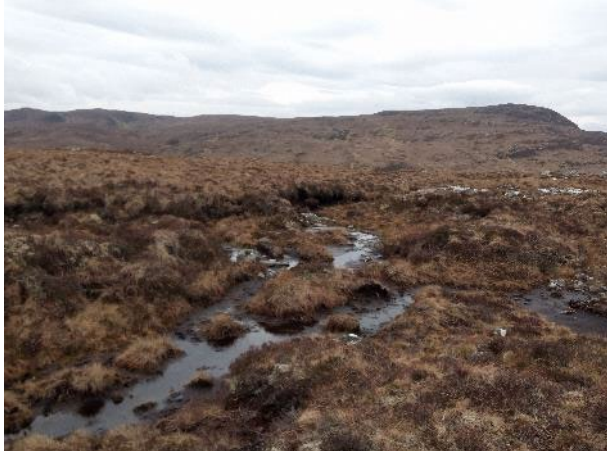
Area ID and Description	Recommended Restoration Techniques	Images	
<p>Area ID: 163</p> <p>Location: NH 40006 26726</p> <p>Description: Network of erosional features with extensive bare peat areas at break in slope at transition to wetter habitat on saddle of ridge.</p> <p>Area: 582 m²</p>	<p>Repair of eroded / bare areas using machine-based techniques</p> <p>Access via non wind farm tracks</p>

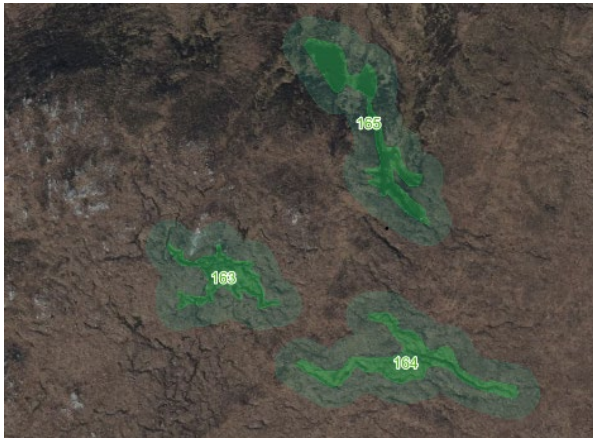
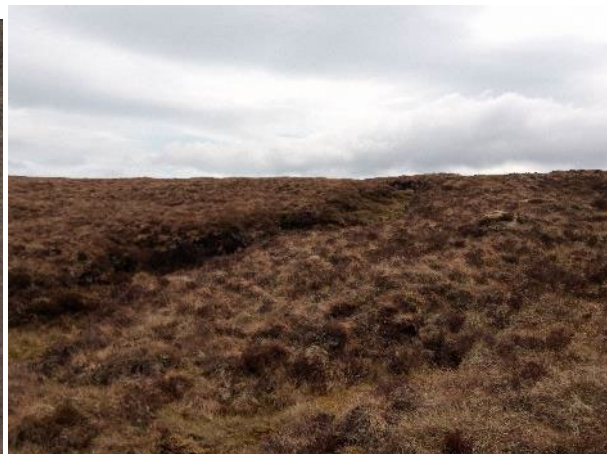
<p>Area ID: 164</p> <p>Location: NH 40093 26685</p> <p>Description: Old erosional gully with some bare peat exposed within very dry modified bog habitat.</p> <p>Area: 947 m²</p>	<p>Repair of eroded / bare areas using machine-based techniques</p> <p>Access via non wind farm tracks</p>

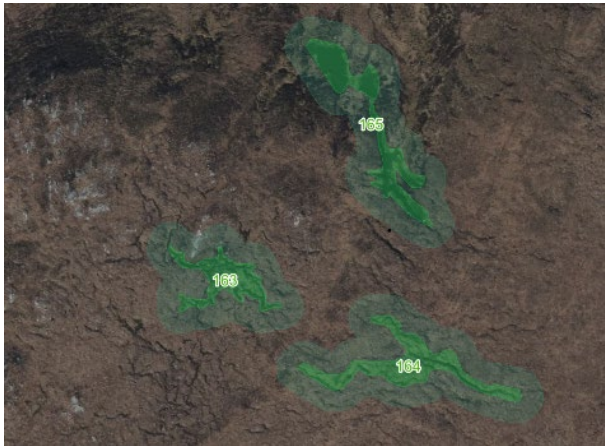
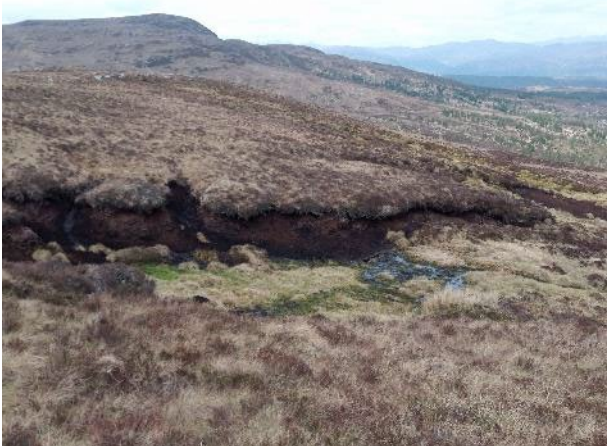
Area ID and Description	Recommended Restoration Techniques	Images	
<p>Area ID: 165 Location: NH 40075 26799 Description: Large peat hag >2 m in depth draining north via watercourse channel. Area: 921 m²</p>	<p>Repair of eroded / bare areas using machine-based techniques Access via non wind farm tracks</p>

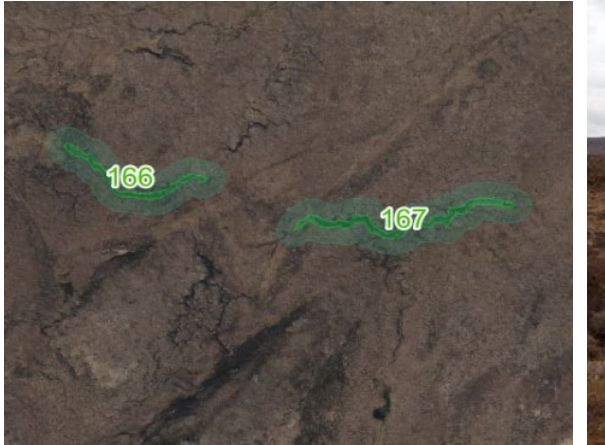
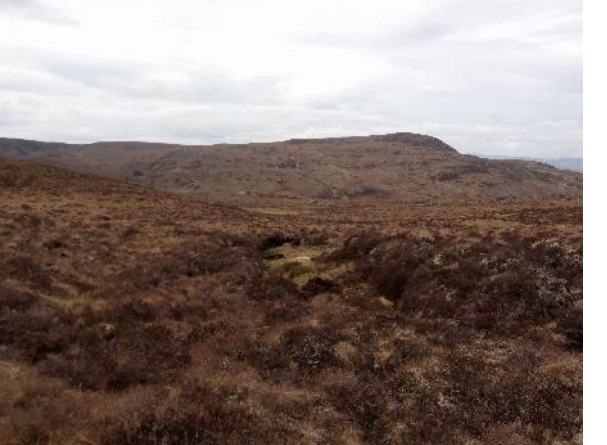
<p>Area ID: 166 Location: NH 40155 26537 Description: Erosional gully with evidence of recent wall collapse. Area: 364 m²</p>	<p>Repair of eroded / bare areas using machine-based techniques Access via non wind farm tracks</p>

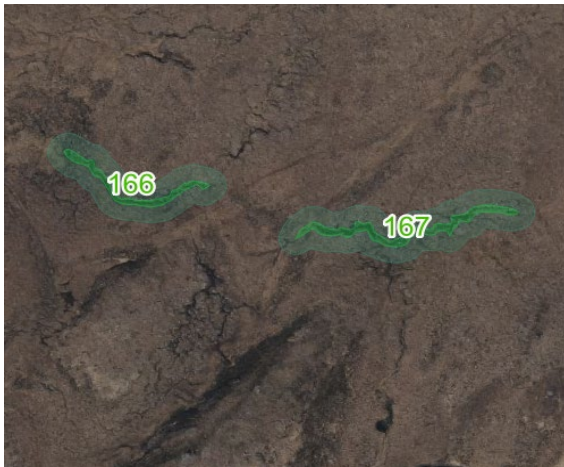
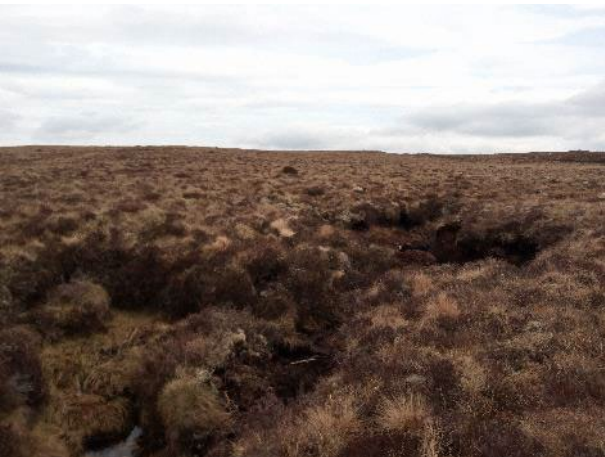
Area ID and Description	Recommended Restoration Techniques	Images	
<p>Area ID: 167 Location: NH 40320 26509 Description: Erosional gully with bare peat exposures. Area: 632 m²</p>	<p>Repair of eroded / bare areas using machine-based techniques Access via non wind farm tracks</p>

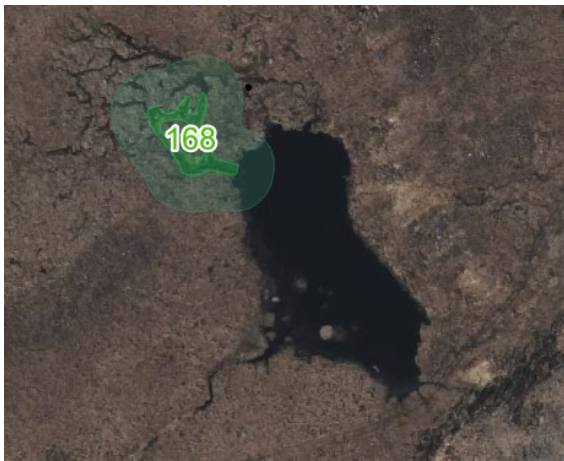
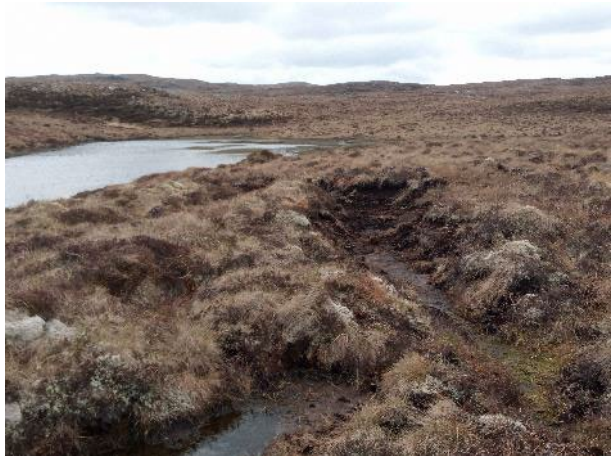
<p>Area ID: 168 Location: NH 40480 26478 Description: Erosional gully adjacent to lochan draining bog pool habitat to north-west. Area: 185 m²</p>	<p>Repair of eroded / bare areas using machine-based techniques Access via non wind farm tracks</p>

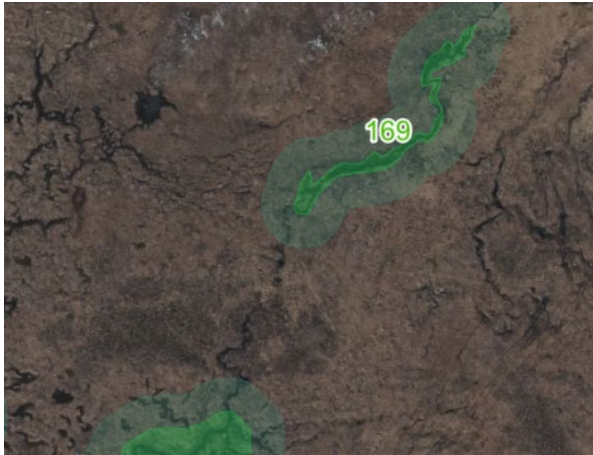
Area ID and Description	Recommended Restoration Techniques	Images	
<p>Area ID: 169 Location: NH 40797 27153 Description: Erosional gully with extensive dry bare peat exposures. Area: 316 m²</p>	<p>Repair of eroded / bare areas using machine-based techniques Access via non wind farm tracks</p>

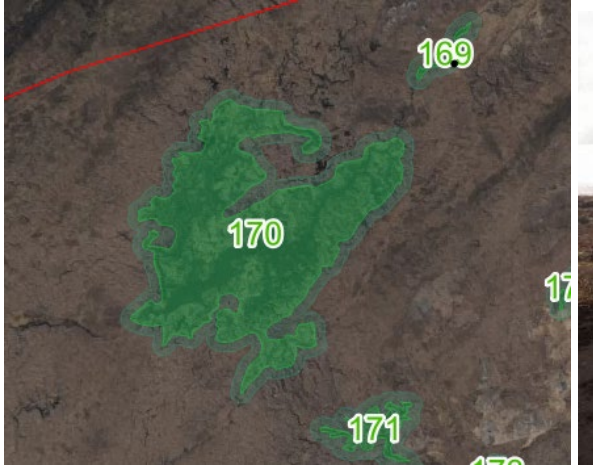
<p>Area ID: 170 Location: NH 40601 26967 Description: Large eroded area with extensive bare peat exposures and ongoing lowering of water table via erosional gullies around periphery of area. Area: 37,217 m²</p>	<p>Repair of eroded / bare areas using machine-based techniques Access via non wind farm tracks</p>

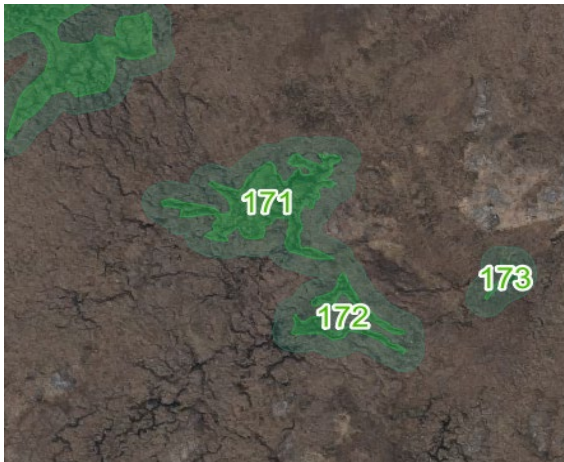
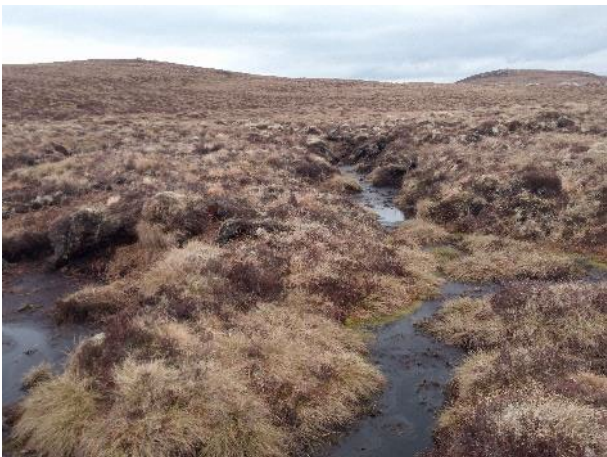
Area ID and Description	Recommended Restoration Techniques	Images	
<p>Area ID: 171 Location: NH 40725 26766 Description: Dendritic network of erosional features with bare peat exposures. Area: 2,056 m²</p>	<p>Repair of eroded / bare areas using machine-based techniques Access via non wind farm tracks</p>

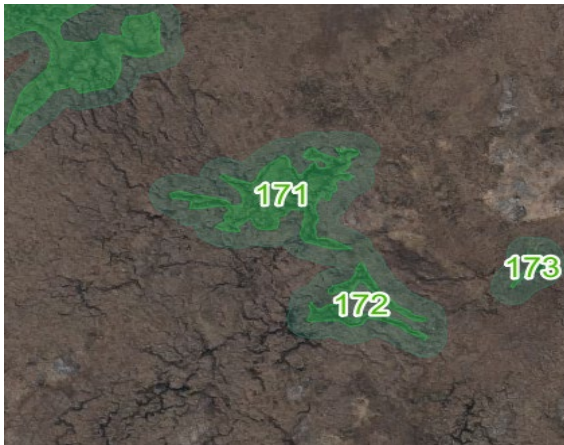
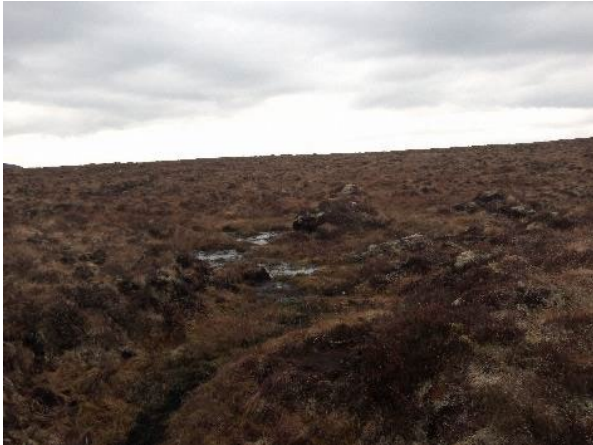
<p>Area ID: 172 Location: NH 40764 26700 Description: Dendritic network of erosional features with bare peat exposures. Area: 603 m²</p>	<p>Repair of eroded / bare areas using machine-based techniques Access via non wind farm tracks</p>

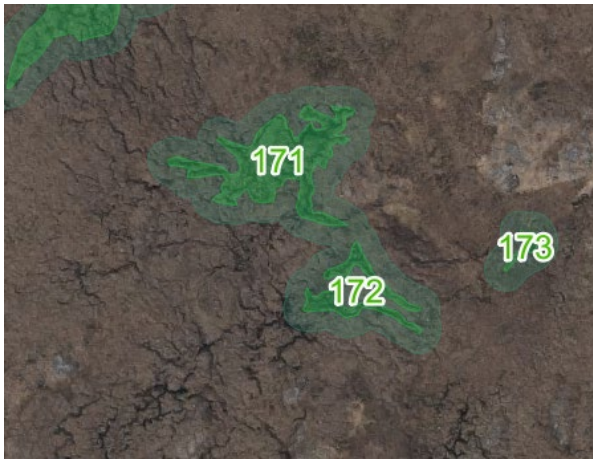
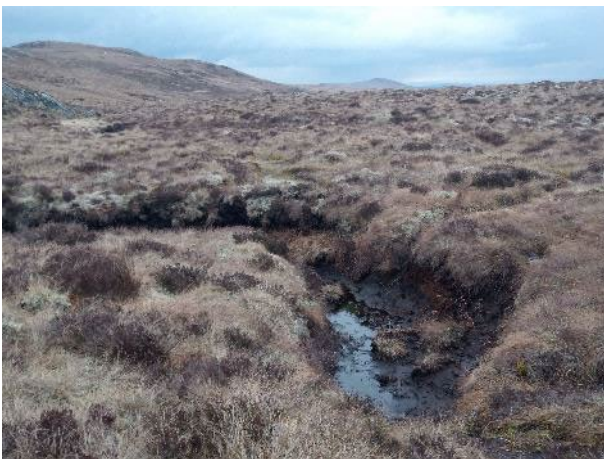
Area ID and Description	Recommended Restoration Techniques	Images	
<p>Area ID: 173 Location: NH 40851 26722 Description: Erosional feature with bare peat exposures and peat pipes. Area: 82 m²</p>	<p>Repair of eroded / bare areas using machine-based techniques Access via non wind farm tracks</p>

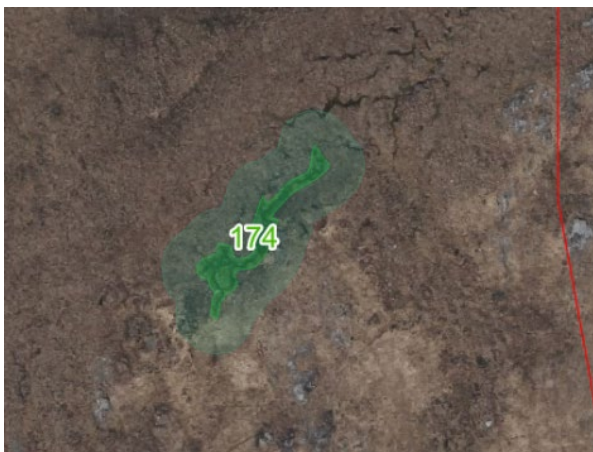
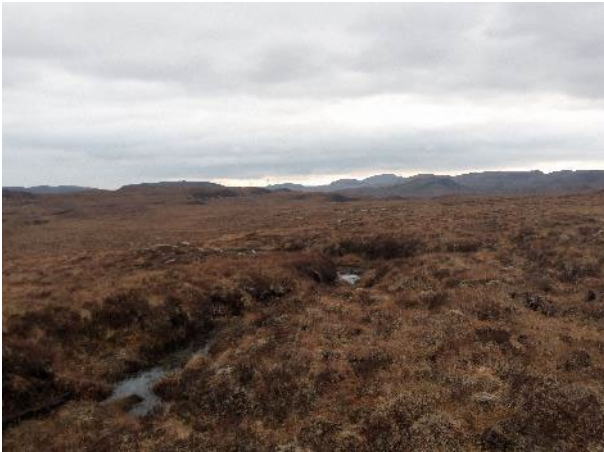
<p>Area ID: 174 Location: NH 40928 26912 Description: Erosional gully with bare peat exposures and evidence of recent wall collapse. Area: 310 m²</p>	<p>Repair of eroded / bare areas using machine-based techniques Access via non wind farm tracks</p>

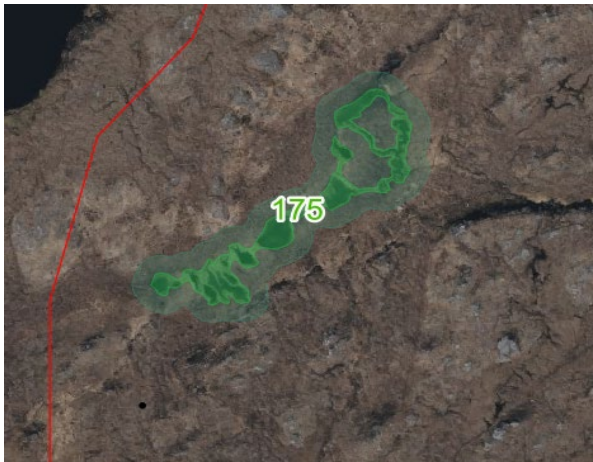
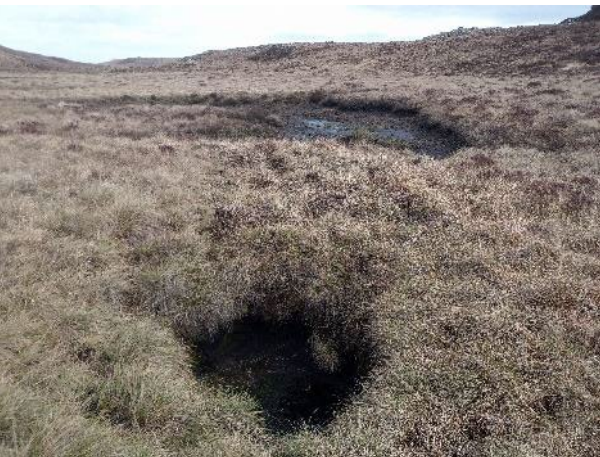
Area ID and Description	Recommended Restoration Techniques	Images	
<p>Area ID: 175 Location: NH 41058 26391 Description: Dry lochans with extensive bare peat. Evidence of ongoing erosion through bank collapse and peat pipes connecting bare peat areas. Area: 2,342 m²</p>	<p>Repair of eroded / bare areas using machine-based techniques Access via non wind farm tracks</p>

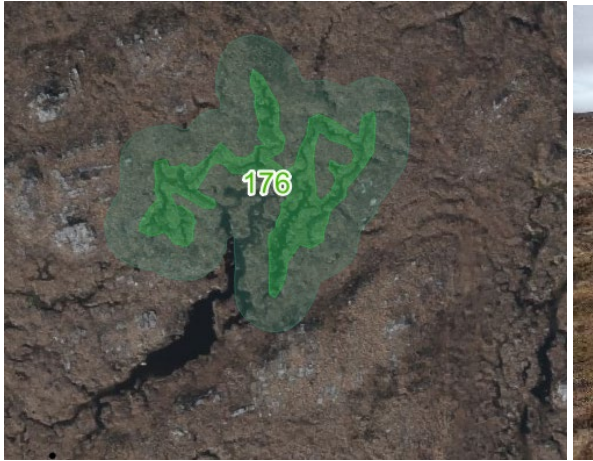
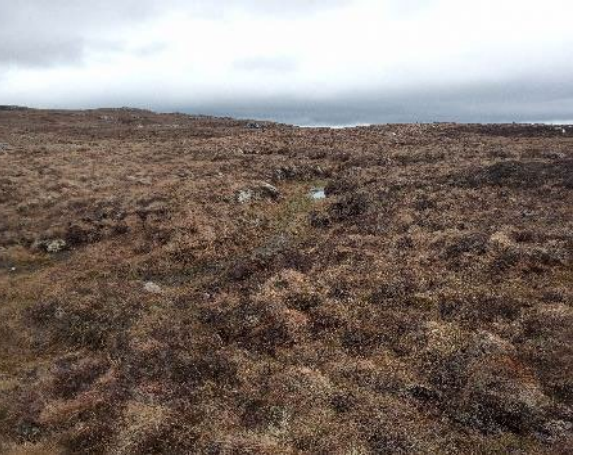
<p>Area ID: 176 Location: NH 40481 25899 Description: Erosional gullies with ongoing surface water drainage and bare peat exposures. Area: 1,142 m²</p>	<p>Repair of eroded / bare areas using machine-based techniques Access via non wind farm tracks</p>

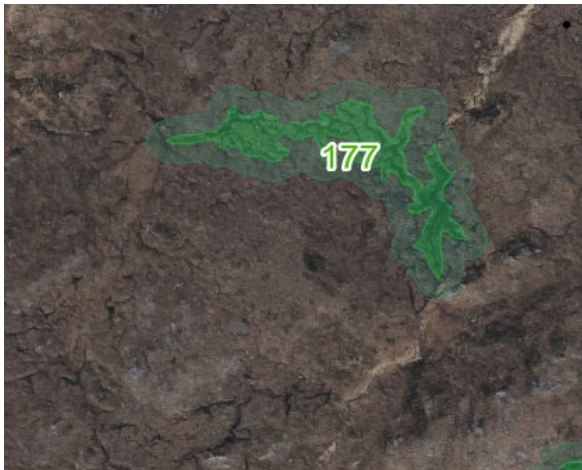
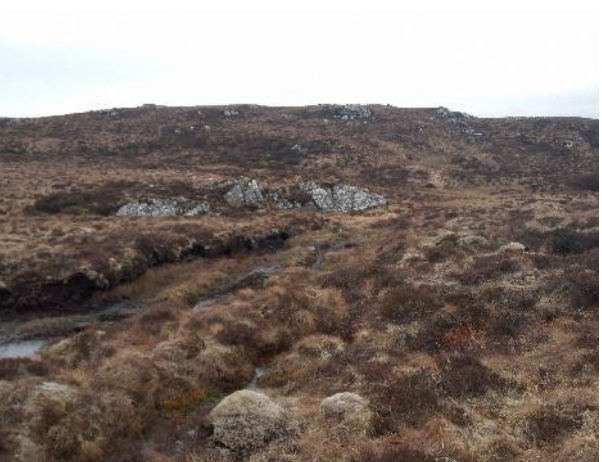
Area ID and Description	Recommended Restoration Techniques	Images	
<p>Area ID: 177</p> <p>Location: NH 40691 26062</p> <p>Description: Erosional features with bare peat exposures and evidence of recent wall collapse draining to watercourse north-east.</p> <p>Area: 2,643 m²</p>	<p>Repair of eroded / bare areas using machine-based techniques</p> <p>Access via non wind farm tracks</p>

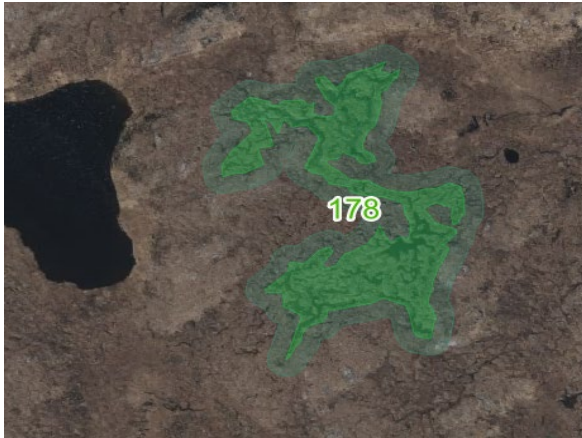
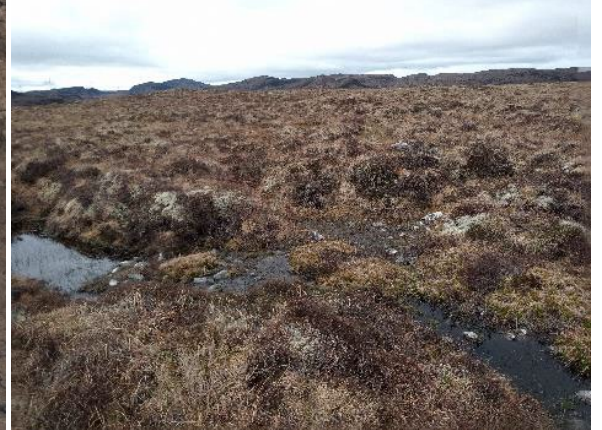
<p>Area ID: 178</p> <p>Location: NH 40230 25485</p> <p>Description: Large network of erosional features with bare peat exposures and ongoing peat erosion. Threatening bog pool habitats adjacent to features.</p> <p>Area: 7,095 m²</p>	<p>Repair of eroded / bare areas using machine-based techniques</p> <p>Access via non wind farm tracks</p>

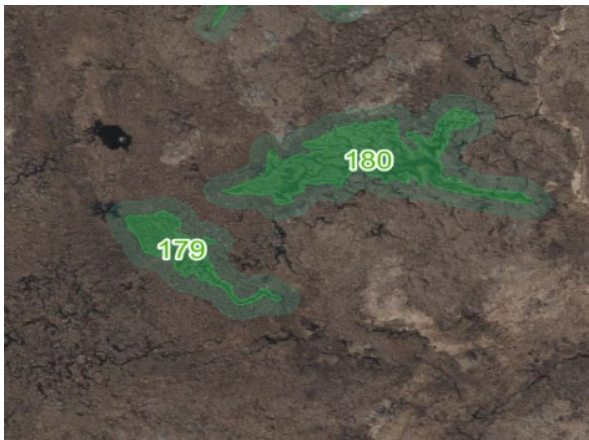
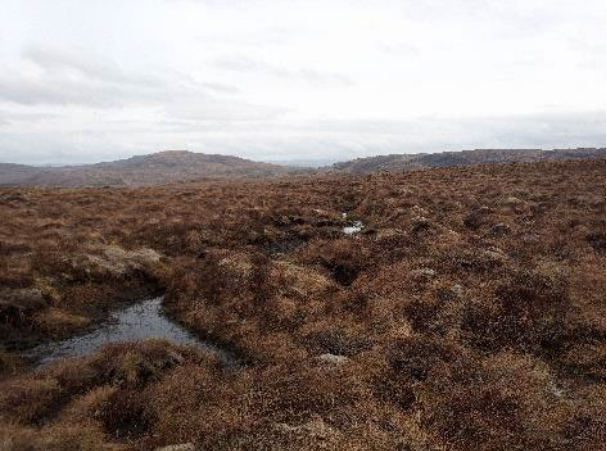
Area ID and Description	Recommended Restoration Techniques	Images	
<p>Area ID: 179 Location: NH4017525237 Description: Relatively shallow erosional features draining bog pool habitat to west with bare peat and evidence of ongoing peat erosion. Area: 1,439 m²</p>	<p>Repair of eroded / bare areas using machine-based techniques Access via non wind farm tracks</p>

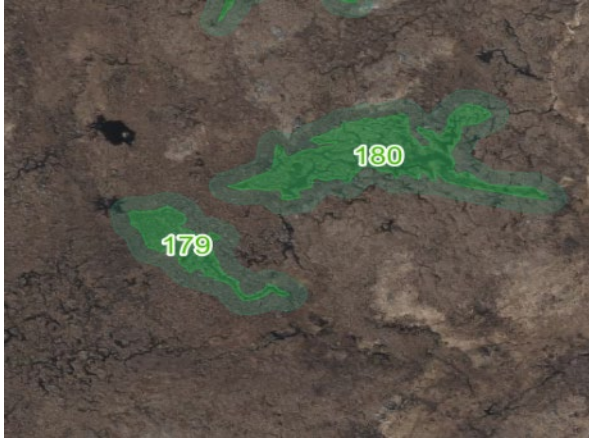
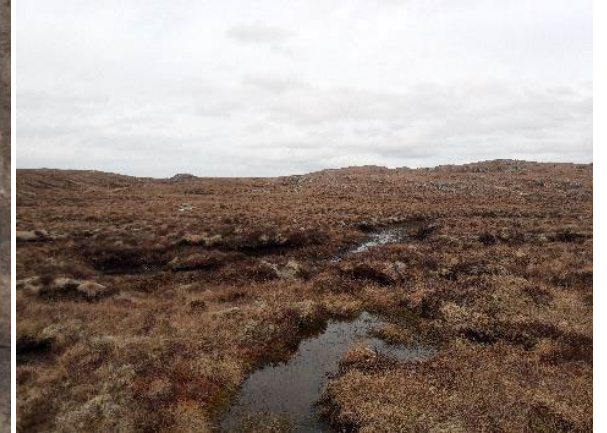
<p>Area ID: 180 Location: NH4028425300 Description: Dendritic erosional features draining via erosional gullies up to 1.5m deep. Area: 4,135 m²</p>	<p>Repair of eroded / bare areas using machine-based techniques Access via non wind farm tracks</p>

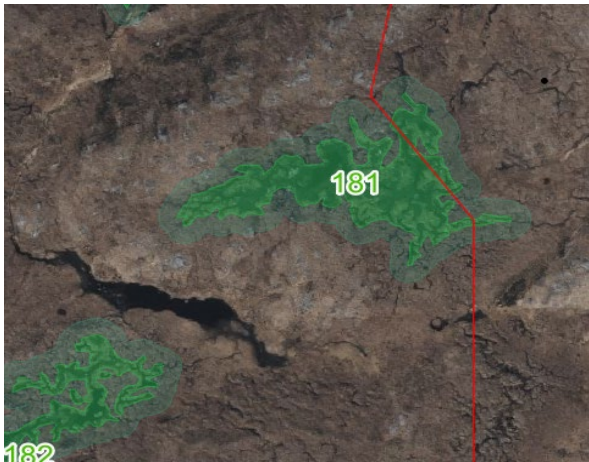
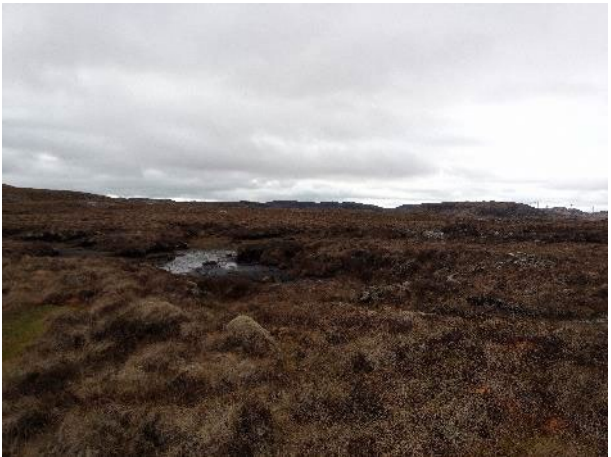
Area ID and Description	Recommended Restoration Techniques	Images	
<p>Area ID: 181</p> <p>Location: NH 40861 25891</p> <p>Description: Large eroded area with extensive bare peat exposures and evidence of ongoing erosion. Erosional features draining bog east of area.</p> <p>Area: 5,468 m²</p>	<p>Repair of eroded / bare areas using machine-based techniques</p> <p>Access via wind farm track network</p>

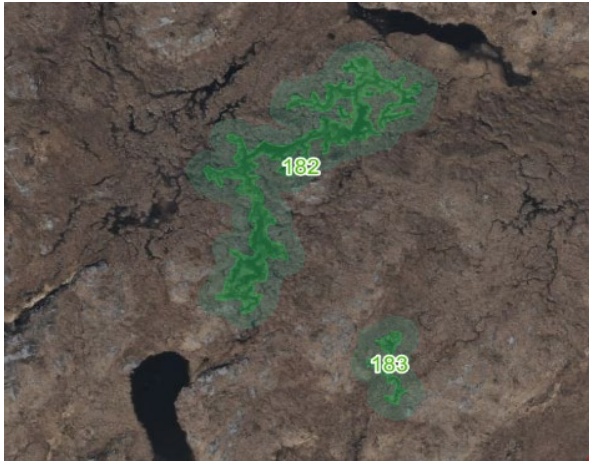
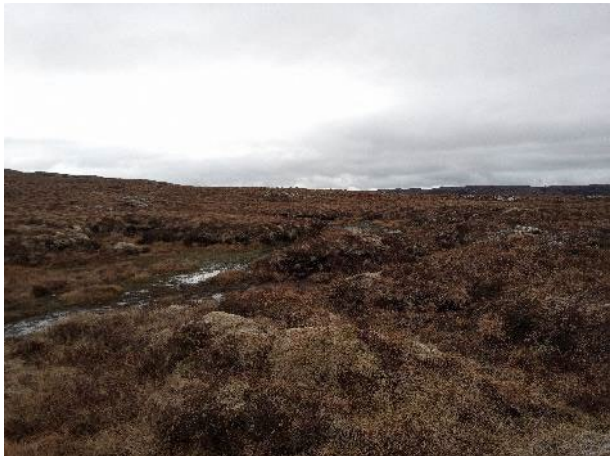
<p>Area ID: 182</p> <p>Location: NH 40680 25724</p> <p>Description: Dendritic network of erosional gullies with some surface water accumulation and extensive bare peat exposures.</p> <p>Area: 4,023 m²</p>	<p>Repair of eroded / bare areas using machine-based techniques</p> <p>Access via wind farm track network</p>

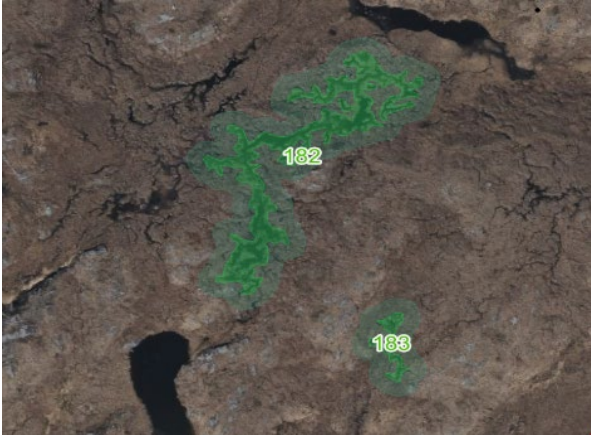
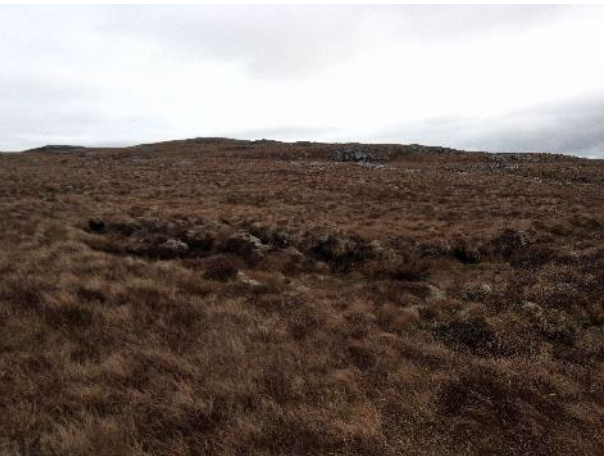
Area ID and Description	Recommended Restoration Techniques	Images	
<p>Area ID: 183</p> <p>Location: NH 40735 25590</p> <p>Description: Minor erosional feature within modified bog, well vegetated but evidence of ongoing drainage likely to contribute to further erosion.</p> <p>Area: 342 m²</p>	<p>Repair of eroded / bare areas using machine-based techniques</p> <p>Access via wind farm track network</p>

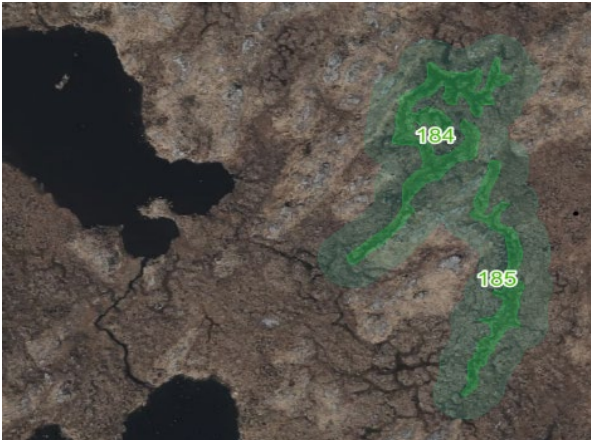
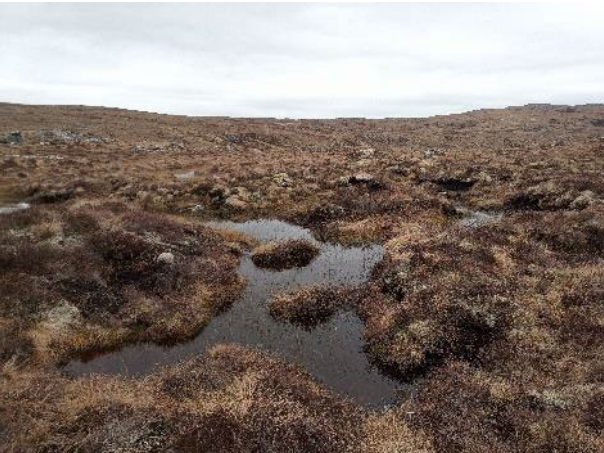
<p>Area ID: 184</p> <p>Location: NH 40331 24428</p> <p>Description: Shallow erosional features, well vegetated with surface water accumulation in pools. Evidence that surface water drainage is ongoing towards lochan. Bare peat exposures within features.</p> <p>Area: 1,035 m²</p>	<p>Repair of eroded / bare areas using machine-based techniques</p> <p>Access via wind farm track network</p>

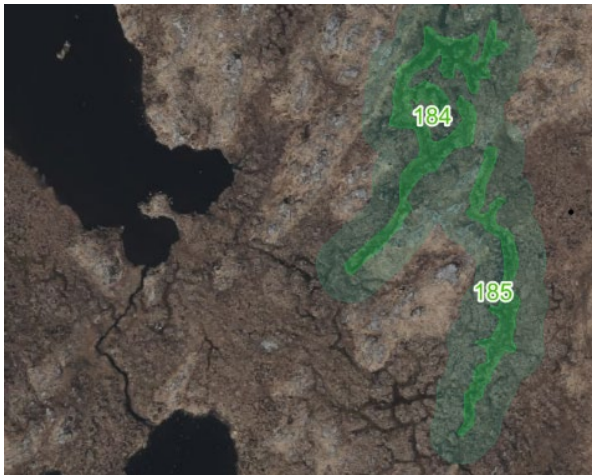
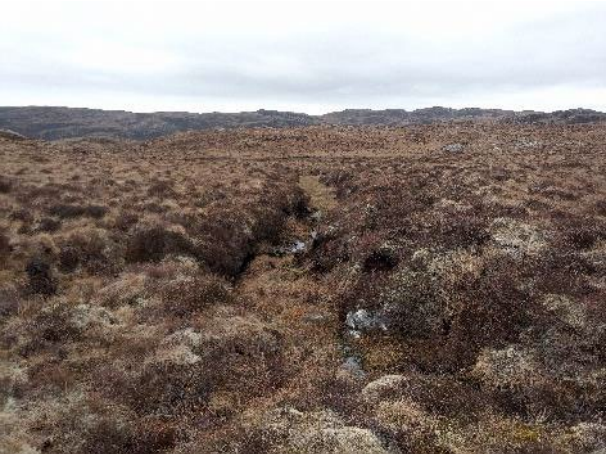
Area ID and Description	Recommended Restoration Techniques	Images	
<p>Area ID: 185</p> <p>Location: NH 40353 24364</p> <p>Description: Erosional gully, generally vegetated at base with bare peat exposures in walls.</p> <p>Area: 561 m²</p>	<p>Repair of eroded / bare areas using machine-based techniques</p> <p>Access via wind farm track network</p>

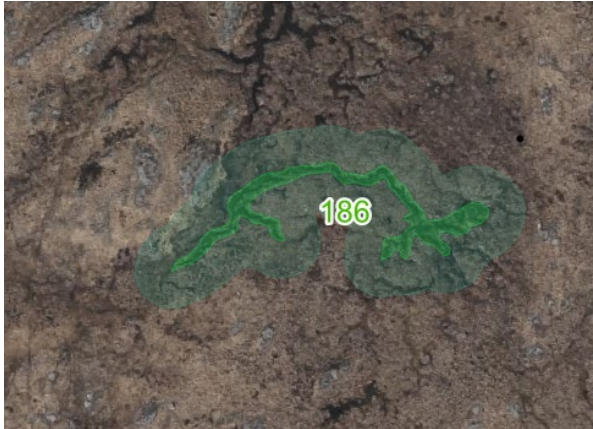
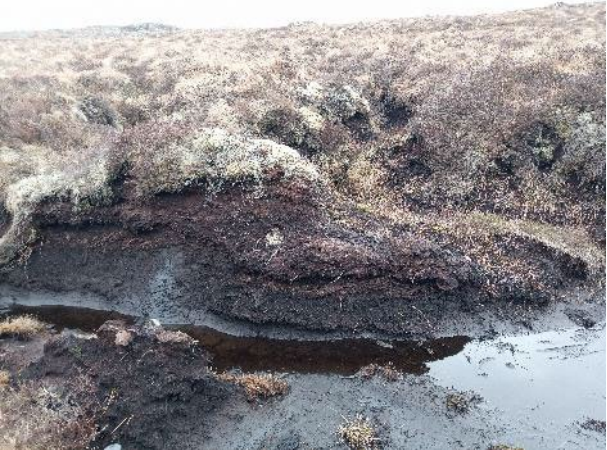
<p>Area ID: 186</p> <p>Location: NH 40484 24421</p> <p>Description: Erosional gullies with ongoing surface water drainage in base of features and extensive bare peat exposures up to 1.2 m deep.</p> <p>Area: 475 m²</p>	<p>Repair of eroded / bare areas using machine-based techniques</p> <p>Access via wind farm track network</p>

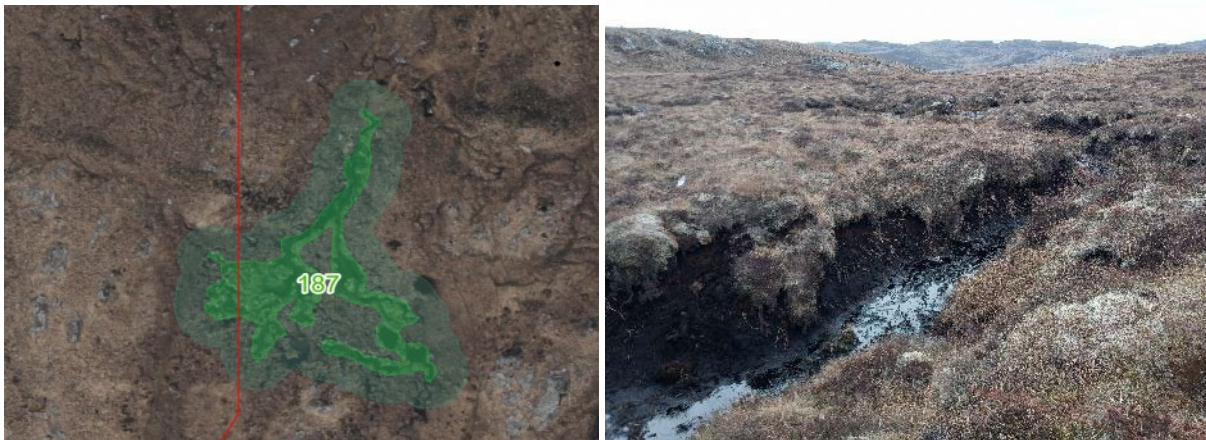
Area ID and Description	Recommended Restoration Techniques	Images	
<p>Area ID: 187</p> <p>Location: NH 40654 24506</p> <p>Description: Erosional gullies with extensive bare peat exposures and surface water drainage in base of features, evidence of recent wall collapse.</p> <p>Area: 1,766 m²</p>	<p>Repair of eroded / bare areas using machine-based techniques</p> <p>Access via wind farm track network</p>

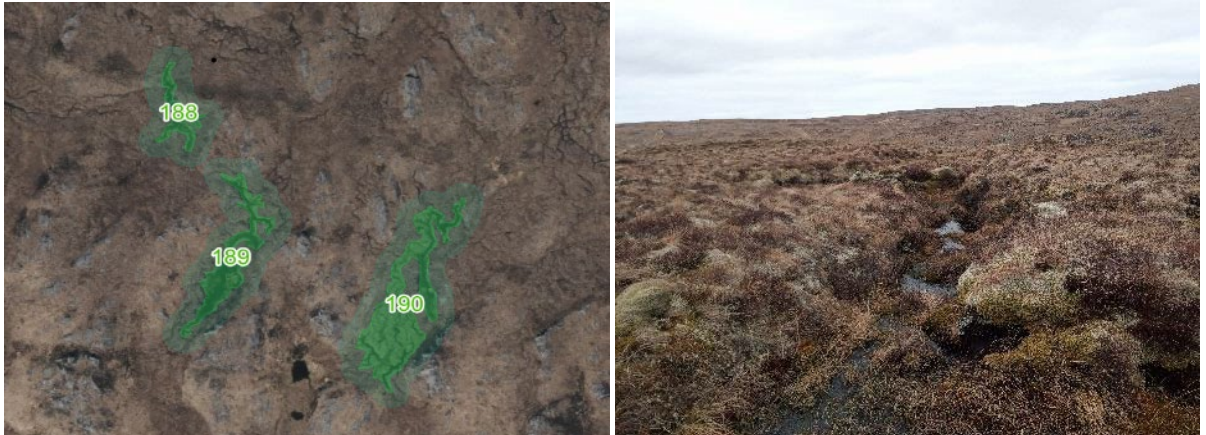
<p>Area ID: 188</p> <p>Location: NH 40859 24513</p> <p>Description: Erosional gully draining north, surface water accumulation and bog mosses within feature. Bare peat exposures upgradient.</p> <p>Area: 484 m²</p>	<p>Repair of eroded / bare areas using machine-based techniques</p> <p>Access via wind farm track network</p>

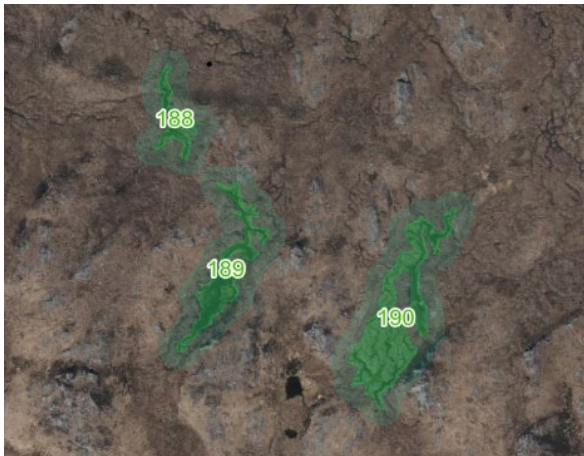
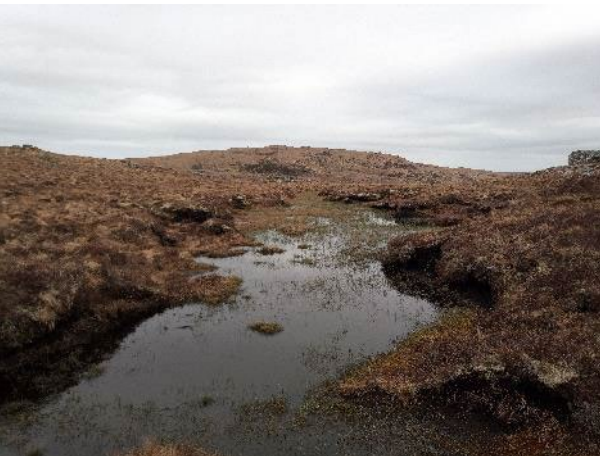
Area ID and Description	Recommended Restoration Techniques	Images	
<p>Area ID: 189</p> <p>Location: NH 40891 24415</p> <p>Description: Extensive eroded area with surface water accumulation. Bare peat exposures present within feature and signs of recent peat collapse at periphery of features.</p> <p>Area: 1,183 m²</p>	<p>Repair of eroded / bare areas using machine-based techniques</p> <p>Access via wind farm track network</p>

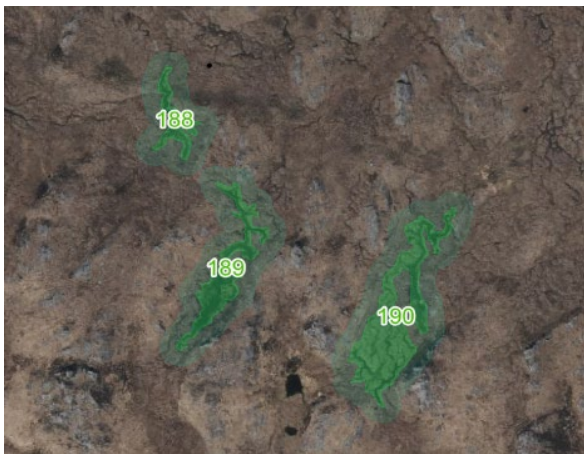
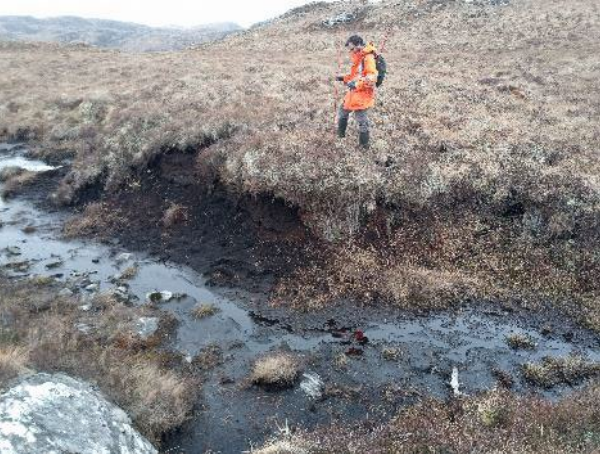
<p>Area ID: 190</p> <p>Location: NH 40996 24383</p> <p>Description: Eroded peat area 1-4 m wide and up to 1.5 m deep with visible surface water drainage in base of feature.</p> <p>Area: 2,515 m²</p>	<p>Repair of eroded / bare areas using machine-based techniques</p> <p>Access via wind farm track network</p>

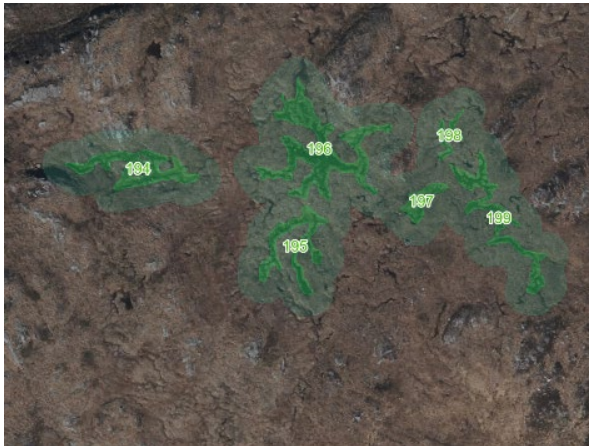
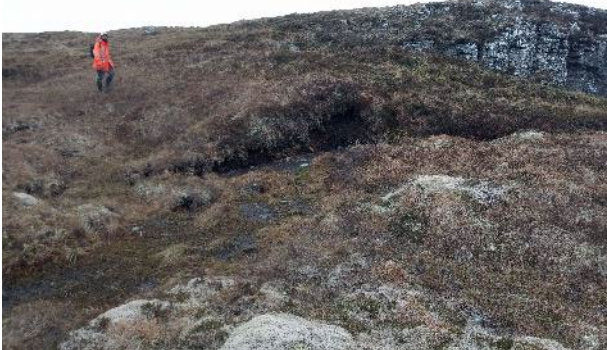
Area ID and Description	Recommended Restoration Techniques	Images	
<p>Area ID: 194</p> <p>Location: NH 41339 26036</p> <p>Description: Erosional gully with islands of peat remaining in centre, generally vegetated but exposures of peat present up to 1 m depth.</p> <p>Area: 458 m²</p>	<p>Repair of eroded / bare areas using machine-based techniques</p> <p>Access via wind farm track network</p>

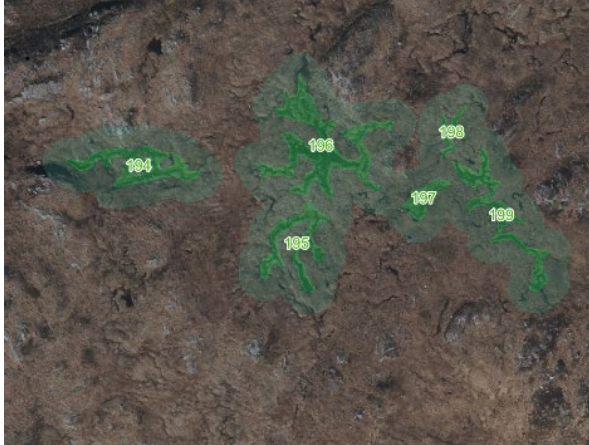
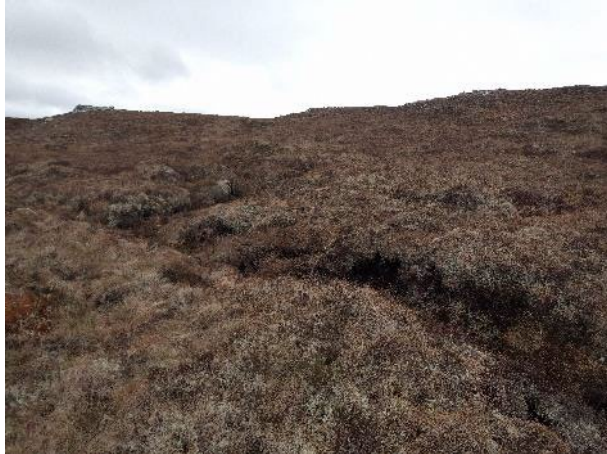
<p>Area ID: 195</p> <p>Location: NH 41413 26000</p> <p>Description: Erosional gully, mostly vegetated with some bare peat exposures. Bog pools nearby.</p> <p>Area: 385 m²</p>	<p>Repair of eroded / bare areas using machine-based techniques</p> <p>Access via wind farm track network</p>

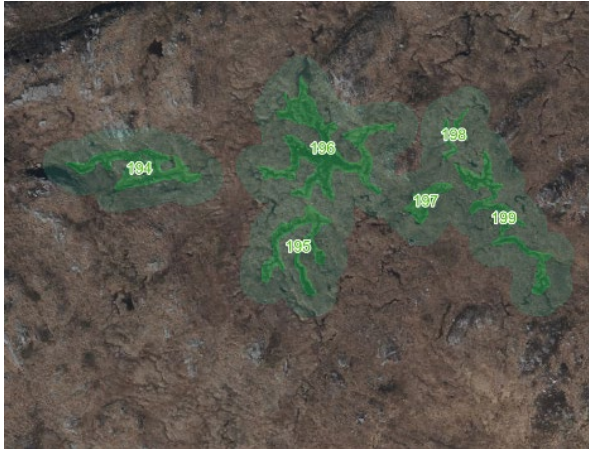
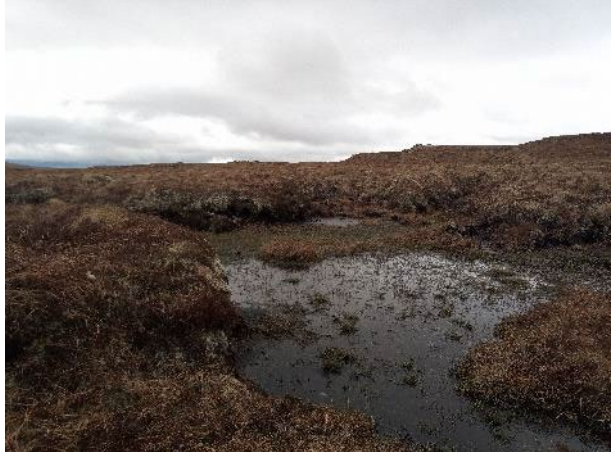
Area ID and Description	Recommended Restoration Techniques	Images	
<p>Area ID: 196</p> <p>Location: NH 41424 26045</p> <p>Description: Eroded area with extensive bare peat and surface water accumulation in base of feature.</p> <p>Area: 982 m²</p>	<p>Repair of eroded / bare areas using machine-based techniques</p> <p>Access via wind farm track network</p>

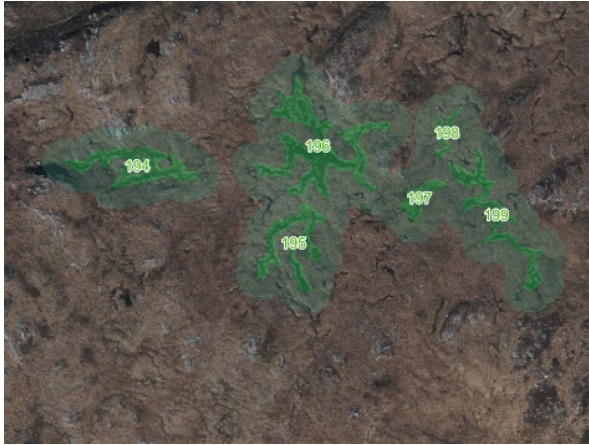
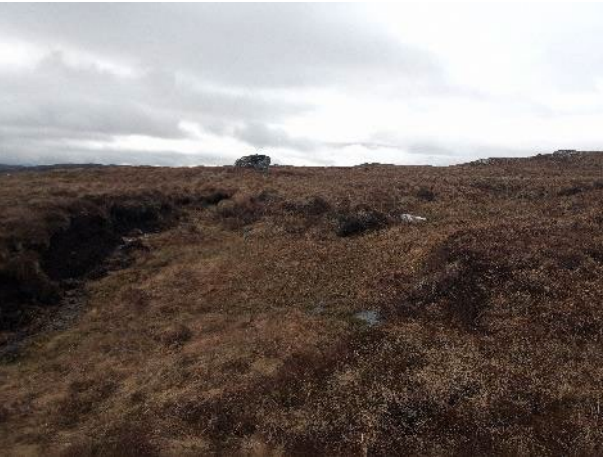
<p>Area ID: 197</p> <p>Location: NH 41473 26021</p> <p>Description: Erosional gully up to 4 m wide with 1.5 m deep dry peat exposure.</p> <p>Area: 158 m²</p>	<p>Repair of eroded / bare areas using machine-based techniques</p> <p>Access via wind farm track network</p>

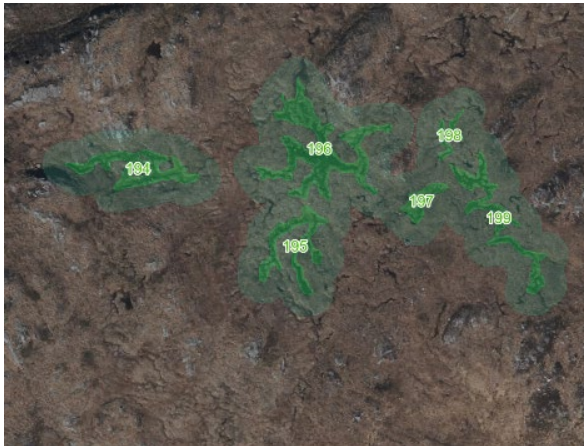
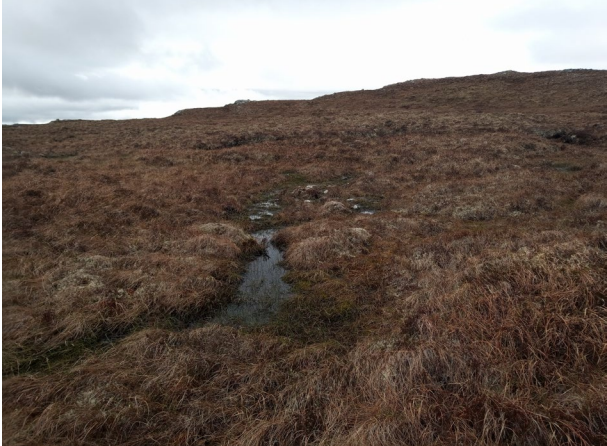
Area ID and Description	Recommended Restoration Techniques	Images	
<p>Area ID: 198</p> <p>Location: NH 41486 26052</p> <p>Description: Well vegetated erosional feature with bog pools in vicinity, draining north via erosional gully.</p> <p>Area: 93 m²</p>	<p>Repair of eroded / bare areas using machine-based techniques</p> <p>Access via wind farm track network</p>

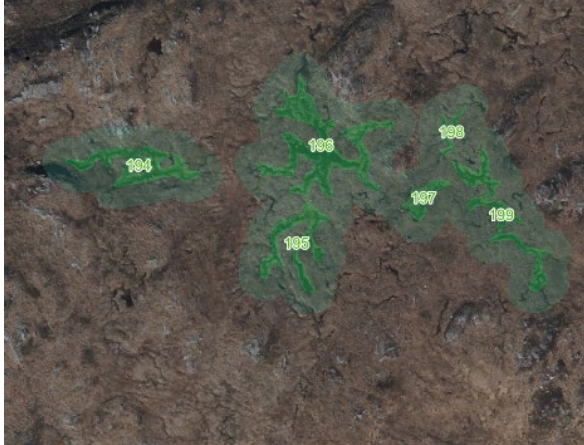
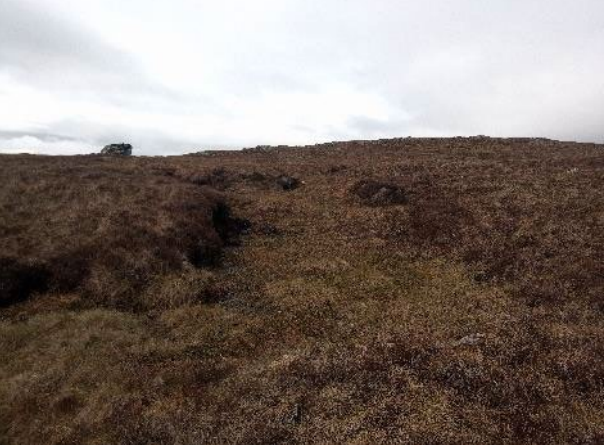
<p>Area ID: 199</p> <p>Location: N H41509 26013</p> <p>Description: Erosional gully with bare peat exposures.</p> <p>Area: 435 m²</p>	<p>Repair of eroded / bare areas using machine-based techniques</p> <p>Access via wind farm track network</p>

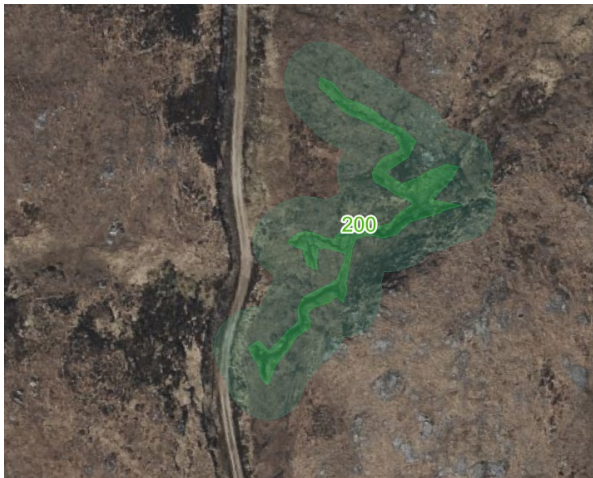
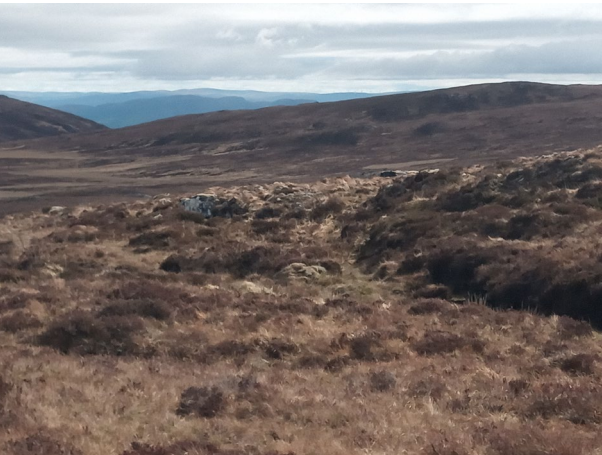
Area ID and Description	Recommended Restoration Techniques	Images	
<p>Area ID: 200 Location: NH 41937 26329 Description: Shallow eroded peat area draining to north below rock outcrops. Area: 659 m²</p>	<p>Repair of eroded / bare areas using machine-based techniques Access via non wind farm tracks</p>
