East Claydon, Buckingham, Buckinghamshire, MK18 2LF

Envirocheck® Report:

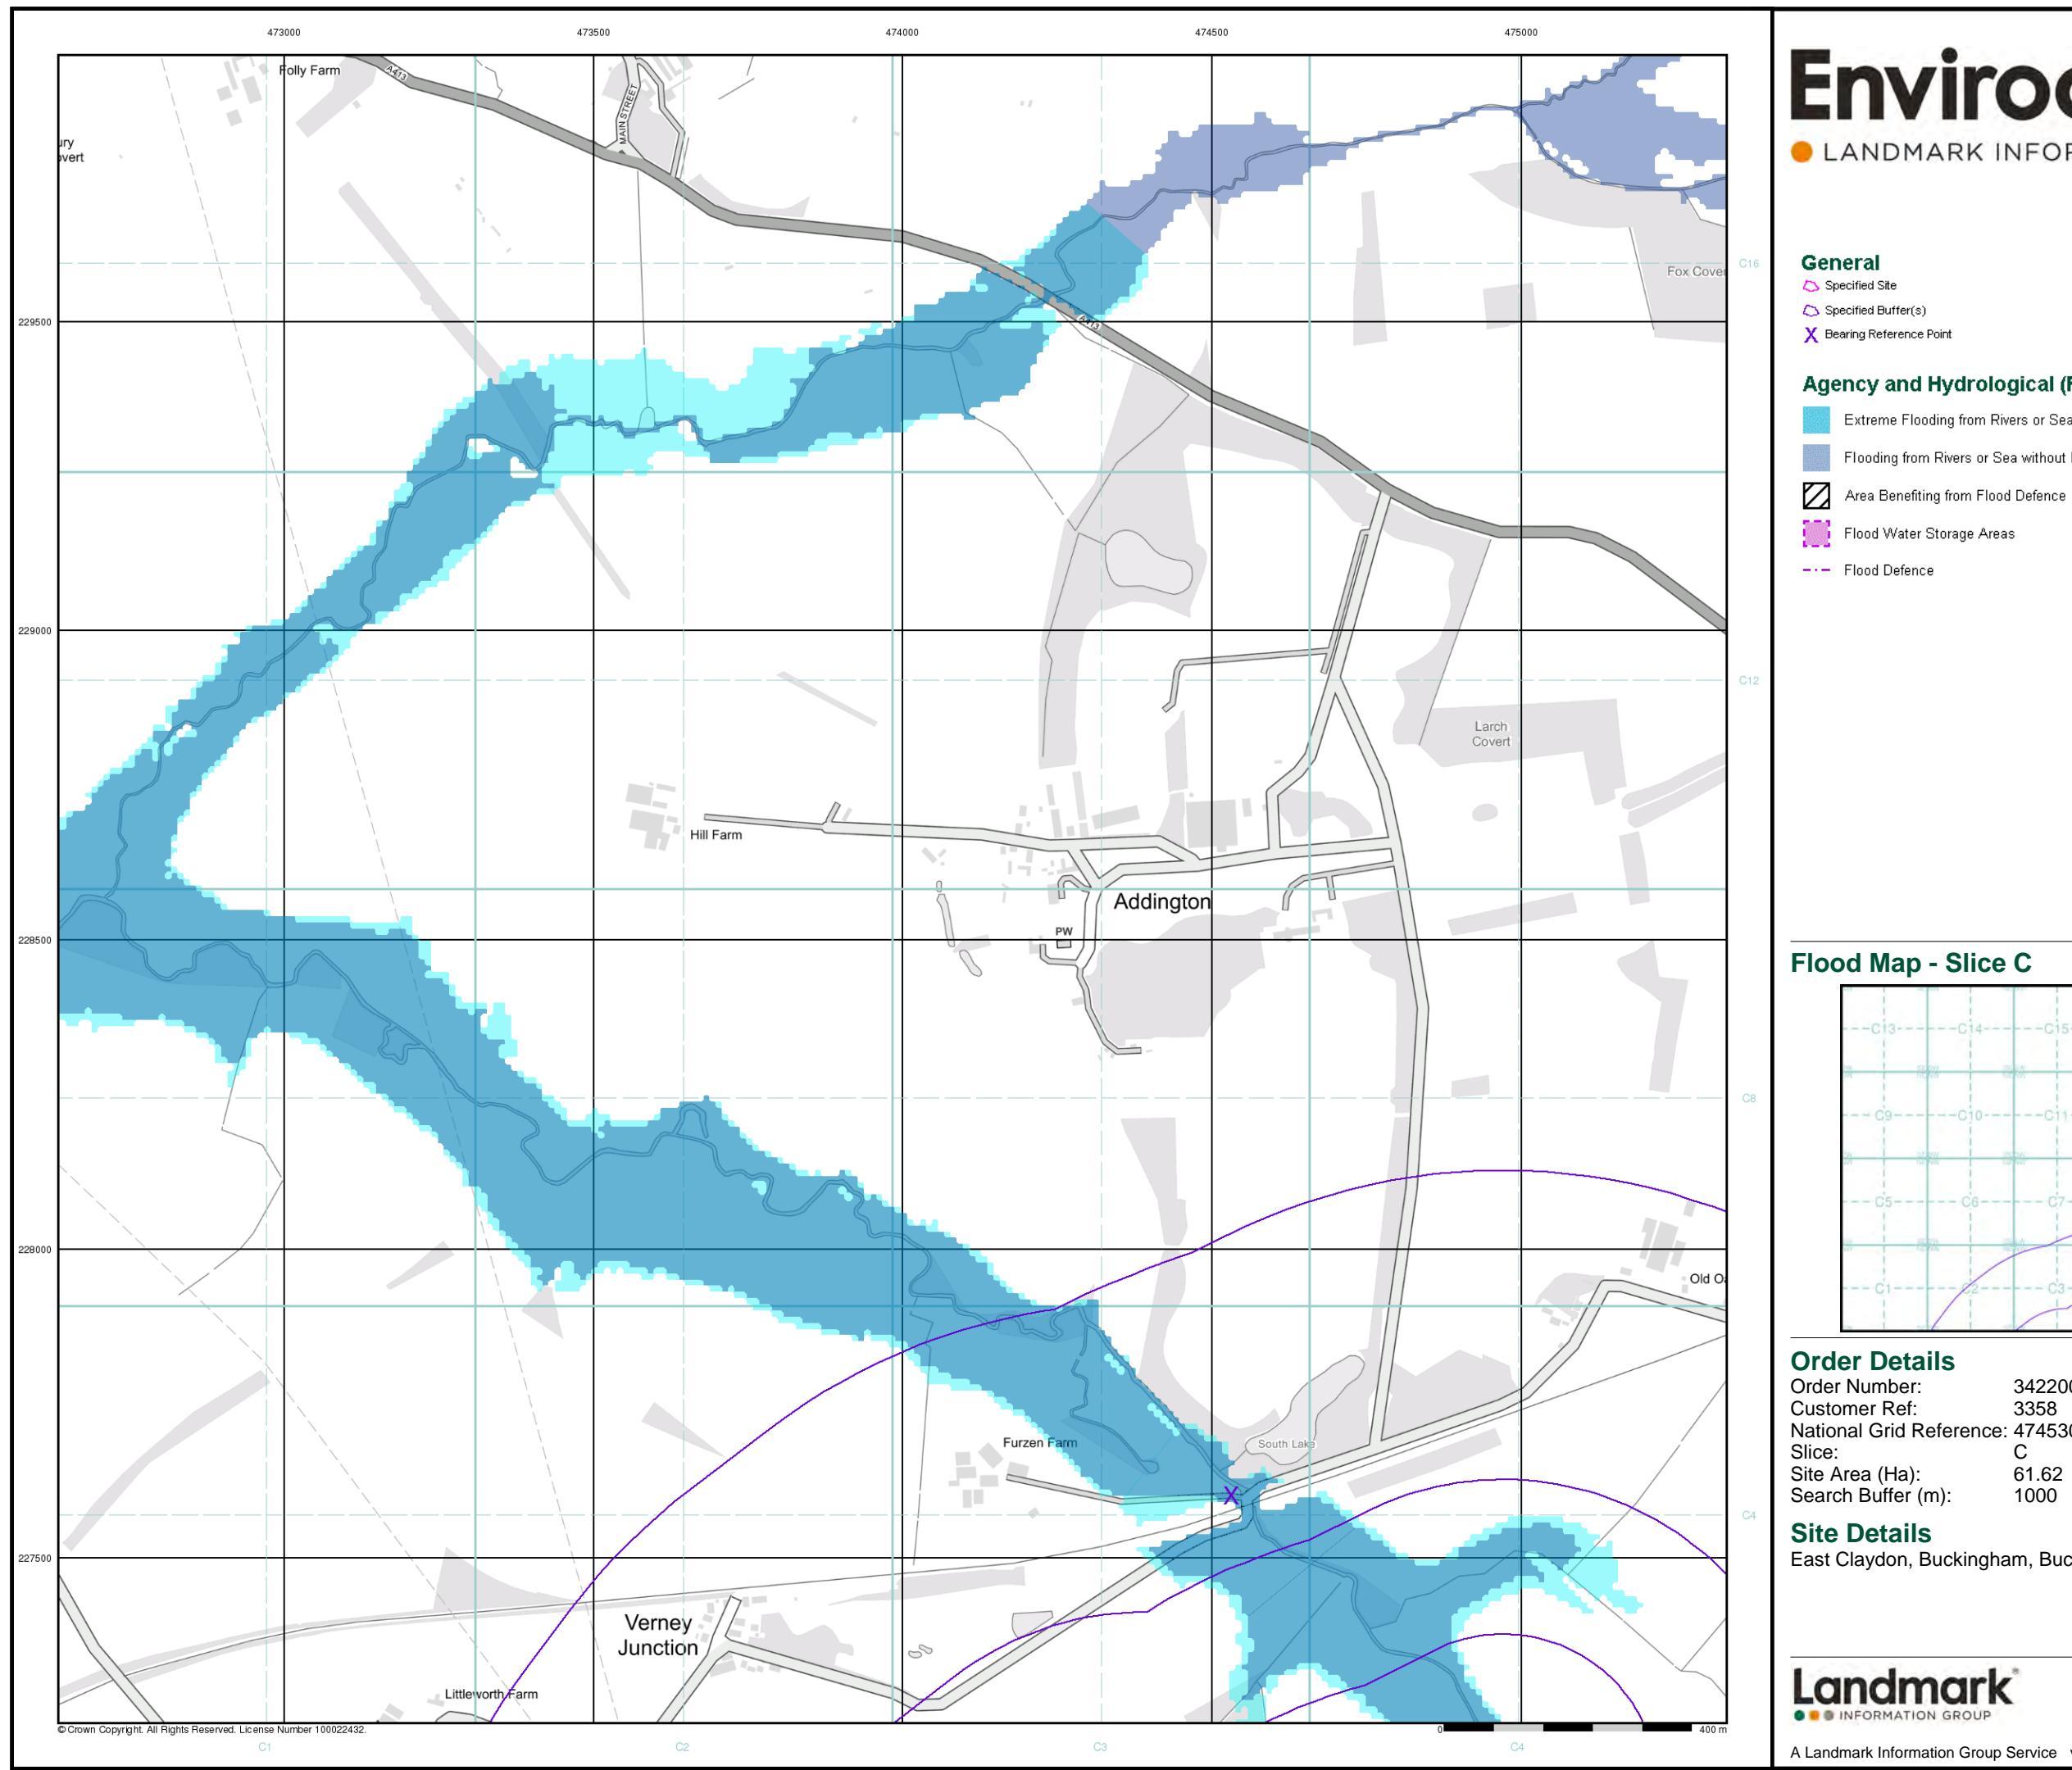
Agency and Hydrological (Flood)

Extreme Flooding from Rivers or Sea without Defences (Zone 2)

Flooding from Rivers or Sea without Defences (Zone 3)

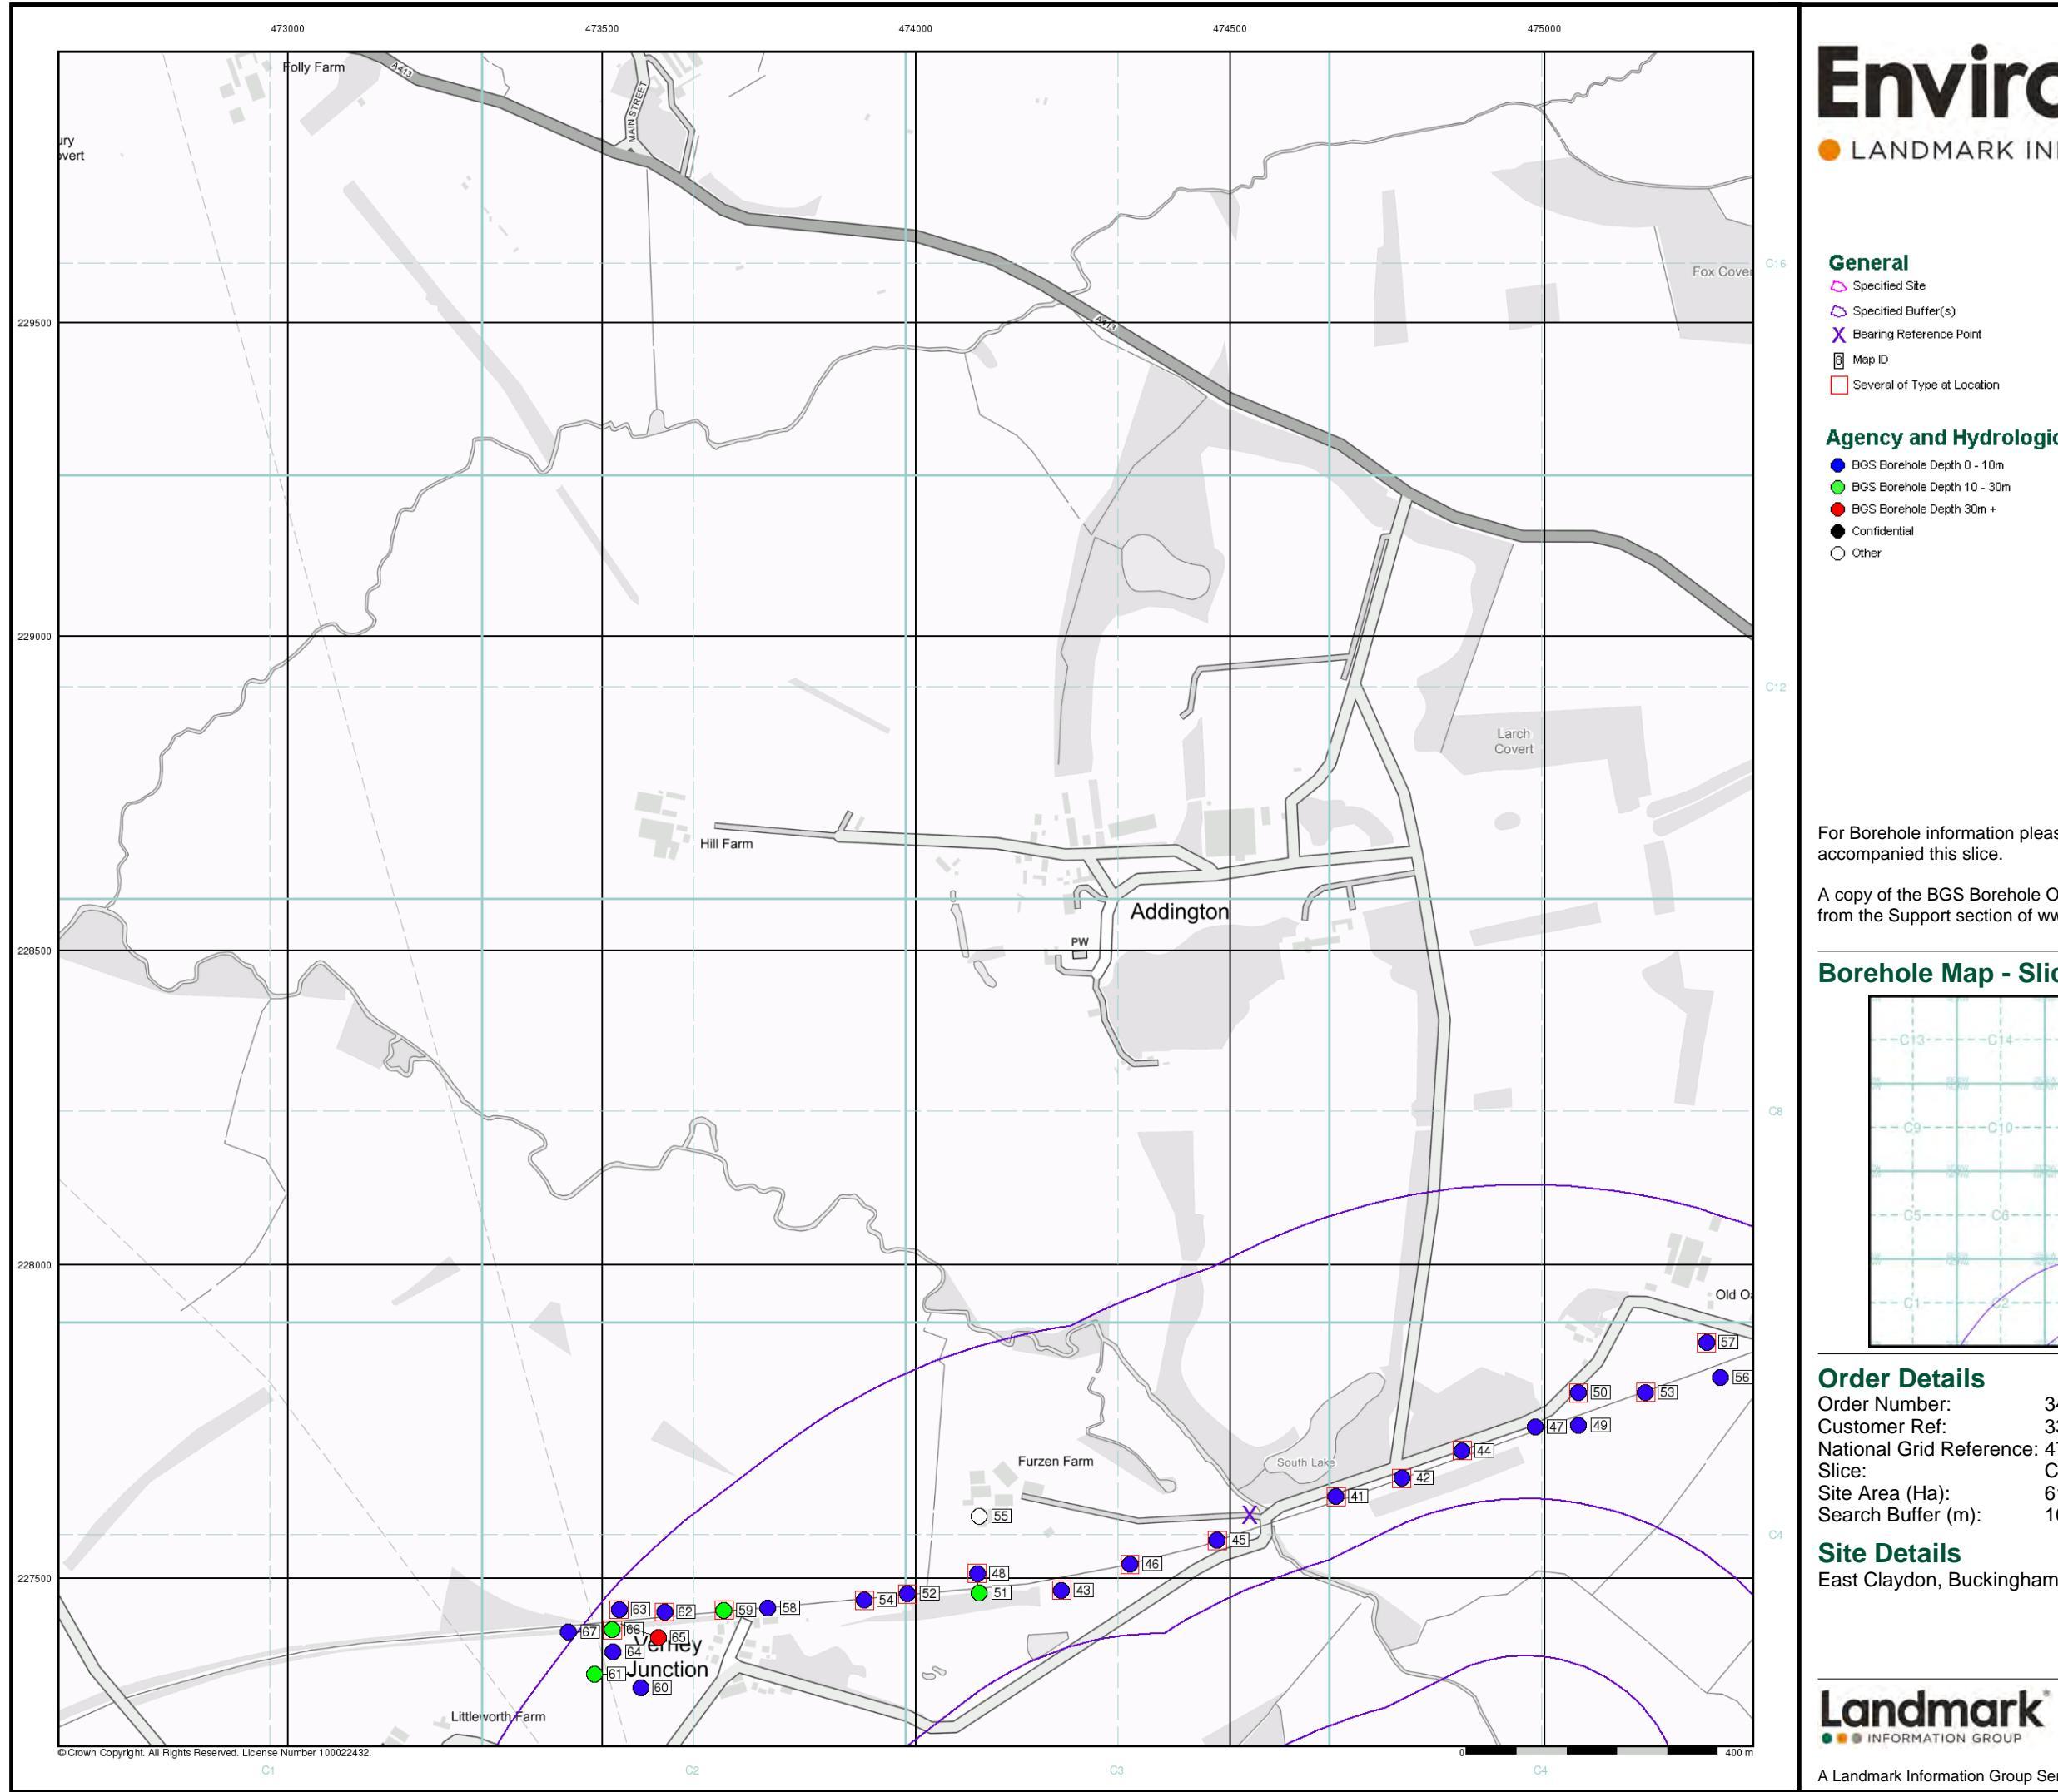
Borehole Map - Slice C

Agency and Hydrological (Boreholes)

For Borehole information please refer to the Borehole .csv file which

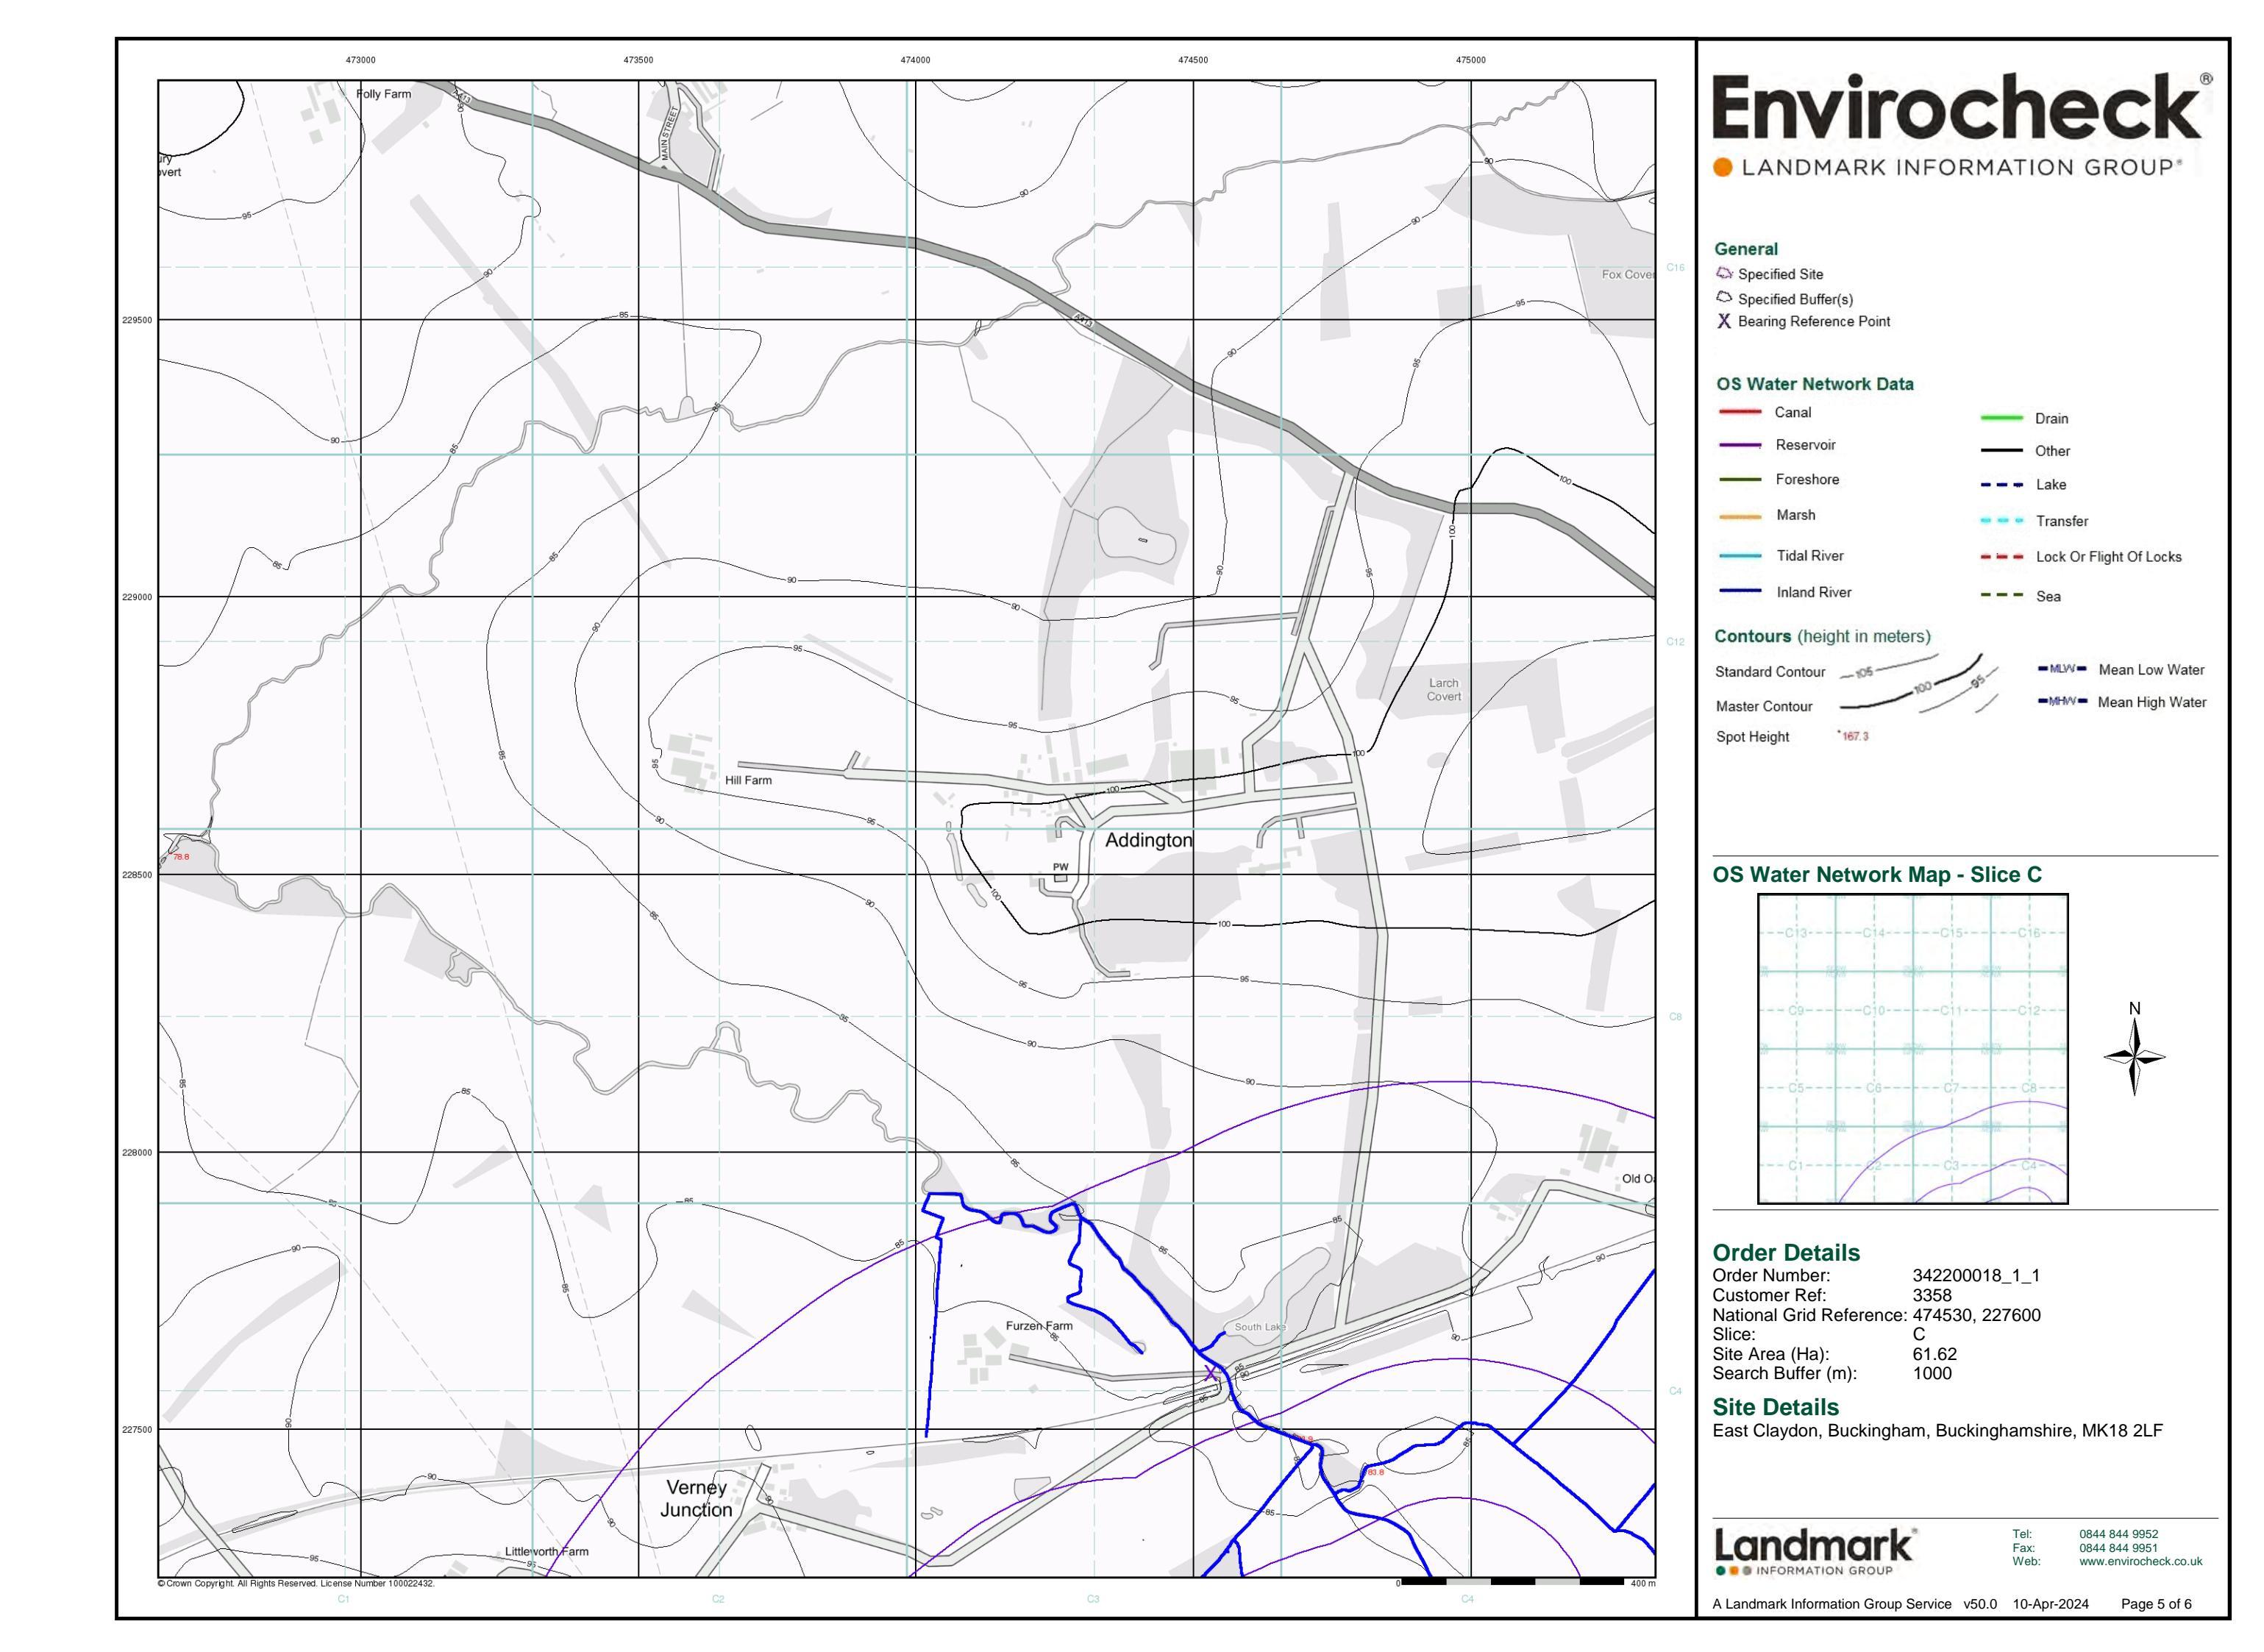
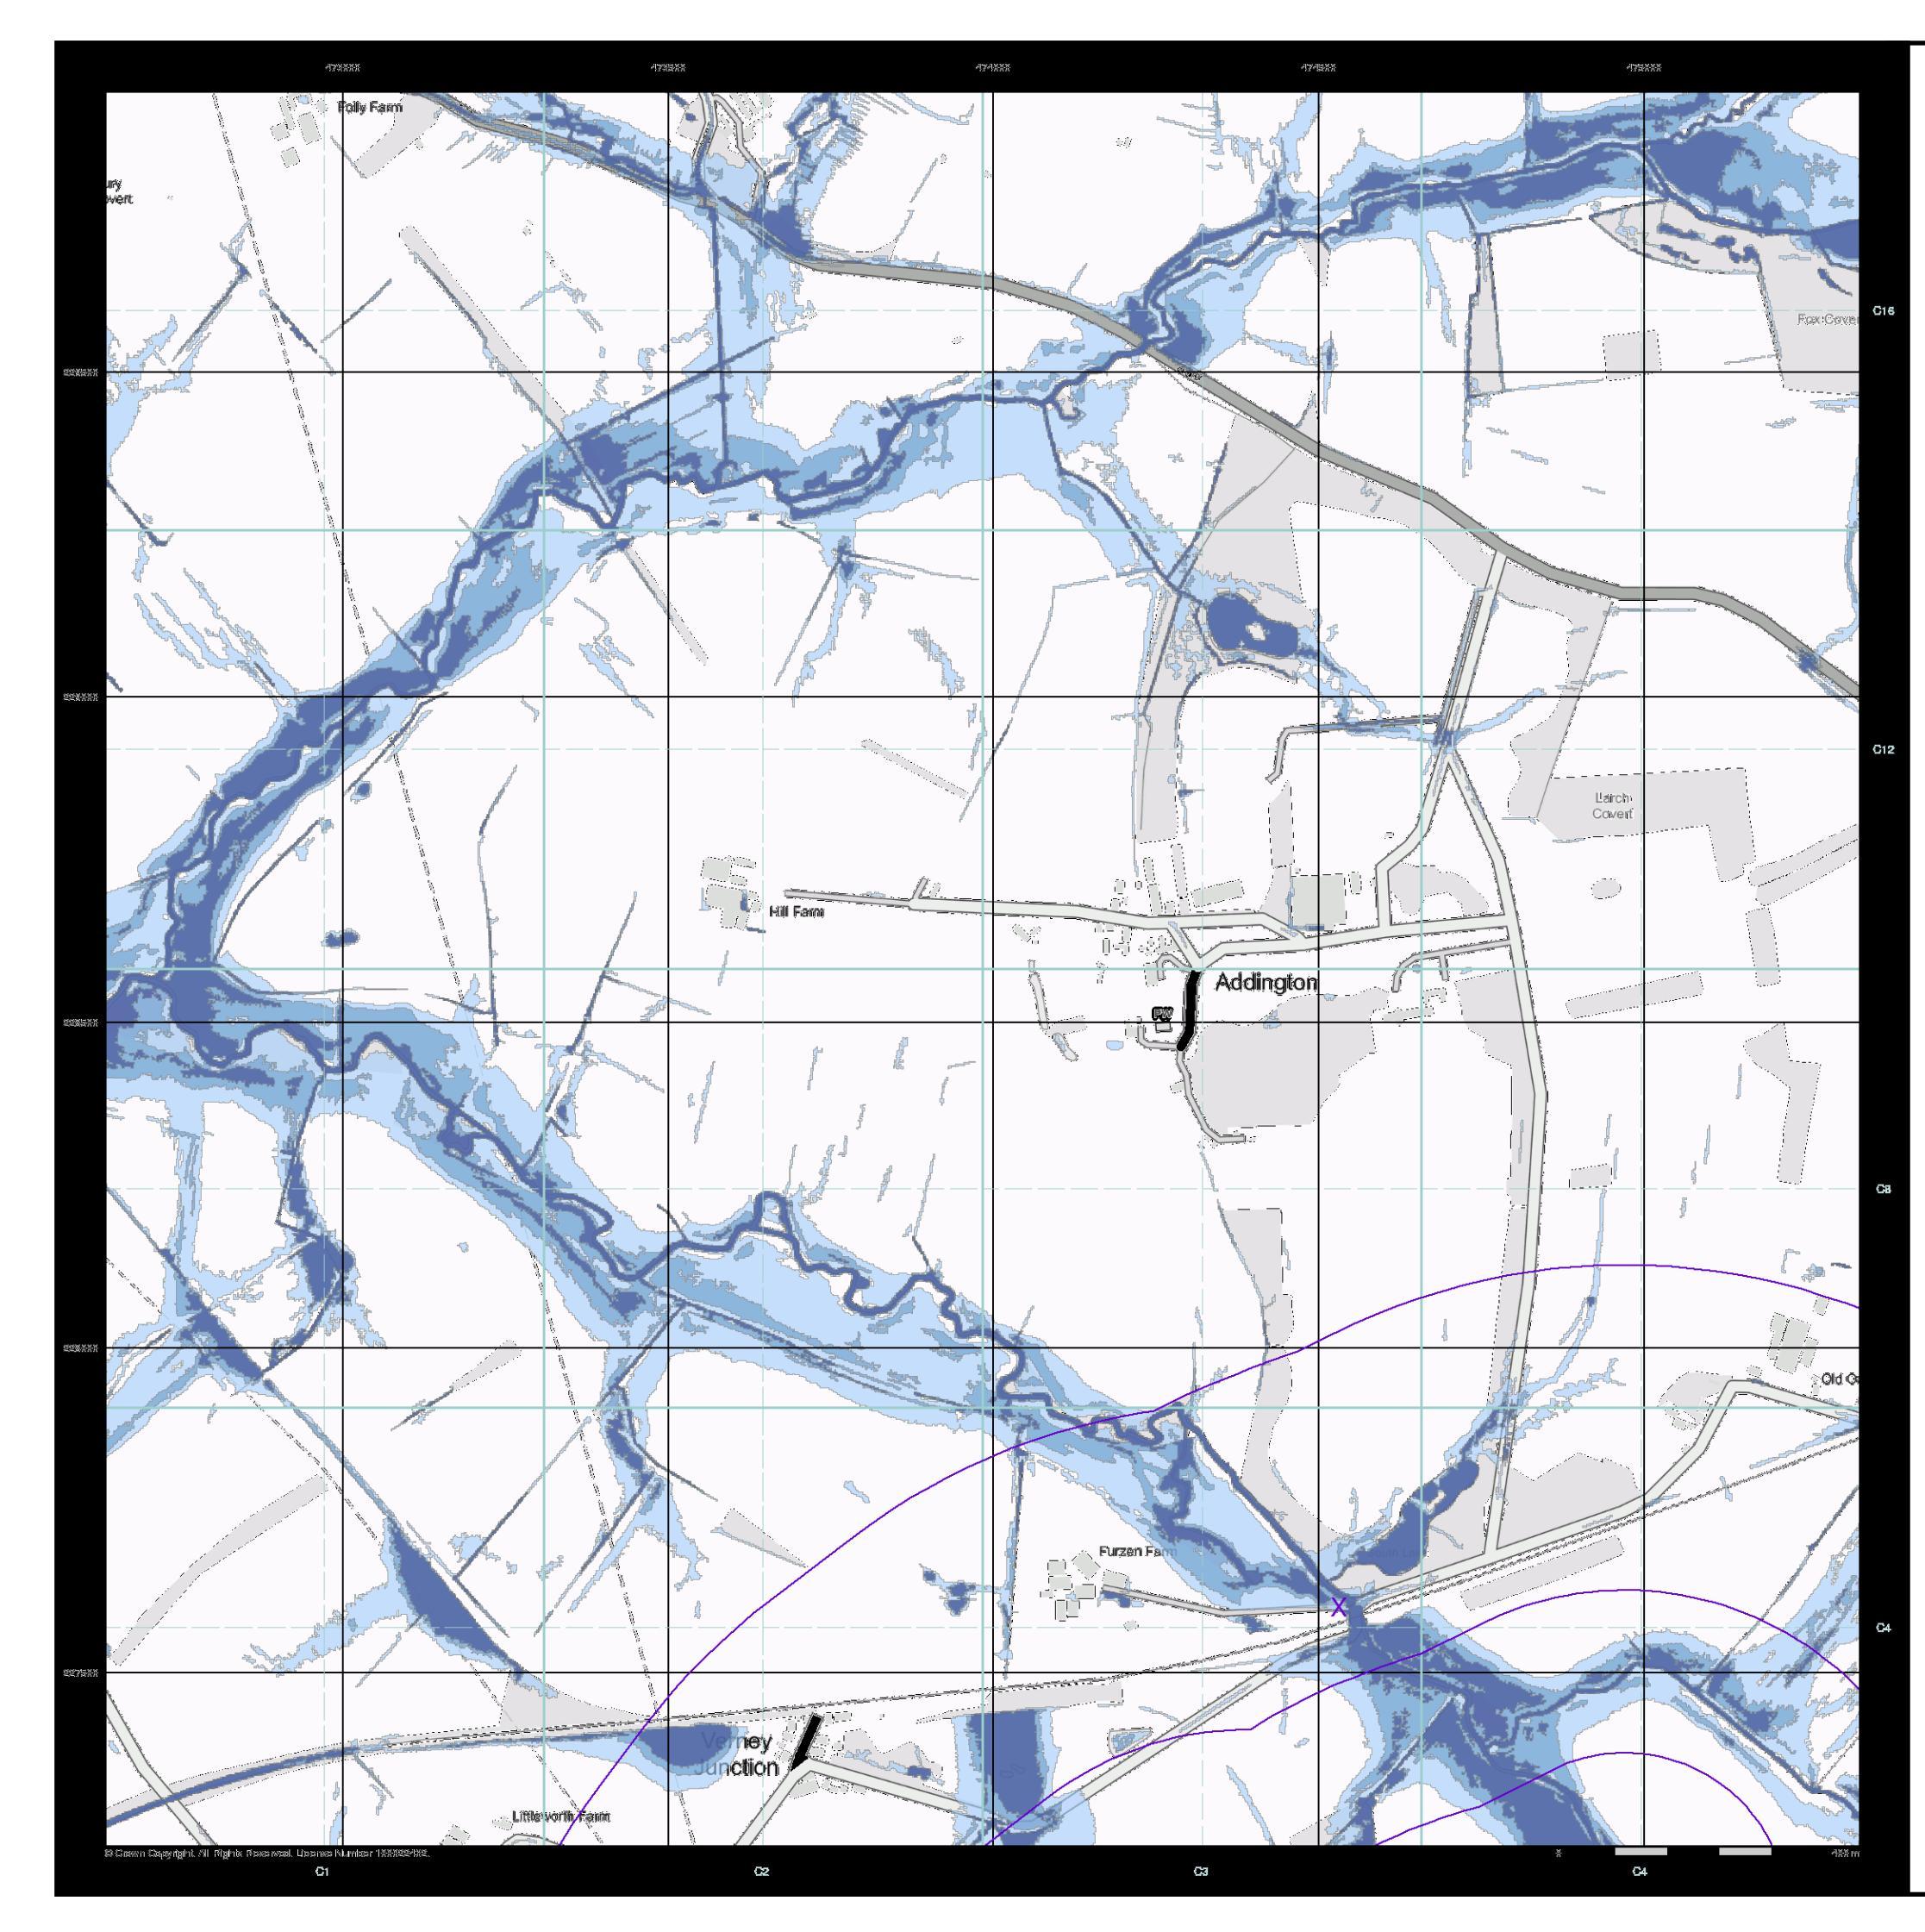
Risk of Flooding from Surface Water

High - 30 Year Return
	Medium - 100 Year Return
	Low - 1000 Year Return

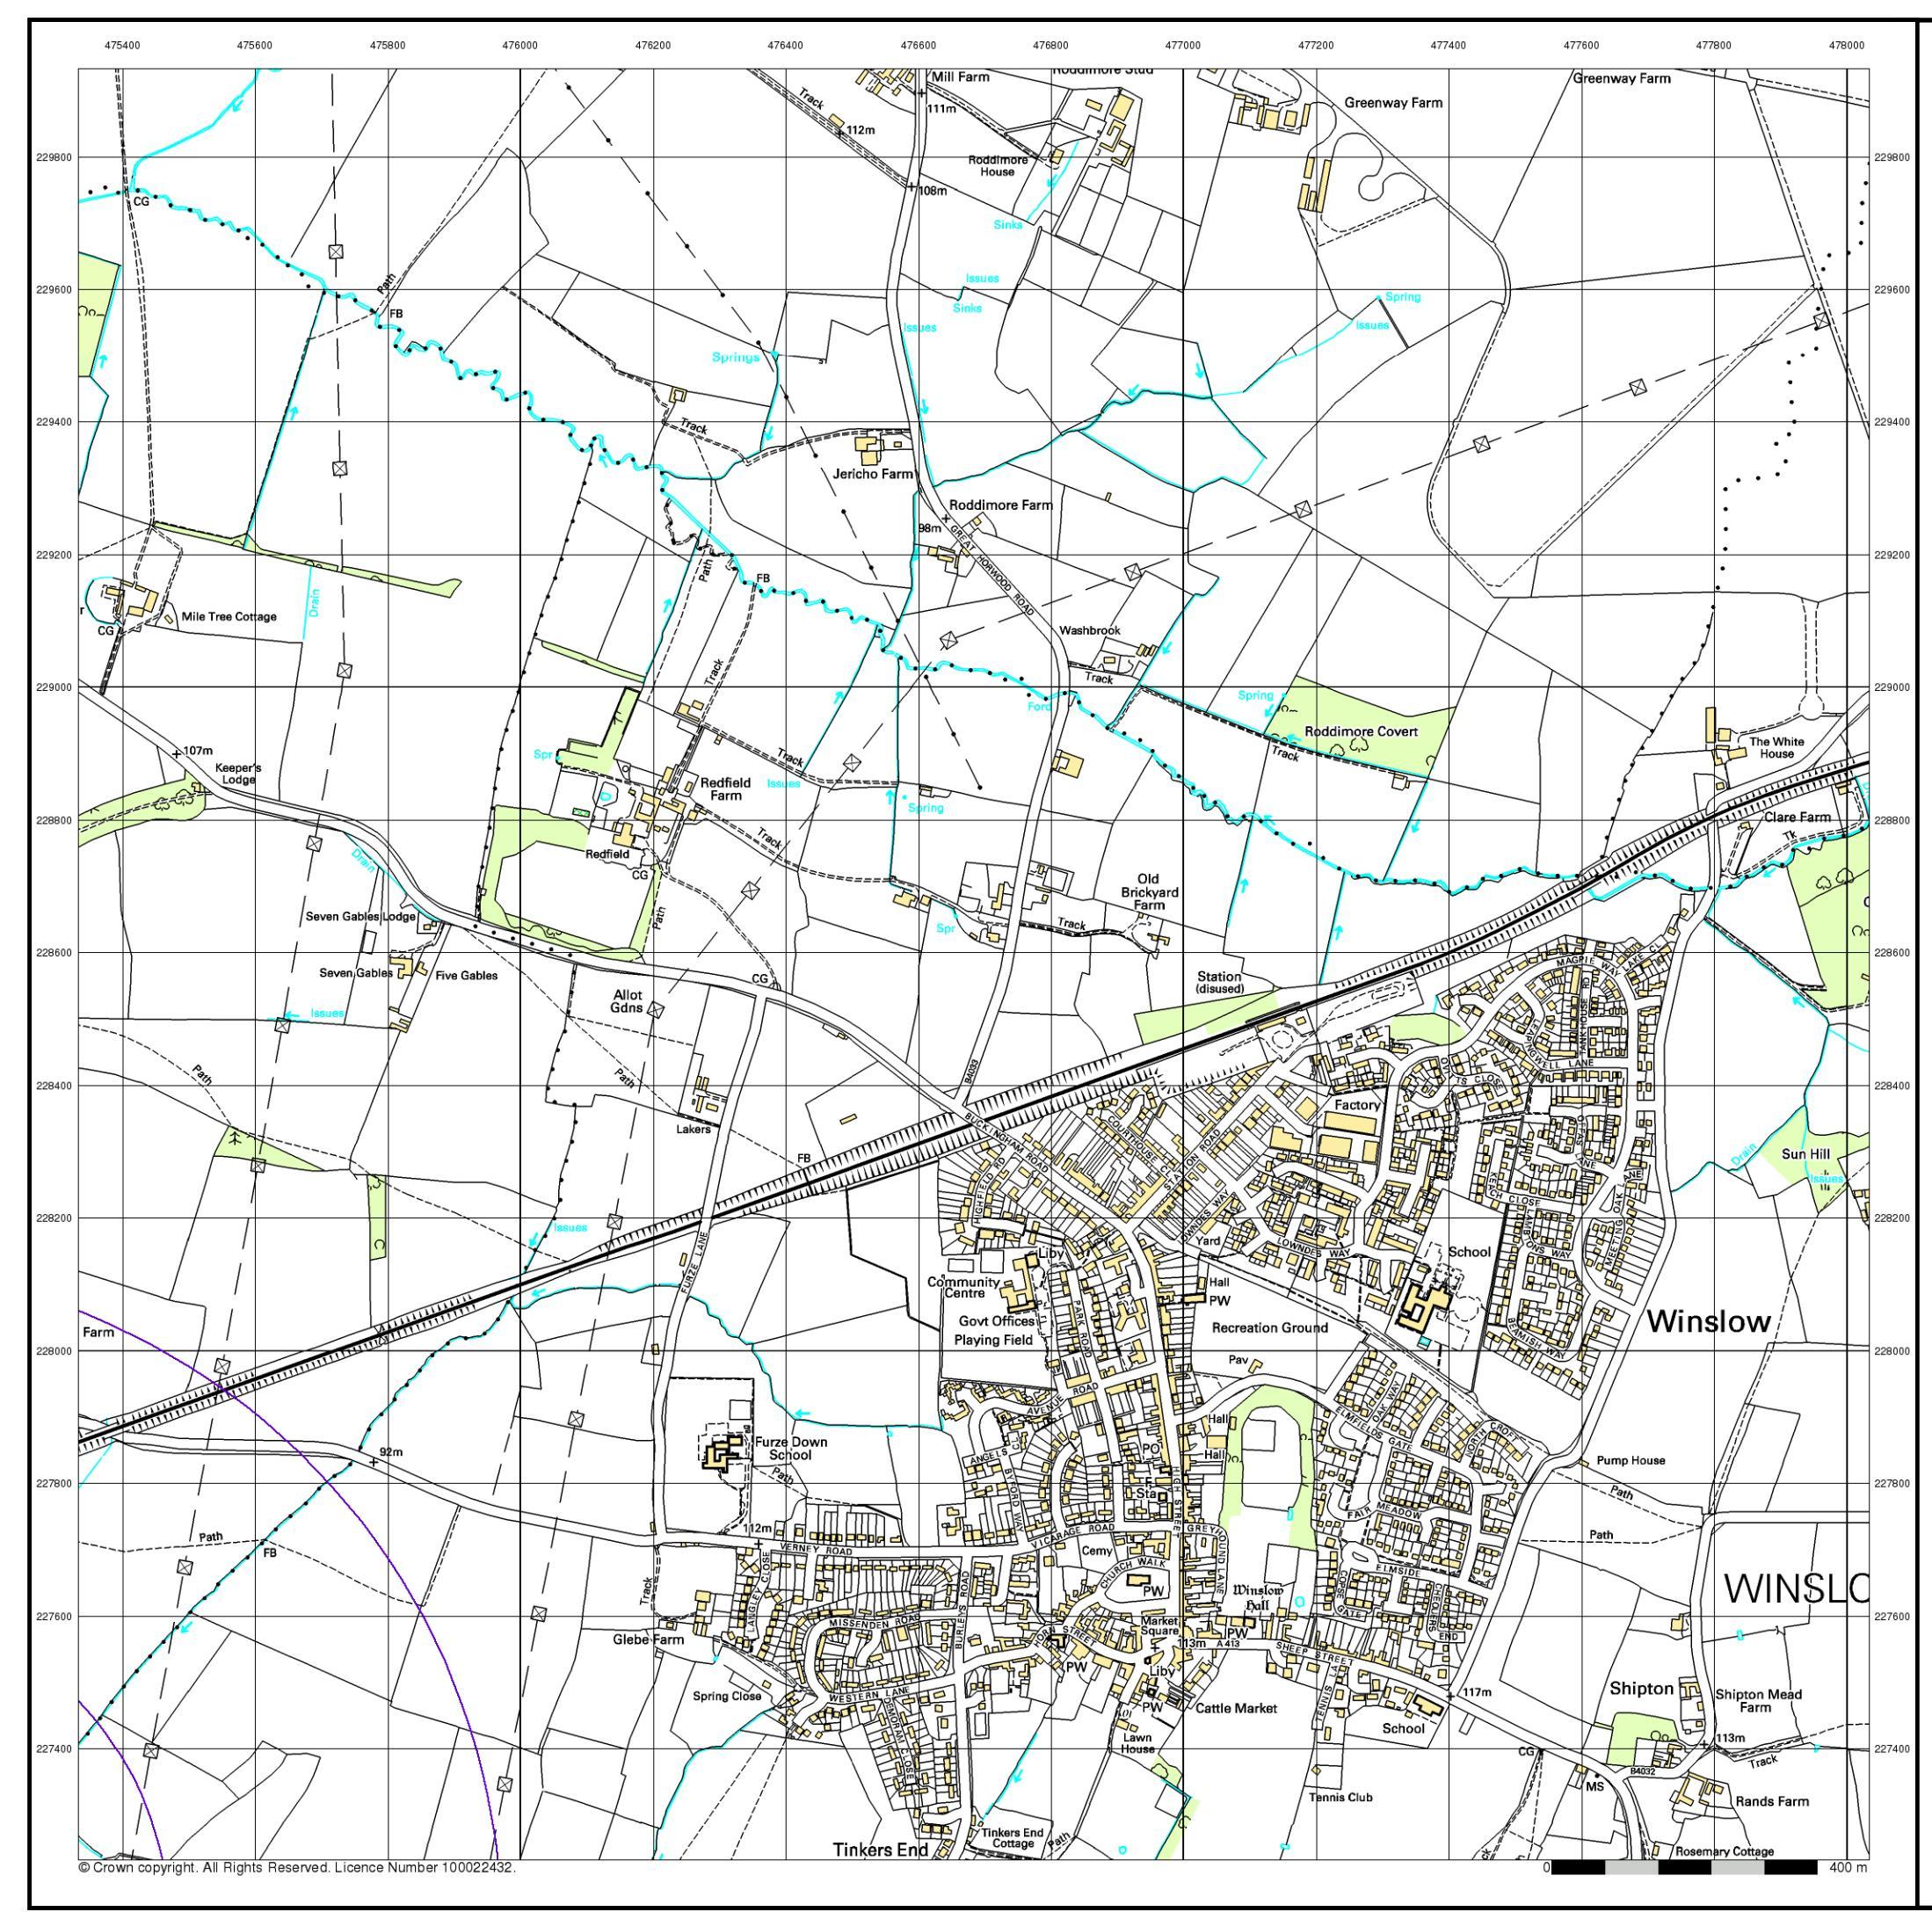
10k Raster Mapping

The historical maps shown were produced from the Ordnance Survey's 1:10,000 colour raster mapping. These maps are derived from Landplan which replaced the old 1:10,000 maps originally published in 1970. The data is highly detailed showing buildings, fences and field boundaries as well as all roads, tracks and paths. Road names are also included together with the relevant road number and classification. Boundary information depiction includes county, unitary authority, district, civil parish and constituency.

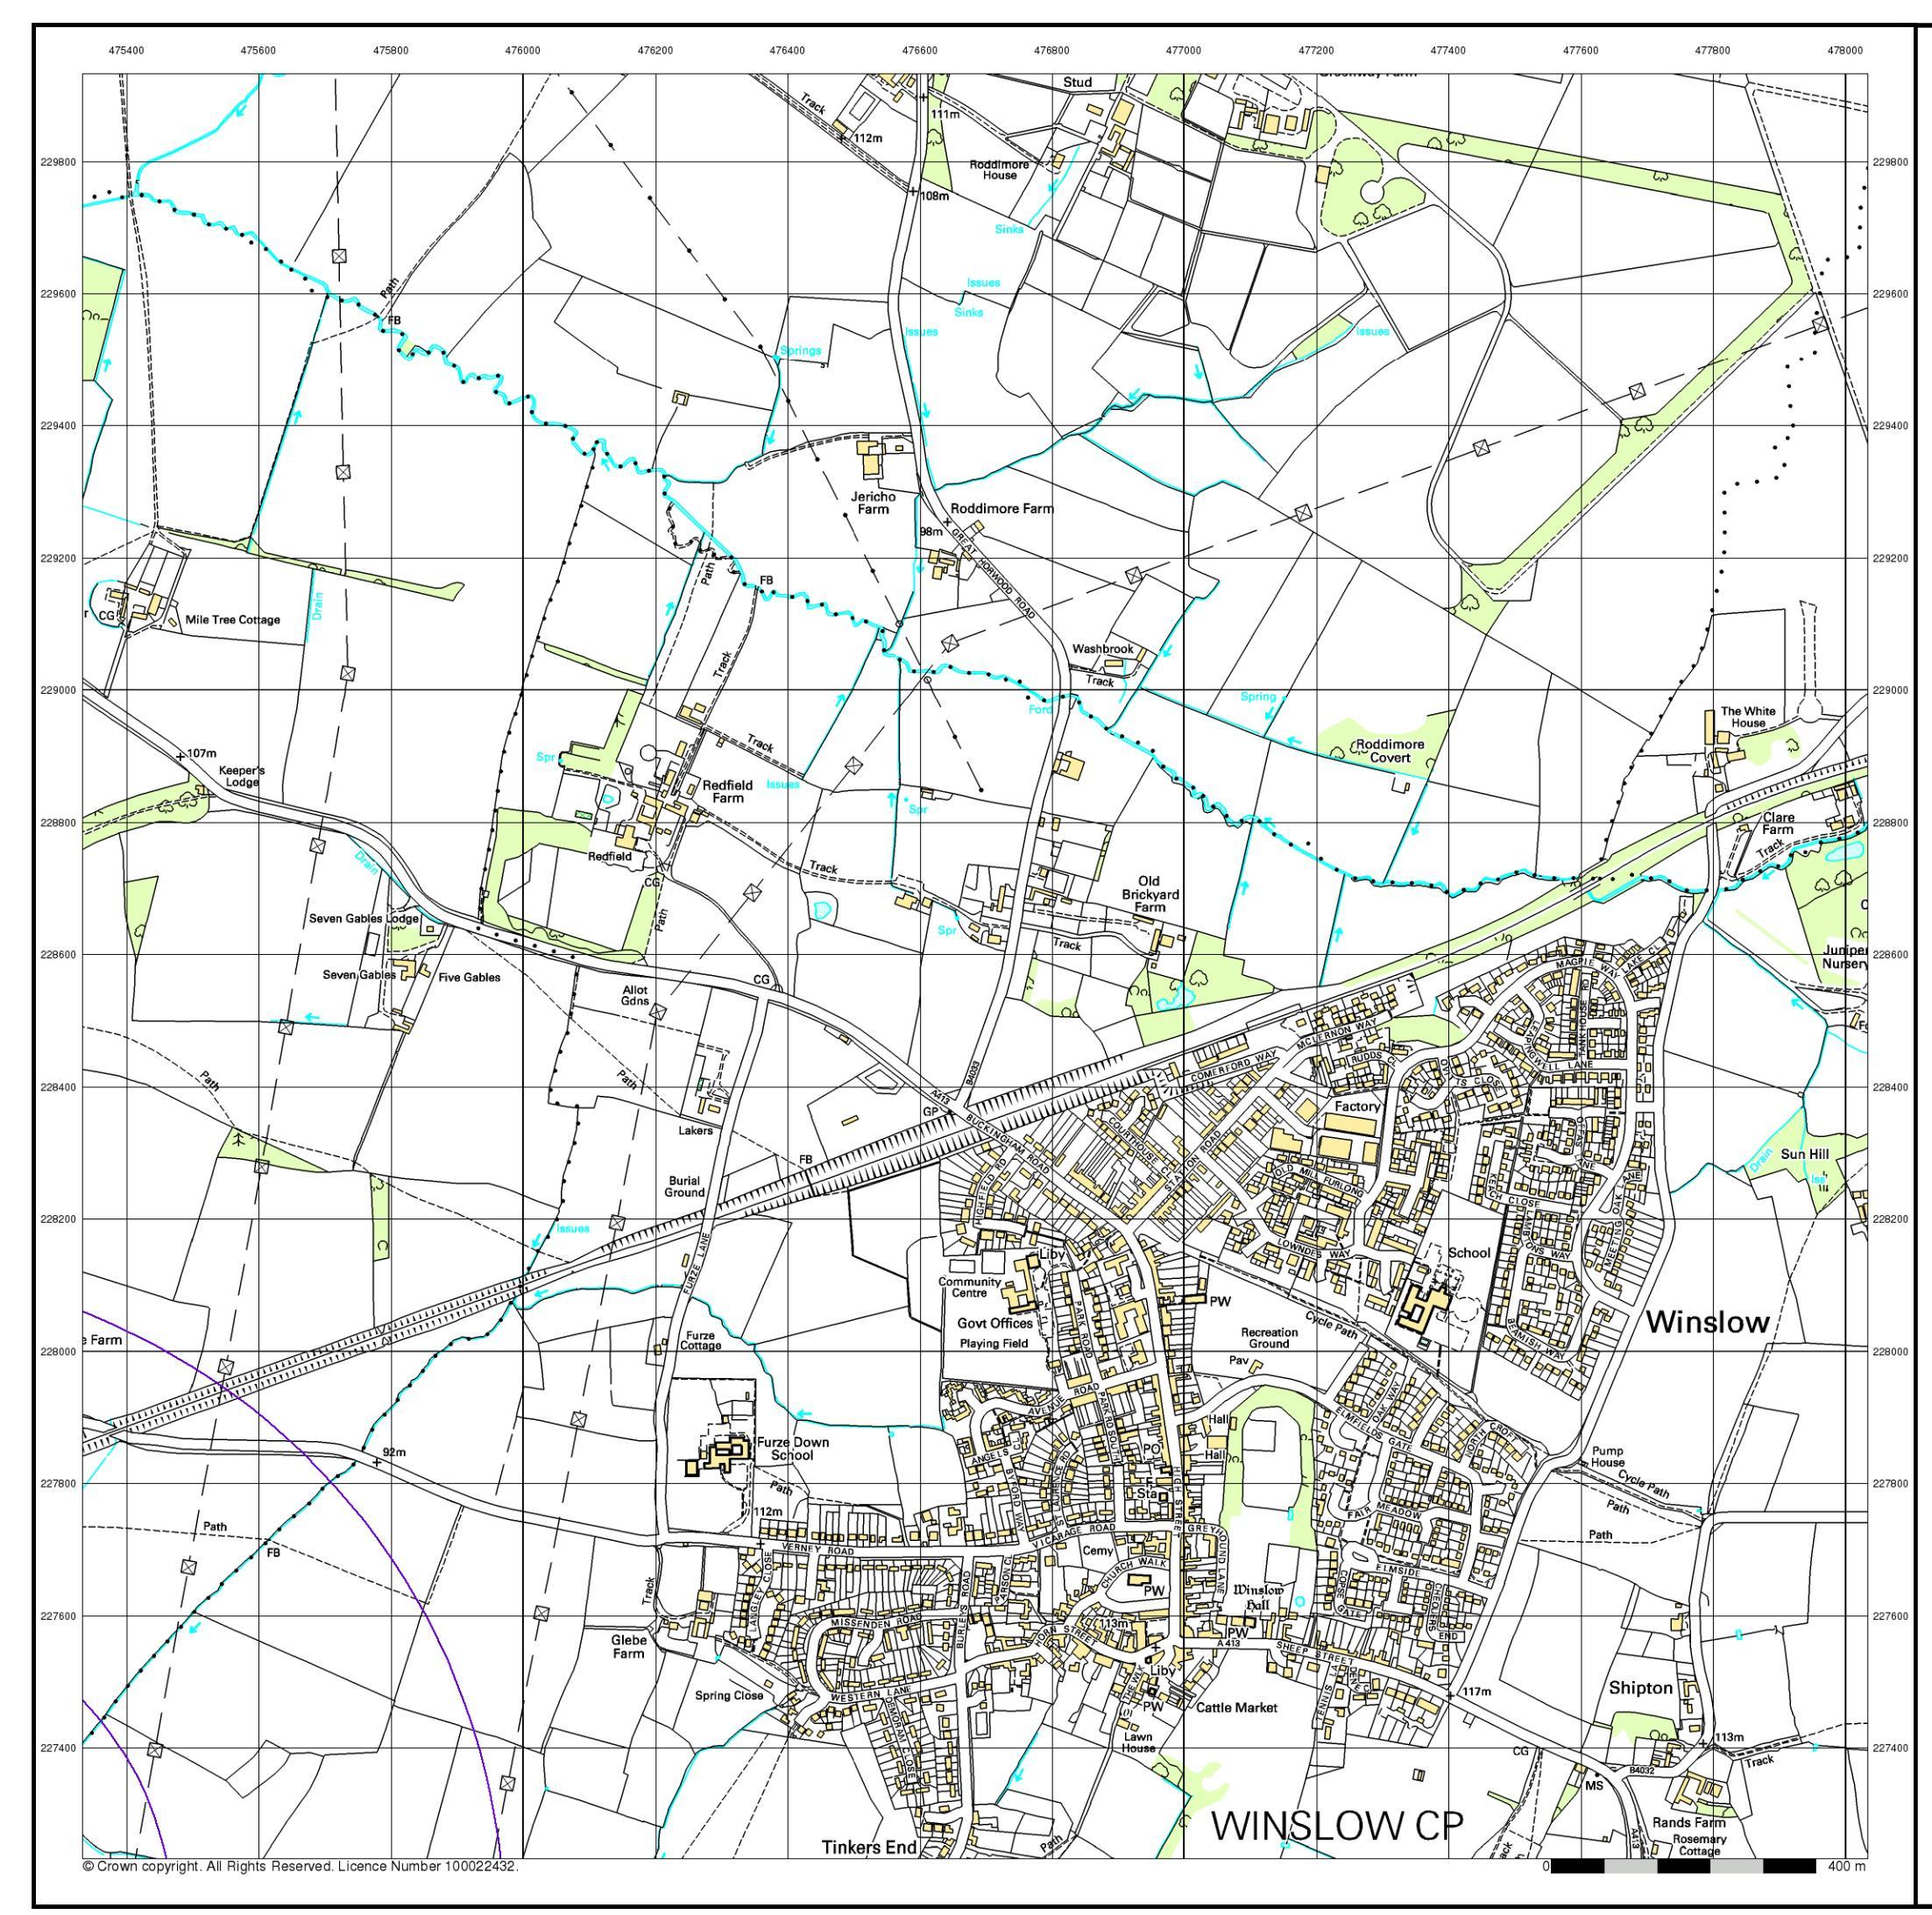
10k Raster Mapping

The historical maps shown were produced from the Ordnance Survey's 1:10,000 colour raster mapping. These maps are derived from Landplan which replaced the old 1:10,000 maps originally published in 1970. The data is highly detailed showing buildings, fences and field boundaries as well as all roads, tracks and paths. Road names are also included together with the relevant road number and classification. Boundary information depiction includes county, unitary authority, district, civil parish and constituency.
