# Minutes of the Meeting of the Berry Burn Extension Ecology Workshop

Project	Berry Burn Extension
Meeting	Ecology Workshop
Date	Saturday 23 November 10:30 – 11:30
Location	Forres Town Hall
Attendee	Howard Fearn (HF), Avian Ecology
	Mícheál Ó Broin (MOB), Statkraft
	Linda Henderson (LH), East Nairnshire Community Council
	Peter Elford

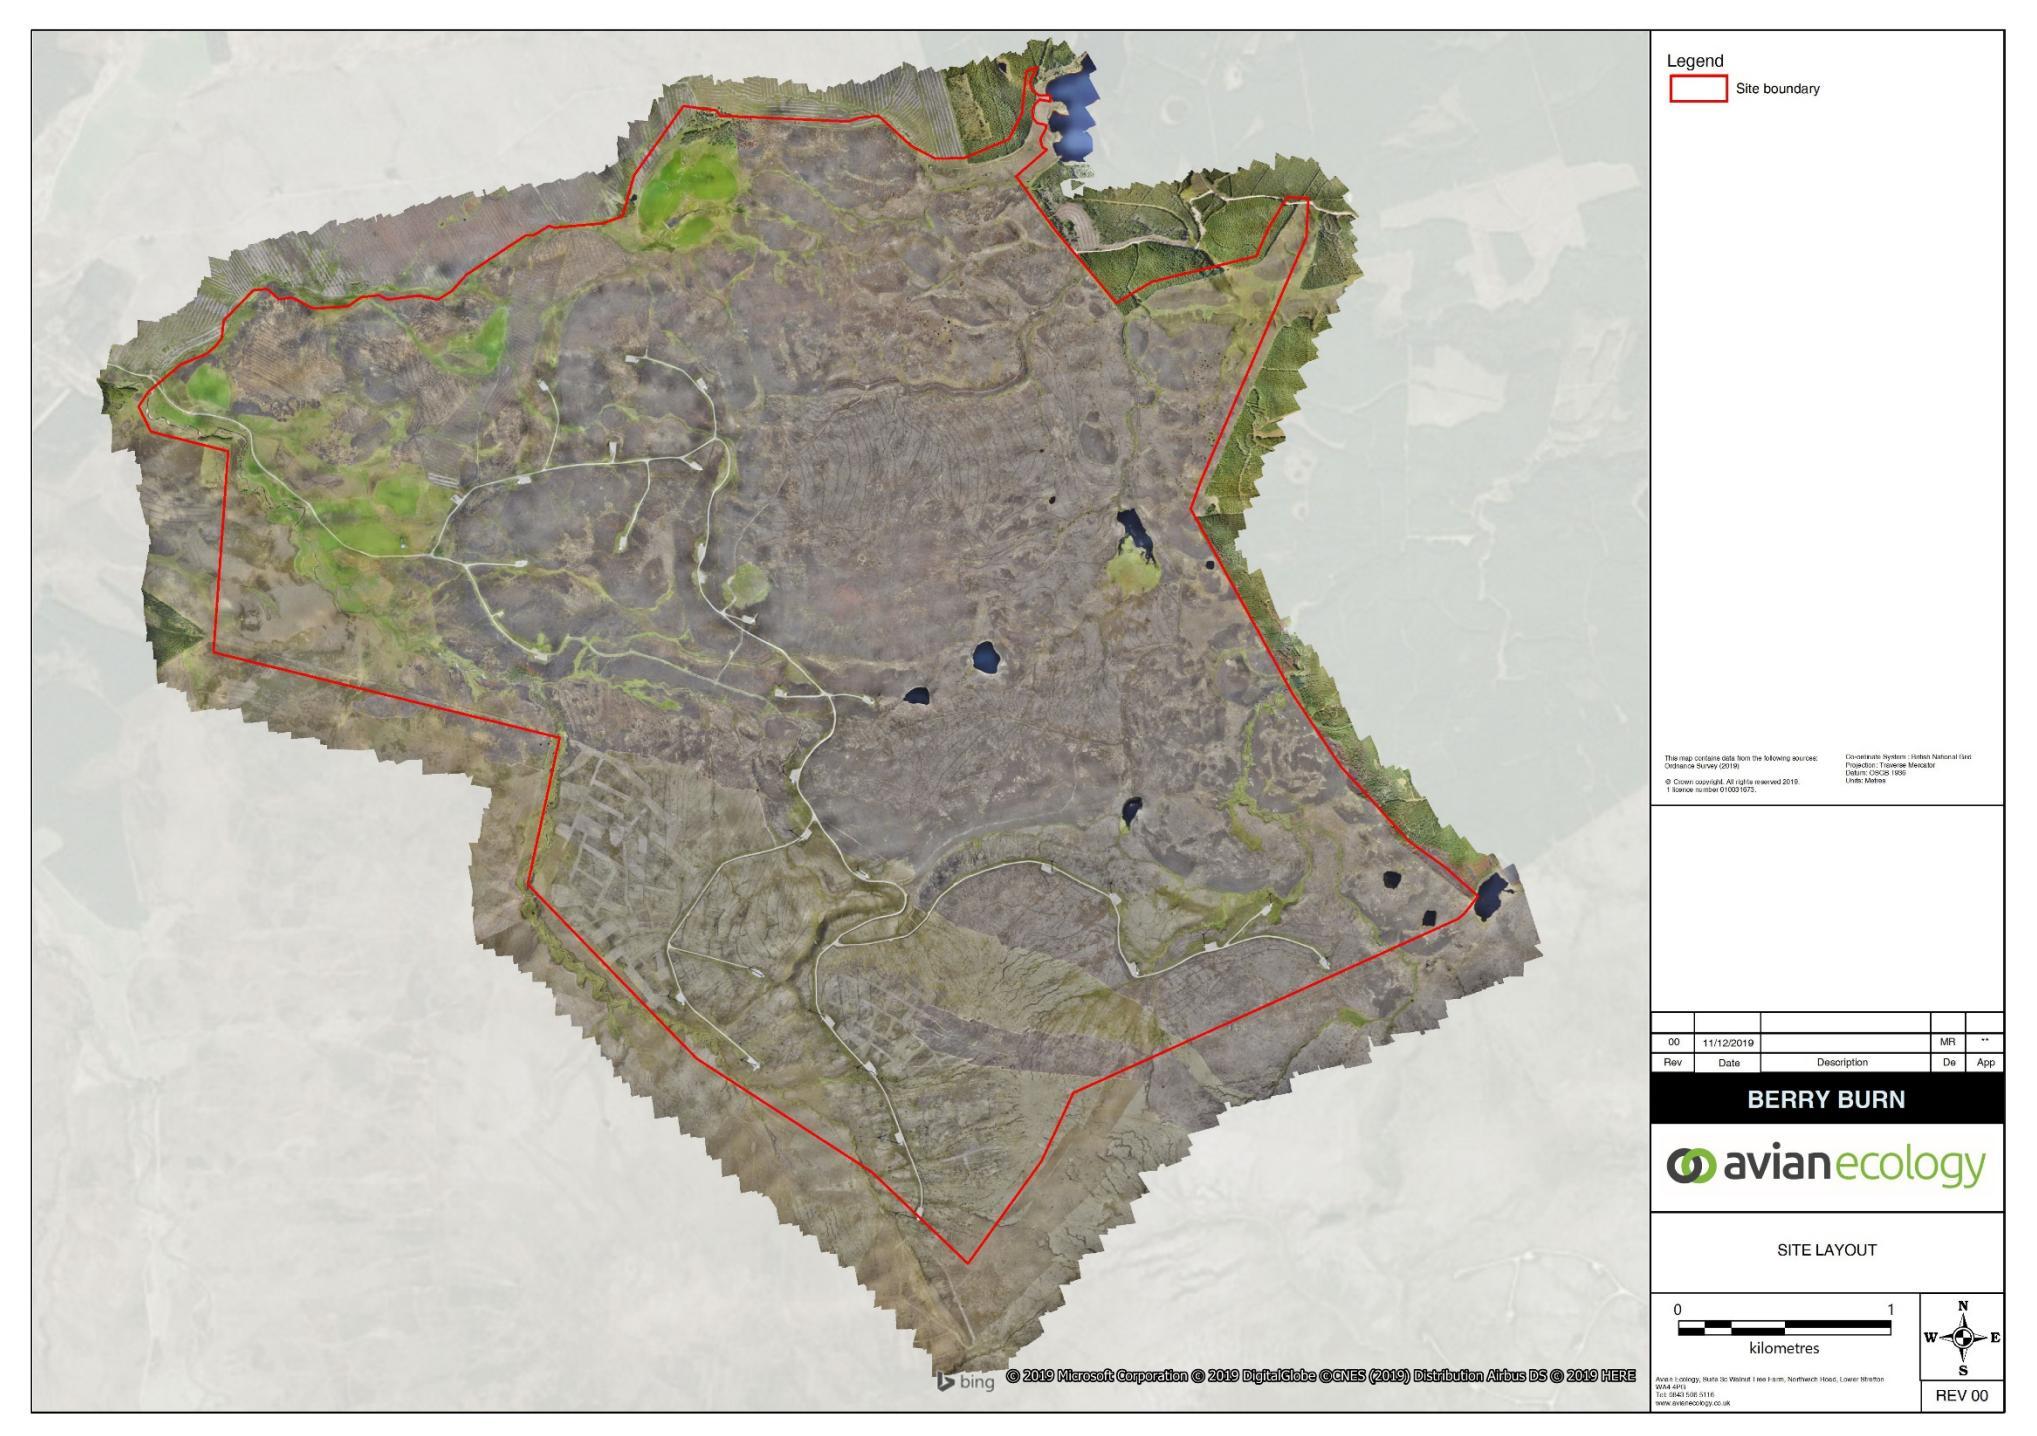
Figure 1: Post-fire Drone Imagery

Statkraft commissioned a high definition drone survey of the Berry Burn Wind Farm area, (Figure 1). While this showed the extent of the fire within the site it did not contain any information on the severity of the damage to habitats and the underlying blanket bog peat.

- ii. Did the fire expose drains on site?
  - a. Yes, the drainage network has been exposed through the site, this can be clearly seen from the image of the drone footage, Figure 1.

- iii. Could the re-wetting of the land help to stop the infilling of Loch Noir? (the aerial photograph indicates that Loch Noir may be infilling)
  - a. Unfortunately our hydrologist is not present to comment but there is a possibility that by bringing the habitat surrounding the loch back to its natural state, that will see a reduction in the infilling of the loch.
