Appendix 8.2: Habitats and Vegetation Survey Report

Loch Liath Wind Farm Ltd

EIA Report

Final report Prepared by LUC April 2023

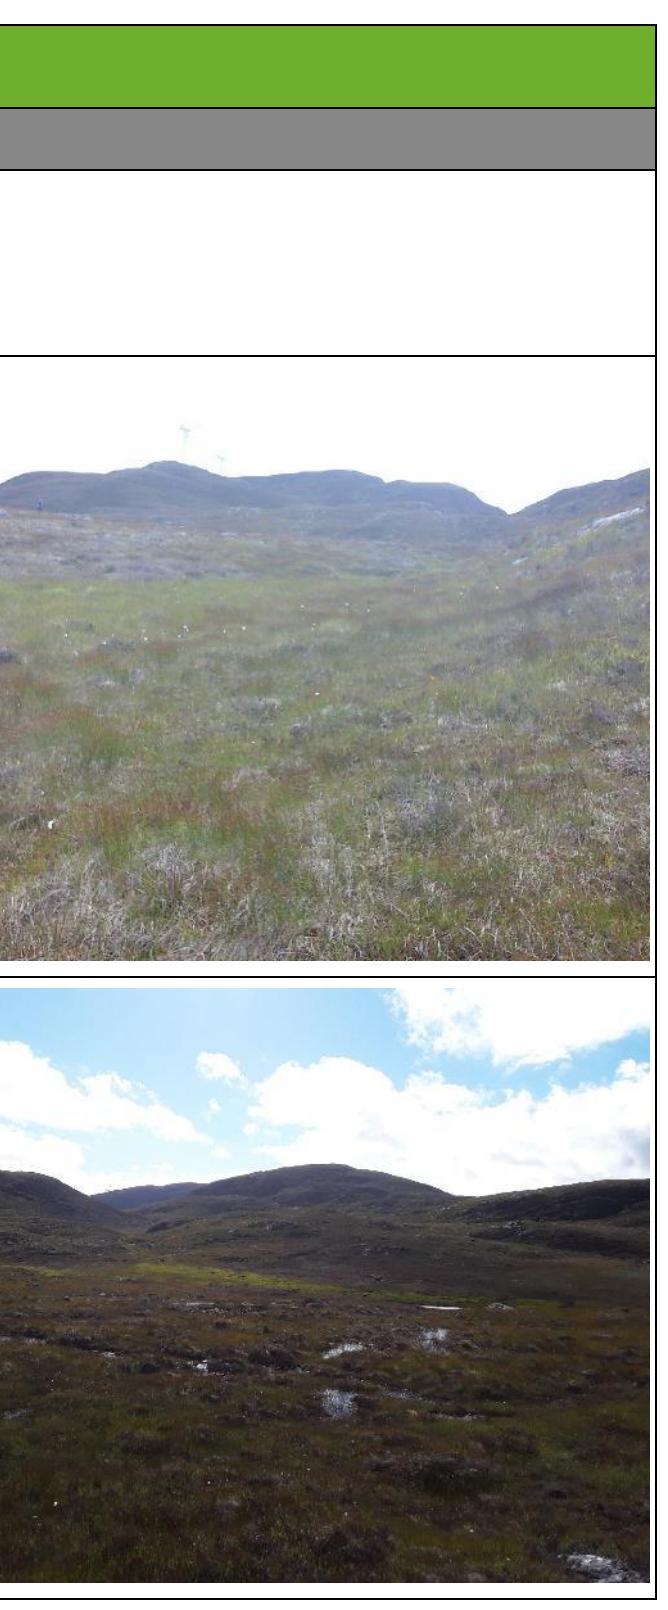
Infrastructure	Peat Depth Range (cm)	NVC Communities	Notable Features	Peatland Activity and Condition	Quality	Comments	Photo
Turbine Locations							
T1	5-70	M17/M3	 Montane bog Continuous unit >25ha Exposed peat noted Natural surface pattern 	 Peat-forming considered possible Modified 	Moderate	Wider area comprises M17 bog, but location of turbine is area of shallow deposits and not considered peatland. Areas of exposed peat proposed for restoration within vicinity.	
Τ2	5-55	H14/M15	Few drains/haggs noted	Not peatland	n/a	Turbine located on small summit of dry heath on shallow deposits with wet heath on shallow deposits leading to turbine. Not considered peatland. Bog habitats present nearby.	
Т3	0-190	M19/M20	 Montane bog Continuous unit >25ha Few drains/haggs noted Dwarf birch nearby 	 Peat-forming considered possible Modified 	Moderate	Sphagnum present but not abundant. Peat depths largely shallow at turbine location, with deeper deposits surrounding. Some exposed peat nearby but not extensive. Recorded as dry modified bog with drier raised areas. M19 and M20 likely to be created and maintained by grazing.

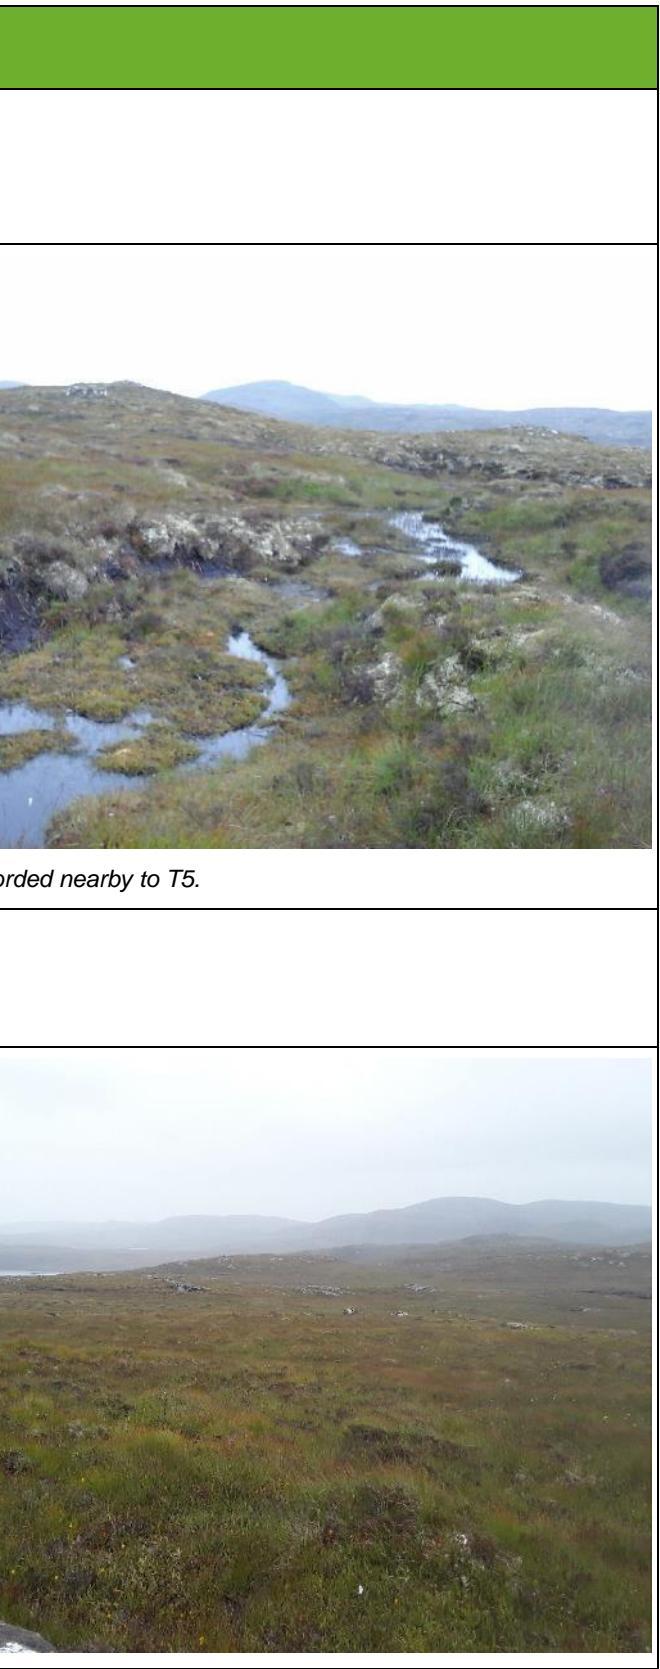
Infrastructure	Peat Depth Range (cm)	NVC Communities	Notable Features	Peatland Activity and Condition	Quality	Comments	Photo
Τ4	0-90	M17/M15/M2	 Montane bog Continuous unit >25ha Exposed peat noted 	 Peat-forming considered possible Modified 	Moderate	Turbine on area of shallow deposits, not considered to be peatland. Surrounded by deeper deposits, therefore assessed. Extents of exposed peat recorded nearby, proposed for restoration.	
Τ5	0-140	M17/M15/M2	 Montane bog Continuous unit >25ha Exposed peat noted Natural surface pattern Sphagnum-rich 	 Peat-forming considered possible Modified 	Moderate	Turbine located on area of shallow deposits, surrounded by deeper peat. Temporary hardstanding impinges on deeper deposits therefore assessed as peatland. <i>S.capillifolium</i> and <i>S.papillosum</i> fairly extensive in bog communities nearby. Exposed peat to north-east demonstrating an element of modification.	Hagging recou

Τ6	0-70	M15	Exposed peat notedDwarf birch nearby	Not peatland	n/a	Area of shallow deposits, with deeper peat nearby, although not extensive within vicinity. Exposed peat nearby to north-east and north-west. Area of turbine not considered to be peatland.	
Τ7	0-125	M17/M3/M15	Few drains/haggs noted	Not peatland	n/a	Turbine located on largely shallow deposits, with deeper peat to the south. Wet heath vegetation dominant within vicinity of location. Not considered peatland.

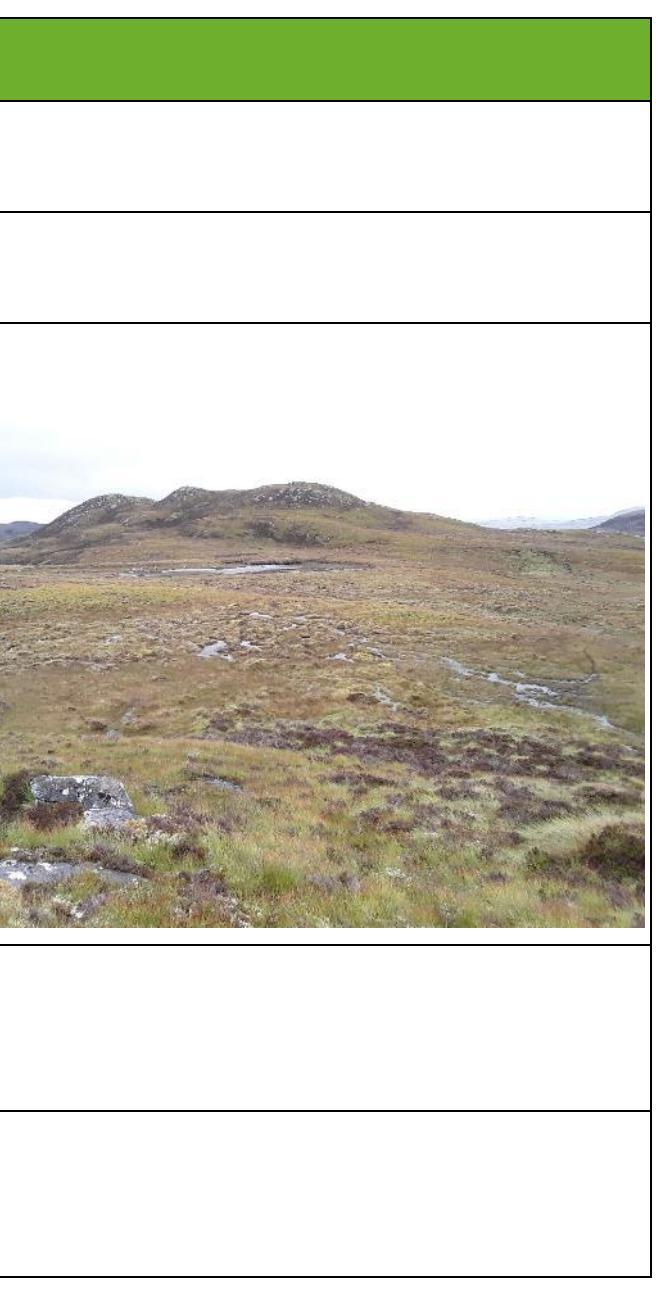
Infrastructure	Peat Depth Range (cm)	NVC Communities	Notable Features	Peatland Activity and Condition	Quality	Comments	Photo
Т8	0-90	M15/M19	Few drains/haggs notedDwarf birch nearby	Not peatland	n/a	Largely shallow deposits on gentle slope leading down to loch. Dominated by wet heath vegetation. Not considered peatland.	
Т9	0-90	M15/M19/M25	Exposed peat notedDwarf birch nearby	Not peatland	n/a	Shallow deposits on gentle slope near loch. Some hagged gullies recorded nearby. Dominated by wet heath vegetation. Not considered peatland.	
T10	5-280	M17/M20	 Montane bog Few drains/haggs noted Natural surface pattern Dwarf birch nearby 	 Peat-forming considered possible Modified 	Moderate	Largely shallow at turbine, but northern edge impinges on a pocket of deeper peat. Relatively limited overall extent of habitats however, as the location is surrounded by M15 and dry heath communities. M20 likely to be created and maintained through grazing.

T11	5-195	M15/H12/M19	Exposed peat noted	Not peatland	n/a	Turbine location largely shallow, dominated by wet heath and dry heath communities. Extents of deeper deposits to north and south-east, but turbine location not considered peatland. Exposed peat proposed for restoration to north.	
T12	5-130	M15/H12/M19	Exposed peat notedDwarf birch nearby	Not peatland	n/a	Area of shallow deposits with pockets of deep. Deeper to south, including area of exposed peat proposed for restoration. Patchy sphagnum coverage. Dominated by wet heath and dry heath communities. Not considered to be peatland.

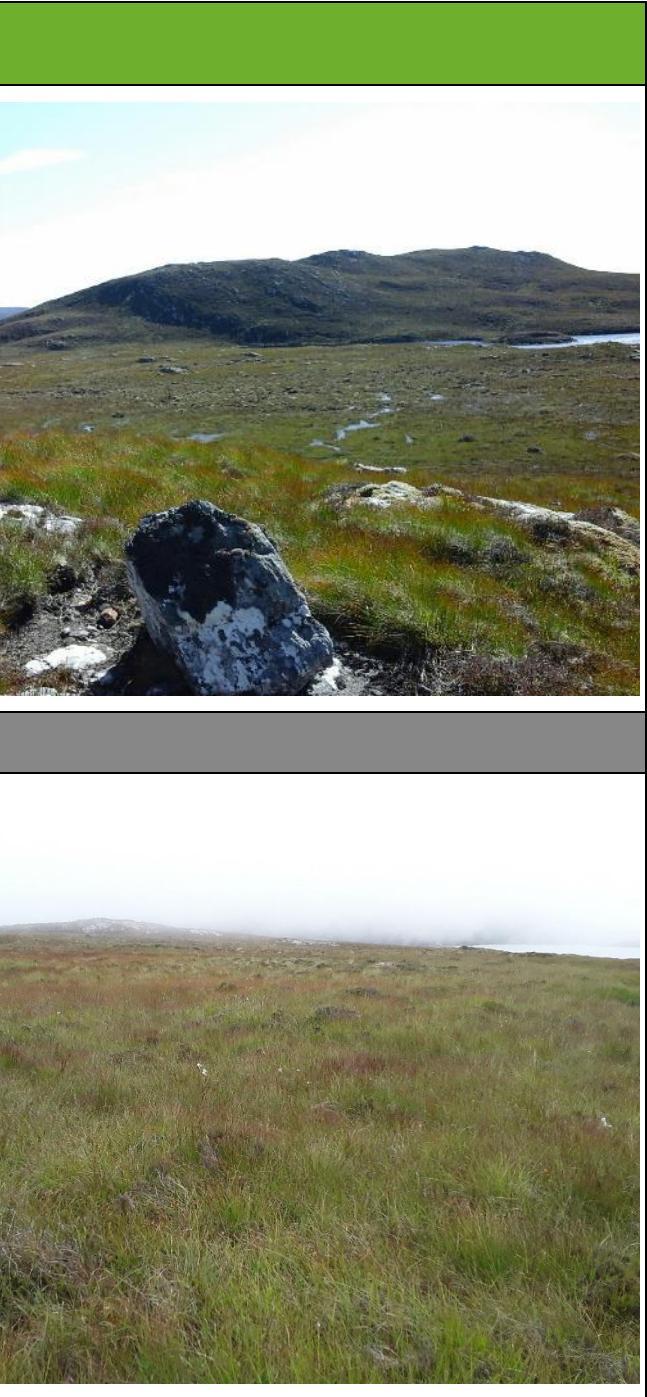
Infrastructure	Peat Depth Range (cm)	NVC Communities	Notable Features	Peatland Activity and Condition	Quality	Comments	Photo
T13	0-95	M15/M19	 Montane bog Continuous unit >25ha Exposed peat noted Natural surface pattern Dwarf birch nearby 	 Peat-forming considered possible Modified 	Moderate	Largely shallow at turbine location, but adjacent to deep deposits so assessed as peatland. Limited sphagnum. Exposed area proposed for restoration adjacent. Largely surrounded by wet heath and dry heath communities, but bog communities form a fairly continuous extent to the west and north-west.	
Other Infrastruct	ture	1					
Met mast	60-70	M20/M15/M19	 Montane bog Continuous unit >25ha Few drains/haggs noted Natural surface pattern Dwarf birch nearby 	 Peat-forming considered possible Modified 	Moderate	Location on the edge of shallow deposits, with deeper peat to the south-east. Patchy sphagnum coverage noted, and many channels leading down to the loch. Vegetation dominated by vegetation indicative of grazing and relatively shallow conditions.

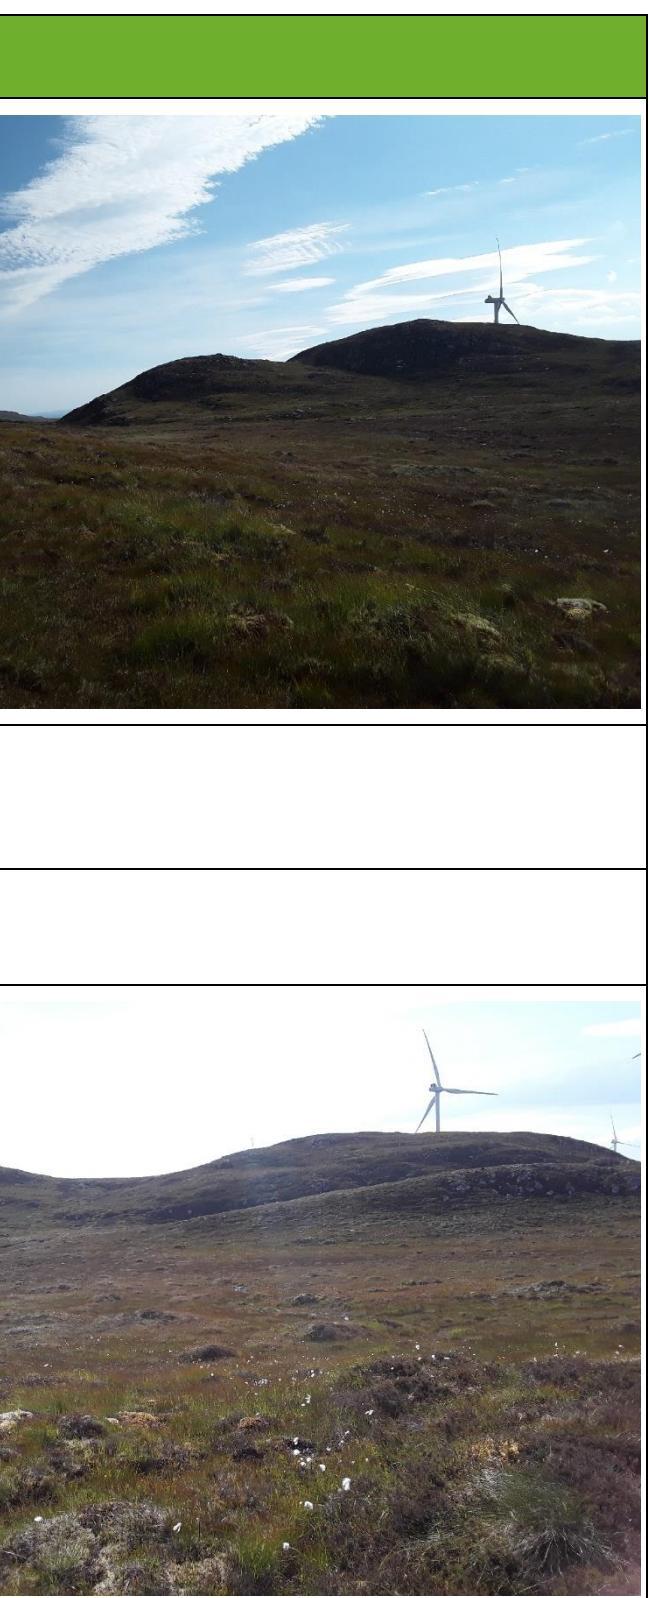
Infrastructure	Peat Depth Range (cm)	NVC Communities	Notable Features	Peatland Activity and Condition	Quality	Comments	Photo
Substation	20-140	M17/M3	 Montane bog Continuous unit >25ha Few drains/haggs noted Natural surface pattern 	 Peat-forming considered likely nearby Near-natural 	High	Substation is located on the edge between shallow deposits to the north-west and deeper peat to the south-east. The area is likely grazed, although not noticeably significantly modified.	
Construction compound	5-100	H22/H10/M15/ M17	Few drains/haggs noted	Not peatland	n/a	Largely shallow deposits on a gentle slope of dry heath, with only small pockets of deep peat within the infrastructure footprint. Extents of montane bog present to the south.	No photo
Borrow pit	0-125	H22/M15/M17	Few drains/haggs noted	Not peatland	n/a	Vegetation dominated by dry heath with extents of wet heath. Largely shallow peat, with limited pockets of deeper deposits supporting bog communities.	No photo

Track section: approach to substation	5-290	M19	 Montane bog Continuous unit >25ha Exposed peat noted 	 Peat-forming considered unlikely Modified 	Low	Area of relatively drier bog vegetation on approach to substation where track crosses deep peat. Erosion feature noted nearby. No rare features recorded, and limited abundance of bog specialists (e.g. sphagnum)

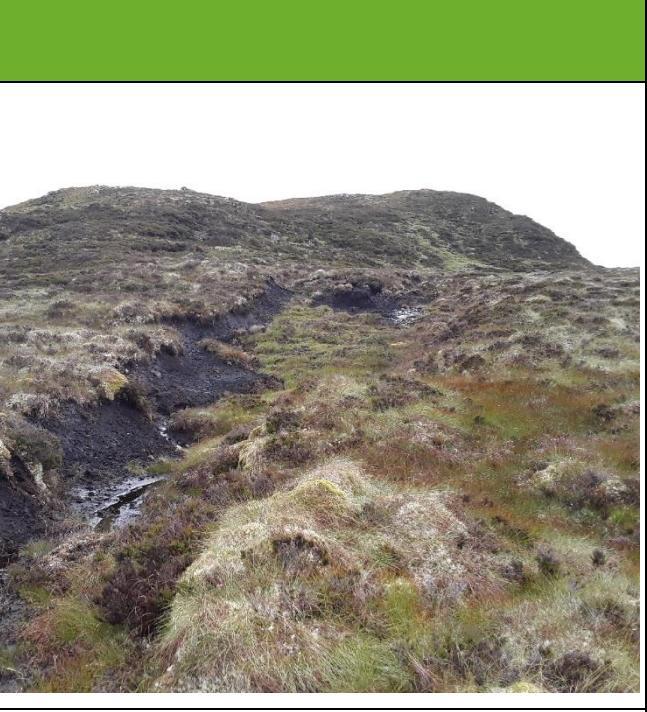
Infrastructure	Peat Depth Range (cm)	NVC Communities	Notable Features	Peatland Activity and Condition	Quality	Comments	Photo
Track section: T9 to T10	30-140	M19/M15	 Montane bog Continuous unit >25ha Exposed peat noted Dwarf birch nearby 	Peat-forming considered possibleModified	Moderate	Gentle slope down to loch, with drier bog community dominated by heather and deergrass. Sphagnum coverage noted to be patchy. Erosion features apparent in the slope.	
Track section: to T11	50-155	M20/M19/M15/ H10	Montane bogExposed peat notedNatural surface pattern	Peat-forming considered unlikelyActively eroding	Low	Flat area with pools and channels. Area of hagging and exposed peat noted. Mosaic of communities reflecting variable underlying conditions.	No photo
