Coille Beith Wind Farm EIA Report

Technical Appendix 8.2: Peat Survey Report

June 2025

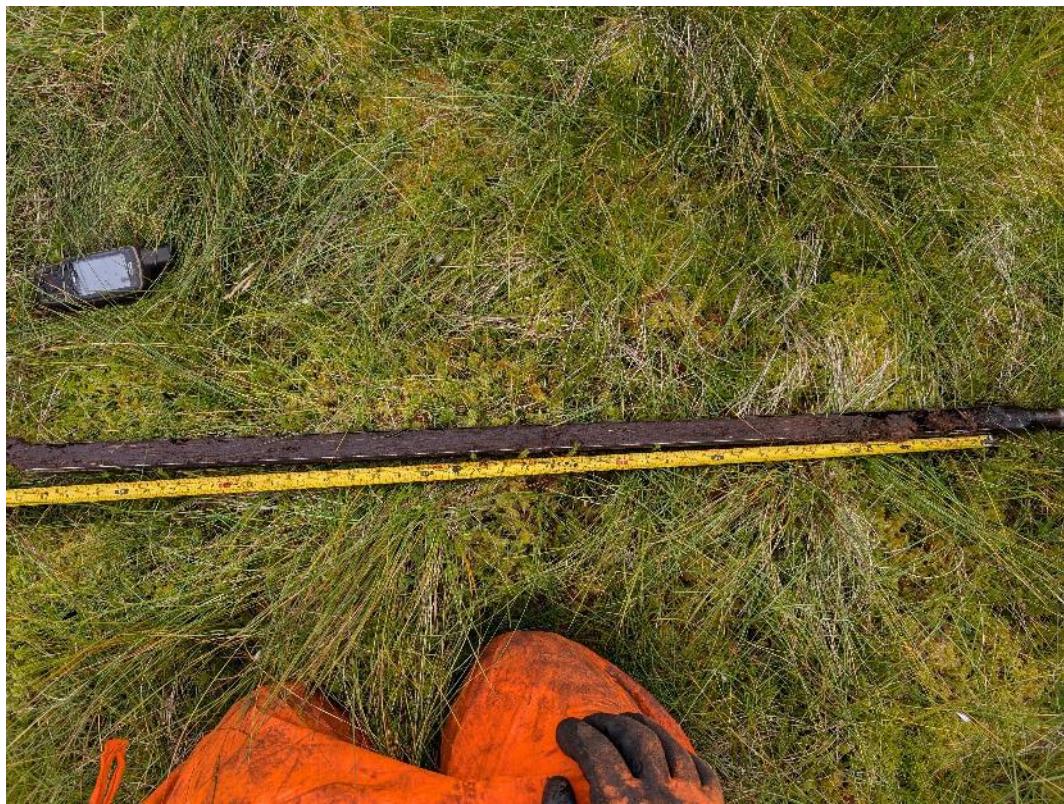
Photo 1 Example of a peat core showing distinct layers of acrotelm and catotelm.

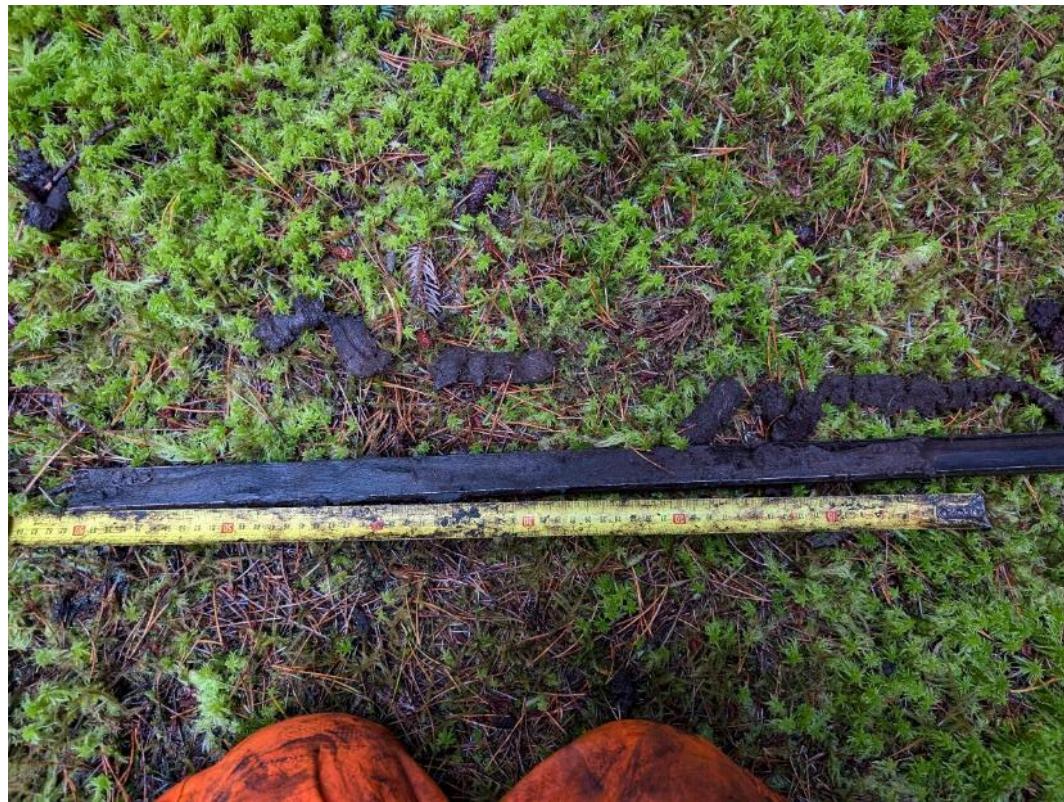
Photo 2 Example of a layer of peaty clay substrate in a core.

- 4.2.3 In three locations the probe overestimated the peat depth.
 - **by 0.20 m in core 302** where the probe recorded 1.50 m compared to 1.30 m observed in the core. This was due to a layer of peaty clay in the core that was indistinguishable from peat using the probe;

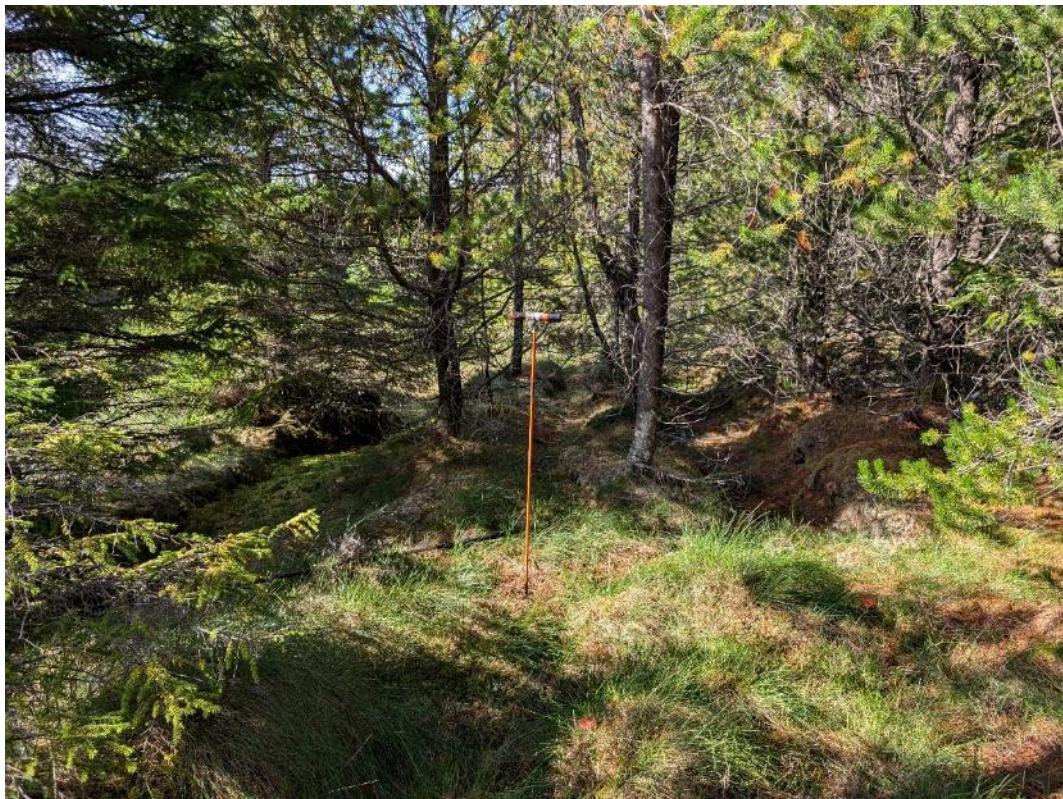
Photo 3 Example of ground conditions on site.

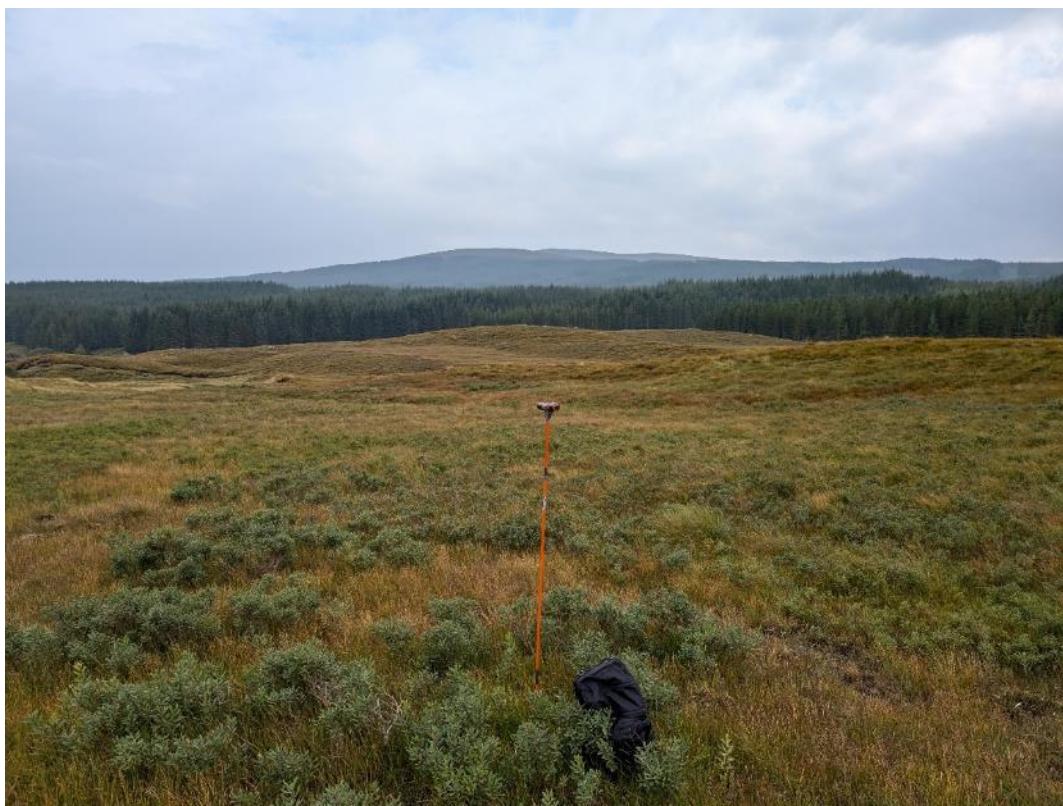
Photo 4 Example of ground conditions on site.

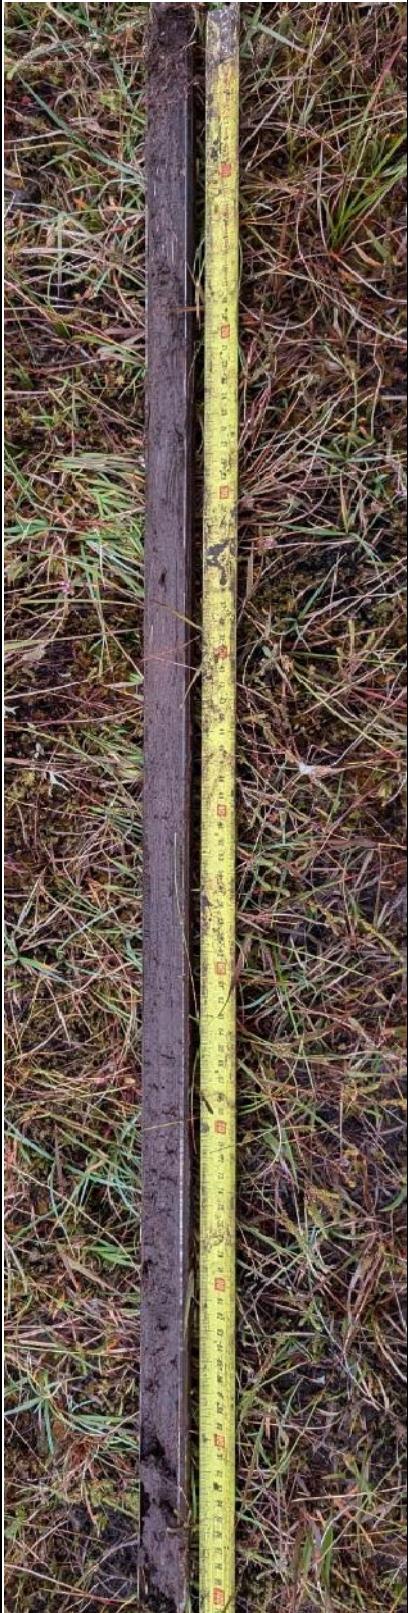
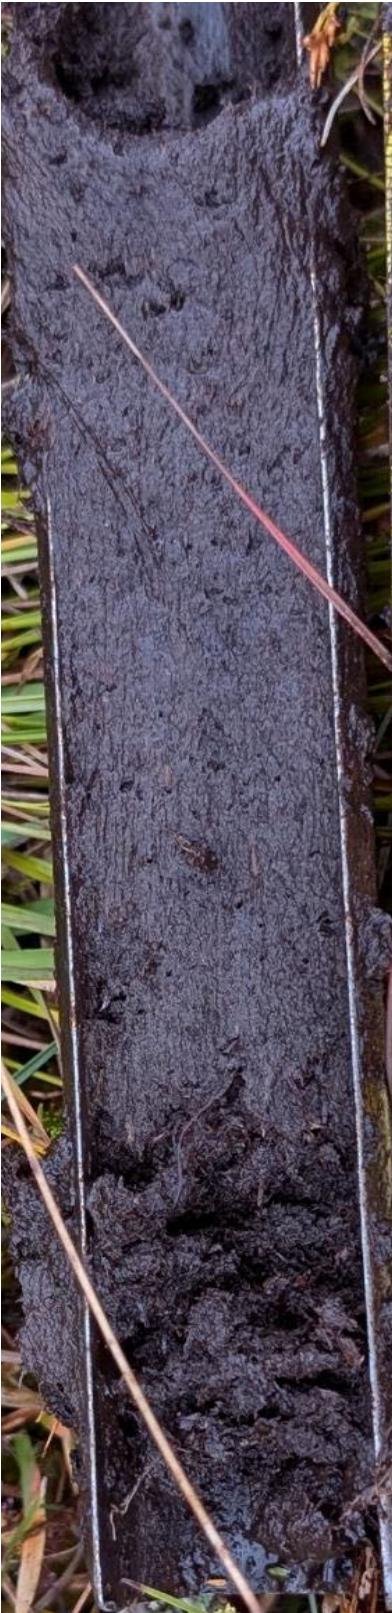
0-1m		Formation	1-1.15m		Formation

Acrotelm

Catotelm
		Catotelm			Rock at 1.15m
