# Appendix 8.3: Watercourse Crossing Assessment

Giants Burn Wind Farm

**Client:** Statkraft  
**Reference:** C5826-1442  
Version 1.0

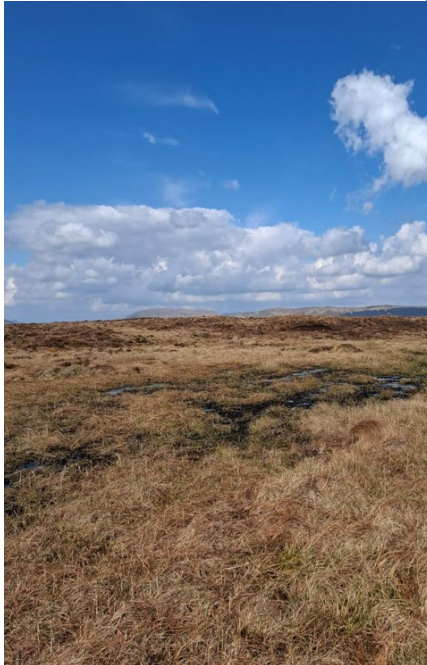
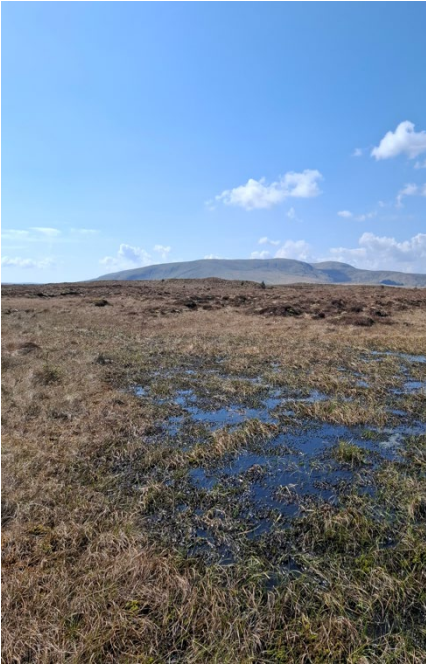
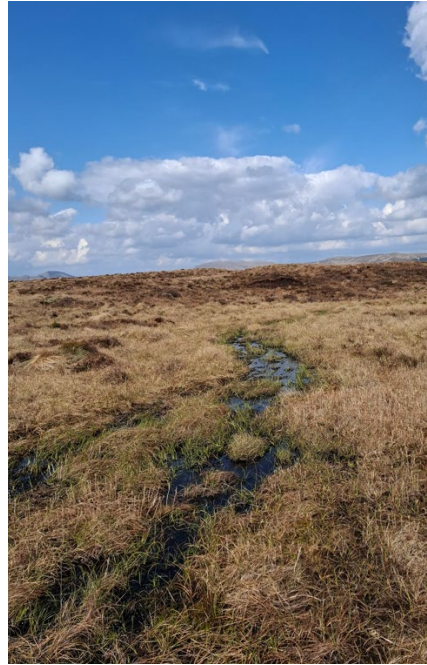
| Water Crossing 12 | | |
|---|---|---|
| <p>Watercourse Name (As shown on 1:10,000 scale OS mapping): Allt a Chromain</p> <p>Easting: 214418      Northing: 679406      Type of Crossing: Flush Crossing</p> <p>Description: This water crossing is located at the headwaters of Allt a Chromain. A wide area of waterlogged ground was observed with some instances of pooling.</p> <p>There was no distinct channel or embankment visible, instead water collects in this area before flowing downhill to the east. A flush crossing has been considered for this location to avoid any disruption to flow paths or supply into the Allt a Chromain.</p> | | |
| Across | Upstream | Downstream |
