## Appendix 9.2 Peat Survey Report

### Introduction

Fluid Environmental Consulting Ltd (Fluid) were commissioned by Statkraft to complete depth of penetration probing and coring at the site of the Proposed Development. The site is located approximately 4.8 km south of Straiton, South Ayrshire, Scotland and covers an area of 540 ha. The site slopes northwards, in places steeply, from higher ground in the south.

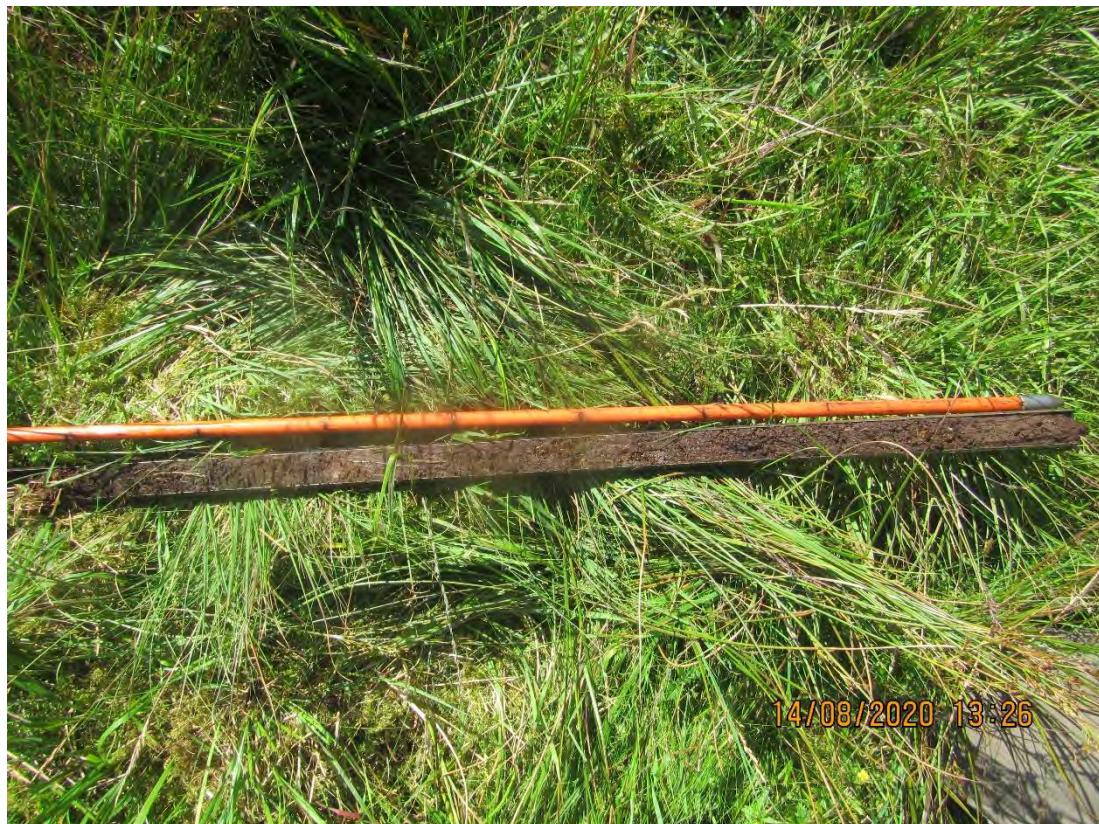
Photo 1 Example of a peat core showing a distinct layer of acrotelm.

A series of cores have therefore been obtained using a gouge auger to determine the actual depth of the peat and obtain a sample of the underlying formation. Observations on the soil and peat characteristics were determined from the cores using recognised criteria (Von Post assessment). The acrotelm, catotelm and amorphous layers (if present) within the peat have also been identified within the peat where possible. The probes and gouge auger used at the Proposed Development are of the types shown in Photo 1, Annex I of this Technical Appendix 9.2 report.

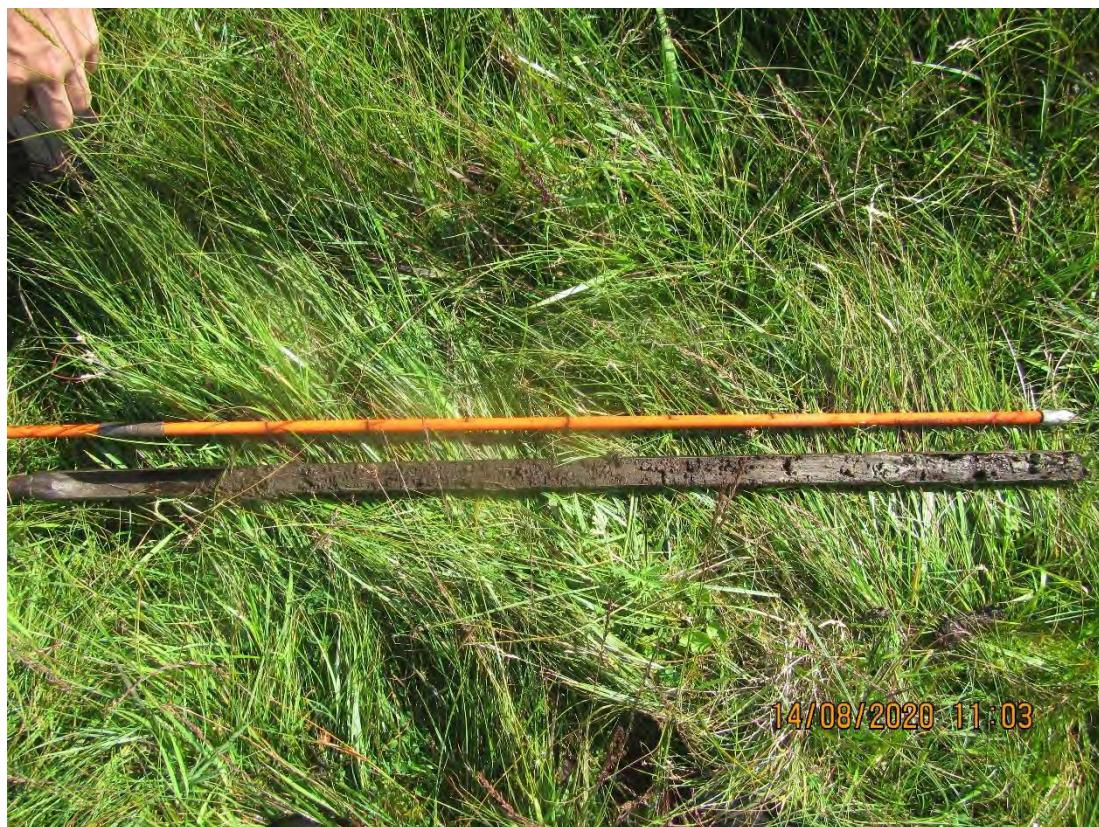
Photo 2 Example of a layer of clay in a core.

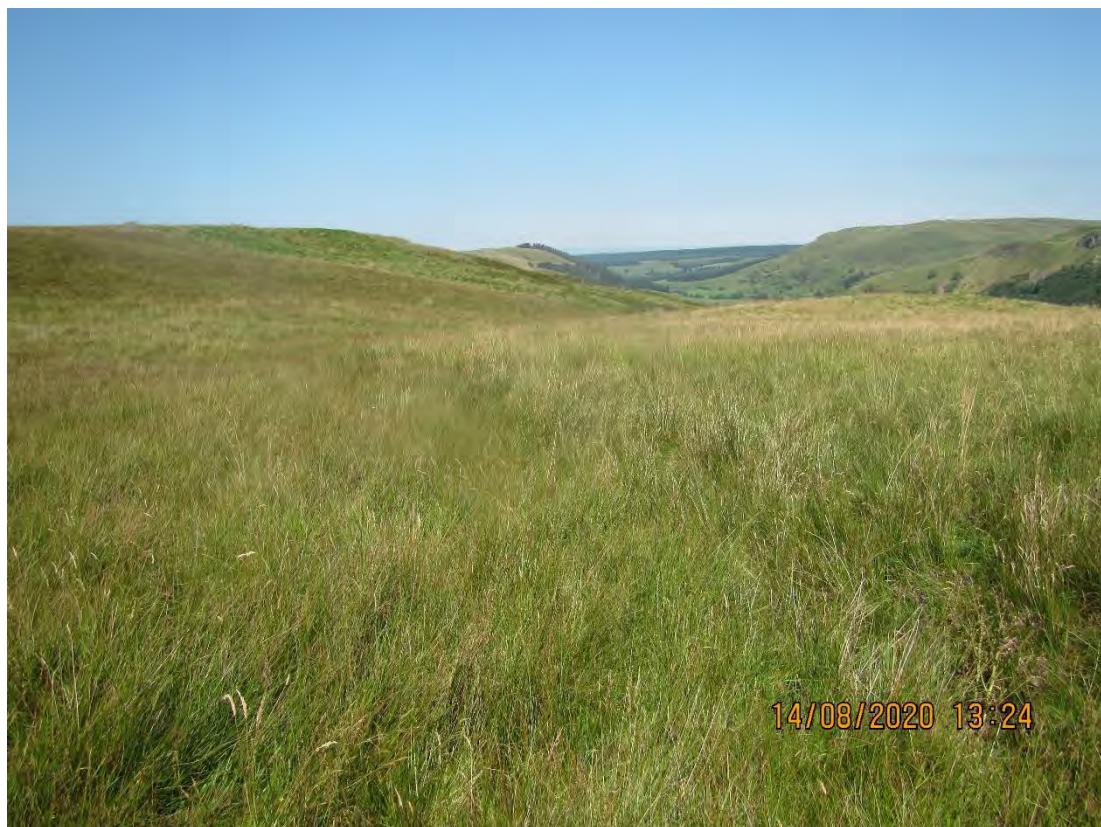
Photo 3 Example of ground conditions on site.

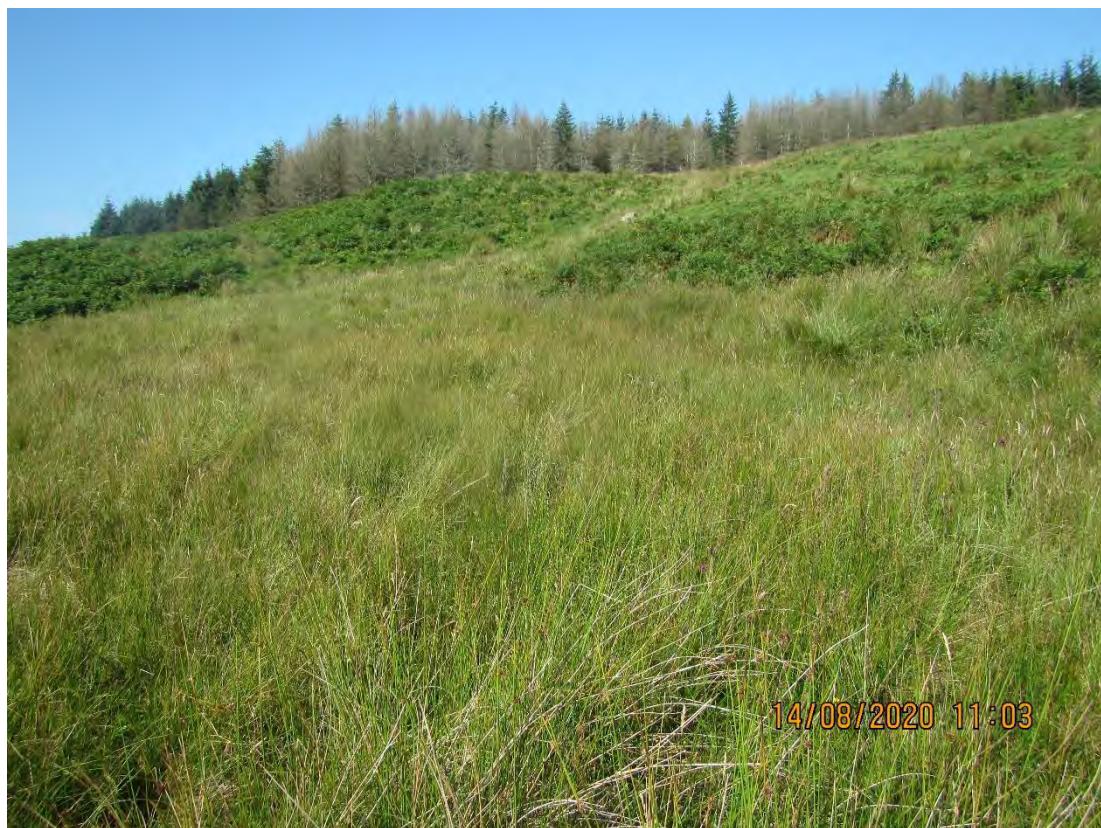
Photo 4 Example of ground conditions on site.

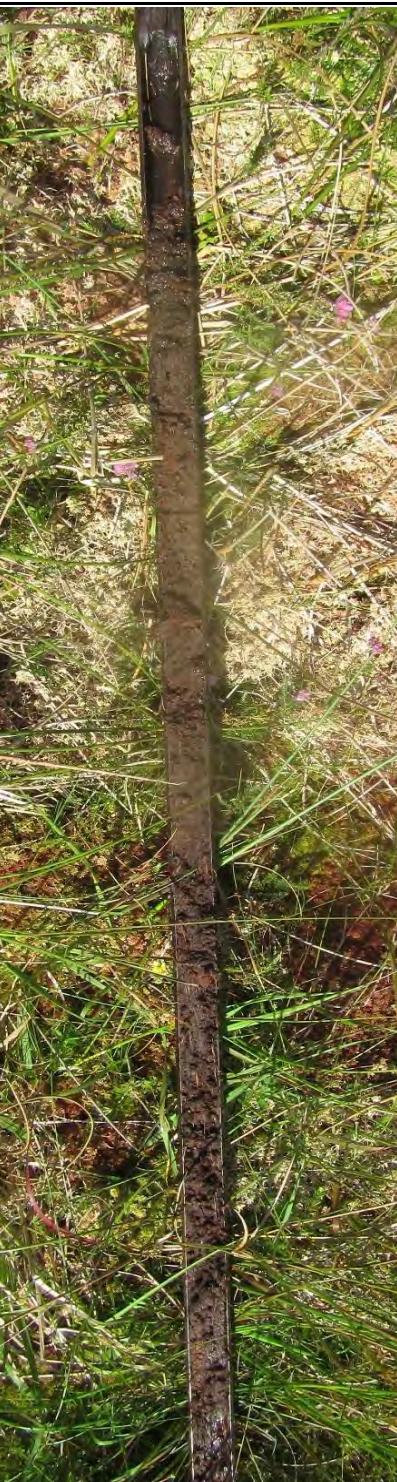
Site	Knockcronal Wind Farm	Easting	237310
Client	ITP Energised	Northing	237310
Survey Dates	11 – 14/8/2020	Probe Depth (m)	1.10
Core Number	Pr_108	Auger Depth (m)	1.10
Page	1 of 1

Acrotelm	0.20	0.20	H3 B5

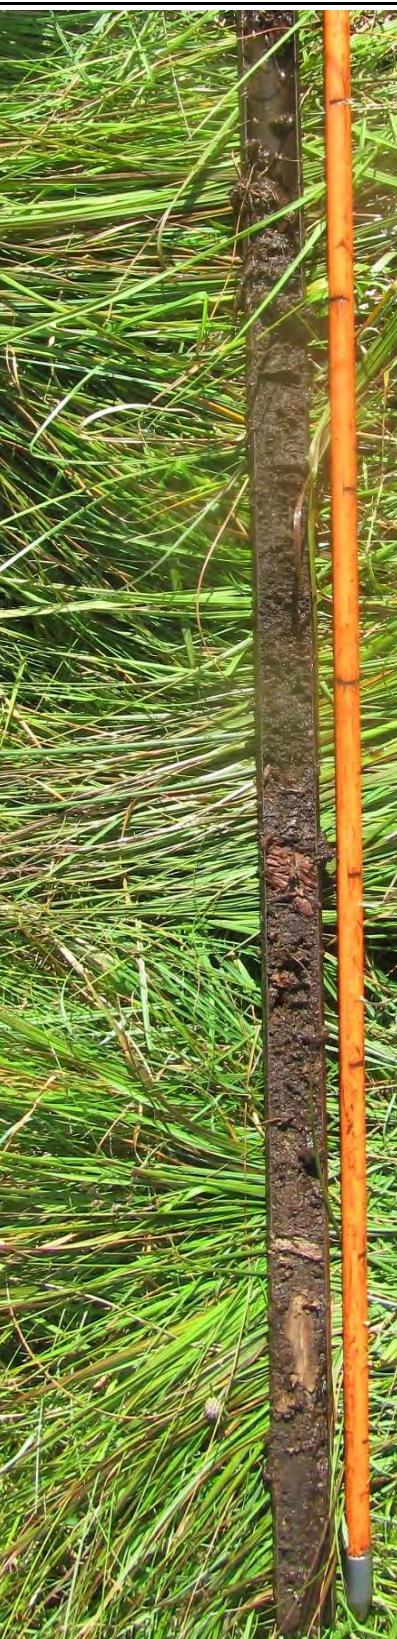
Site	Knockcronal Wind Farm	Easting	237510
Client	ITP Energised	Northing	237510
Survey Dates	11 – 14/8/2020	Probe Depth (m)	0.85
Core Number	Pr_156	Auger Depth (m)	0.85
Page	1 of 1

Acrotelm	0.15	0.15	H3	B5	
	Catotelm	0.85	0.70	H8	B4	at 0.70m
				Rock at 0.85m

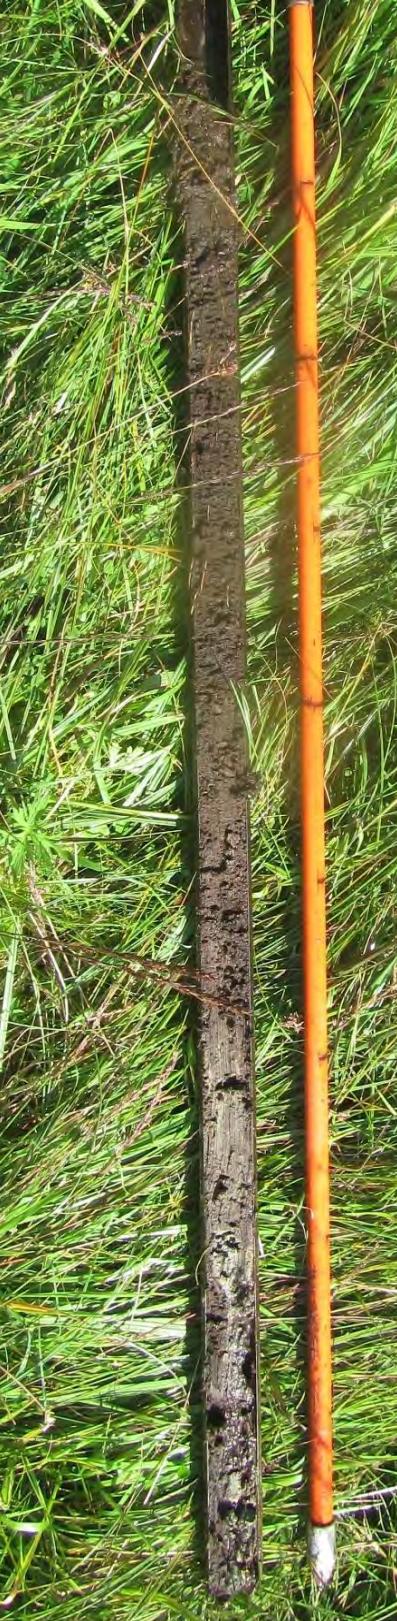
Site	Knockcronal Wind Farm	Easting	236810
Client	ITP Energised	Northing	236810
Survey Dates	11 – 14/8/2020	Probe Depth (m)	0.80
Core Number	Pr_28	Auger Depth (m)	0.90
Page	1 of 1

Acrotelm	0.15	0.15	H3 B4
	Catotelm	0.60	0.45	H7 B4 at 0.50m
			Silty clay at 0.6m

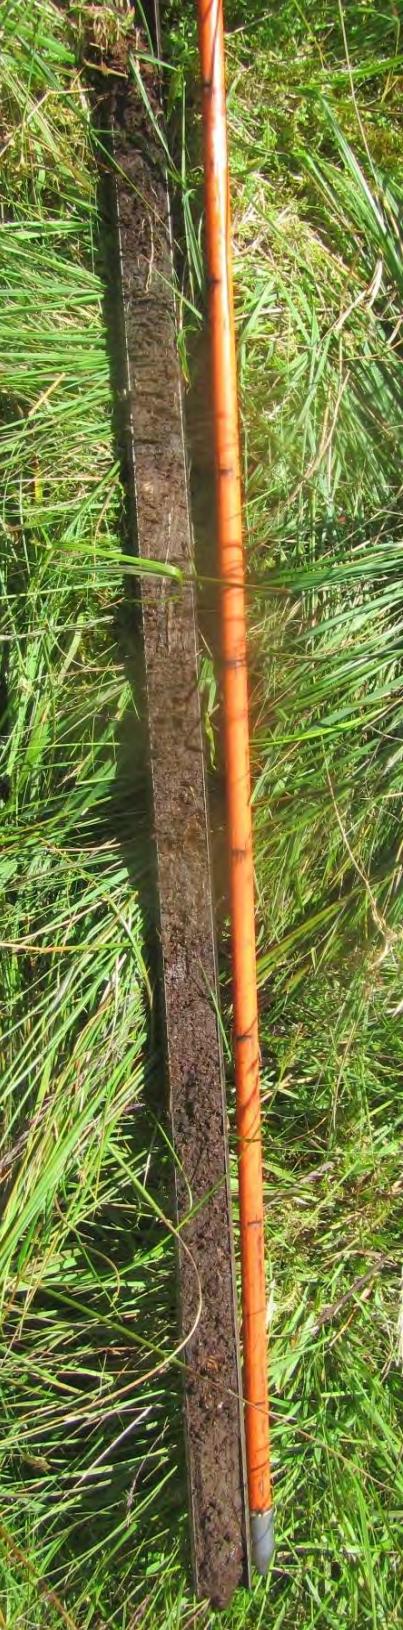
Site	Knockcronal Wind Farm	Easting	238210
Client	ITP Energised	Northing	238210
Survey Dates	11 – 14/8/2020	Probe Depth (m)	0.85
Core Number	Pr_336	Auger Depth (m)	0.85
Page	1 of 1

Acrotelm	0.10	0.10	H4 B2		
	Catotelm	0.85	0.75	H7	B3	at 0.75m
				Rock at 0.85m

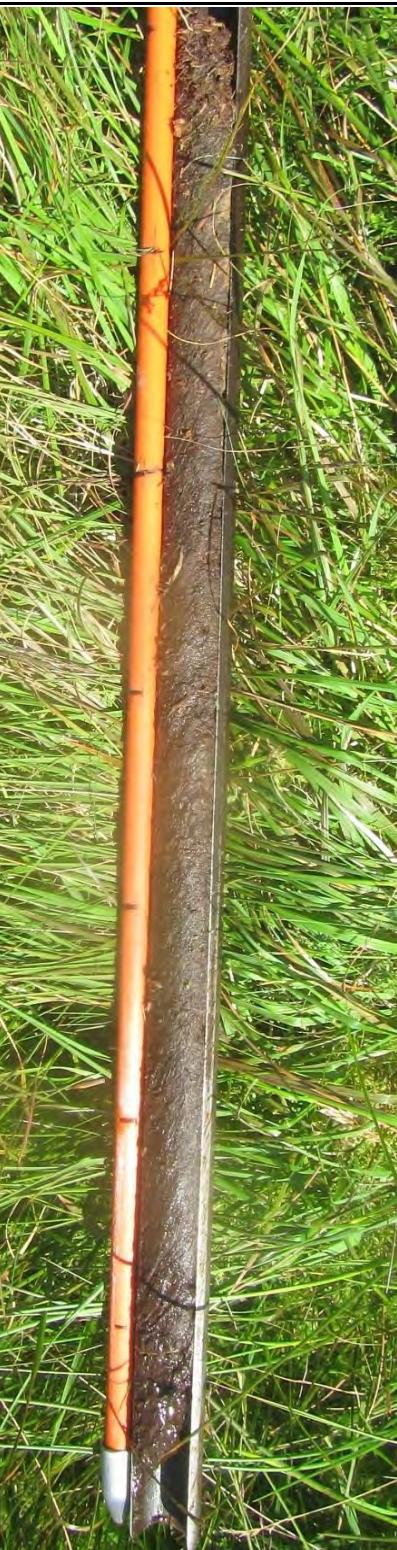
Site	Knockcronal Wind Farm	Easting	238510
Client	ITP Energised	Northing	238510
Survey Dates	11 – 14/8/2020	Probe Depth (m)	0.70
Core Number	Pr_405	Auger Depth (m)	0.70
Page	1 of 1

Acrotelm	0.10	0.10	H2 B3		
	Catotelm	0.70	0.60	H7	B3	at 0.50m
				Rock at 0.7m

Notes:	
Open moor, gentle slope

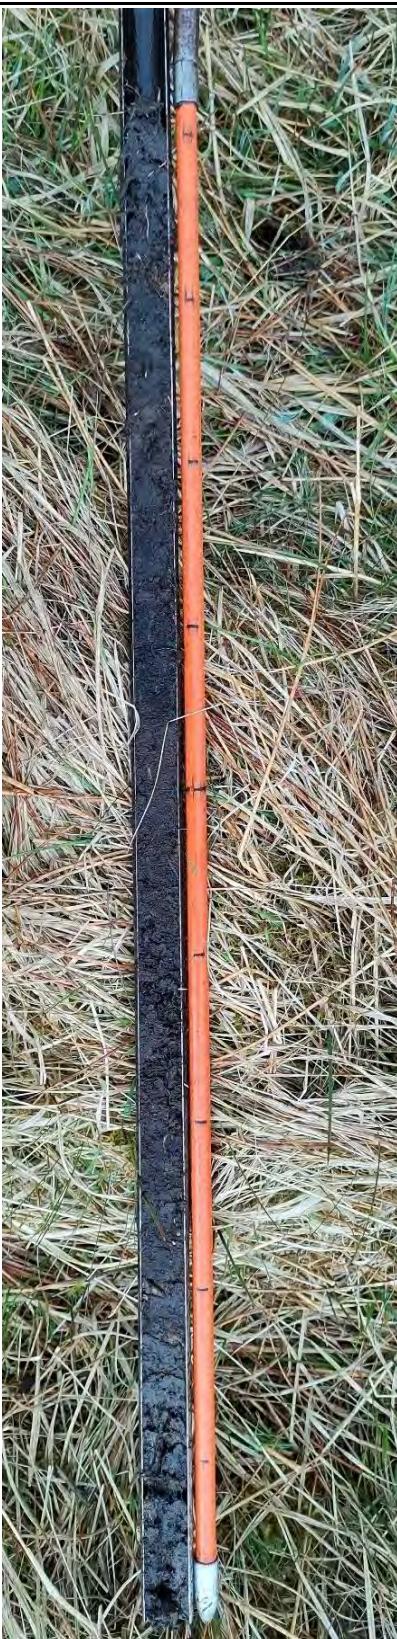
Site	Knockcronal Wind Farm	Easting	237240
Client	ITP Energised	Northing	599876
Survey Dates	3 - 15/5/2021	Probe Depth (m)	0.95
Core Number	CC_23	Auger Depth (m)	0.95
Page	1 of 1

Acrotelm	0.15	0.15	H3 B4
	Catotelm	0.95	0.80	H5 B4 at 0.80m
Thin layer of gritty silt on top of rock at 0.95 m

Notes:	
Open moor, gentle slope

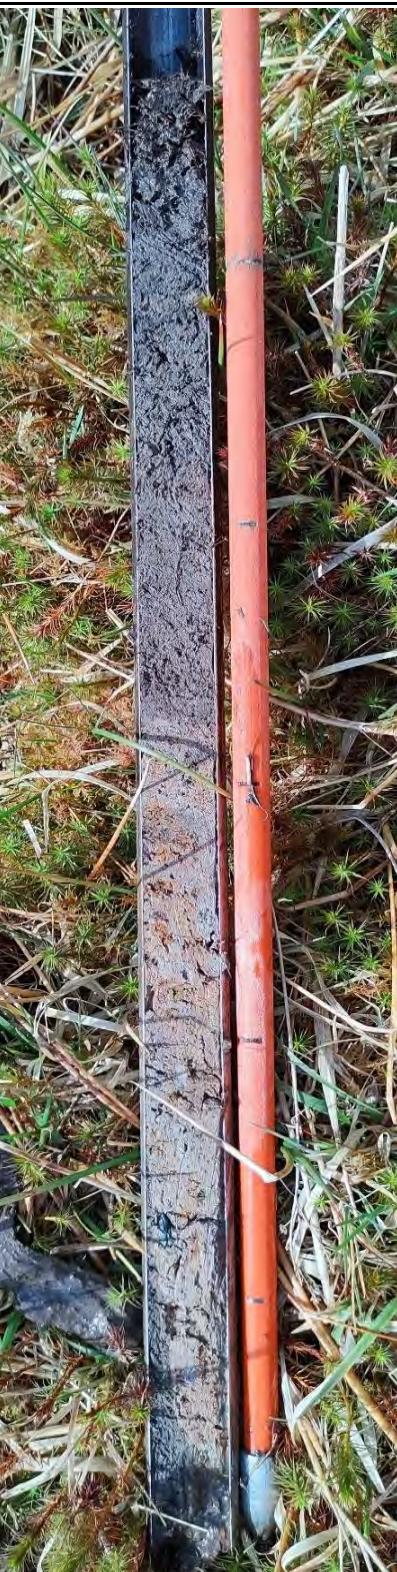
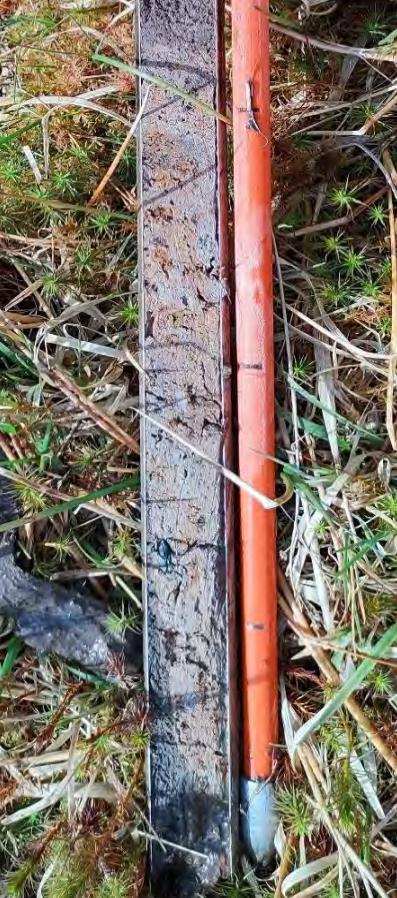
Site	Knockcronal Wind Farm	Easting	237914
Client	ITP Energised	Northing	599593
Survey Dates	3 - 15/5/2021	Probe Depth (m)	0.25
Core Number	CC_25	Auger Depth (m)	0.60
Page	1 of 1

Gritty silt mixed with peat	0.25	0.25

Gritty clay at 0.25m

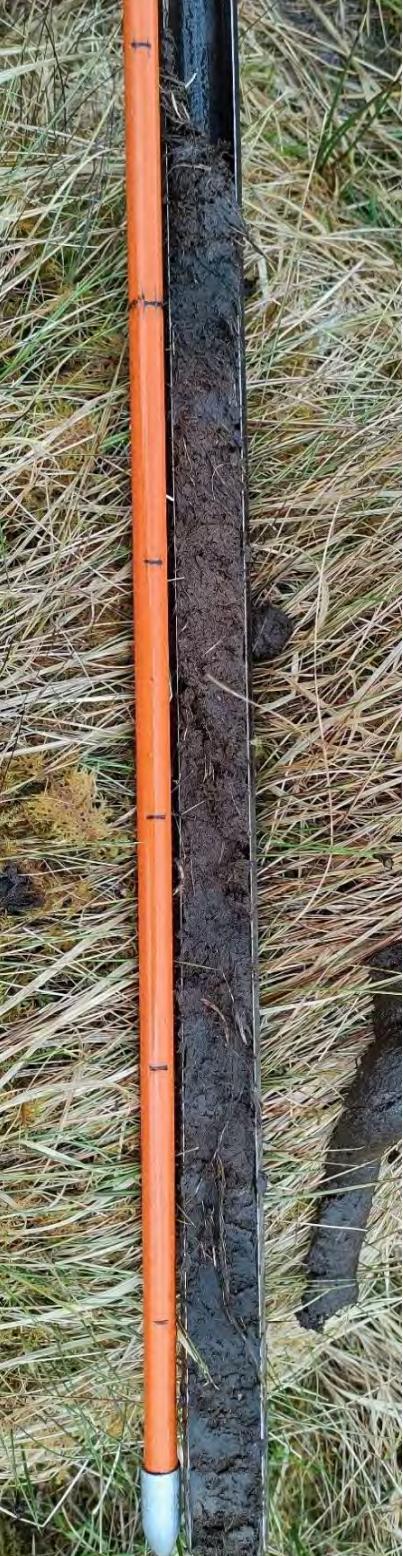
Site	Knockcronal Wind Farm	Easting	237144
Client	ITP Energised	Northing	599242
Survey Dates	3 - 15/5/2021	Probe Depth (m)	0.60
Core Number	CC_28	Auger Depth (m)	0.60
Page	1 of 1

Acrotelm	0.20	0.20	H2 B4
	Catotelm	0.55	0.35	H5 B4 at 0.45m
Grit mixed with peat at 0.55m, rock at 0.60m

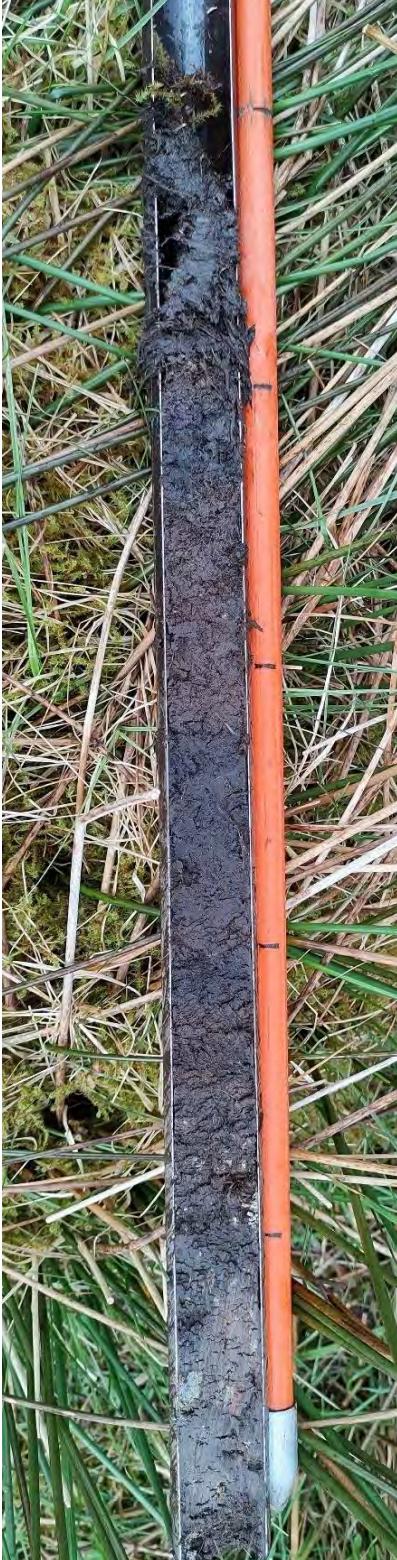
Site	Knockcronal Wind Farm	Easting	238228
Client	ITP Energised	Northing	599394
Survey Dates	3 - 15/5/2021	Probe Depth (m)	0.40
Core Number	CO_01	Auger Depth (m)	0.50
Page	1 of 1

Acrotelm	0.10	0.10	H2 B4
	Catotelm	0.35	0.25	H7 B4 at 0.30m
				Clayey silt at 0.35m

Open moor, gentle slope

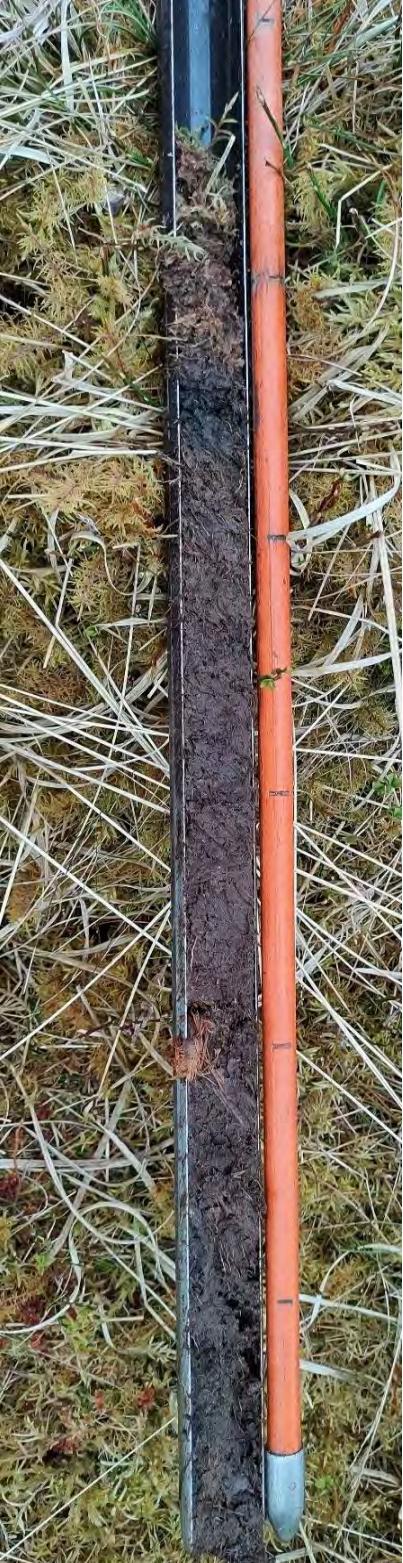
Site	Knockcronal Wind Farm		Easting	234157
Client	ITP Energised		Northing	601032
Survey Dates	3 - 15/5/2021		Probe Depth (m)	0.55
Core Number	CO_02		Auger Depth (m)	0.55
Page	1 of 1			
	Formation	Depth (m)	Thickness (m)	Von Post

Acrotelm	0.10	0.10	H2 B3
	Catotelm	0.55	0.45	H6 B4 at 0.50m
	Rock at 0.55m			
Notes:				
Cleared forestry, fairly flat

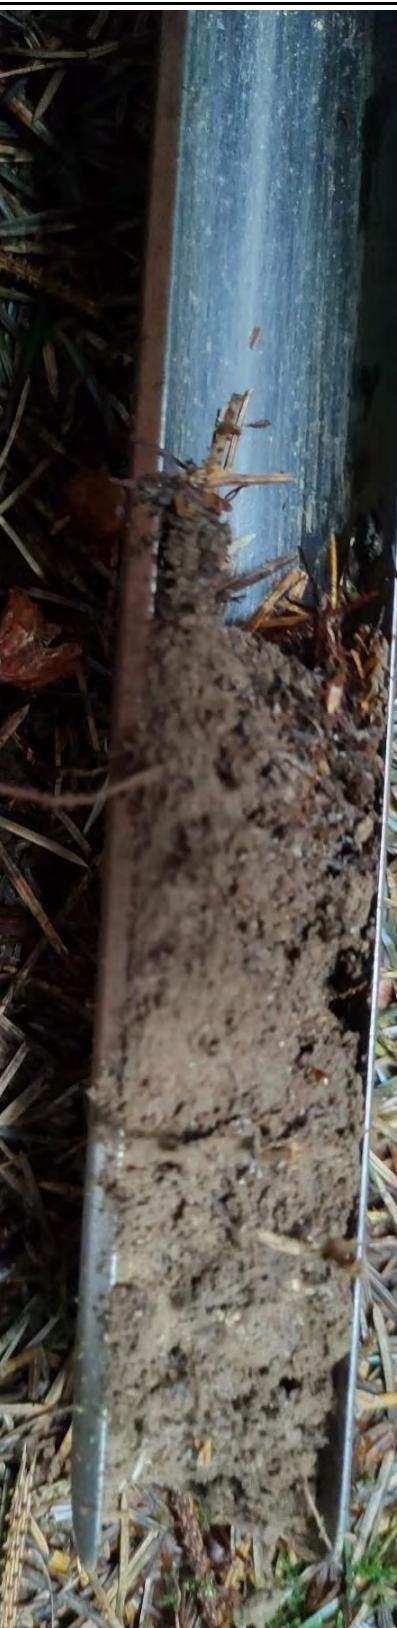
Site	Knockcronal Wind Farm	Easting	236070
Client	ITP Energised	Northing	603872
Survey Dates	3 - 15/5/2021	Probe Depth (m)	0.00
Core Number	CO_03	Auger Depth (m)	0.10
Page	1 of 1

Silty topsoil	0.10	0.10

Notes:  
Forestry, gentle slope

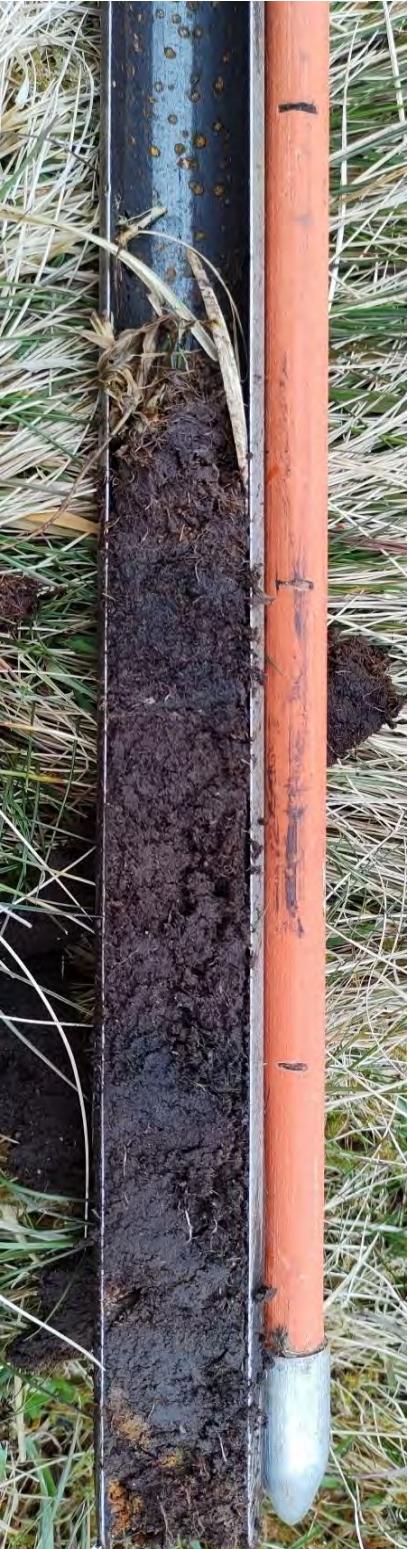
Site	Knockcronal Wind Farm		Easting	237830
Client	ITP Energised		Northing	600140
Survey Dates	3 - 15/5/2021		Probe Depth (m)	0.30
Core Number	CO_04		Auger Depth (m)	0.25
Page	1 of 1			
	Formation	Depth (m)	Thickness (m)	Von Post

Acrotelm	0.05	0.05	H3 B2
	Catotelm	0.25	0.20	H7 B2 at 0.20m
	Silt at 0.25 m			
Notes:				
Open moor, gentle slope

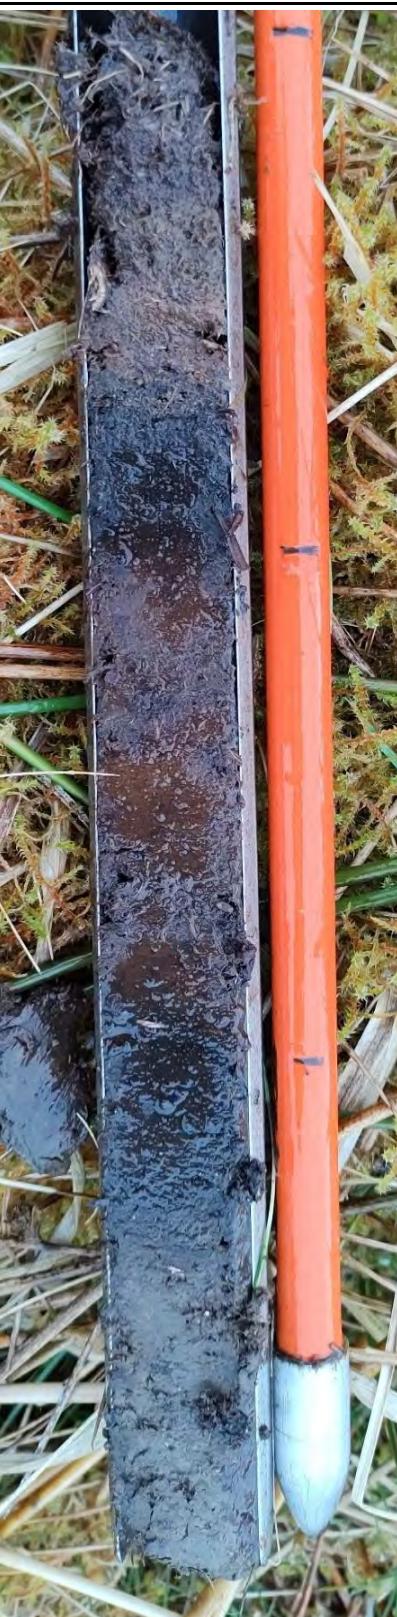
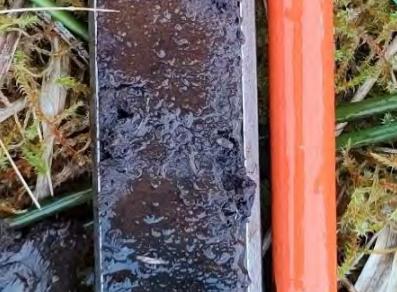
Site	Knockcronal Wind Farm	Easting	237432
Client	ITP Energised	Northing	600070
Survey Dates	3 - 15/5/2021	Probe Depth (m)	0.20
Core Number	CO_07	Auger Depth (m)	0.30
Page	1 of 1

Acrotelm	0.10	0.10	H2 B4

Catotelm	0.20	0.10	H6 B3 at 0.15m
				Silt at 0.20 m

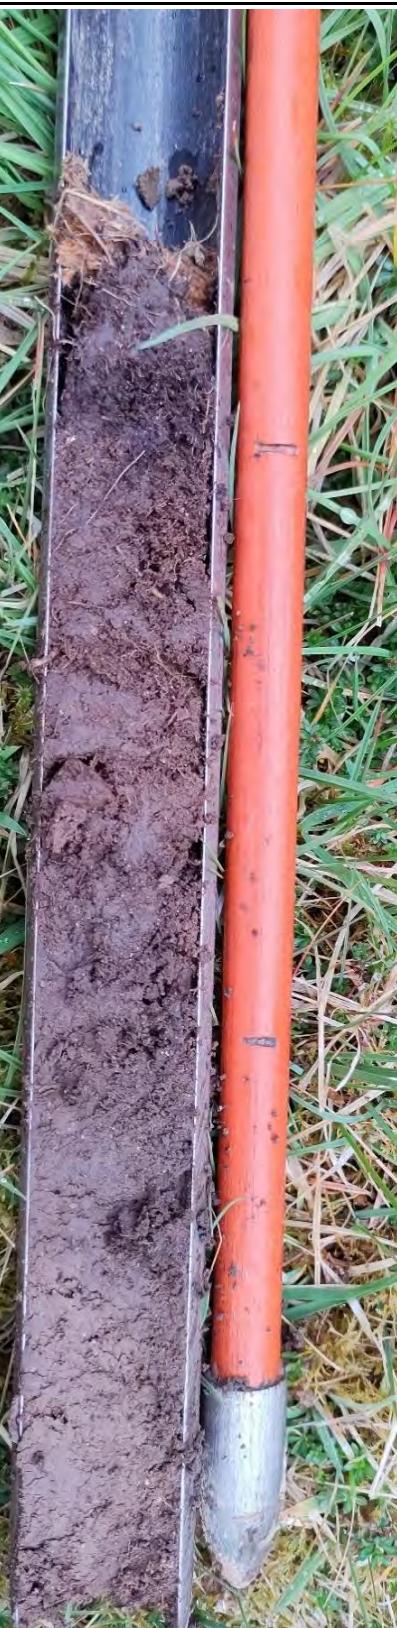
Site	Knockcronal Wind Farm	Easting	235257
Client	ITP Energised	Northing	600487
Survey Dates	3 - 15/5/2021	Probe Depth (m)	0.00
Core Number	CO_09	Auger Depth (m)	0.25
Page	1 of 1

Sandy silty soil	0.25	0.25

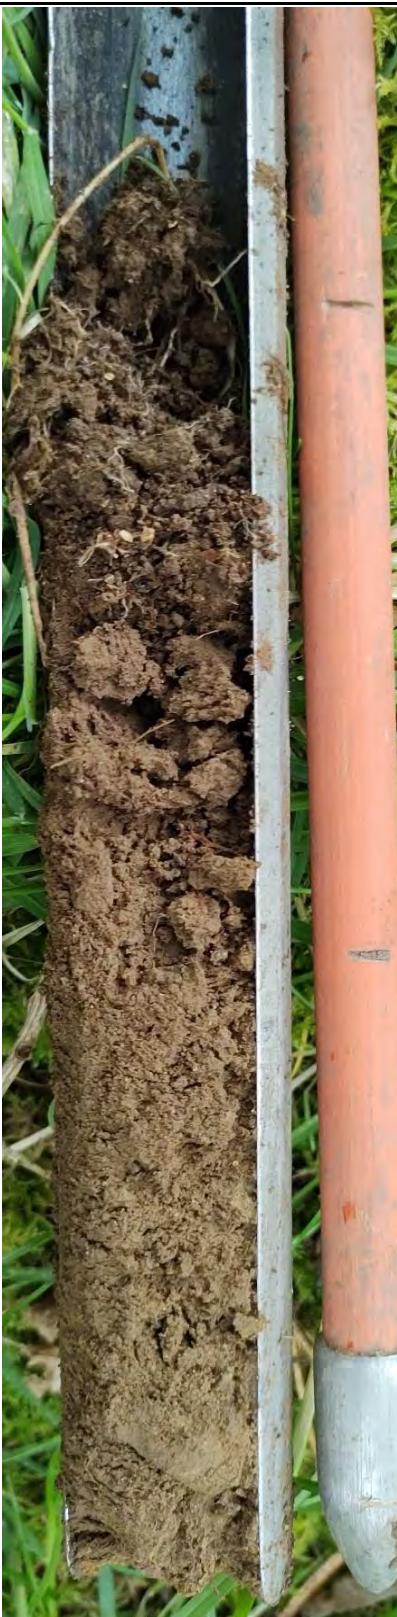
Site	Knockcronal Wind Farm	Easting	237157
Client	ITP Energised	Northing	604424
Survey Dates	3 - 15/5/2021	Probe Depth (m)	0.00
Core Number	CO_12	Auger Depth (m)	0.20
Page	1 of 1

Silty topsoil	0.20	0.20

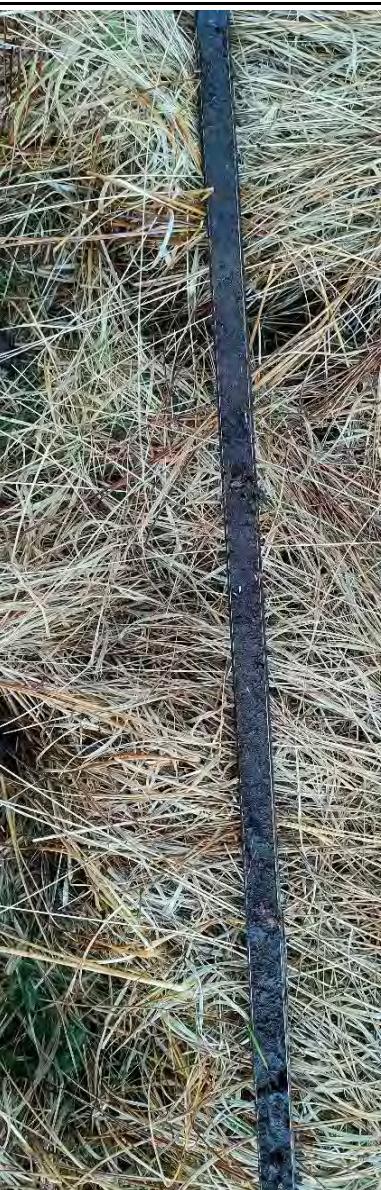
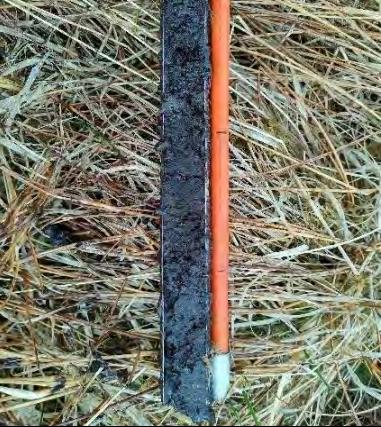
Site	Knockcronal Wind Farm	Easting	236759
Client	ITP Energised	Northing	599642
Survey Dates	3 - 15/5/2021	Probe Depth (m)	1.30
Core Number	CT_15	Auger Depth (m)	1.30
Page	1 of 1

Acrotelm	0.10	0.10	H4 B3

Catotelm	1.30	1.20	H7 B3 at 10.80m

H7 B3 at 1.20m
				Rock at 1.30m
Notes:				
Open moor, gentle slope

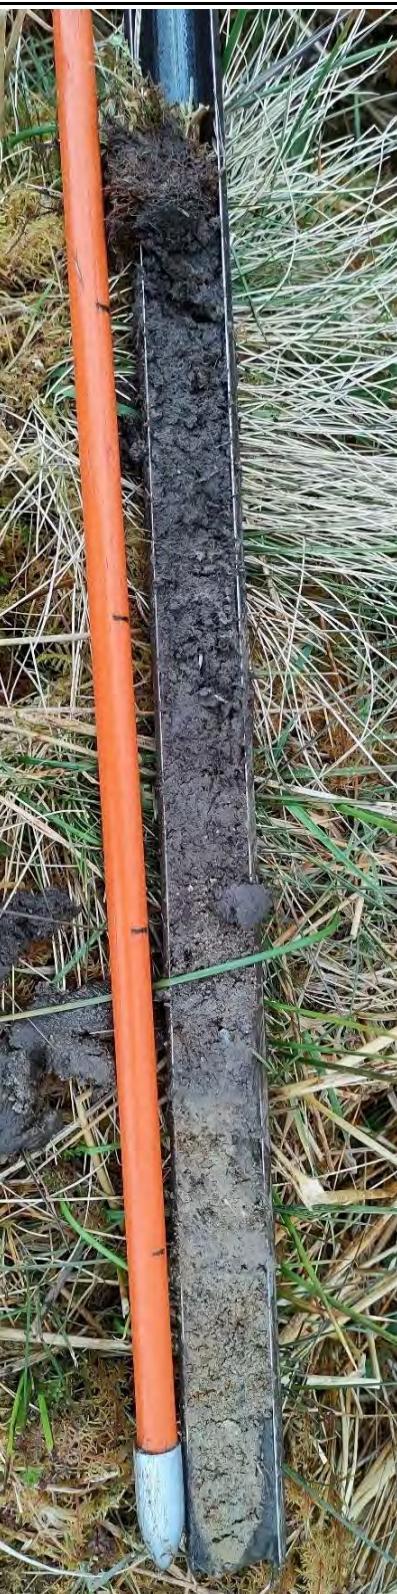
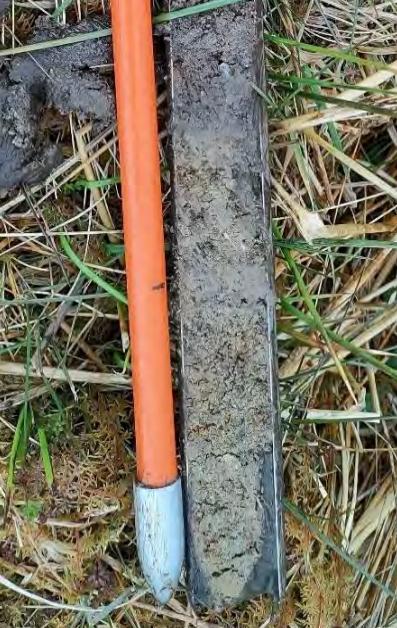
Site	Knockcronal Wind Farm	Easting	237972
Client	ITP Energised	Northing	599514
Survey Dates	3 - 15/5/2021	Probe Depth (m)	0.30
Core Number	CT_16	Auger Depth (m)	0.45
Page	1 of 1

Clayey peaty soil	0.30	0.30

Gritty silt at 0.25m

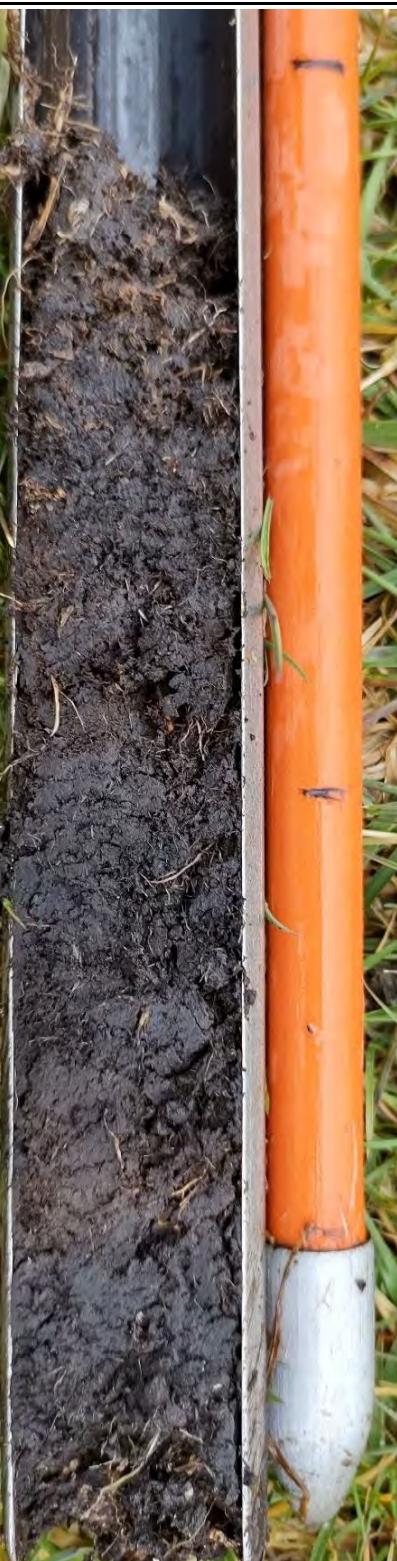
Site	Knockcronal Wind Farm	Easting	237259
Client	ITP Energised	Northing	599234
Survey Dates	3 - 15/5/2021	Probe Depth (m)	0.20
Core Number	CT_19	Auger Depth (m)	0.20
Page	1 of 1

Acrotelm	0.05	0.05	H4 B3
	Catotelm	0.20	0.15	H6 B3 at 0.15m
Thin layer of grit on top of rock at 0.20m

Notes:  
Grassy field, gentle slope

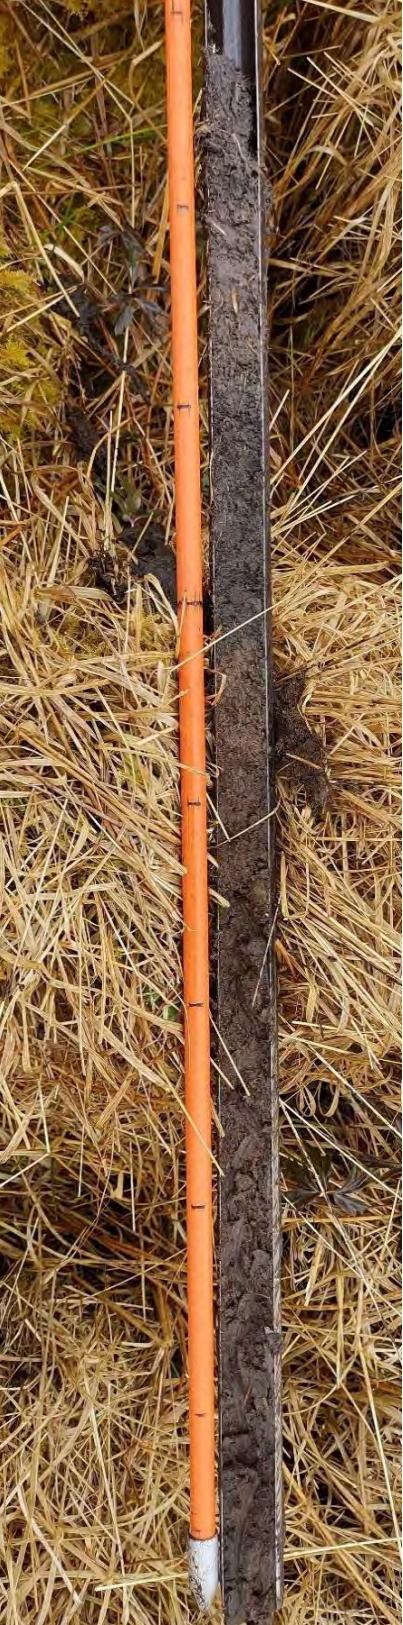
Site	Knockcronal Wind Farm	Easting	237701
Client	ITP Energised	Northing	599166
Survey Dates	3 - 15/5/2021	Probe Depth (m)	0.70
Core Number	CT_21	Auger Depth (m)	0.80
Page	1 of 1

Acrotelm	0.10	0.10	H3 B4
	Catotelm	0.70	0.60	H6 B4 at 0.60m
Gritty clay mixed with peat below 0.70m, rock at 0.80m

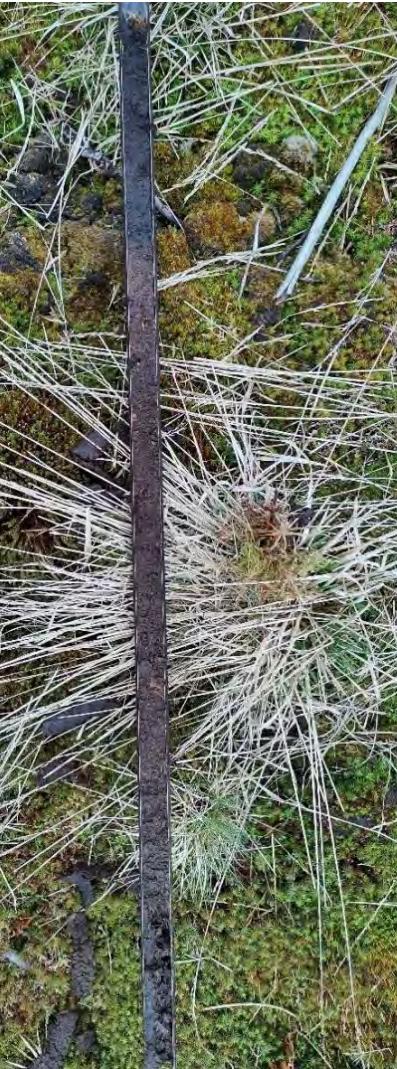
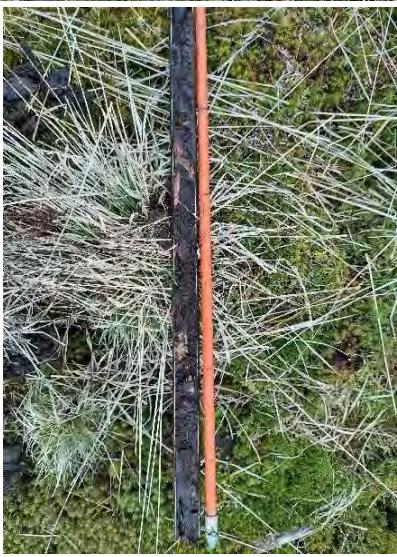
Site	Knockcronal Wind Farm	Easting	234140
Client	ITP Energised	Northing	601023
Survey Dates	3 - 15/5/2021	Probe Depth (m)	1.60
Core Number	CX_31	Auger Depth (m)	1.60
Page	1 of 1

Catotelm	1.60	1.60	H7 B3 at 0.80m
				Rock at 1.60m

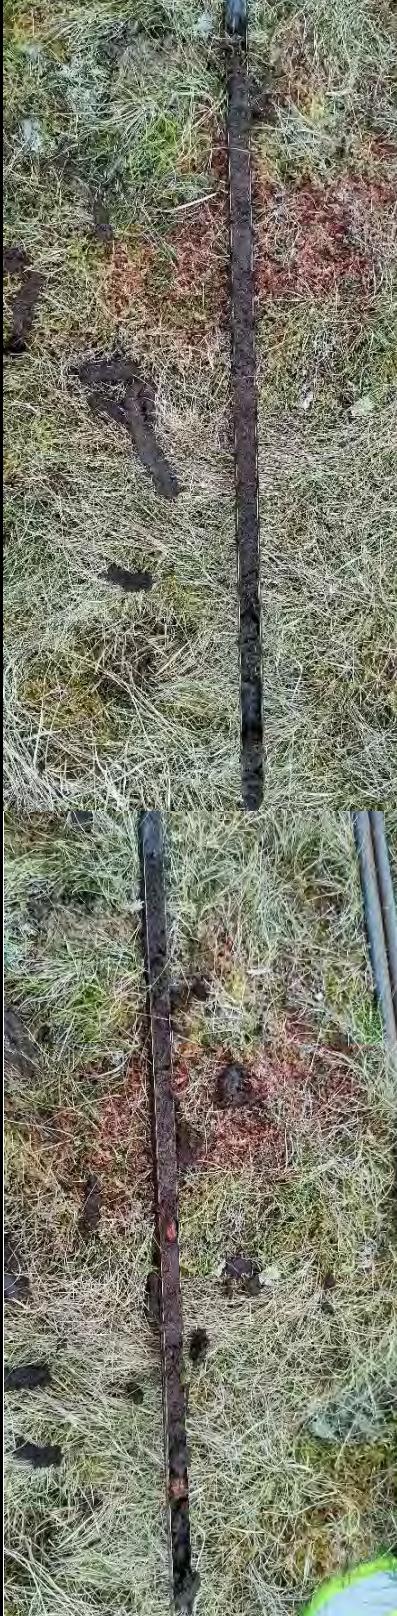
Site	Knockcronal Wind Farm	Easting	237417
Client	ITP Energised	Northing	600130
Survey Dates	3 - 15/5/2021	Probe Depth (m)	4.40
Core Number	CX_32	Auger Depth (m)	4.40
Page	1 of 2

Acrotelm	0.20	0.20	H1 B4
				H6 B4 at 0.80m
	Catotelm	4.40	4.20	H7 B4 at 1.80m
