Knockcronal Wind Farm  
 Environmental Impact Assessment Report  
 Technical Appendix 9.4

**Figure 9.4.5**  
**Geomorphology, Hydrology and Land Use**

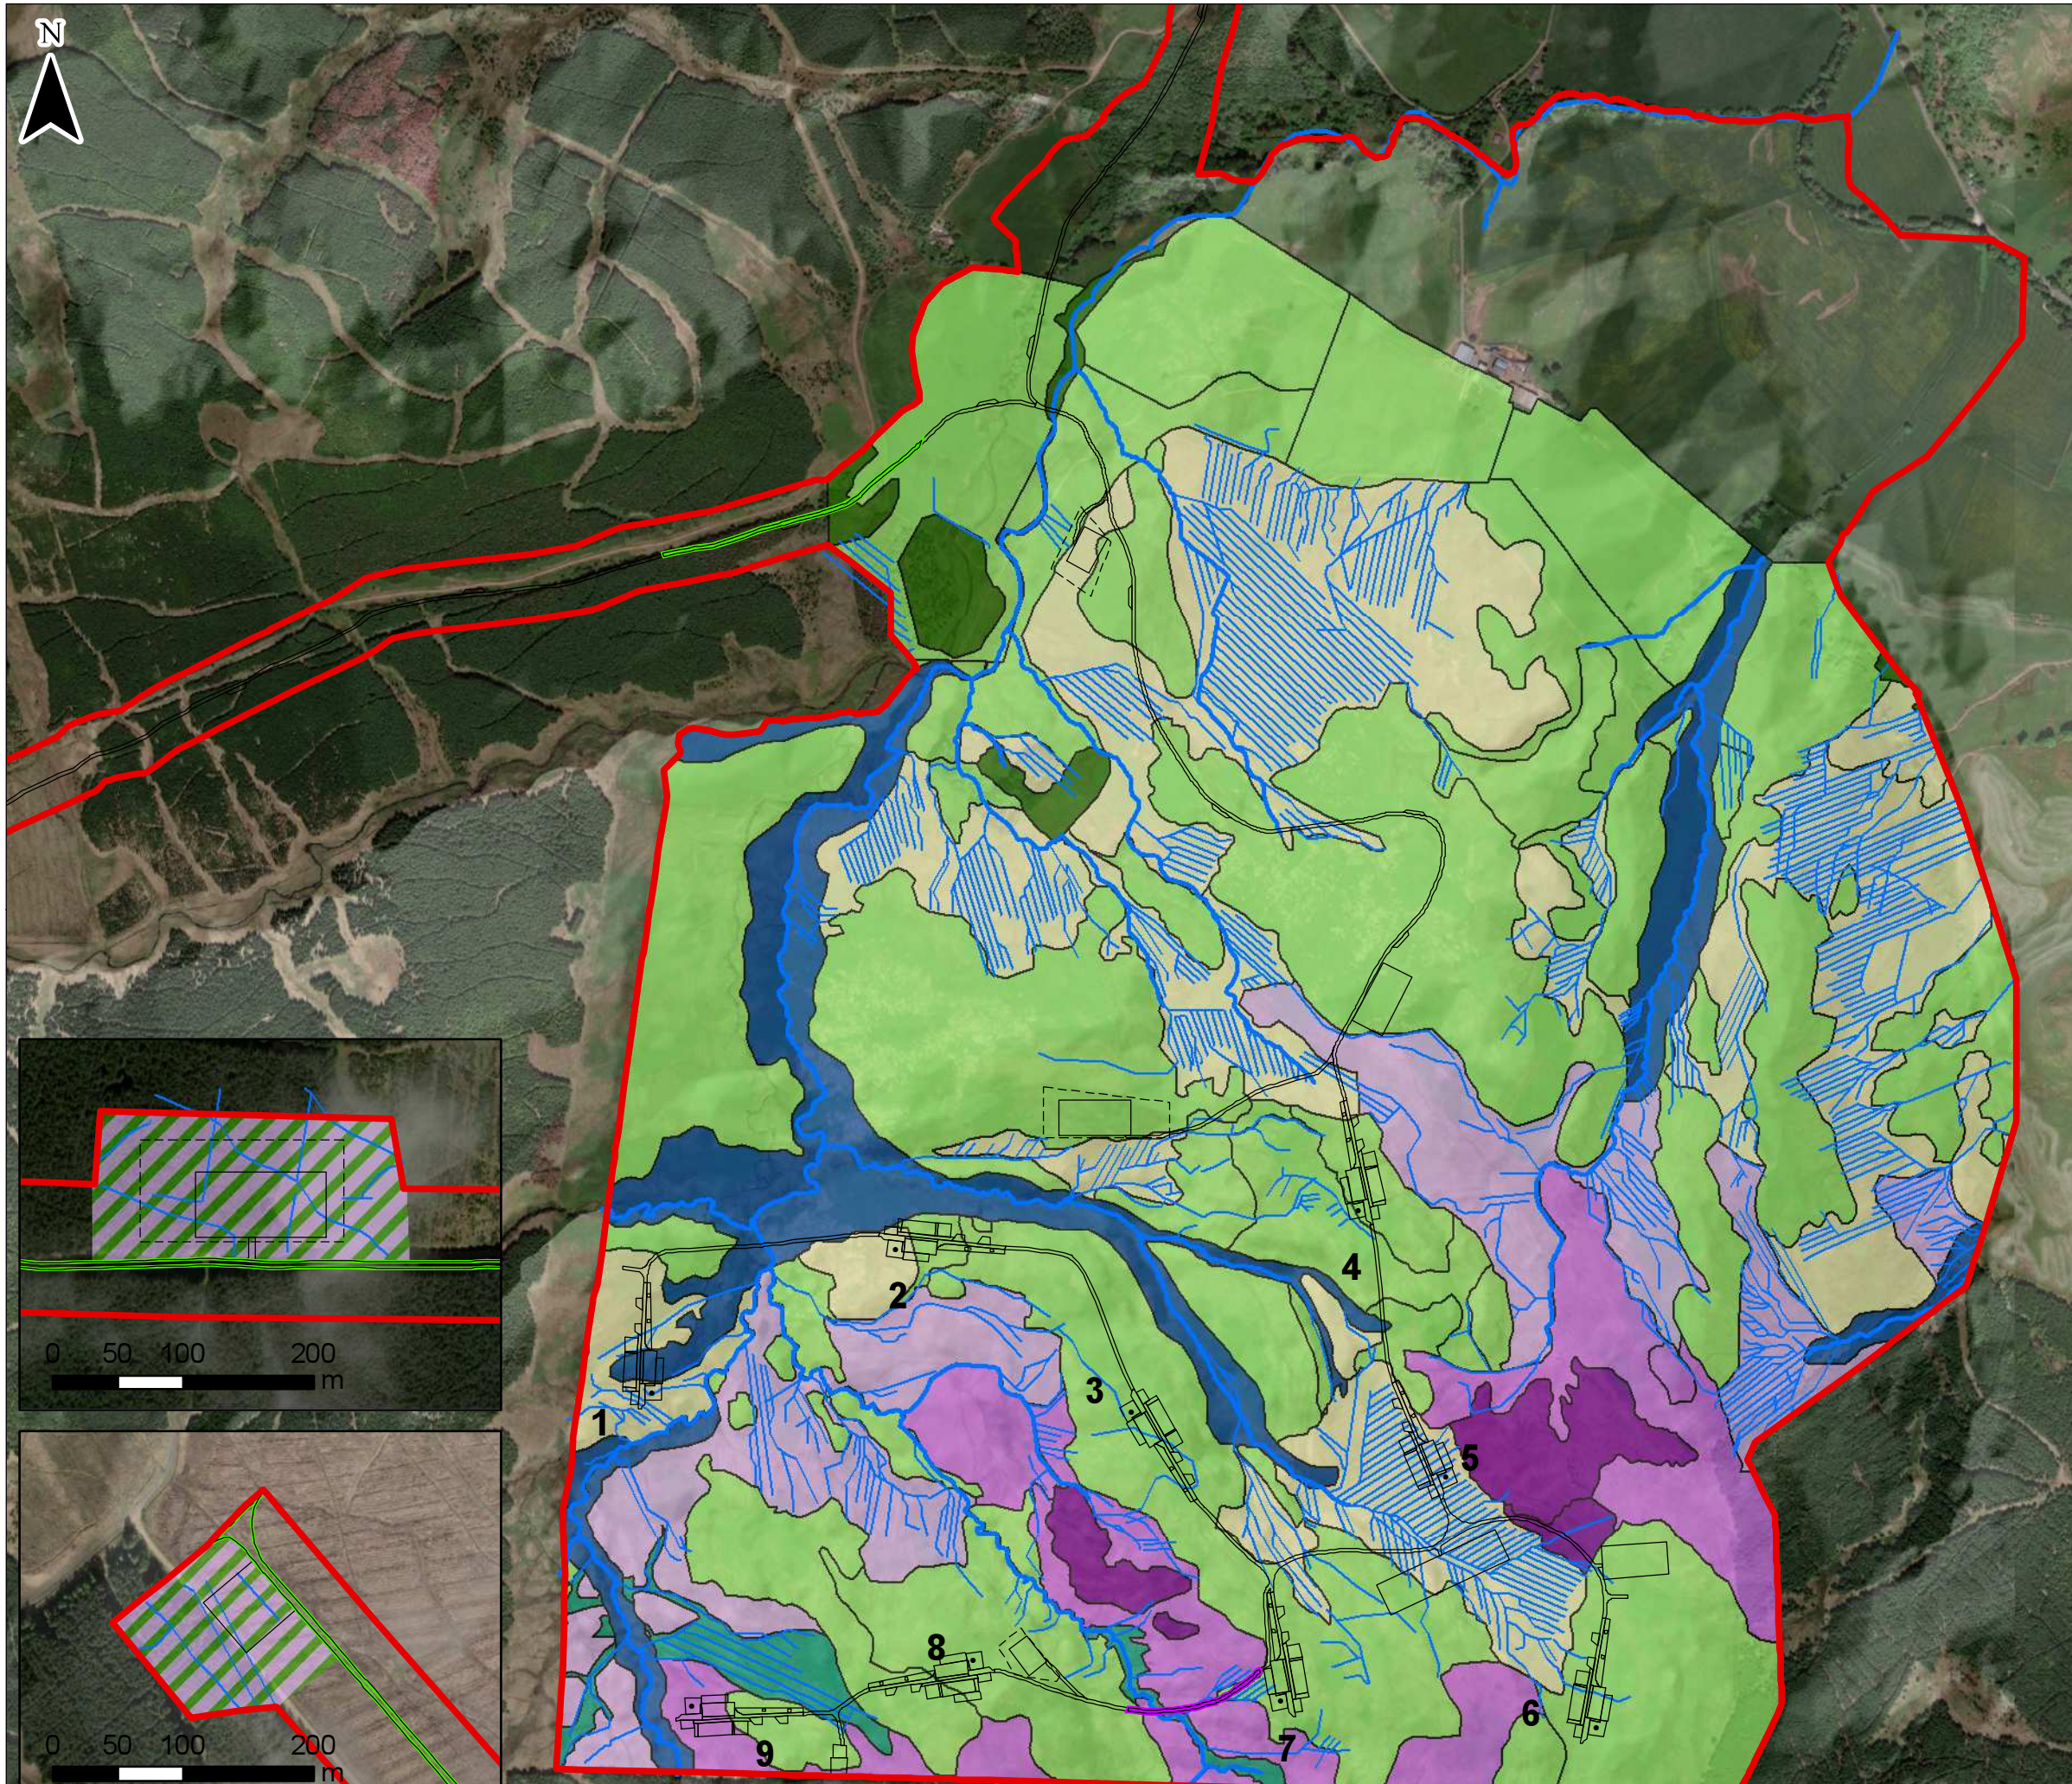
- KEY**
- Site Boundary
  - Turbines Locations
  - Infrastructure Layout
  - Proposed Borrow Pit Search Area
  - Existing Track
  - Floating Track
- Geomorphology and land use**
- Planar hillside - deforested
  - River valley
  - Planar hillside - forested
  - Flush
  - Planar hillside - drained
  - Planar hillside
  - Planar peat - drained
  - Planar peat
  - Planar peat - patterned
- Hydrology**
- Moorland grips / field drains
  - Watercourses
