FORMATION TESTING REPORT RESULTS

Company CANDECCA RESOURCES Ltd Well No SEATON ROSS 4 I Test No 2

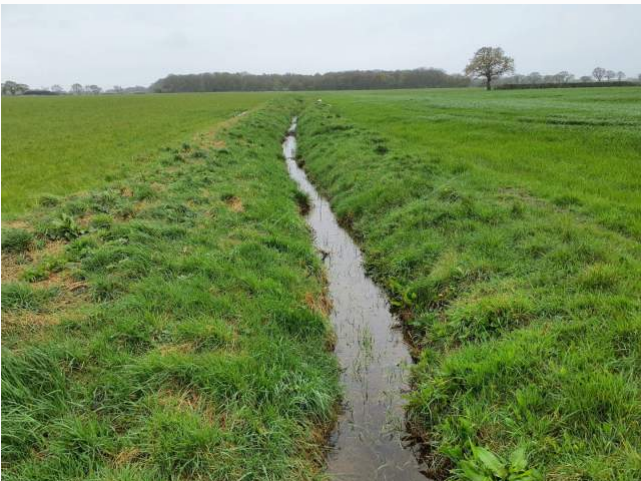
| <i>Select Feature</i> | <i>Description</i> | <i>Direction Taken</i> | |
|---|---|---|--|
| 4d. Surface waters on site | Ditch between 12a and 12c | S | |

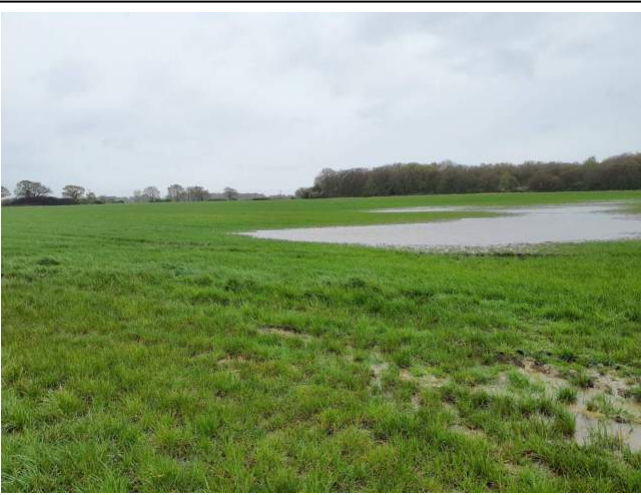
| <p>1a. Main land use(s)</p> | <p>12e from NW corner, with waterlogging. Access road is to the left of the image marking eastern boundary.</p> | <p>SE</p> | |

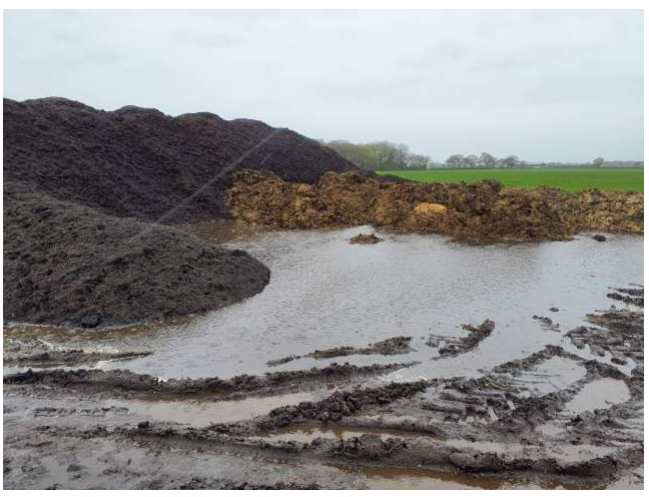
| <p>7b. Waste storage</p> | <p>Farm waste tip by 12e</p> | <p>W</p> | |

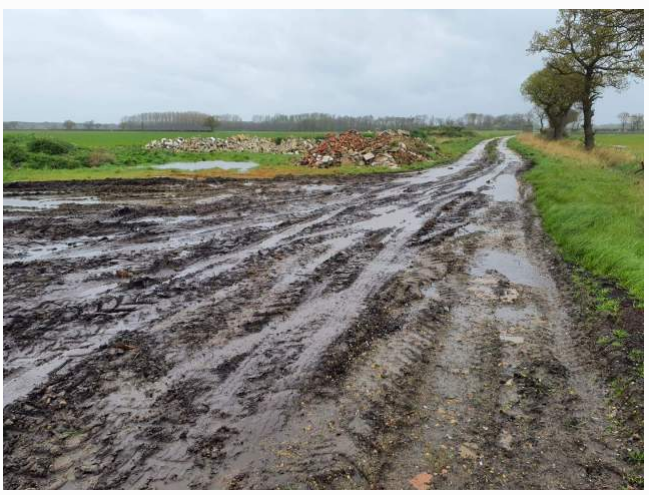
| <p>7b. Waste storage</p> | <p>southern extent of farm waste tip showing rubble. State of access road clear in the photo but it does run all the way to Ash Lane.</p> | <p>NW</p> | |

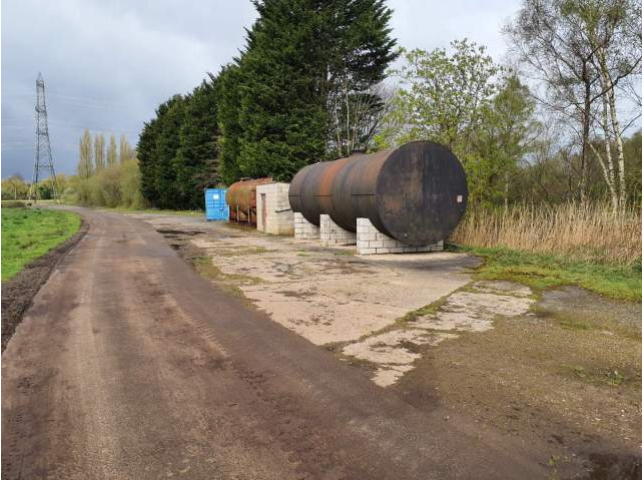
| <p>5a. Existing buildings on-site</p> | <p>Fuel storage at northern end of 13r</p> | <p>W</p> | |

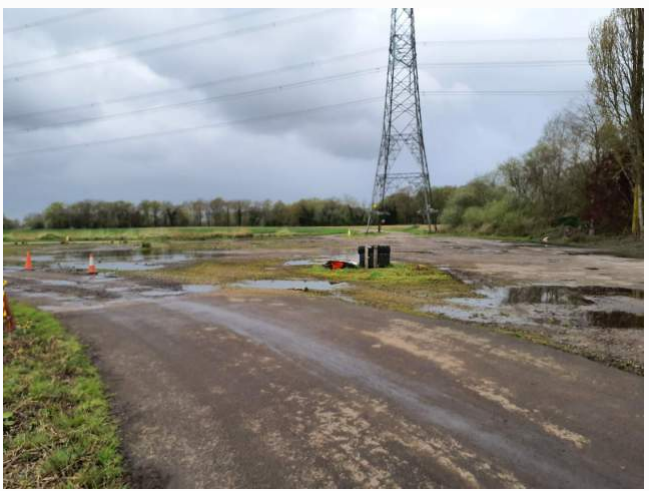
| <p>5c. Buried and overhead services</p> | <p>Pylon at northern end of 13p</p> | <p>W</p> | |

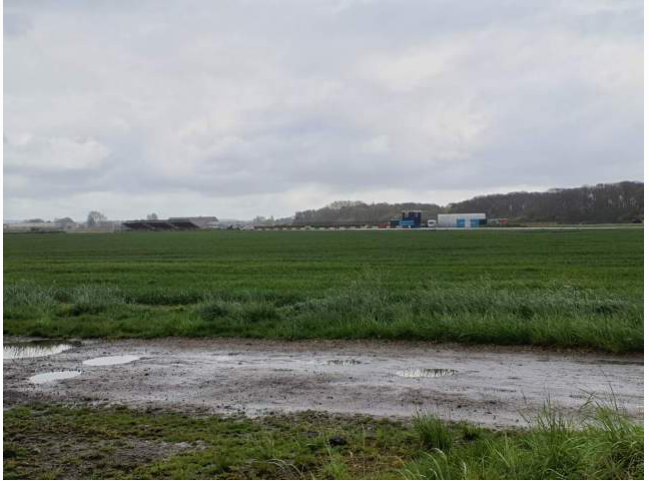
| <p>1c. Adjacent land use(s)</p> | <p>Raceway infrastructure between fields</p> | <p>E</p> | |

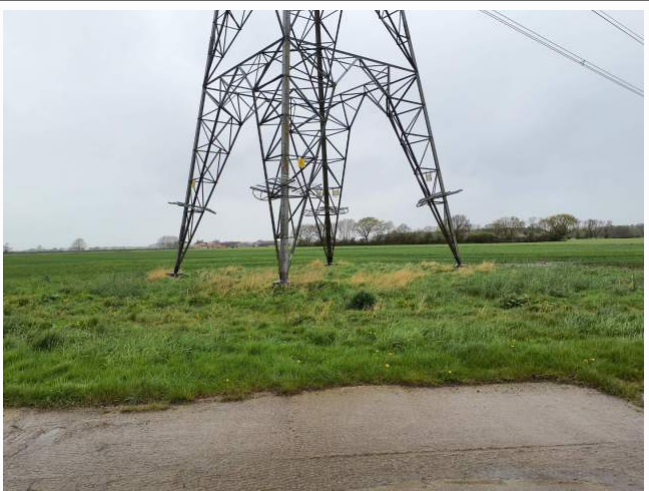
| <p>5c. Buried and overhead services</p> | <p>Pylon at se corner of 13k</p> | <p>NW</p> | |

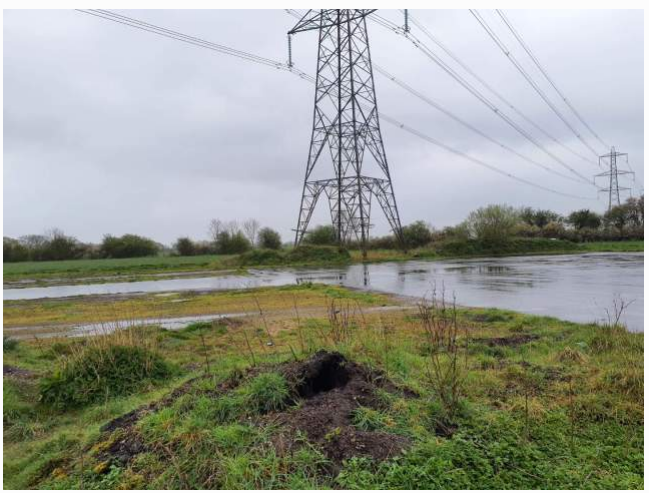
| <p>5c. Buried and overhead services</p> | <p>Pylon in 13ze with runway in fg</p> | <p>N</p> | |

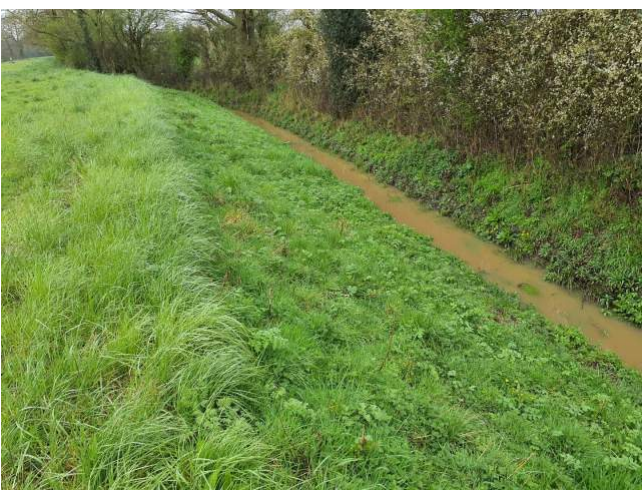
| <p>1a. Main land use(s)</p> | <p>Ditch along southern edge of 13k before moving between 13j and 13k</p> | <p>NE</p> | |

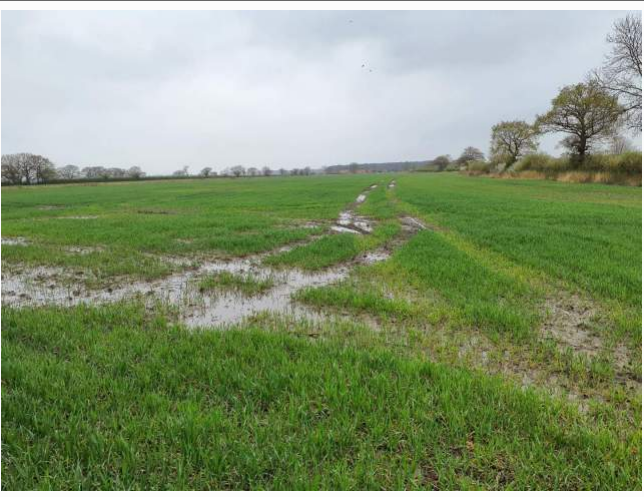
| <p>1a. Main land use(s)</p> | <p>13j from S edge</p> | <p>N</p> | |

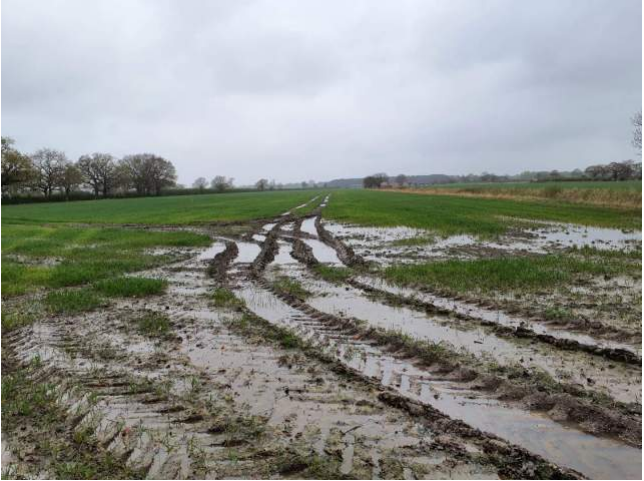
| <p>1a. Main land use(s)</p> | <p>13i from S edge</p> | <p>N</p> | |

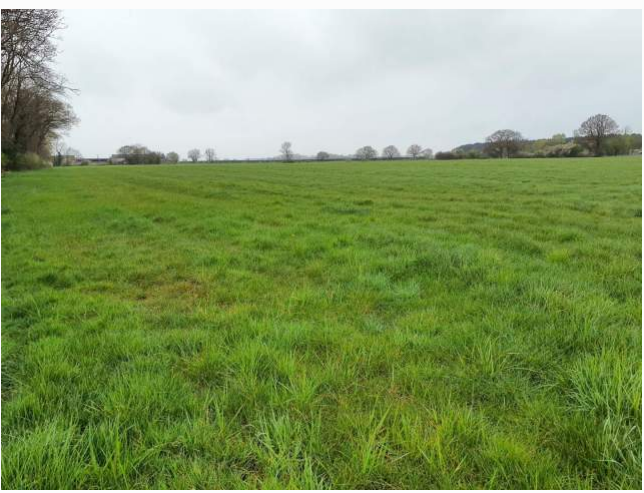
| <p>1a. Main land use(s)</p> | <p>Northern portion of 13L split from southern half by hedging then road to the farm</p> | <p>NW</p> | |

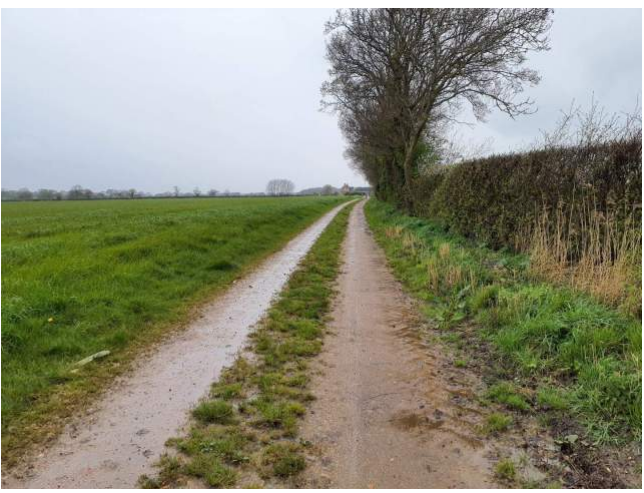
| <p>1c. Adjacent land use(s)</p> | <p>Road to farm splitting 13l in two.</p> | <p>W</p> | |

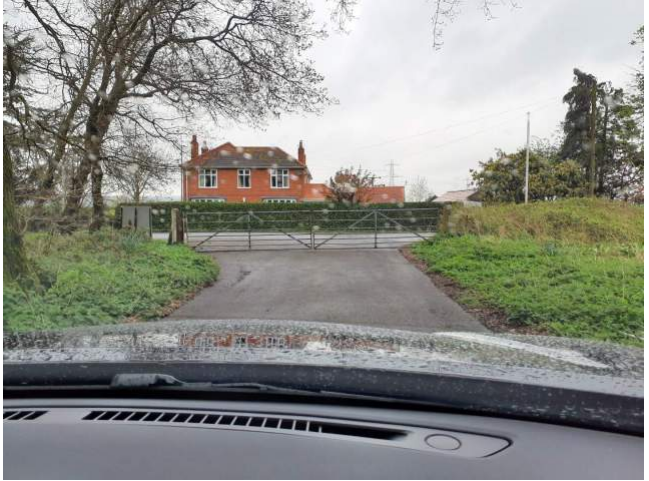
| | <p>Access to northern and</p> | | |

| <p>2a. Access constraints - general.</p> | <p>western end of runway from locked gate off Ash Lane. Code can be retrieved from site office</p> | <p>N</p> | |

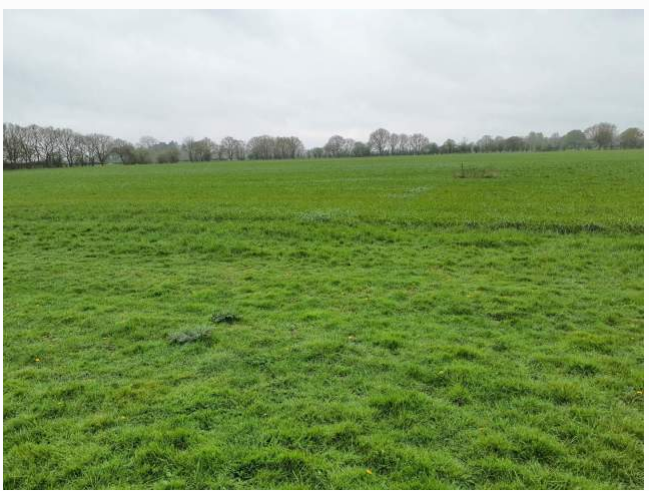
| <p>1a. Main land use(s)</p> | <p>13y from Eastern edge with haulage site</p> | <p>W</p> | |

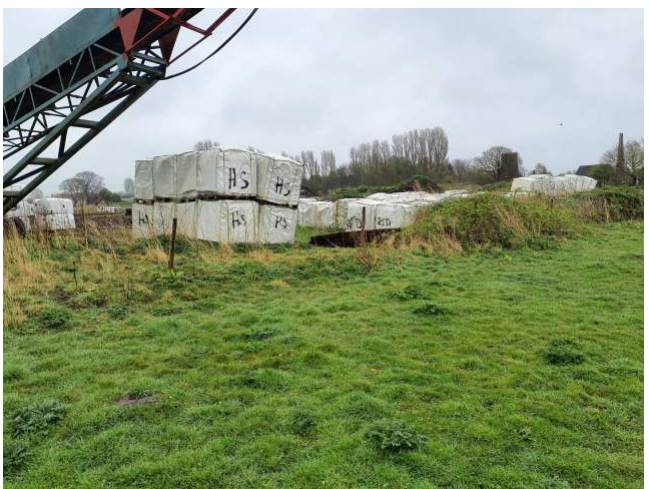
| <p>1c. Adjacent land use(s)</p> | <p>Haulage site from boundary with 13y</p> | <p>E</p> | |

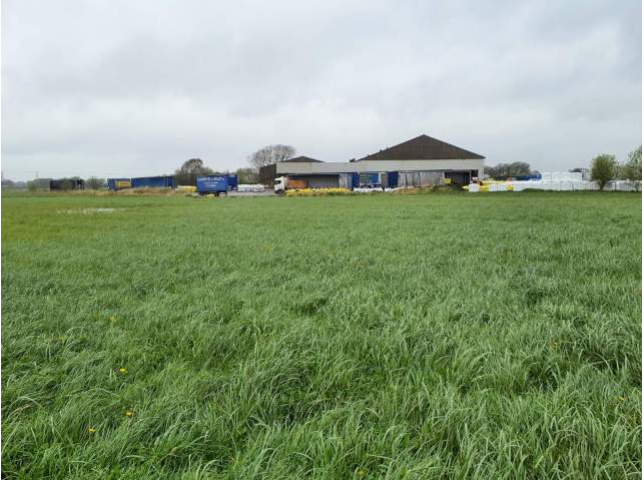
| <p>1c. Adjacent land use(s)</p> | <p>Haulage centre on eastern boundary of 13w.</p> | <p>NE</p> | |

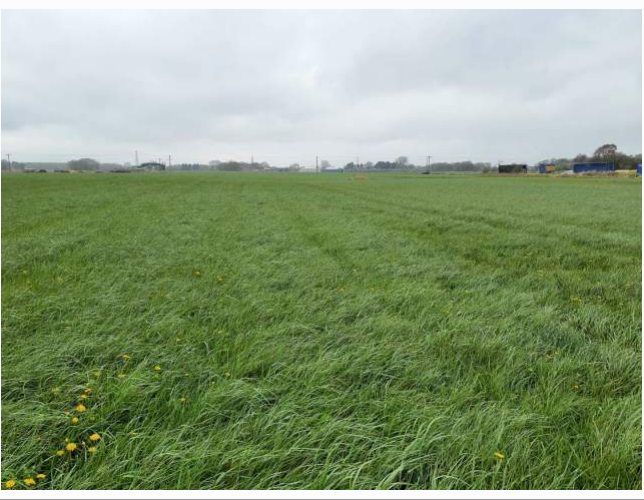
| <p>1a. Main land use(s)</p> | <p>13w from 13y boundary. Pylons run down the access road.</p> | <p>N</p> | |

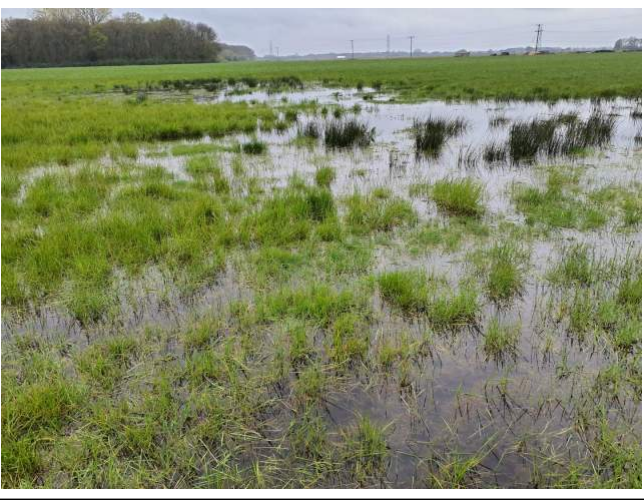
| <p>4i. Waterlogging or flooding</p> | <p>Flooding in 13w by eastern boundary.</p> | <p>S</p> | |

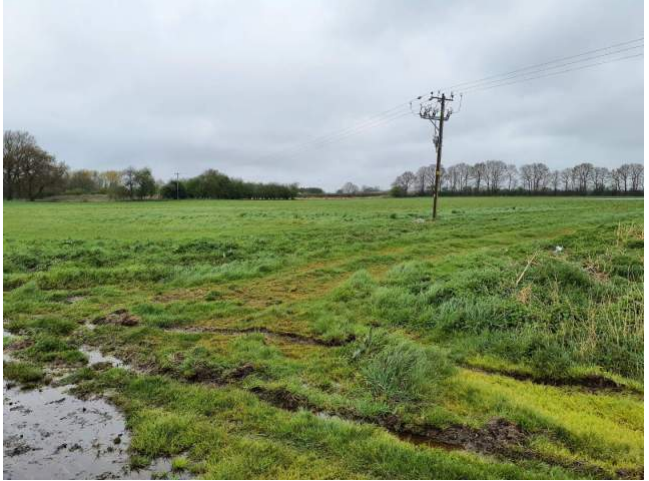
| <p>1a. Main land use(s)</p> | <p>13v with 2 pylons in</p> | <p>NE</p> | |

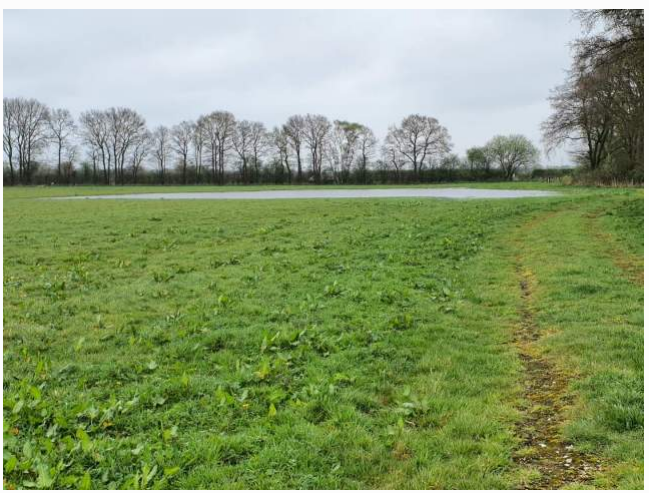
| <p>4i. Waterlogging or flooding</p> | <p>Flooding in 13v</p> | <p>E</p> | |

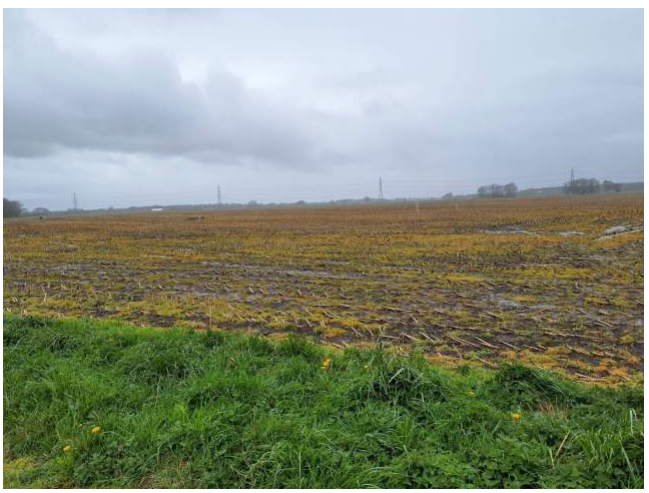
| <p>1a. Main land use(s)</p> | <p>13t from Eastern edge</p> | <p>W</p> | |

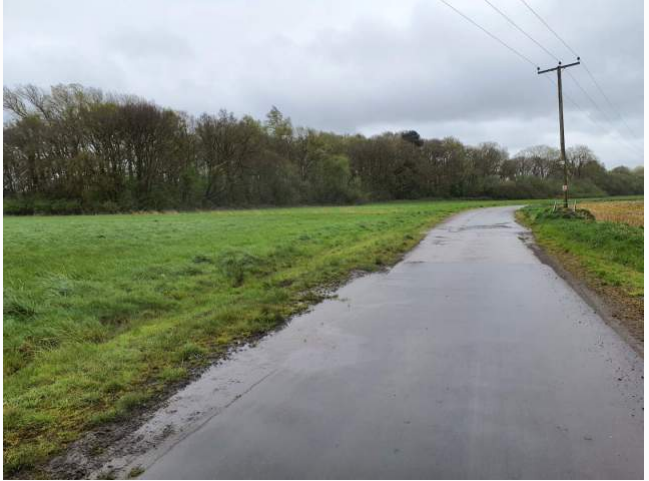
| <p>1a. Main land use(s)</p> | <p>13x western portion with pylon just inside 13t boundary</p> | <p>S</p> | |

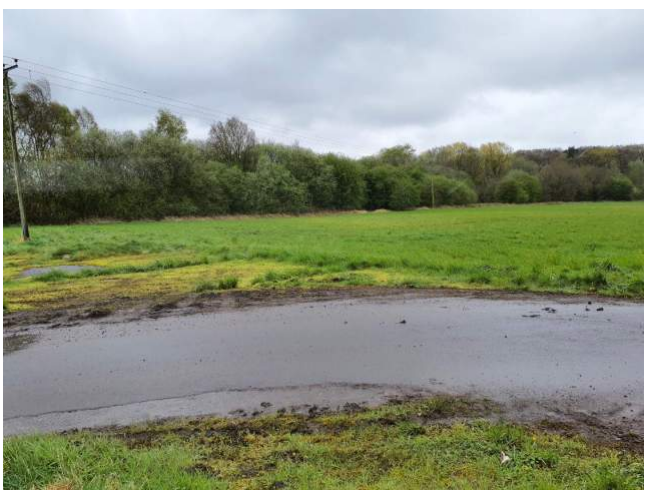
| <p>1a. Main land use(s)</p> | <p>Pylons in 13za</p> | <p>W</p> | |

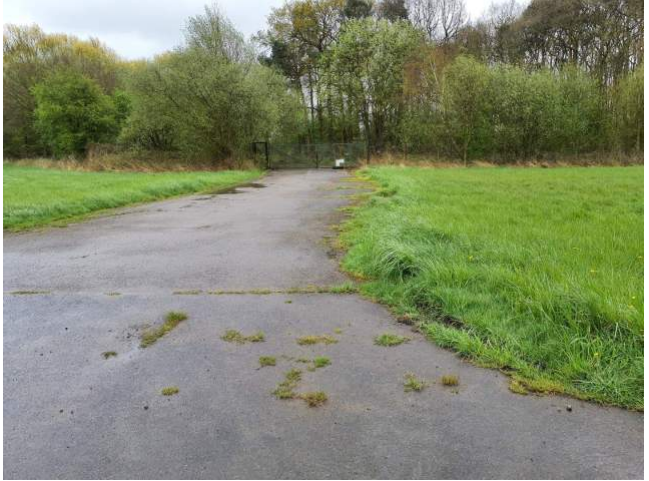
| <p>1c. Adjacent land use(s)</p> | <p>Gate to unknown area between 13za and 13zb</p> | <p>S</p> | |

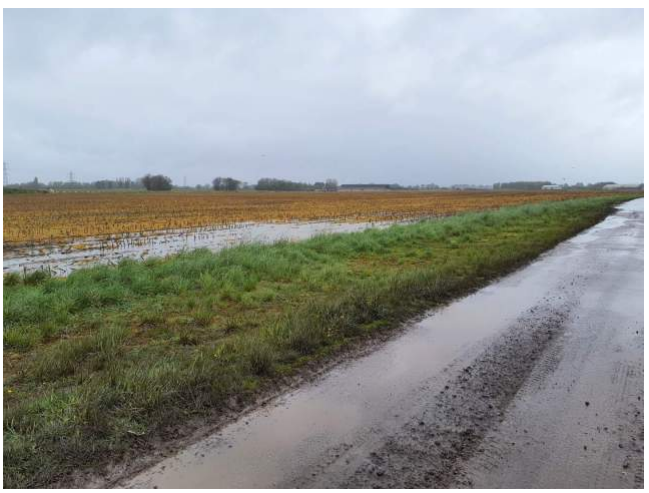
| <p>1a. Main land use(s)</p> | <p>13t from western end</p> | <p>NE</p> | |

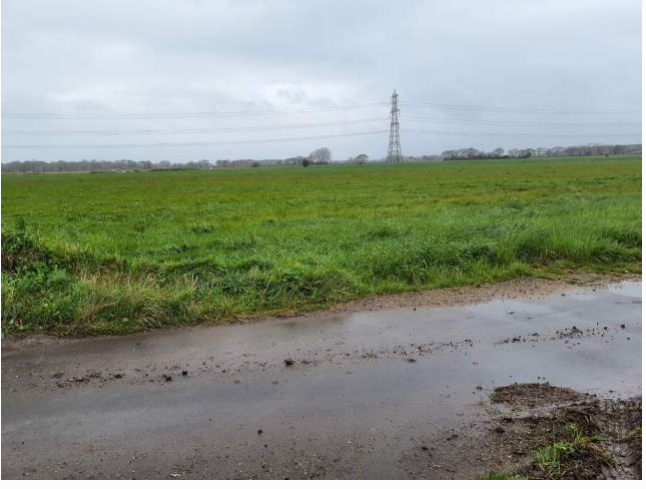
| <p>1a. Main land use(s)</p> | <p>13zd. Pylon from 13k</p> | <p>NW</p> | |

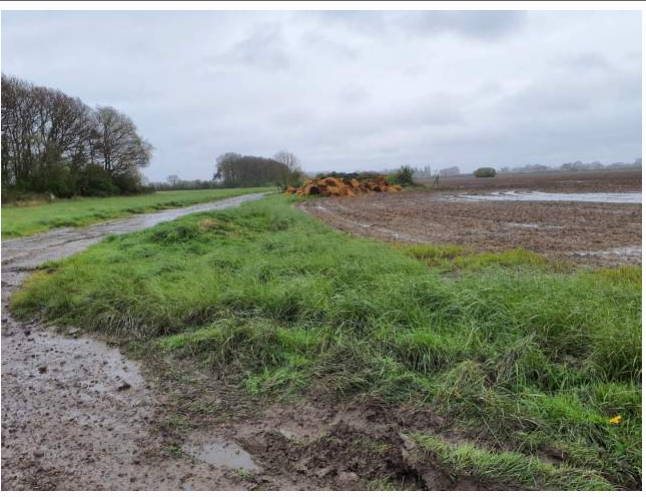
| <p>7b. Waste storage</p> | <p>Farm waste by 13zf alongside boundary with access road to the east</p> | <p>S</p> | |

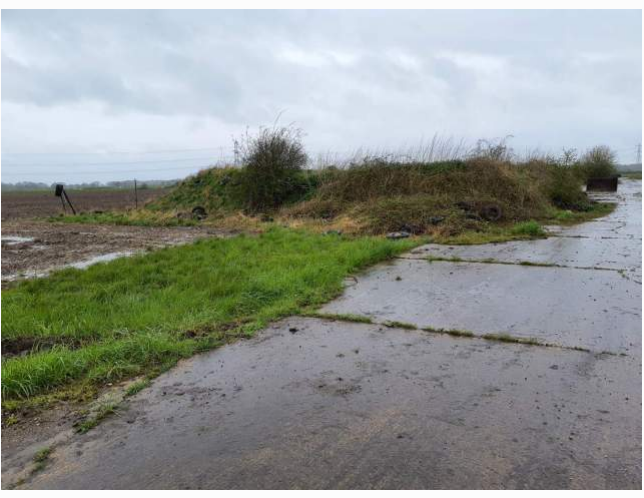
| <p>7b. Waste storage</p> | <p>Farm waste pile looking from the south</p> | <p>N</p> | |

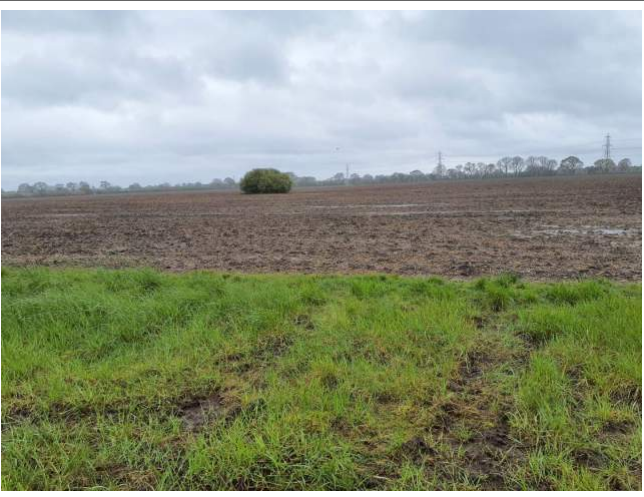
| <p>1a. Main land use(s)</p> | <p>Southern half of 13zf</p> | <p>W</p> | |

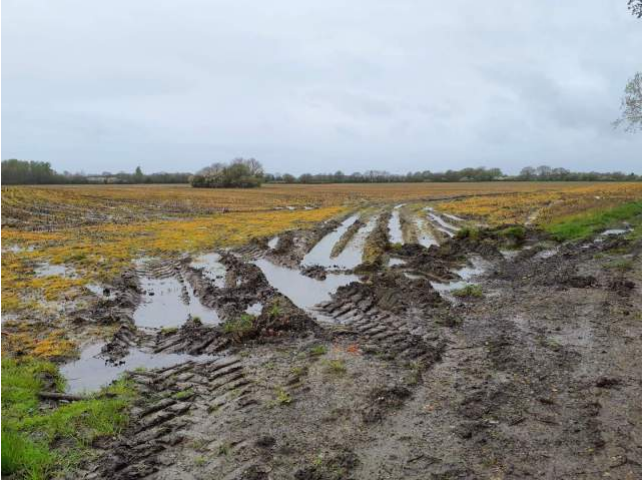
| <p>1a. Main land use(s)</p> | <p>13f from Ash Lane corner</p> | <p>NW</p> | |

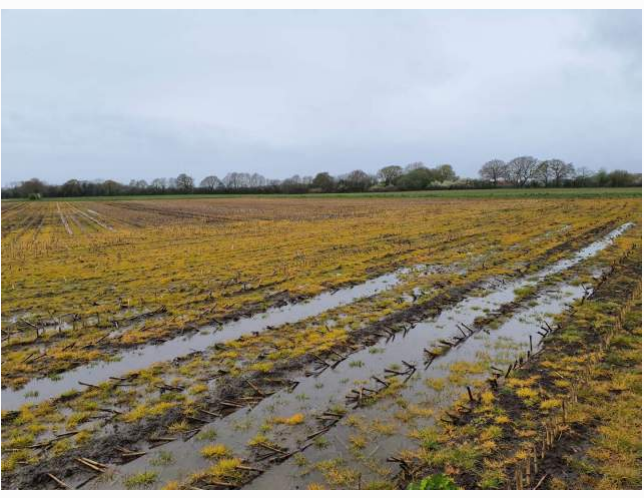
| <p>1a. Main land use(s)</p> | <p>Top of 13f and 13e (greener). Boundary is the ditch between.</p> | <p>NW</p> | |

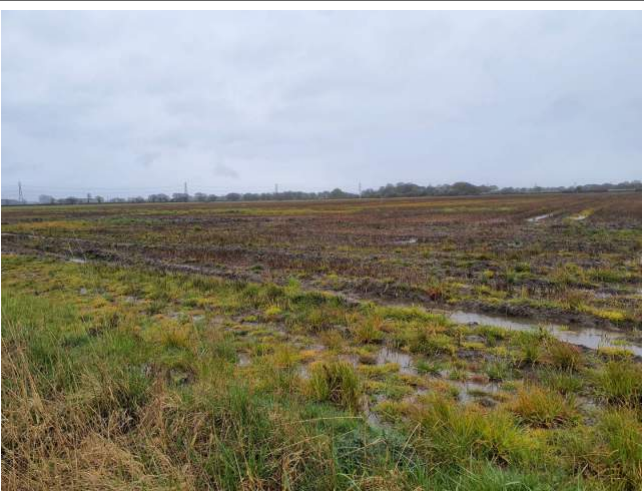
| <p>1a. Main land use(s)</p> | <p>13g and h from boundary with 12f.</p> | <p>SE</p> | |

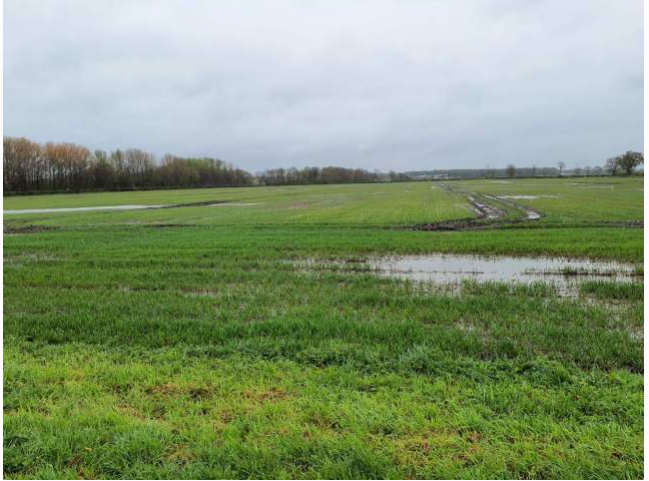
| <p>1a. Main land use(s)</p> | <p>13c. Heavily waterlogged. Powerline runs down western boundary and into 13d from Ash lane</p> | <p>E</p> | |

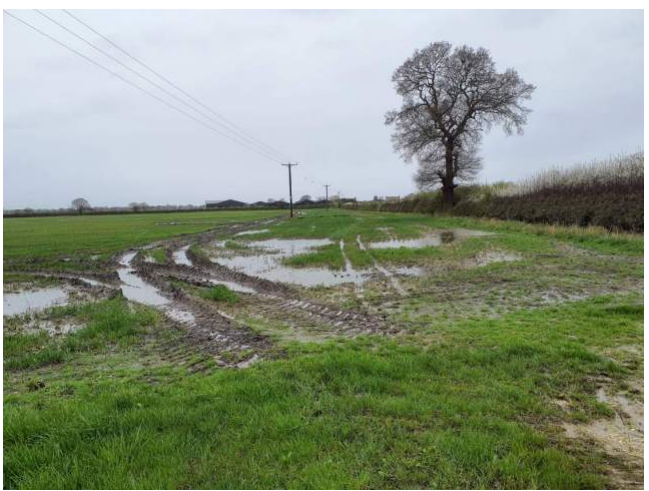
| <p>5c. Buried and overhead services</p> | <p>Powerlines In 13d running to South Acre farm</p> | <p>S</p> | |

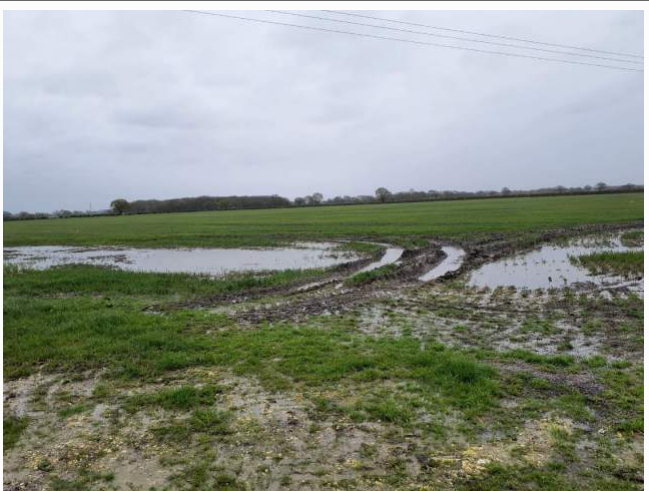
| <p>1a. Main land use(s)</p> | <p>13b southern half</p> | <p>NW</p> | |

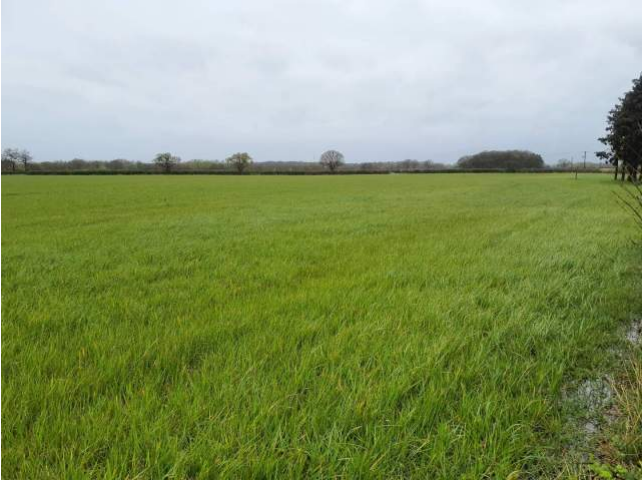
| <p>1a. Main land use(s)</p> | <p>13b northern half. Ash lane marks northern edge</p> | <p>N</p> | |

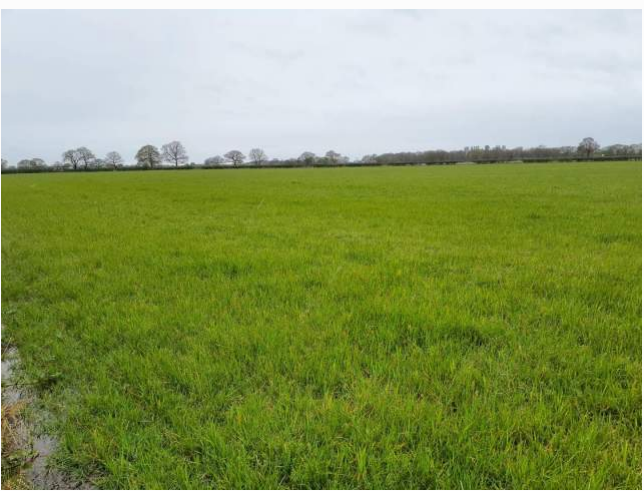
| <p>1a. Main land use(s)</p> | <p>13b southern half</p> | <p>SW</p> | |

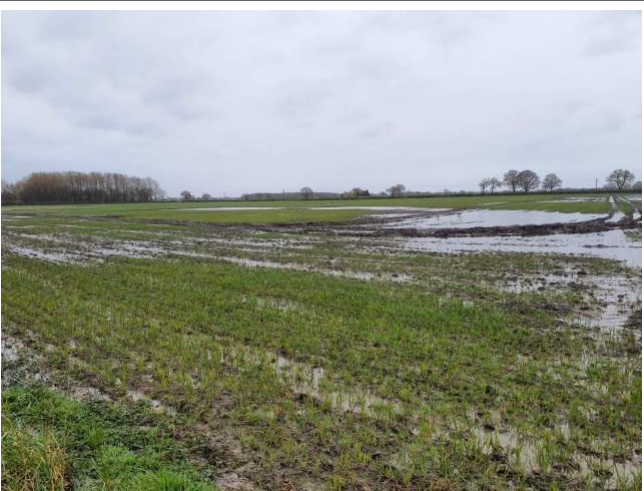
| <p>1a. Main land use(s)</p> | <p>13a from nw corner. Pylons run into the field from the SE corner, head north until the middle of field then W</p> | <p>SE</p> | |

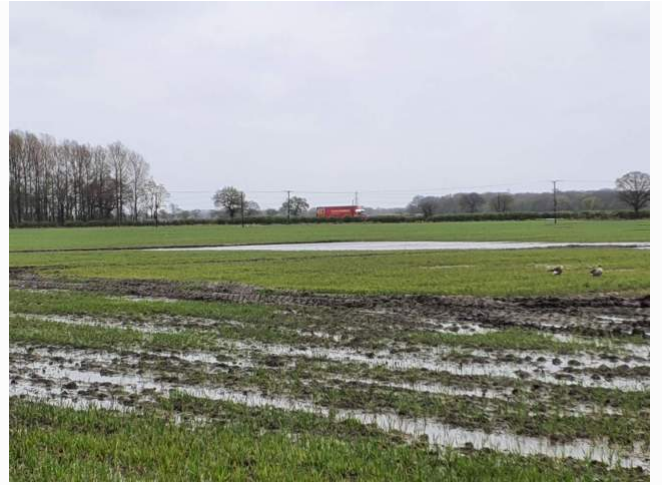
Pylons across the field running E-W

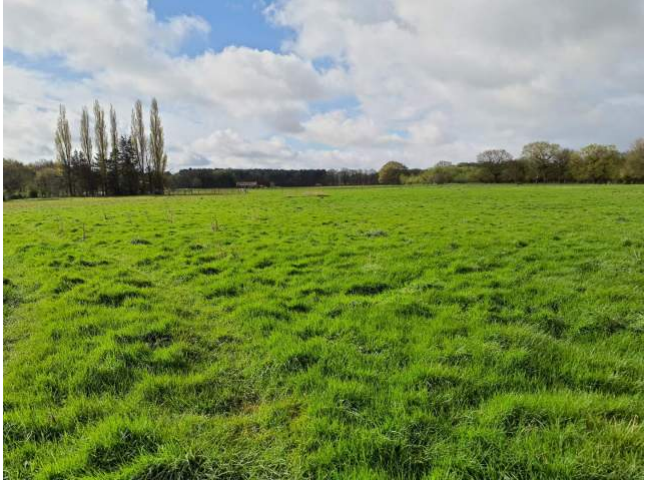
| OTHER | 15b looking south onto 15c | S | |

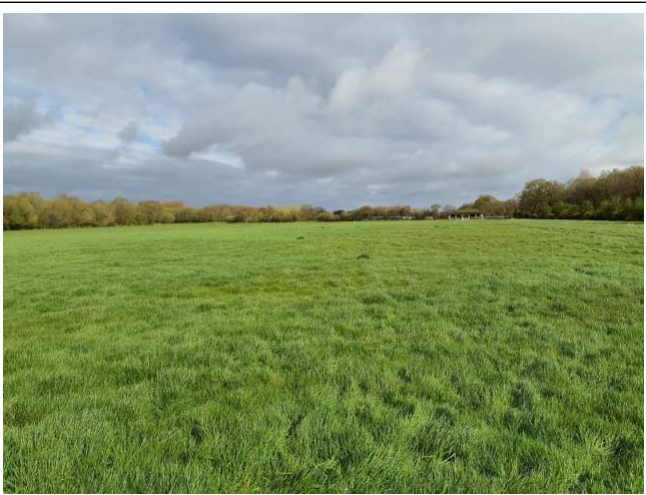
| OTHER | 15b looking north from roughly the centre of the field | N | |

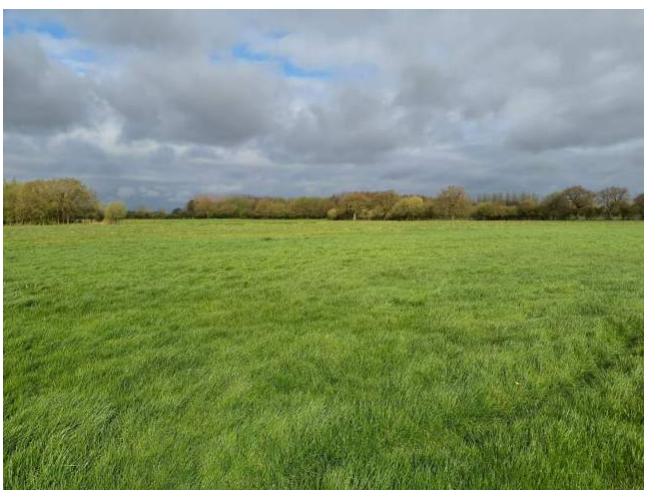
| <p>1a. Main land use(s)</p> | <p>Looking from 15b onto 15a</p> | <p>NW</p> | |

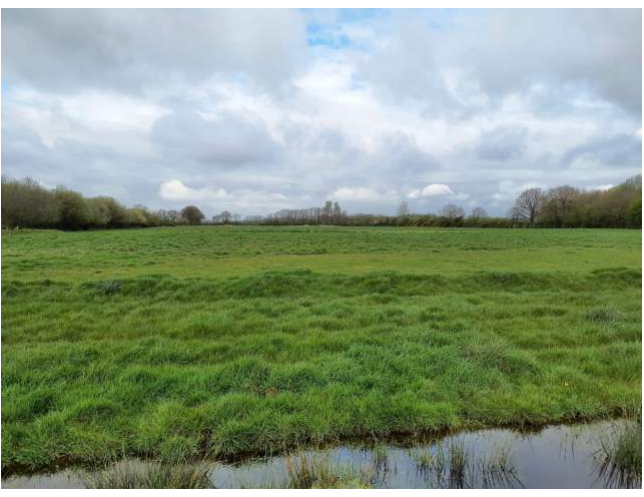
| <p>1a. Main land use(s)</p> | <p>15a from Eastern boundary</p> | <p>W</p> | |

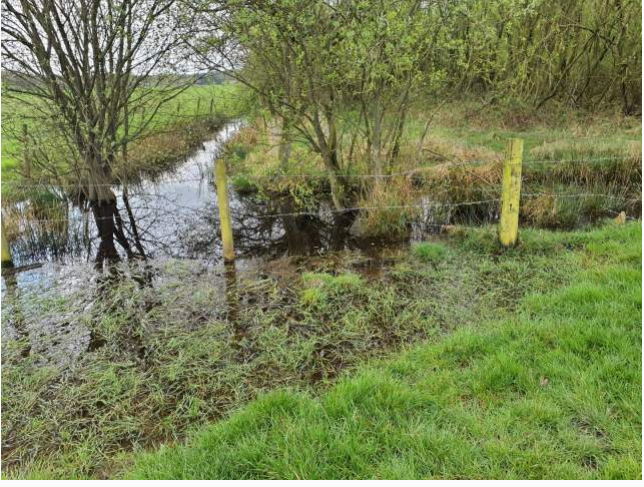
| <p>4d. Surface waters on site</p> | <p>Ditch marking southern edge of 15a, western edge of 15b</p> | <p>S</p> | |

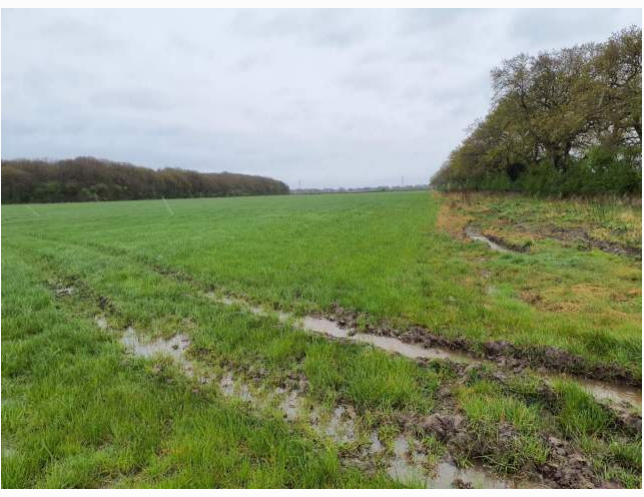
| <p>1a. Main land use(s)</p> | <p>15d bottom (eastern) half. Hedge in background marks western boundary</p> | <p>E</p> | |

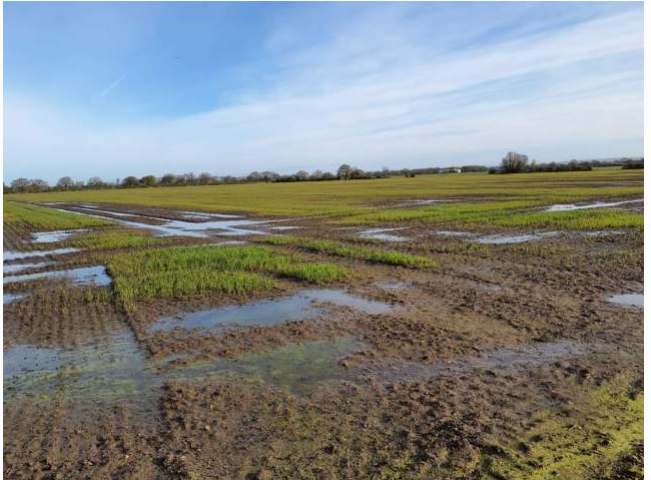
| <i>Select Feature</i> | <i>Description</i> | <i>Direction Taken</i> | |
|---|---|---|--|
| 1a. Main land use(s) | 8a from SW corner | NE | |

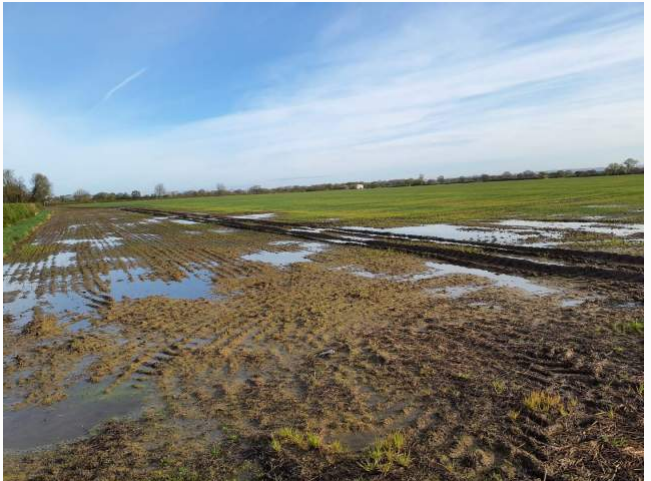
| <i>Select Feature</i> | <i>Description</i> | <i>Direction Taken</i> | |
|---|---|---|--|
| 1a. Main land use(s) | 8b upper half | NE | |

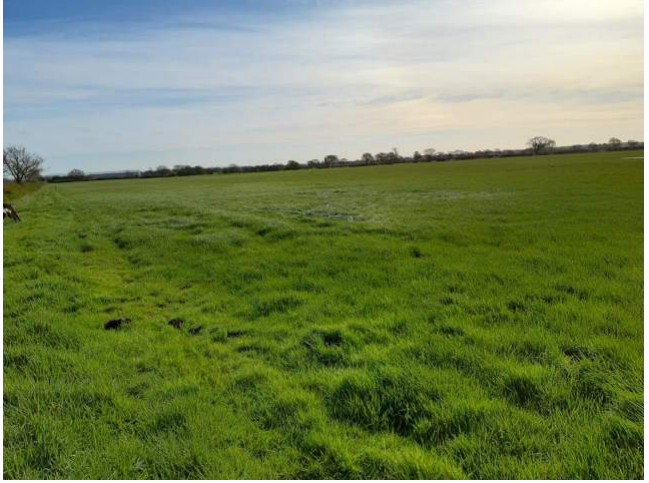
| <p>1a. Main land use(s)</p> | <p>10b from NW corner</p> | <p>SE</p> | |

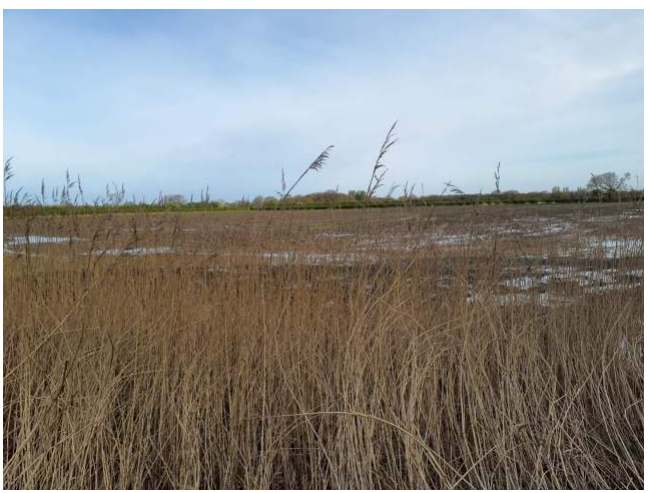
| <p>1a. Main land use(s)</p> | <p>1a. Ditch runs from the NW corner down past the SW corner (where picture is taken) and round to the east.</p> | <p>N</p> | |

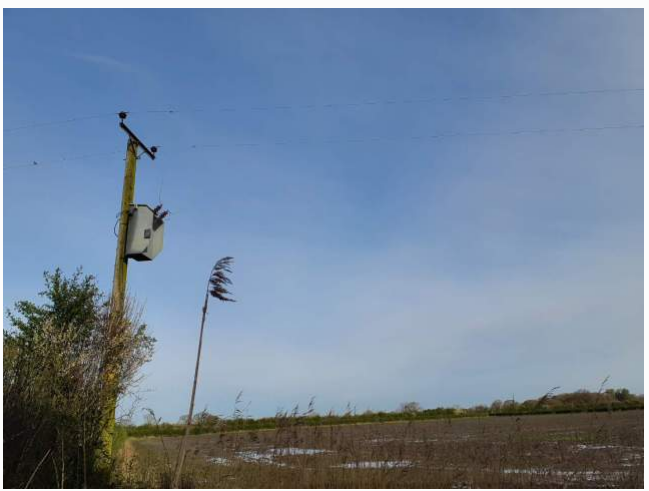
| <p>5c. Buried and overhead services</p> | <p>Powerline running across very SW corner to the SE</p> | <p>N</p> | |

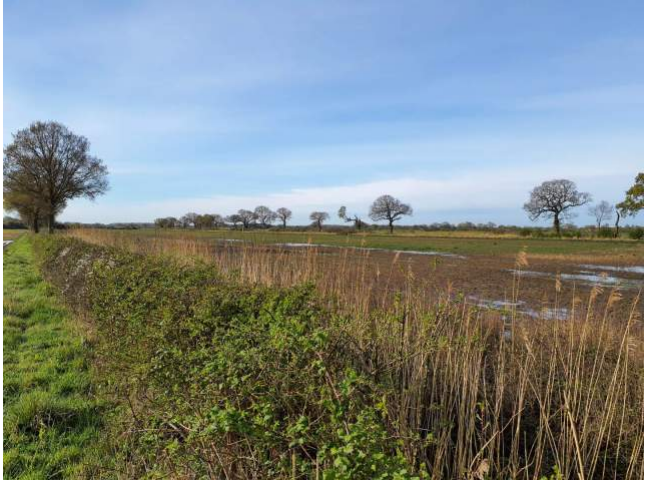
| <p>1a. Main land use(s)</p> | <p>1c from nw tip. overgrow ditch in foreground</p> | <p>SW</p> | |

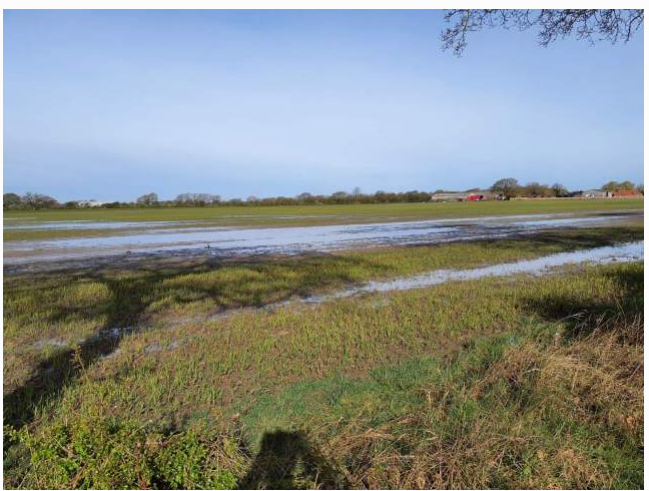
| <p>1a. Main land use(s)</p> | <p>Top half of 9a (bg) and 9b. Sheds are beyond northern boundary</p> | <p>W</p> | |

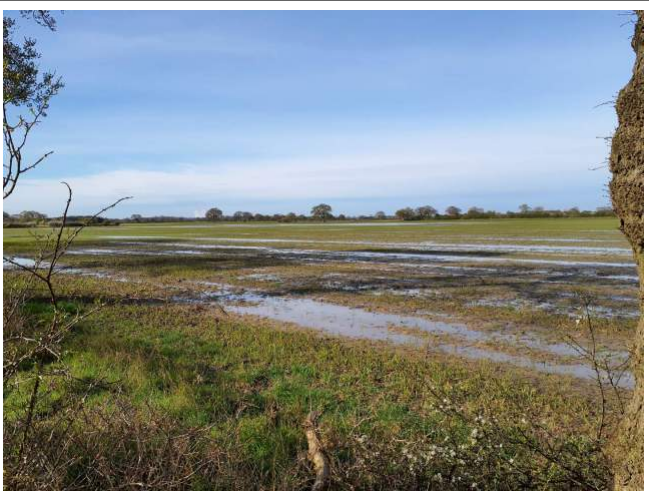
| <p>1a. Main land use(s)</p> | <p>Bottom half of 9a (bg) and 9b</p> | <p>SW</p> | |

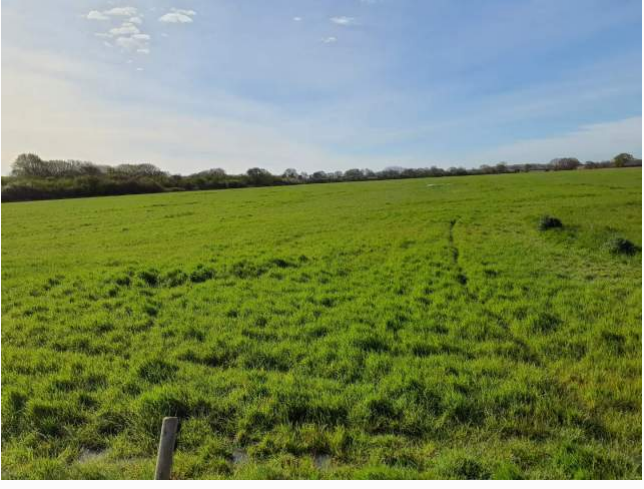
| <p>1a. Main land use(s)</p> | <p>1b eastern half from northern edge</p> | <p>S</p> | |

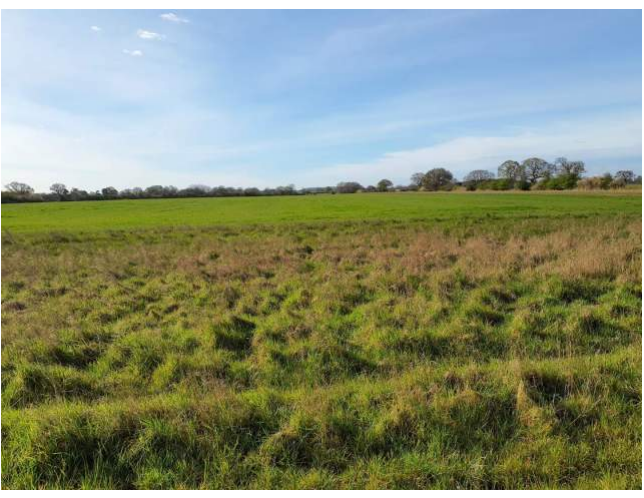
| <p>1a. Main land use(s)</p> | <p>1b western half from northern edge. Very boggy ground along this northern boundary</p> | <p>S</p> | |

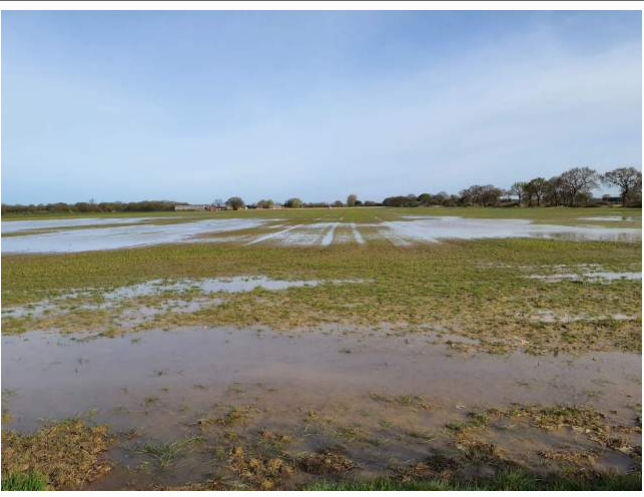
| <p>1a. Main land use(s)</p> | <p>9b from S edge</p> | <p>N</p> | |

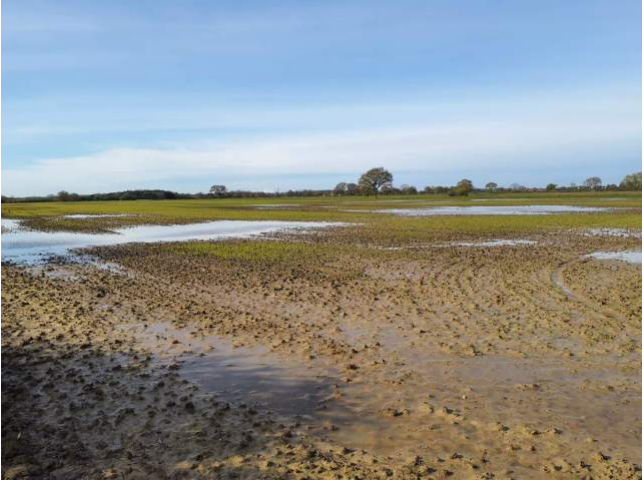
| <p>1a. Main land use(s)</p> | <p>9d and 9c (bg) from NE corner</p> | <p>SW</p> | |

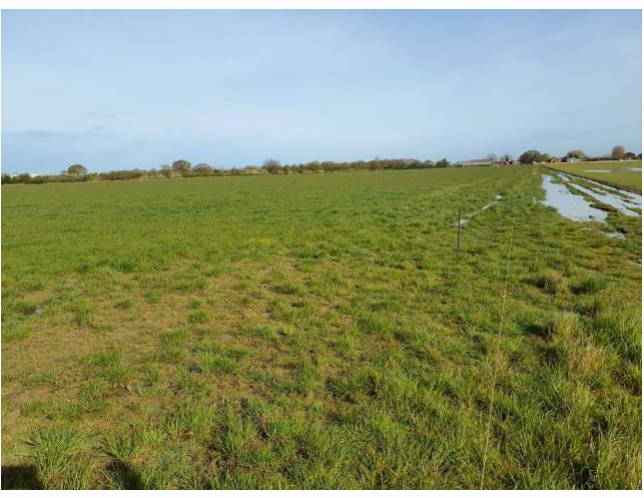
| <p>1a. Main land use(s)</p> | <p>9a from southern edge</p> | <p>NW</p> | |

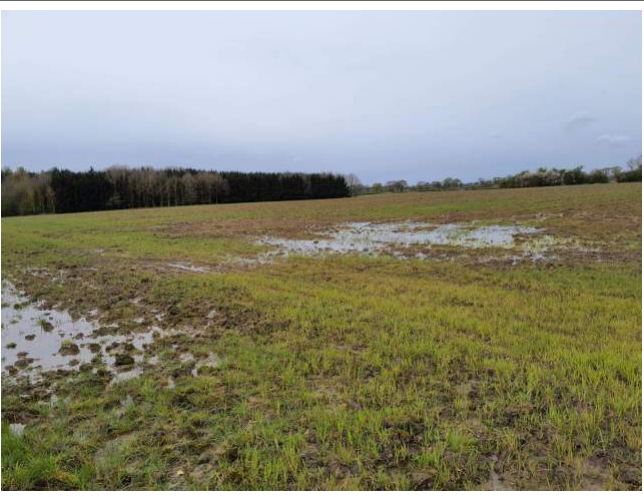
| <p>1a. Main land use(s)</p> | <p>10e western half. Access from bowland lane to the rear of this picture</p> | <p>NW</p> | |

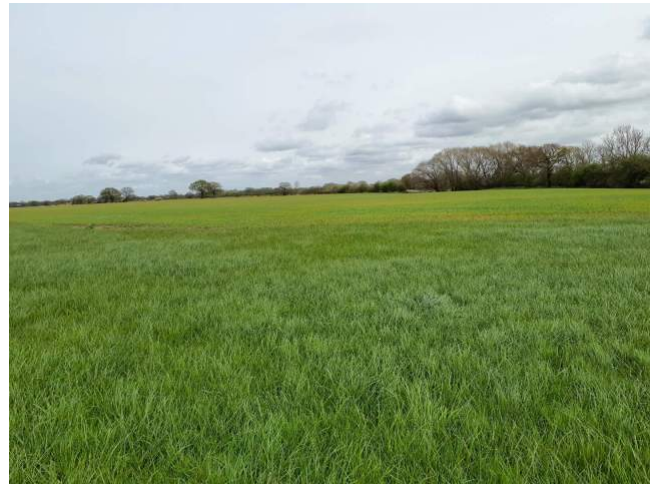
9d east and south. treeline
is southern boundary.

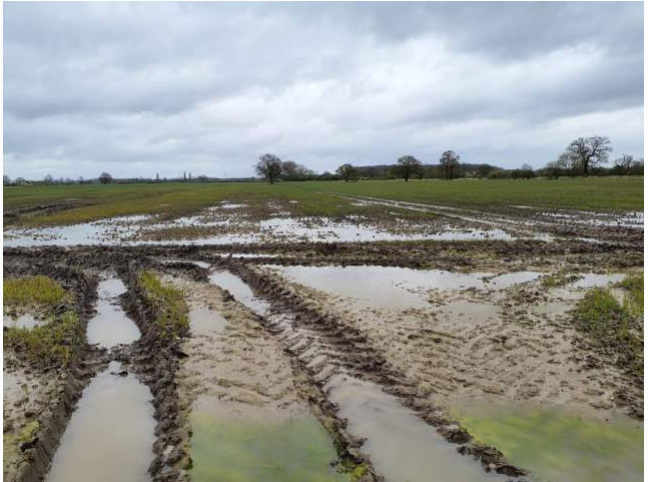
| <i>Select Feature</i> | <i>Description</i> | <i>Direction Taken</i> | |
|---|--|---|--|
| 1a. Main land use(s) | 2d. Far boundary is marked by the bushes beyond the first line of trees. | E | |

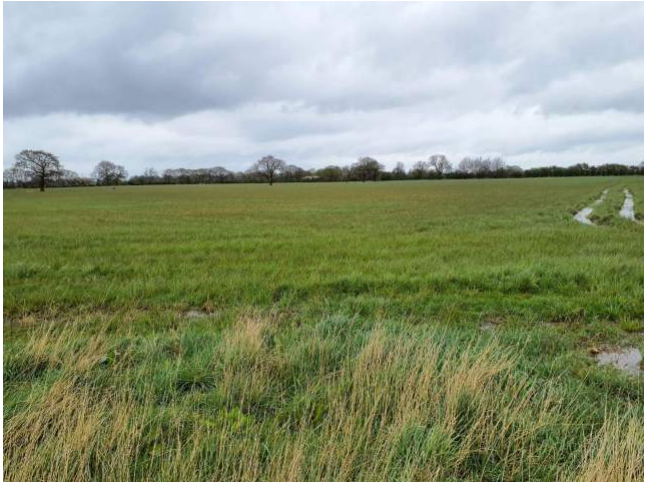
| <i>Select Feature</i> | <i>Description</i> | <i>Direction Taken</i> | |
|---|--|---|--|
| 1a. Main land use(s) | 2b from SW corner. | NE | |

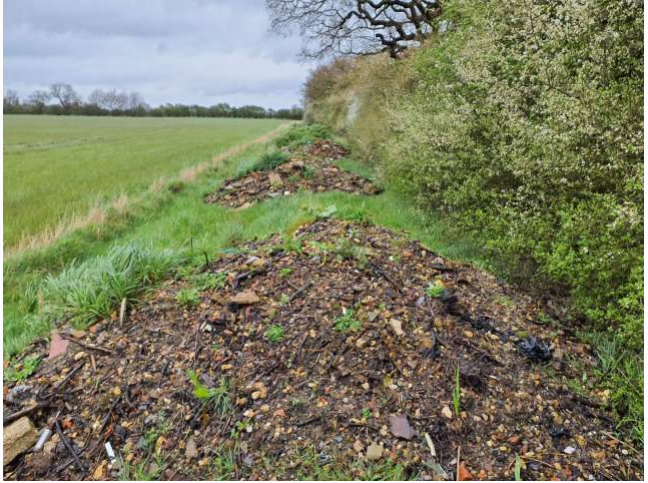
| <i>Question</i> | <i>Combined Response</i> |
|--|--|
| G5. Is there any evidence for ACM on site? | None Observed : Potentially in waste in 2b |

| <i>Select Feature</i> | <i>Description</i> | <i>Direction Taken</i> | |
|---|--|---|--|
| 7b. Waste storage | Piles of rubble along 2b/2d boundary | E | |

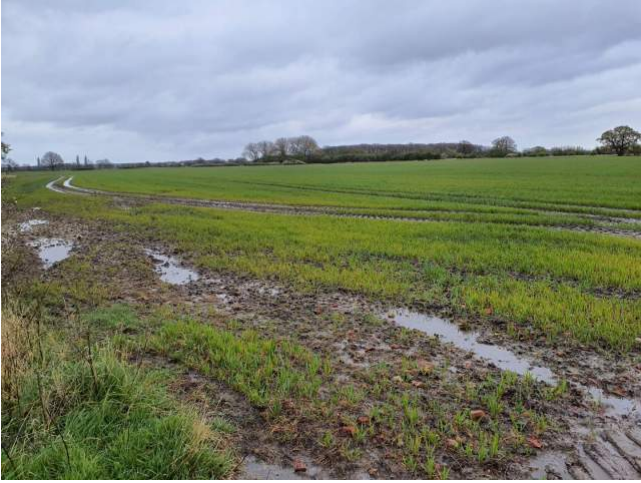
| <p>1a. Main land use(s)</p> | <p>Eastern half of 2d from 2b/2c boundary</p> | <p>S</p> | |
