FORMATION TESTING REPORT RESULTS

Company CANDECCA RESOURCES Ltd Well No SEATON ROSS 4 I Test No 2

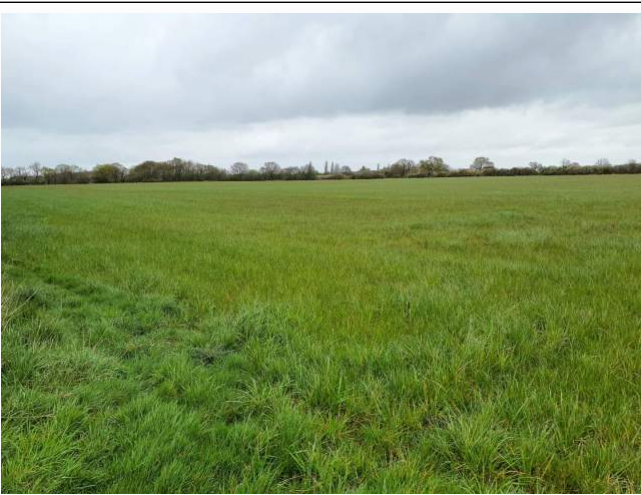
| <p>1a. Main land use(s)</p> | <p>2c from SW corner</p> | <p>NE</p> | |

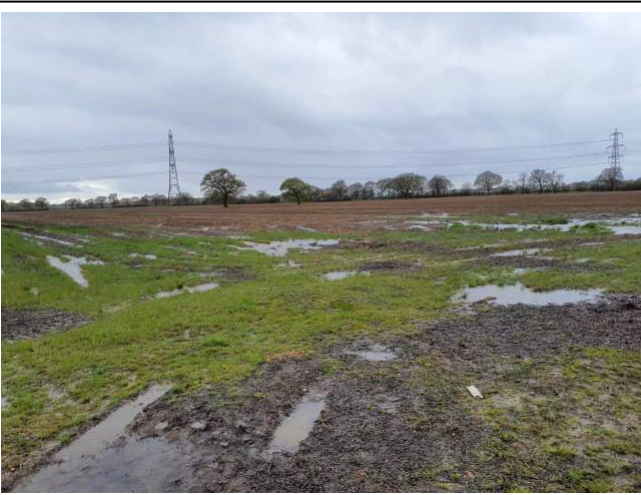
| <p>1a. Main land use(s)</p> | <p>2a. Left Pylon within the boundary, pylon to the right not within 2a</p> | <p>NW</p> | |

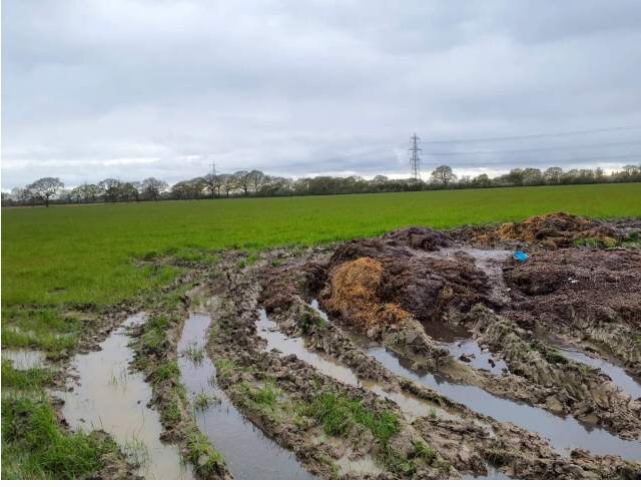
| <p>1a. Main land use(s)</p> | <p>3b with manure/silage pile in the field entrance</p> | <p>W</p> | |

Due to recent weather, fields were very wet underfoot with areas of waterlogging. Access into 3a and 3c was difficult without jumping a ditch. Manure/waste pile at the entrance to 3b may cause access issues as the area has become flooded with the ruts infilled with boggy material. 3c does not extend all the way to the bottom of the piece of land it is in, but instead stops in line with the tree line at the southern edge of 3d. 3e-3j was inaccessible at the time of the walkover with no safe access from the A163 or available access from the north from other fields.

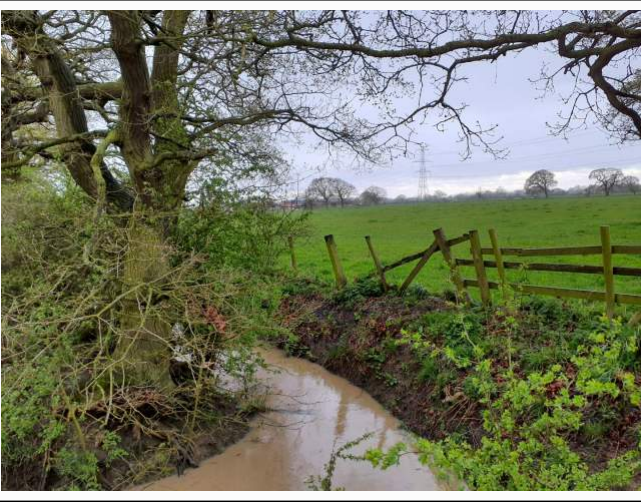
| <p>1a. Main land use(s)</p> | <p>3c. Pylon off boundary</p> | <p>SW</p> | |

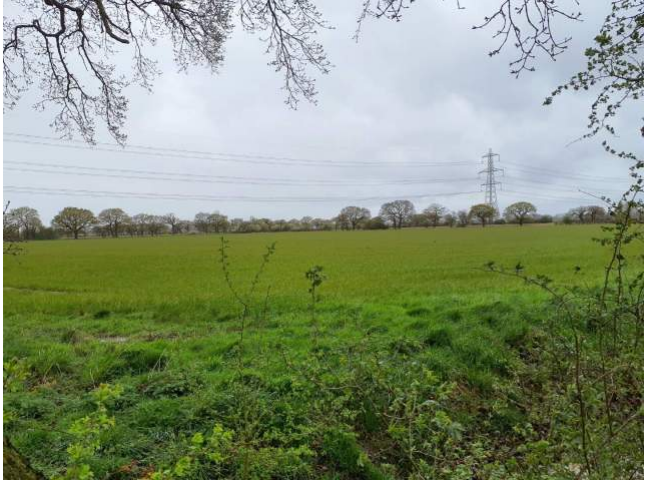
| <p>1a. Main land use(s)</p> | <p>3a. Access into 3a was not possible without jumping a wide ditch</p> | <p>NW</p> | |

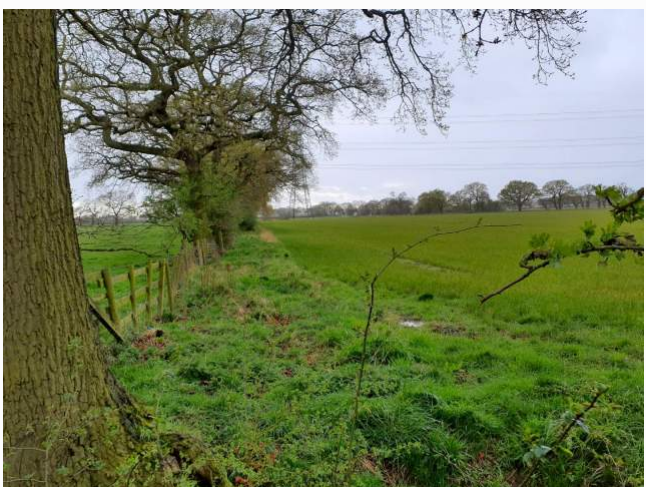
| <p>5c. Buried and overhead services</p> | <p>Pylon on the western edge of 3a</p> | <p>W</p> | |

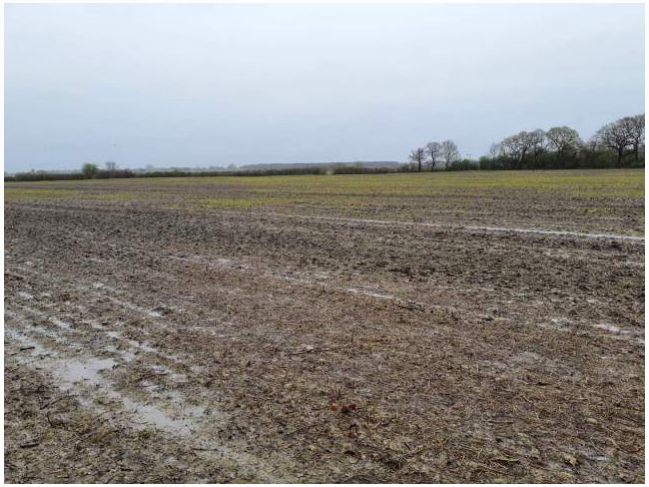
| Select Feature | Description | Direction Taken | |
|---|---|---|--|
| 1a. Main land use(s) | 5a top half | N | |

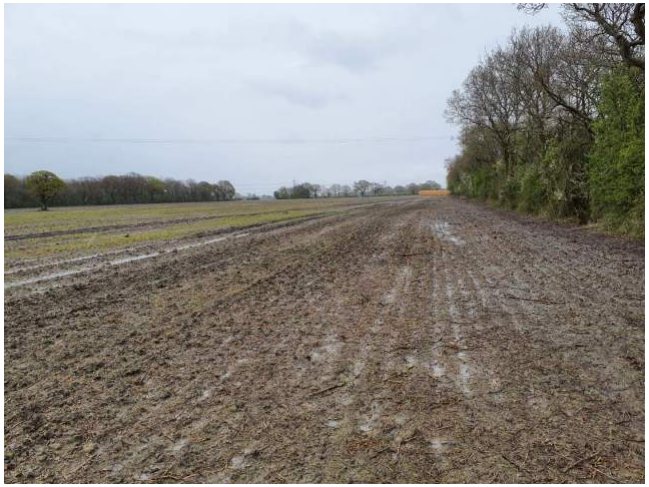
| Select Feature | Description | Direction Taken | |
|---|---|---|--|
| 1a. Main land use(s) | 5a bottom half | S | |

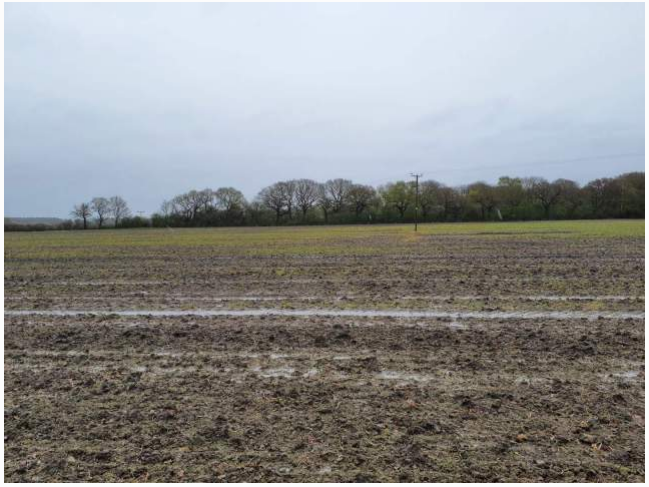
| Select Feature | Description | Direction Taken | |
|---|---|---|--|
| 5c. Buried and overhead services | Powerlines running across 5a into 7 | NE | |

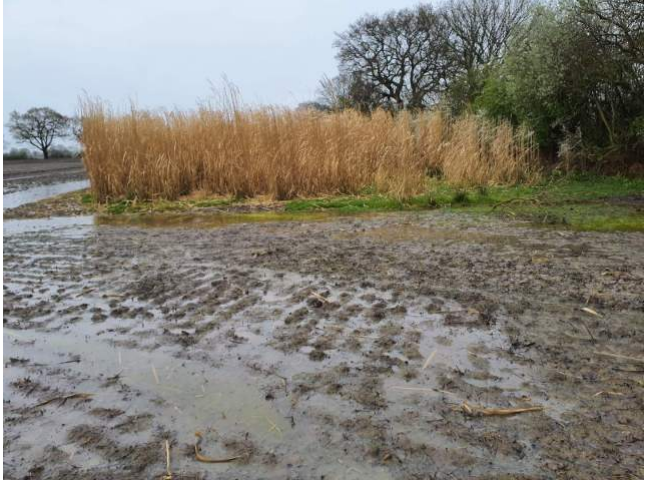
| <p>4d. Surface waters on site</p> | <p>Infiled pond (?) At bottom of 5a</p> | <p>S</p> | |

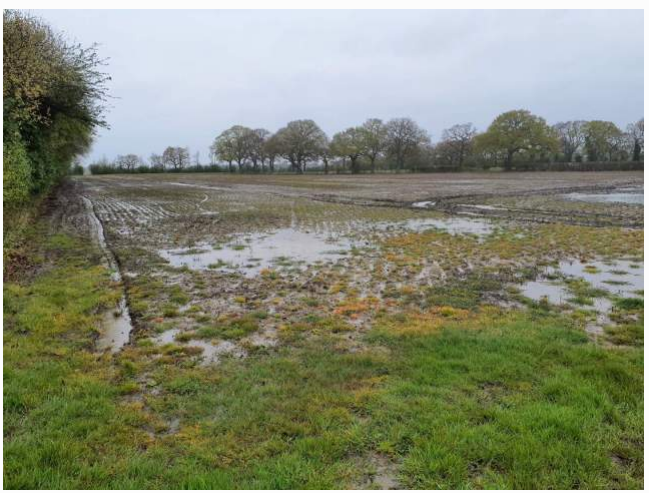
| <p>1a. Main land use(s)</p> | <p>5b from SW corner with 13b beyond the hedge</p> | <p>NE</p> | |

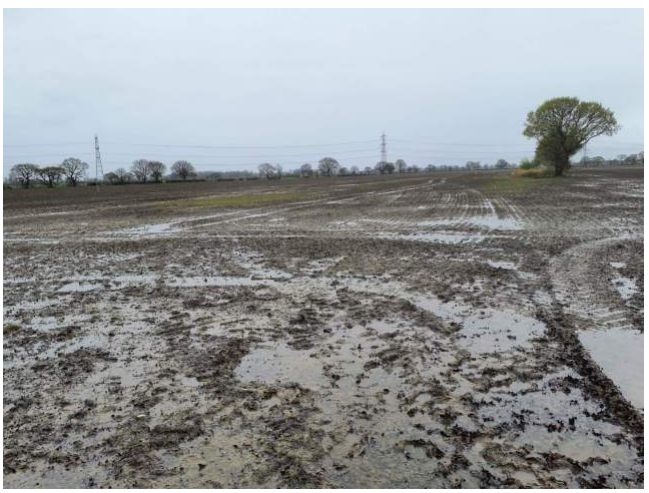
| <p>1a. Main land use(s)</p> | <p>5c eastern third. powerlines off the field</p> | <p>S</p> | |

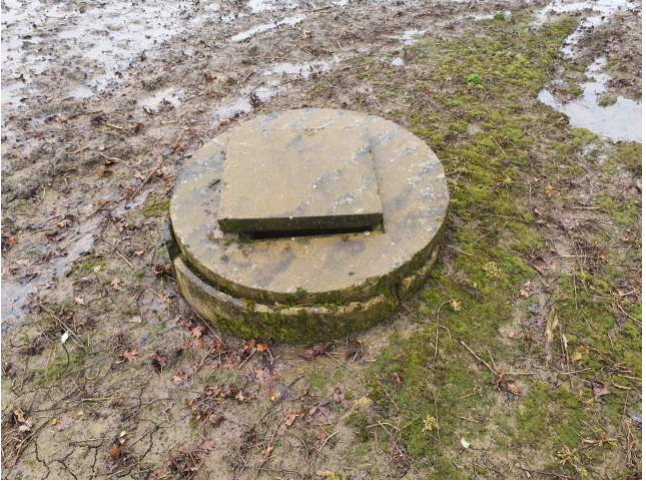
| <p>5d. Underground structures</p> | <p>Drain in 5c</p> | <p>W</p> | |

| <i>Notes / Observations</i> |
|---|
| Many fields were heavily waterlogged. Evidence of land drains beneath fields was found in 5c. Large ditch between 20a and area 4 and 7 had evidence of those fields draining into it. Larger, established flooded areas/small ponds were found in 7c and 5c. 11d was actually a small wooded area and a continuation of the wood on the 18e area of land. |

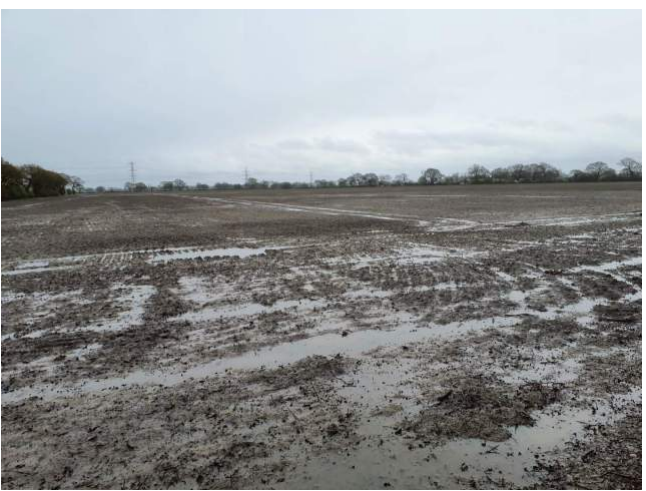
| <p>1a. Main land use(s)</p> | <p>5c middle third. Powerlines beyond field boundary</p> | <p>S</p> | |

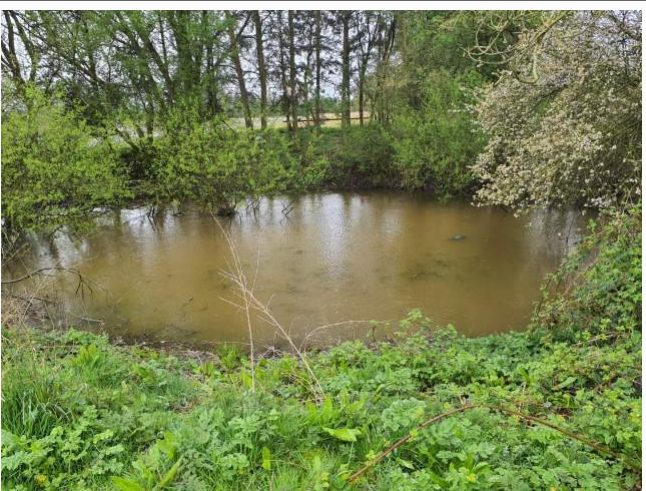
| <p>4g. Site drainage</p> | <p>Waterlogged area at northern edge of 5c</p> | <p>W</p> | |

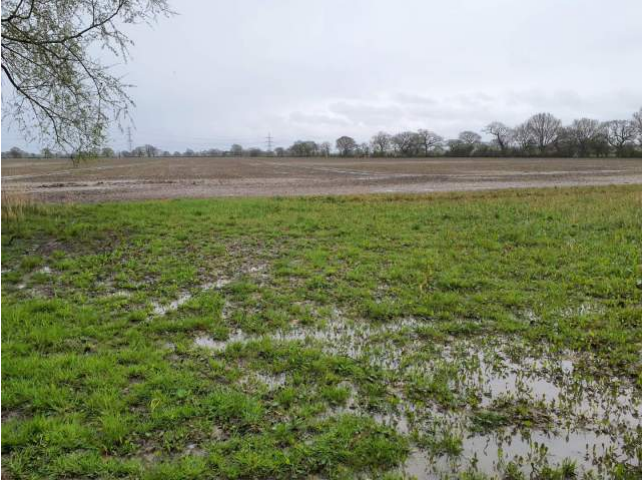
| <p>1a. Main land use(s)</p> | <p>Western third 5c</p> | <p>S</p> | |

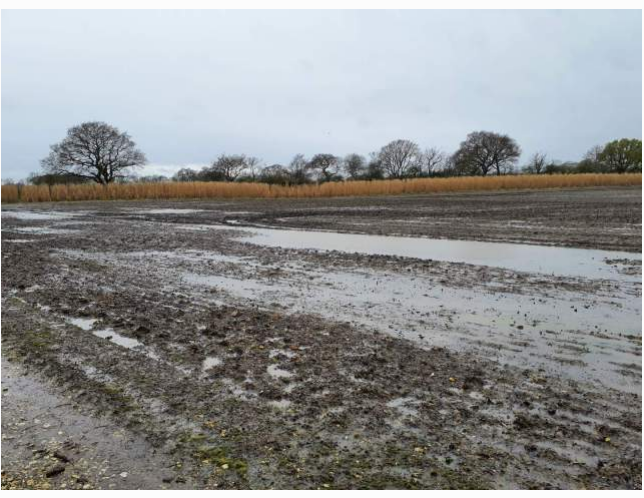
| <p>4d. Surface waters on site</p> | <p>5a full extent of infilled pond</p> | <p>NW</p> | |

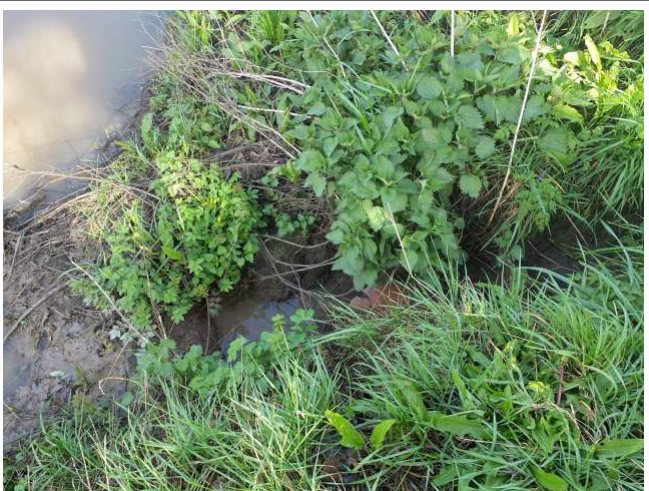
| <p>4g. Site drainage</p> | <p>Drainage from 7b-dry</p> | <p>N</p> | |

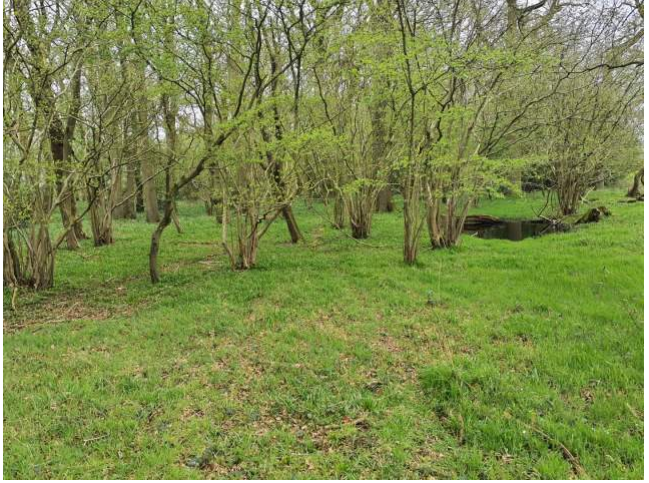
| 1a. Main land use(s) | 11d- actually wooded and not open land | S | |

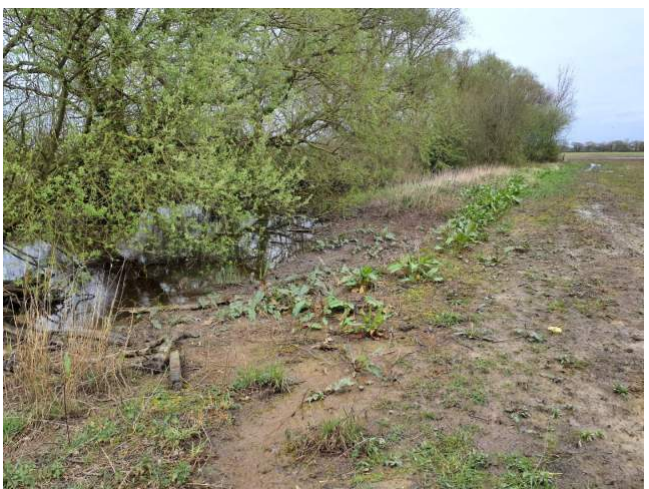
| 4i. Waterlogging or flooding | Flooded area splitting 11i | N | |

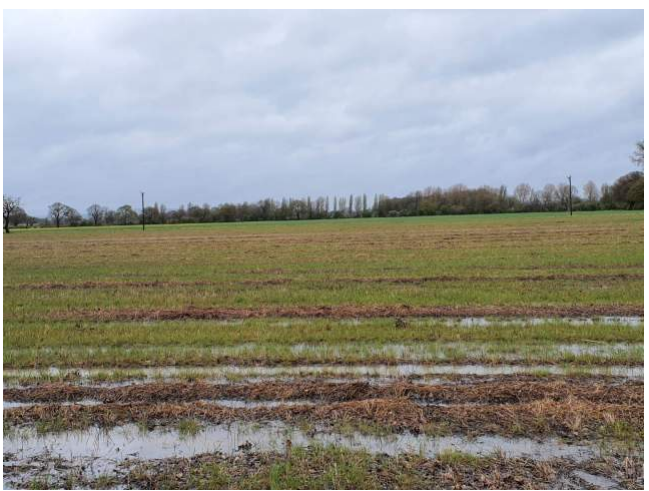
| <p>5c. Buried and overhead services</p> | <p>Pylons running across 16e into 16d and then beyond</p> | <p>E</p> | |

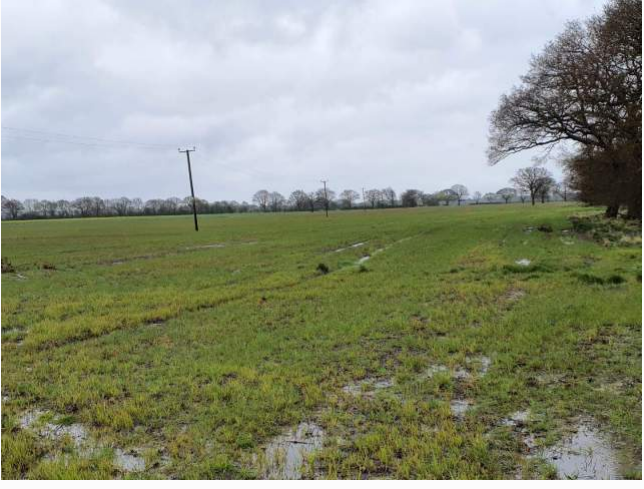
| <p>5c. Buried and overhead services</p> | <p>Pylons running down 16e N-S into 16d</p> | <p>S</p> | |

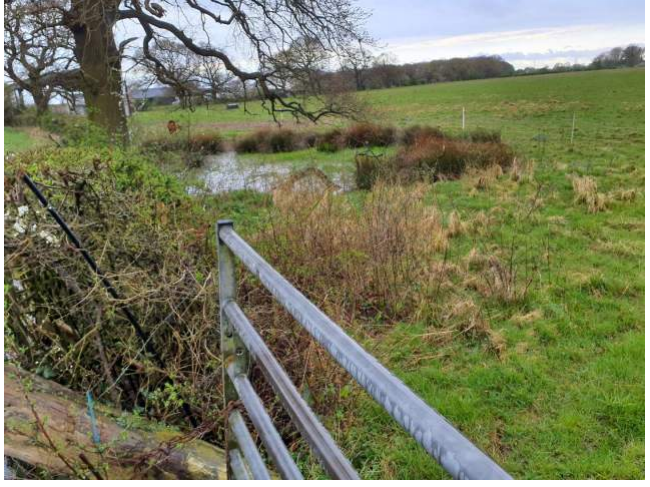
| <p>4i. Waterlogging or flooding</p> | <p>Waterlogged on eastern edge</p> | <p>S</p> | |

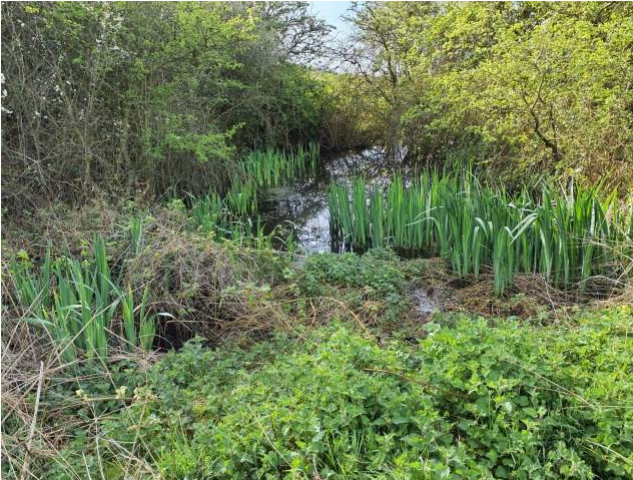
| <i>Select Feature</i> | <i>Description</i> | <i>Direction Taken</i> | |
|---|---|---|--|
| 4e. Surface waters adjacent (within 250m) | Ponder area by SW tip of 14a | S | |

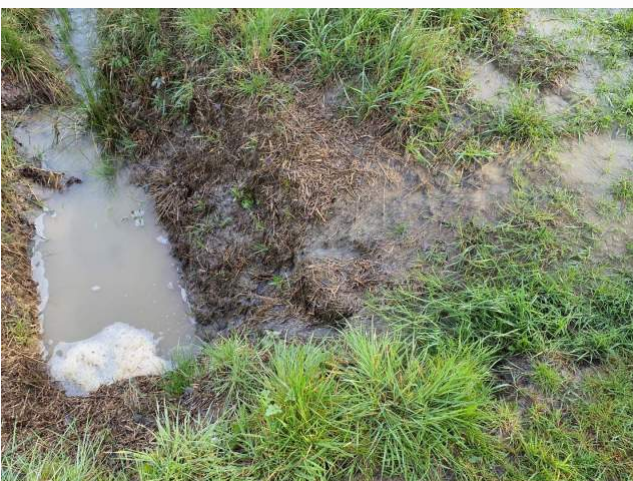
| <i>Select Feature</i> | <i>Description</i> | <i>Direction Taken</i> | |
|---|---|---|--|
| 4g. Site drainage | Drainage into ditch between 14a and 14c | N | |

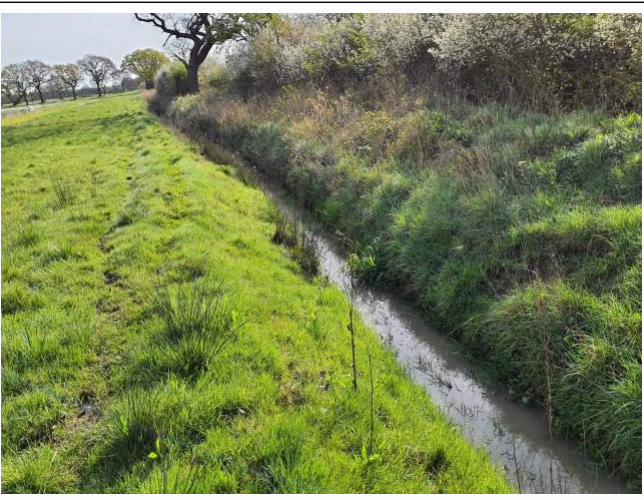
| <p>4g. Site drainage</p> | <p>Ditch at southern edge of 14c</p> | <p>E</p> | |

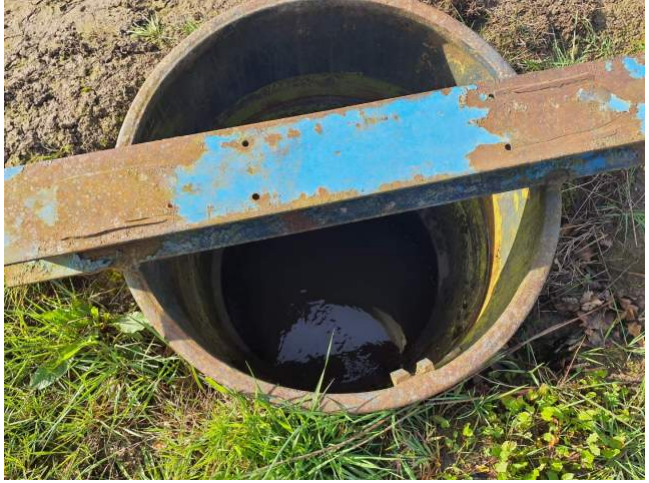
| <p>4g. Site drainage</p> | <p>Drain at top of 20a</p> | <p>N</p> | |

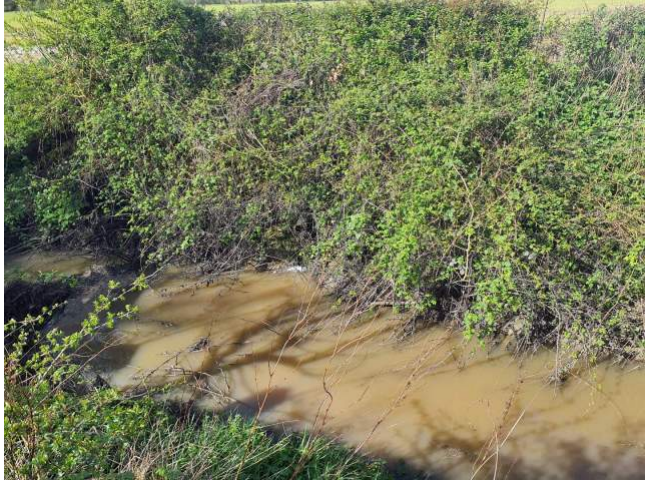
| <p>4g. Site drainage</p> | <p>Drainage from 20a</p> | <p>W</p> | |

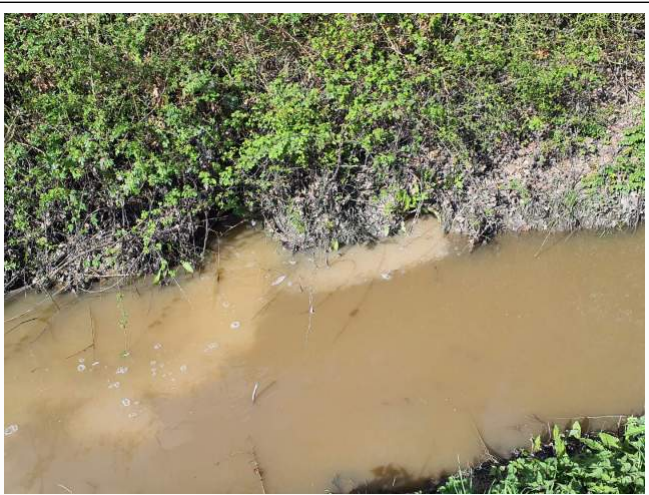
| <p>4g. Site drainage</p> | <p>Drainage from 20a northern half. Significant flow from the left drain</p> | <p>N</p> | |

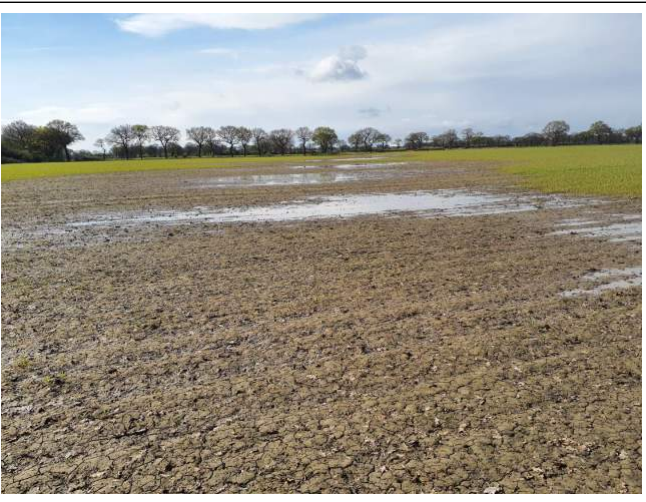
| <p>3d. Surface Cover</p> | <p>Barren area in the middle of the field</p> | <p>S</p> | |

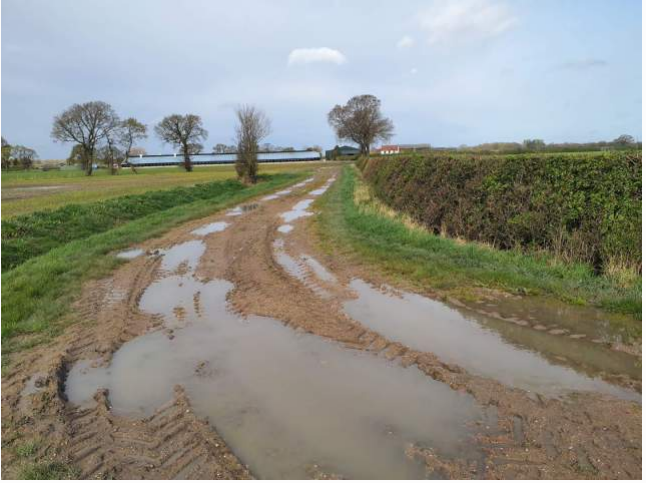
| <p>2a. Access constraints - general.</p> | <p>Road to access many of the fields comes through the farm</p> | <p>N</p> | |

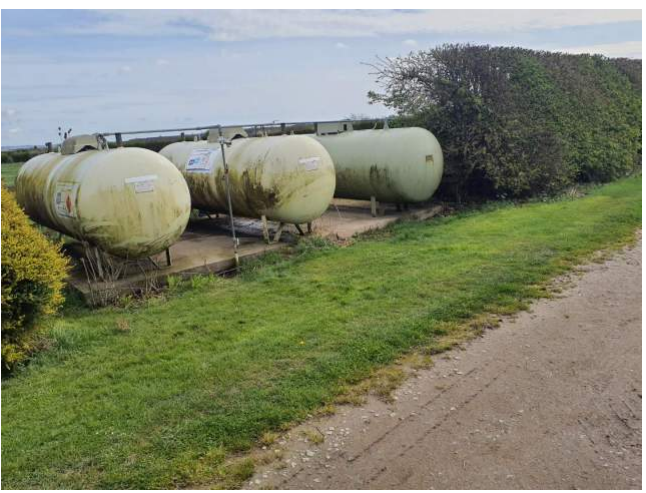
| <p>5a. Existing buildings on-site</p> | <p>Gas tanks on access road</p> | <p>SE</p> | |

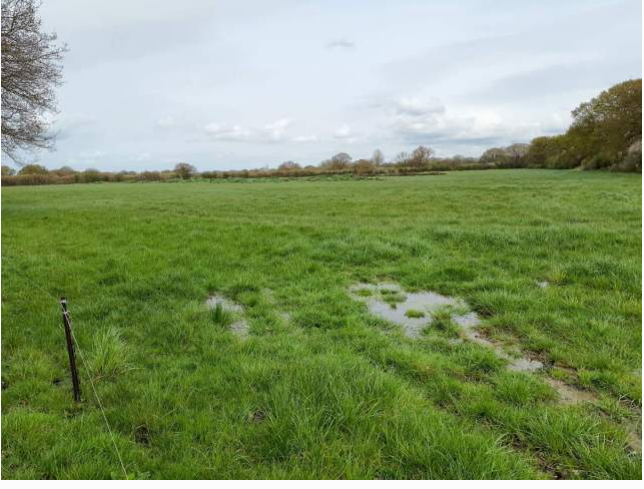
| <p>1a. Main land use(s)</p> | <p>18i with farm waste dumped within</p> | <p>NE</p> | |

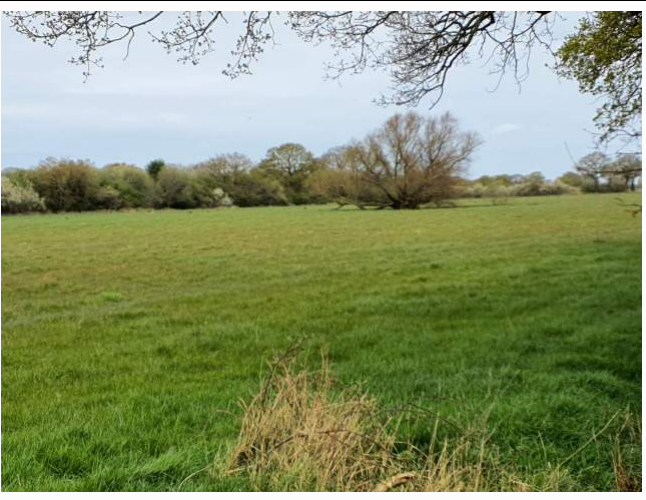
| <p>4d. Surface waters on site</p> | <p>18k infilled pond</p> | <p>NW</p> | |

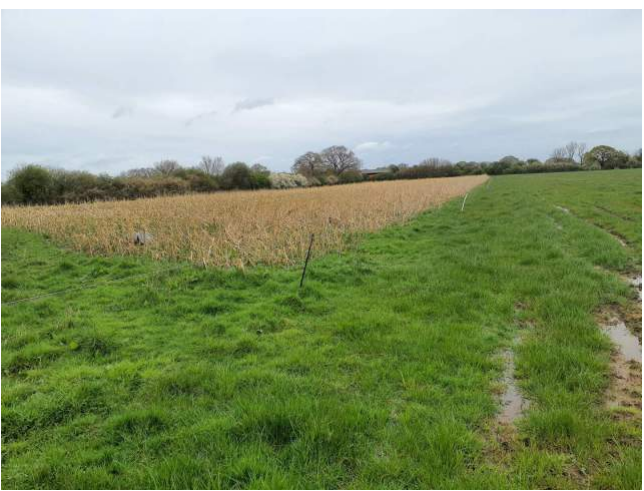
| <p>4d. Surface waters on site</p> | <p>Nw portion of 18c with infilled pond</p> | <p>N</p> | |

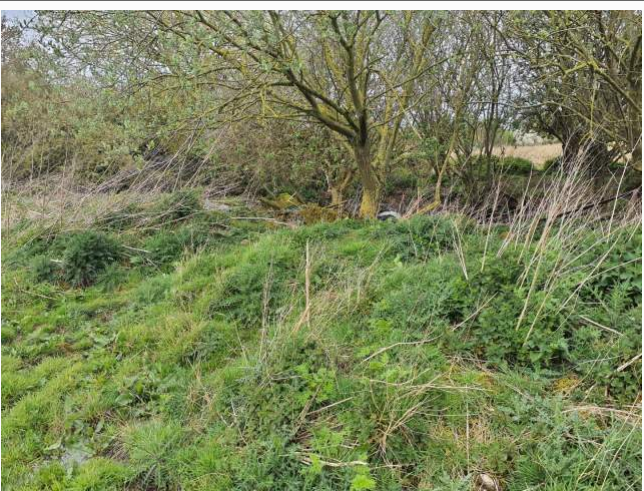
| <p>7d. Fly-tipping</p> | <p>Waste tip in centre west of 18c</p> | <p>N</p> | |

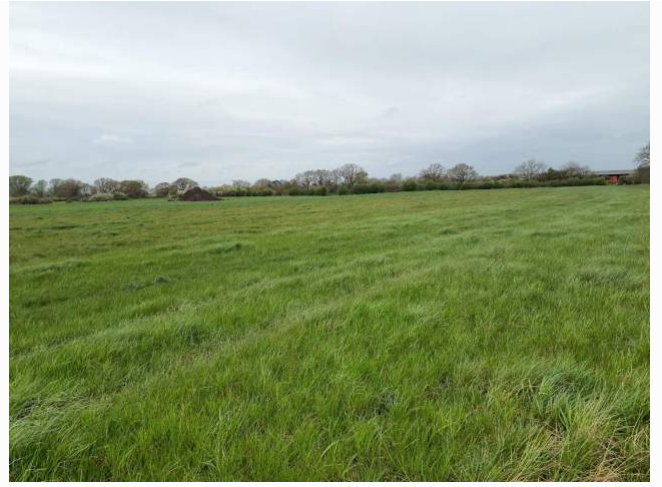
Northern half of 18b
including muck heap

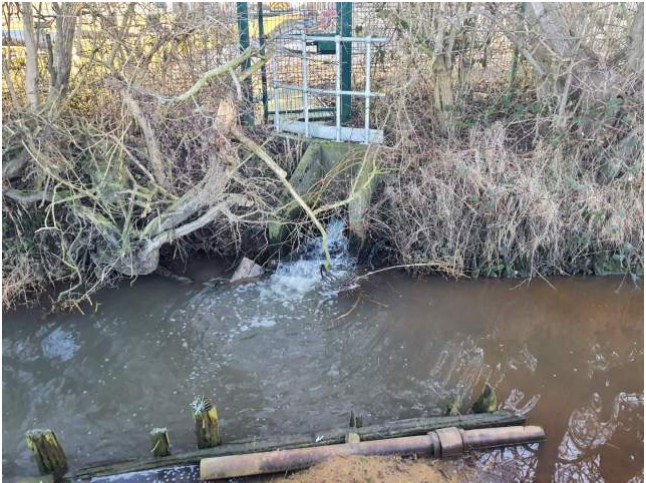
| <p>4h. Outfalls</p> | <p>Outfall from adjacent Morrisons water services/Yorkshire water site into ditch along eastern edge of 23b. No visual/olfactory evidence of contamination.</p> | <p>E</p> | |

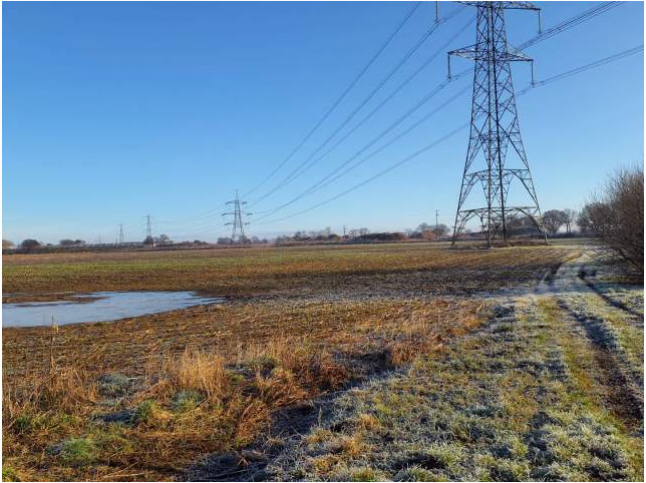
| <p>5c. Buried and overhead services</p> | <p>23c pylons and telephone lines running across 23c from 23f and 23g.</p> | <p>E</p> | |

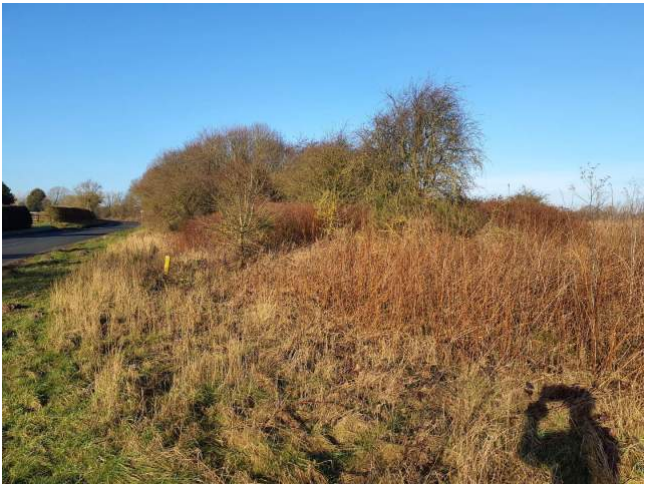
| <p>1a. Main land use(s)</p> | <p>23J. Former landfill now heavily vegetated. From roadside.</p> | <p>W</p> | |

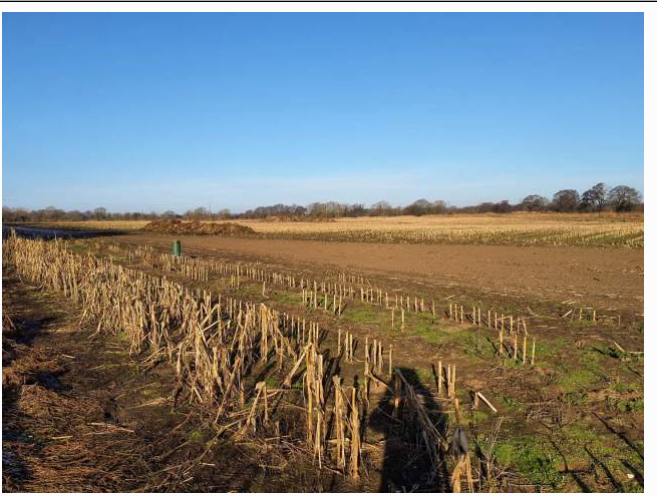
| <p>1a. Main land use(s)</p> | <p>23i. Muck heaps on field. Line of telephone pylons running north-south in field to the west along the boundary.</p> | <p>NW</p> | |

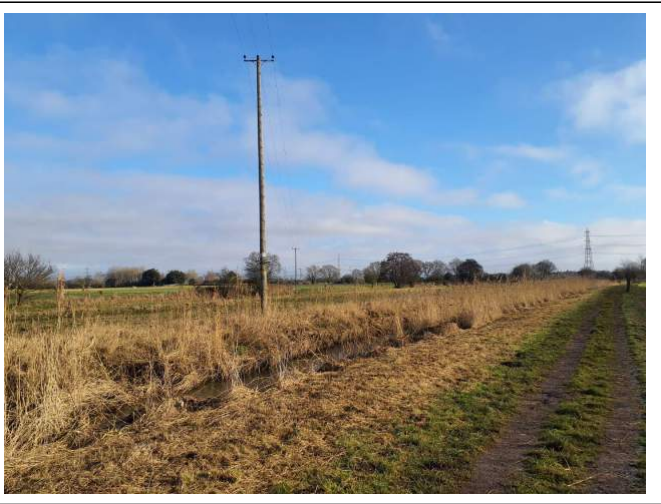
| <p>5c. Buried and overhead services</p> | <p>Pylons within site boundary.</p> | <p>NE</p> | |

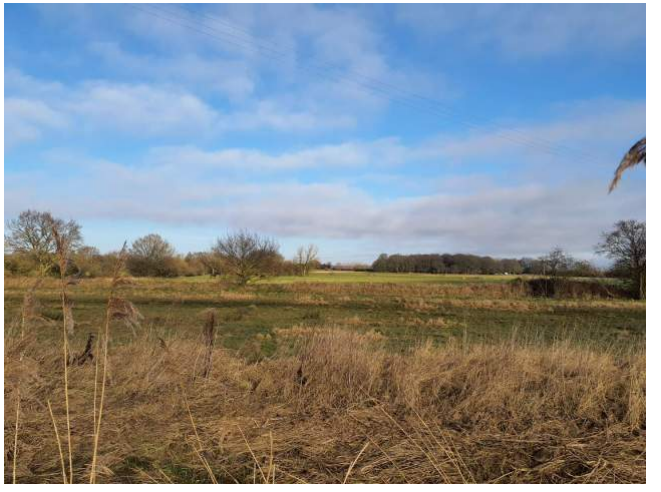
| <p>1a. Main land use(s)</p> | <p>24a (background), 24c (mid) with 23x in foreground. Wooded area is the northern boundary of 24b. Fields not in proposed corridor route lie to the north of 24a.</p> | <p>N</p> | |

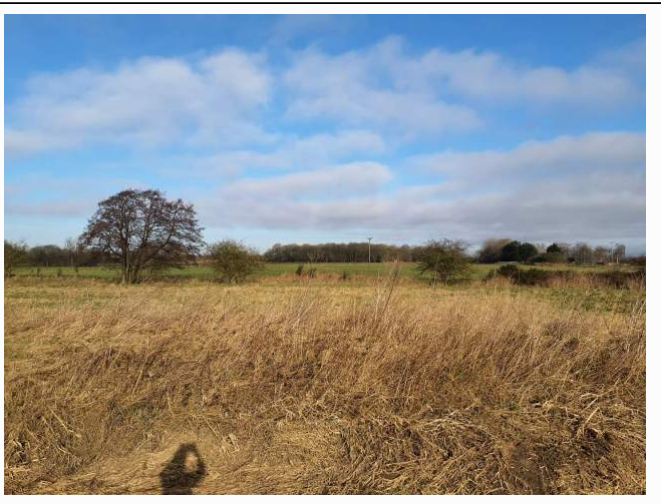
| <p>1a. Main land use(s)</p> | <p>24b (background) and 24d (mid) with 23x in foreground. Woodland area marks northern boundary of 24b. Fenceline on right of photo is boundary with farm and 24e.</p> | <p>N</p> | |

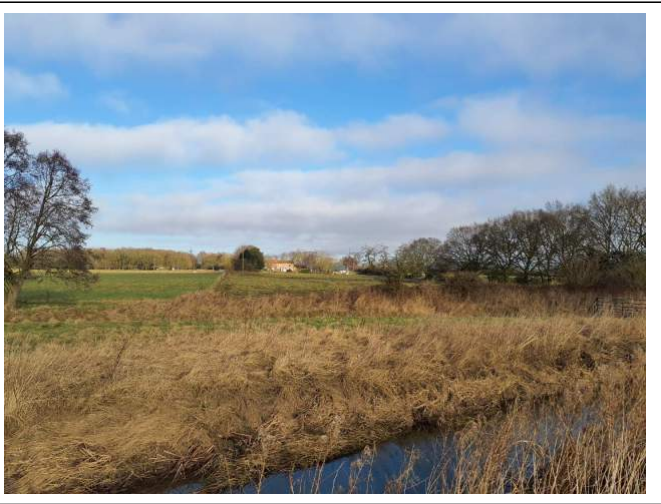
| <p>1a. Main land use(s)</p> | <p>24e, house is northern extent.</p> | <p>N</p> | |

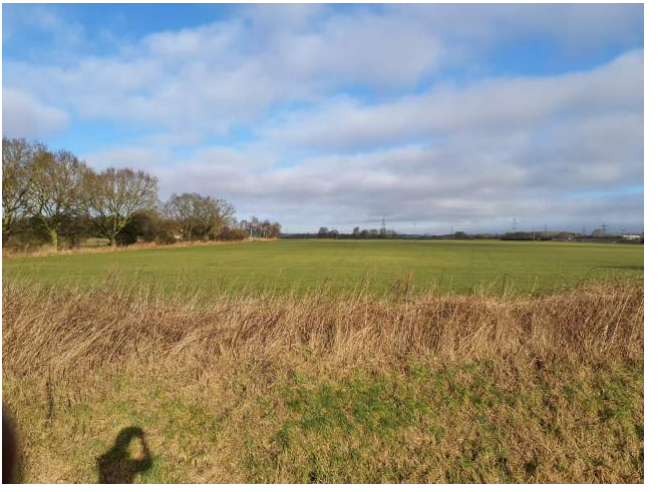
| <p>1a. Main land use(s)</p> | <p>24F. Pylons running west-east across. Farm to west, road to north, 24g to east and canal/beck to the south.</p> | <p>N</p> | |

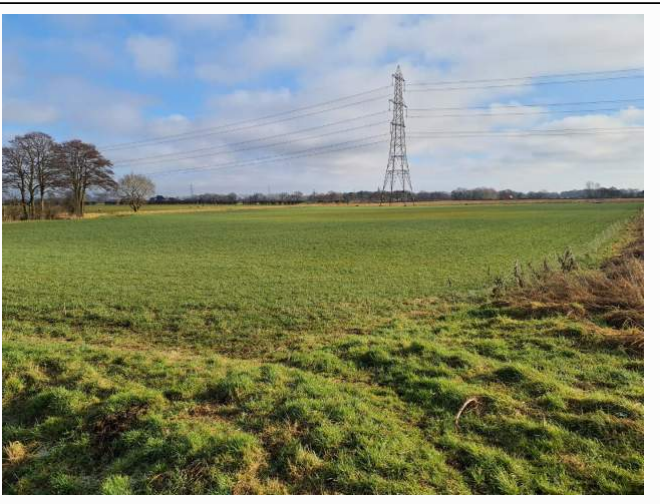
| <p>1a. Main land use(s)</p> | <p>23Y. Pylon is on eastern boundary.</p> | <p>N</p> | |

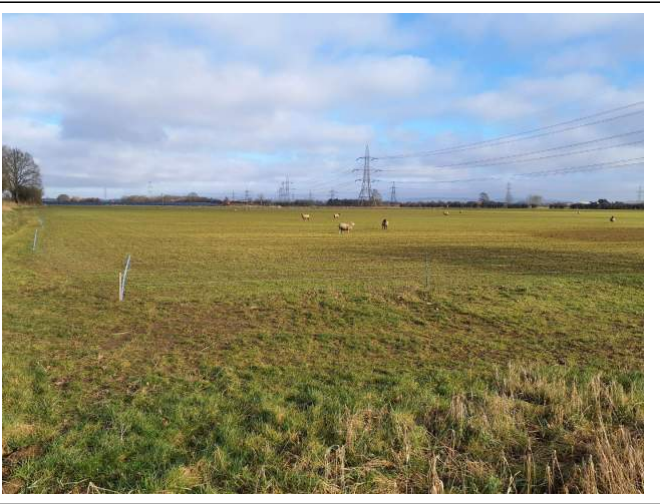
| <p>1a. Main land use(s)</p> | <p>24G. Solar panels already present in North of field. Pylon in northeast corner. Telephone lines running across northwest of field.</p> | <p>N</p> | |

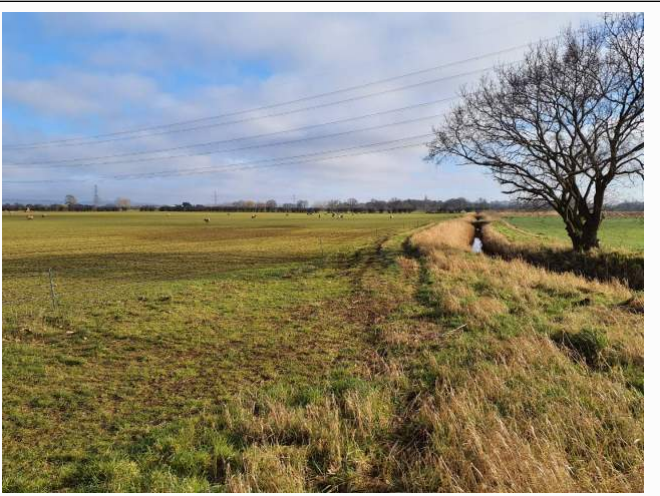
| <p>1a. Main land use(s)</p> | <p>Southern end of 24G. Ditch and 23y to South. Field outside of survey to east.</p> | <p>E</p> | |

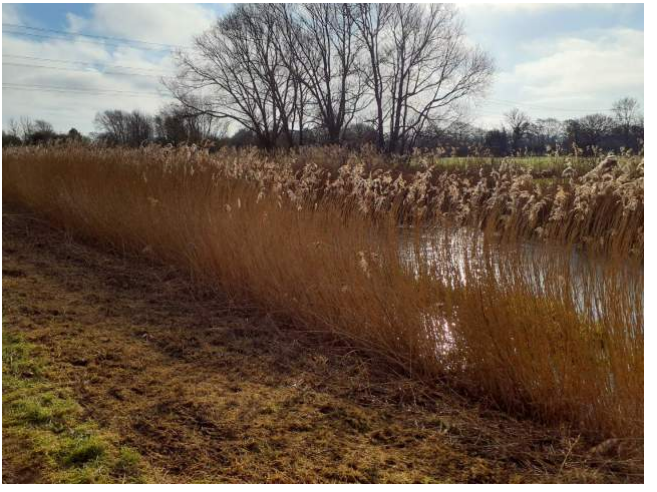
| <p>4d. Surface waters on site</p> | <p>Canal in the eastern end of proposed route, south of 23y.</p> | <p>S</p> | |

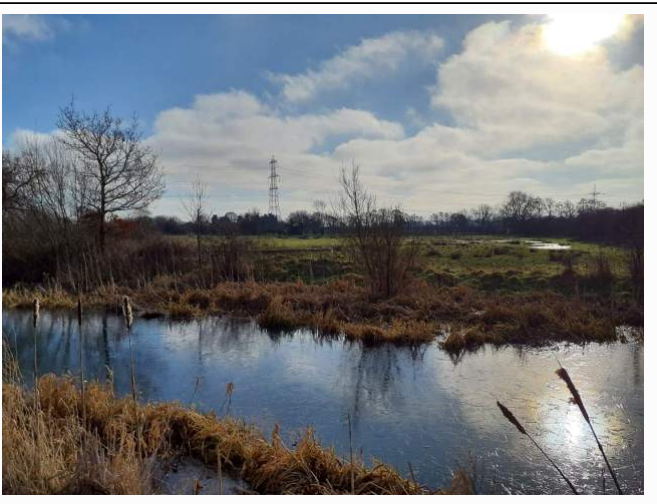
| <p>1a. Main land use(s)</p> | <p>23u from the North, across the canal.</p> | <p>S</p> | |

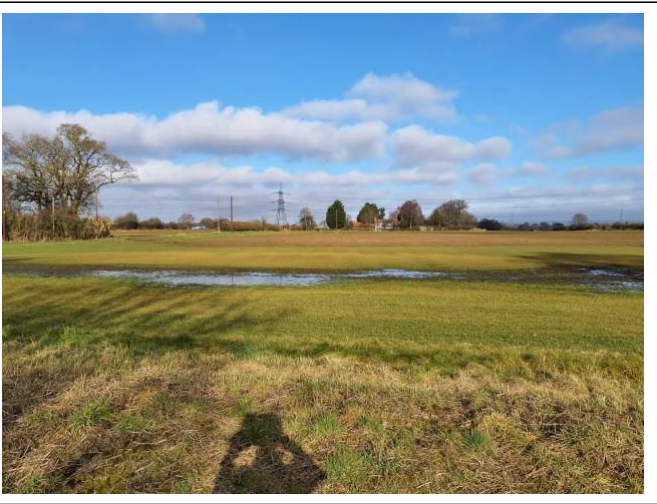
| <p>1a. Main land use(s)</p> | <p>West Side of 24H, showing telephone lines and other wires along western edge. Picture taken from road.</p> | <p>N</p> | |

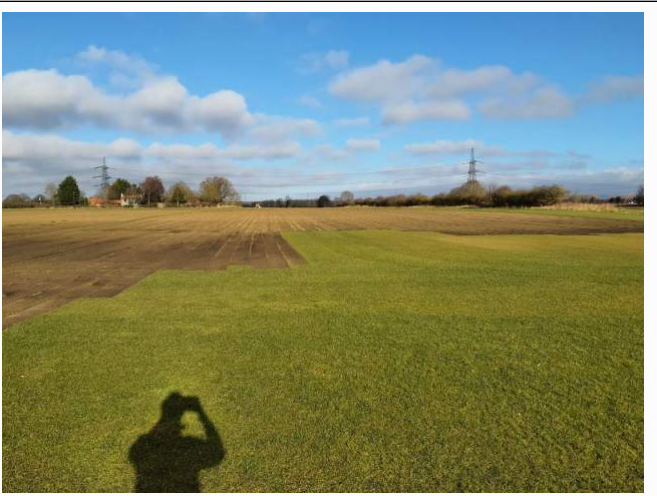
| <p>1a. Main land use(s)</p> | <p>Eastern side of 24H. Hedge marks eastern boundary.</p> | <p>N</p> | |

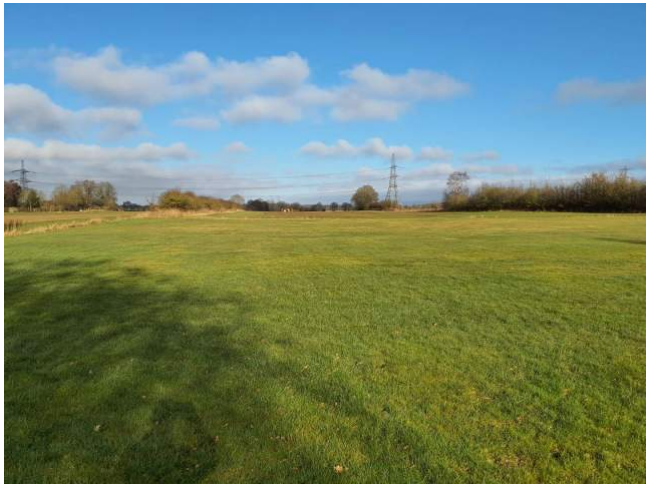
| <p>1a. Main land use(s)</p> | <p>24I. Runs parallel with H and J up to small track that forms northern edge with 24L.</p> | <p>N</p> | |

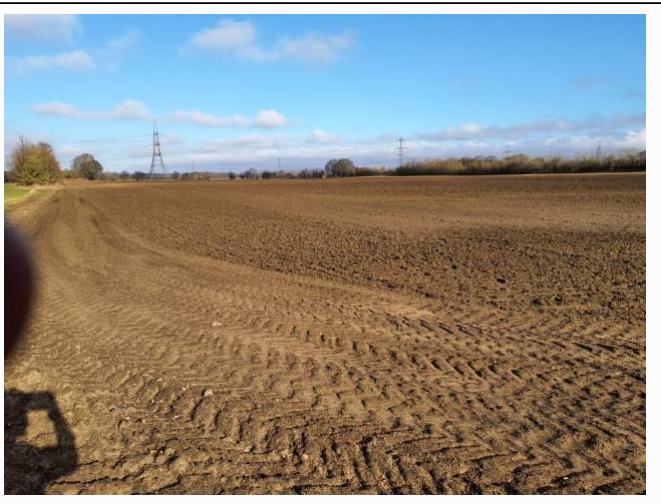
| <p>1a. Main land use(s)</p> | <p>24J. Pylon beyond northern border is in 24L.</p> | <p>N</p> | |

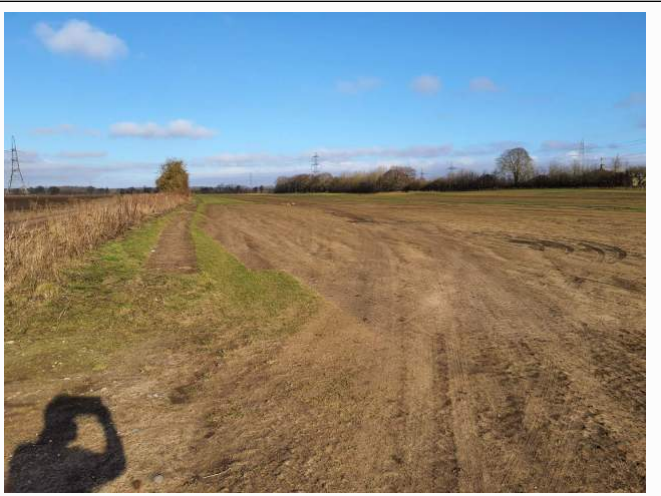
| <p>1a. Main land use(s)</p> | <p>24K. H-K have road as the southern edge. Hedge marks eastern boundary.</p> | <p>N</p> | |

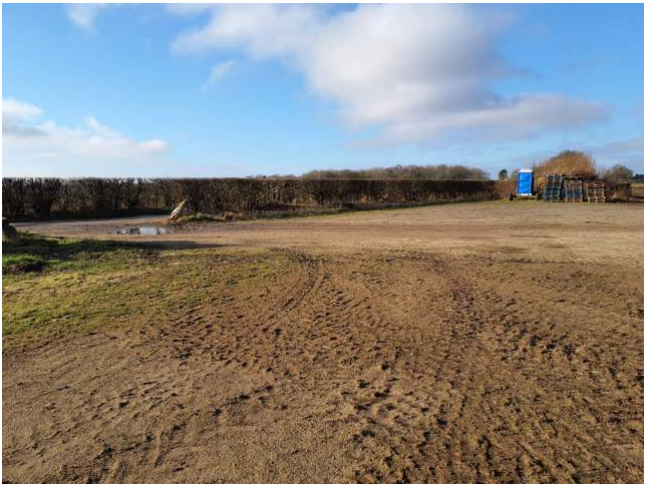
| <p>2a. Access constraints - general.</p> | <p>Access into 24k from road. Note parking area and waste on site in the background.</p> | <p>N</p> | |

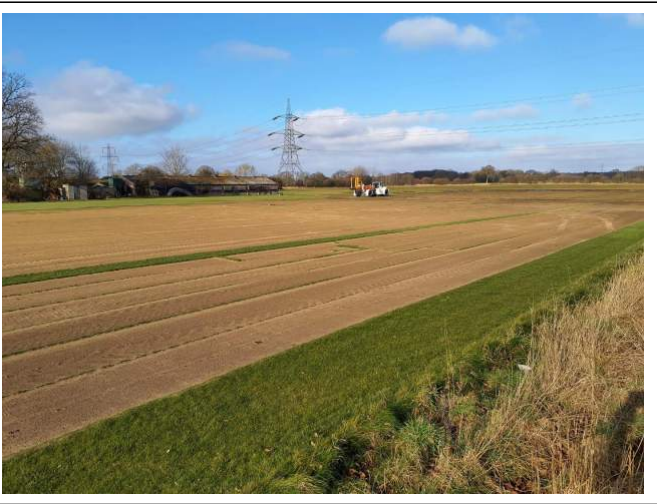
| <p>1a. Main land use(s)</p> | <p>Top corner of 24H.</p> | <p>W</p> | |

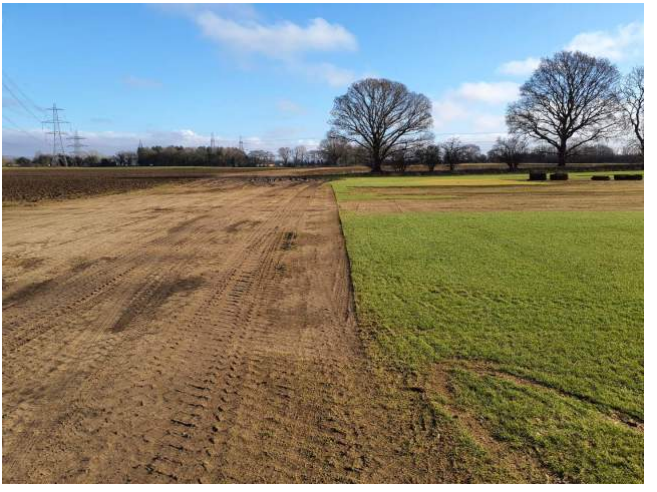
| <p>1a. Main land use(s)</p> | <p>Track marking northern edge of 24I-K, running east from farm buildings in 24H.</p> | <p>E</p> | |

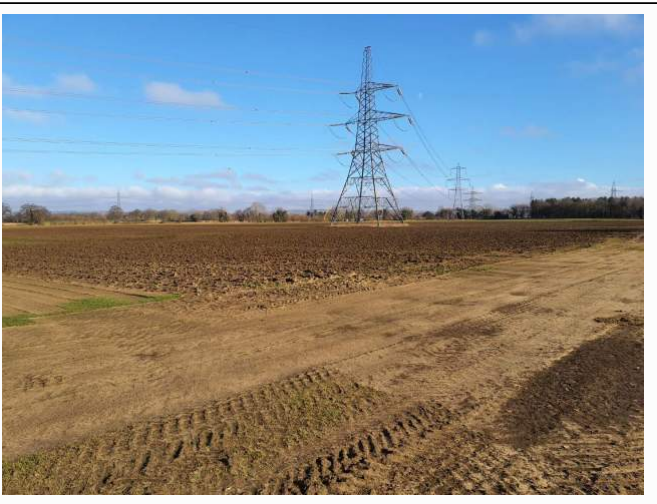
| <p>1a. Main land use(s)</p> | <p>24L. Both electricity pylons are in this field running towards the substation off site beyond fields not in survey area.</p> | <p>E</p> | |

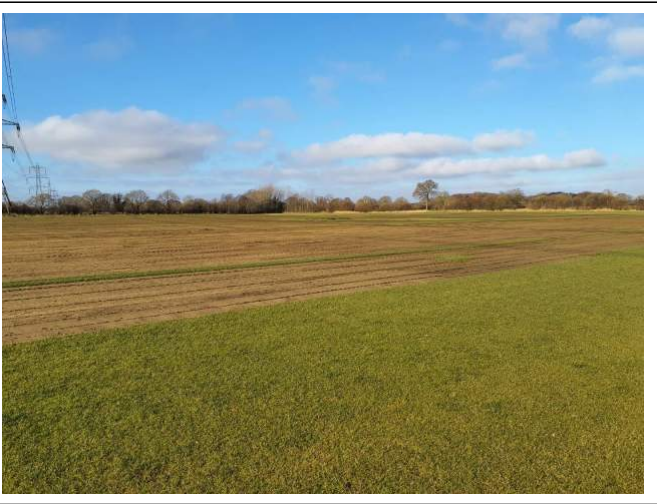
| <p>1a. Main land use(s)</p> | <p>24M. Pylon on field boundary (not clear if in survey area or not). Field bound by hedgerows to W, N, E which are along ditches.</p> | <p>NW</p> | |

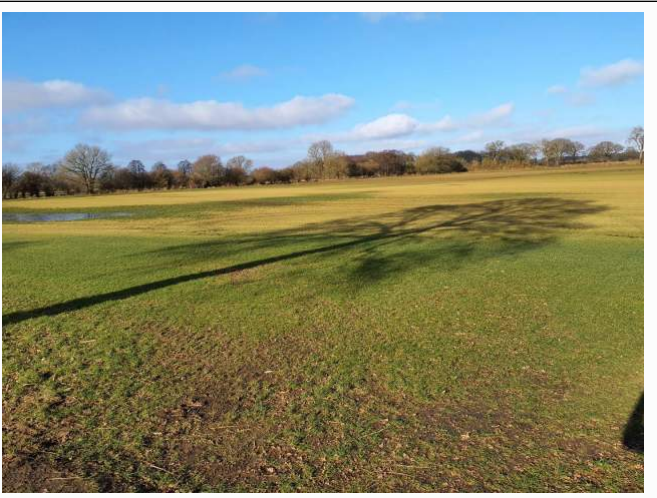
| <p>1a. Main land use(s)</p> | <p>24N western third. Northern border is small hedge. Large hedge to west. Ditch and 24M to south.</p> | <p>N</p> | |

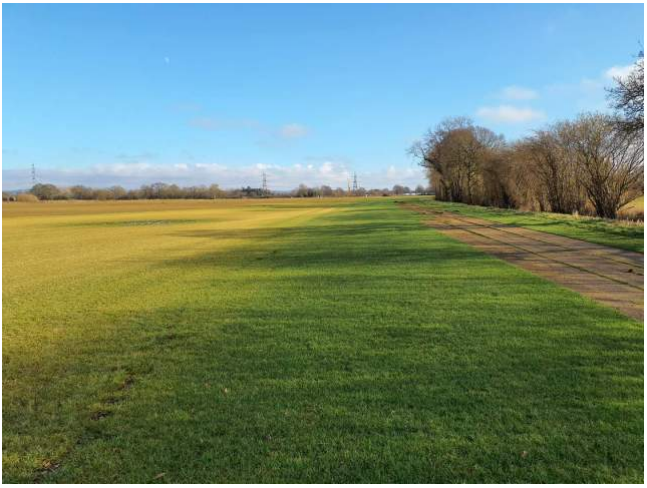
| <p>1a. Main land use(s)</p> | <p>24N eastern 2/3rds.</p> | <p>E</p> | |

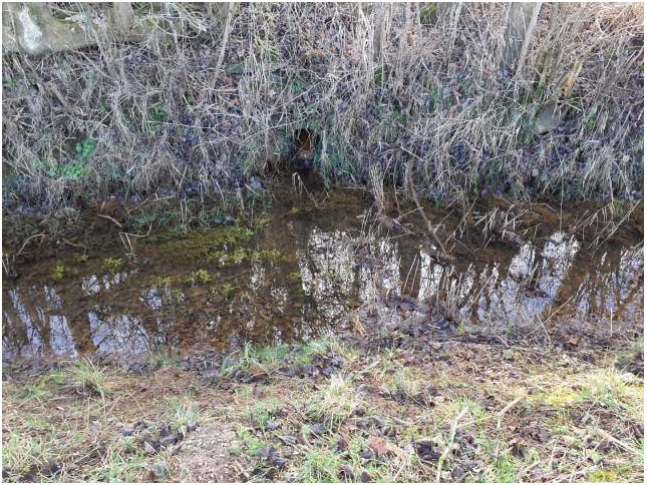
| <p>4g. Site drainage</p> | <p>Field drains from 24M. Water clear.</p> | <p>S</p> | |

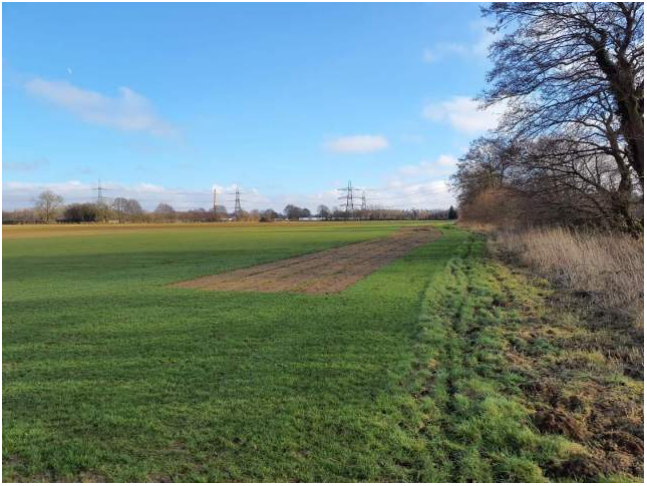
| <p>1a. Main land use(s)</p> | <p>24N eastern half. Boundary is treeline behind excavator in background of photo.</p> | <p>E</p> | |
