FORMATION TESTING REPORT RESULTS

Company CANDECCA RESOURCES Ltd Well No SEATON ROSS 4 I Test No 2

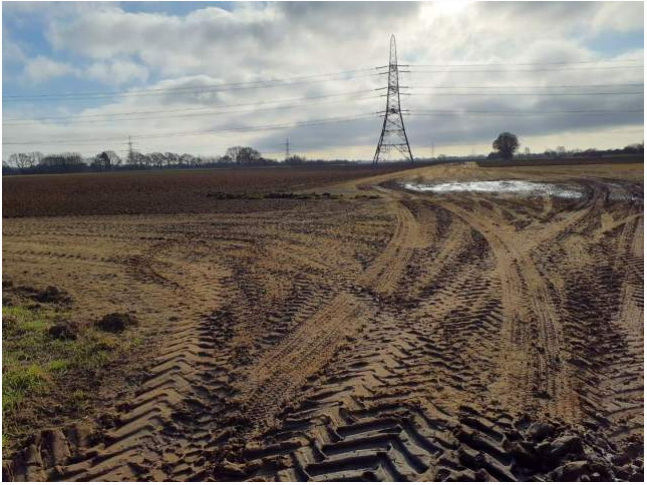
| <p>2a. Access constraints - general.</p> | <p>Access track from 24L to 24N.</p> | <p>S</p> | |
